Inspection Photos

Loc: 380903

Operator: WAVETECH HELIUM INC

Inspection Date: 2/26/2025

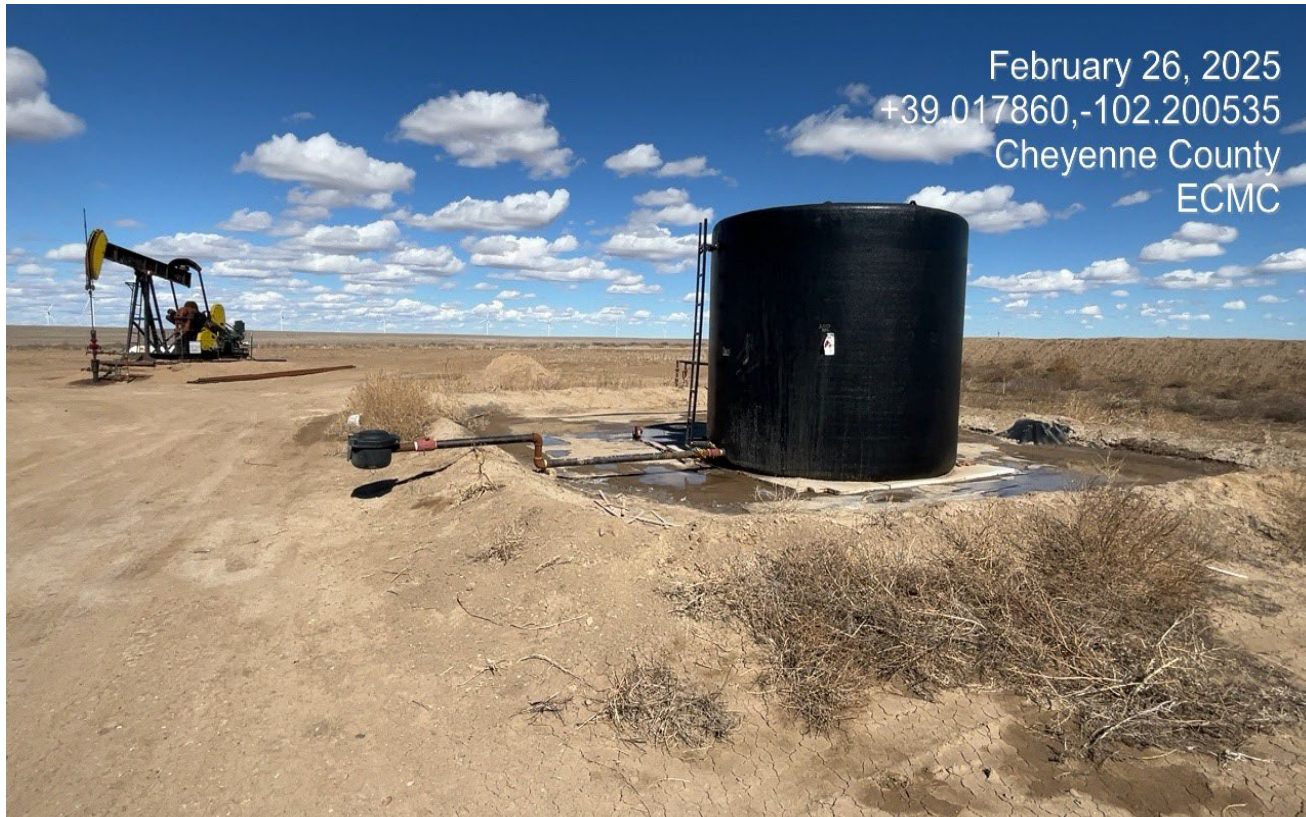
Photo 2. Facing northeast toward the wellsite..

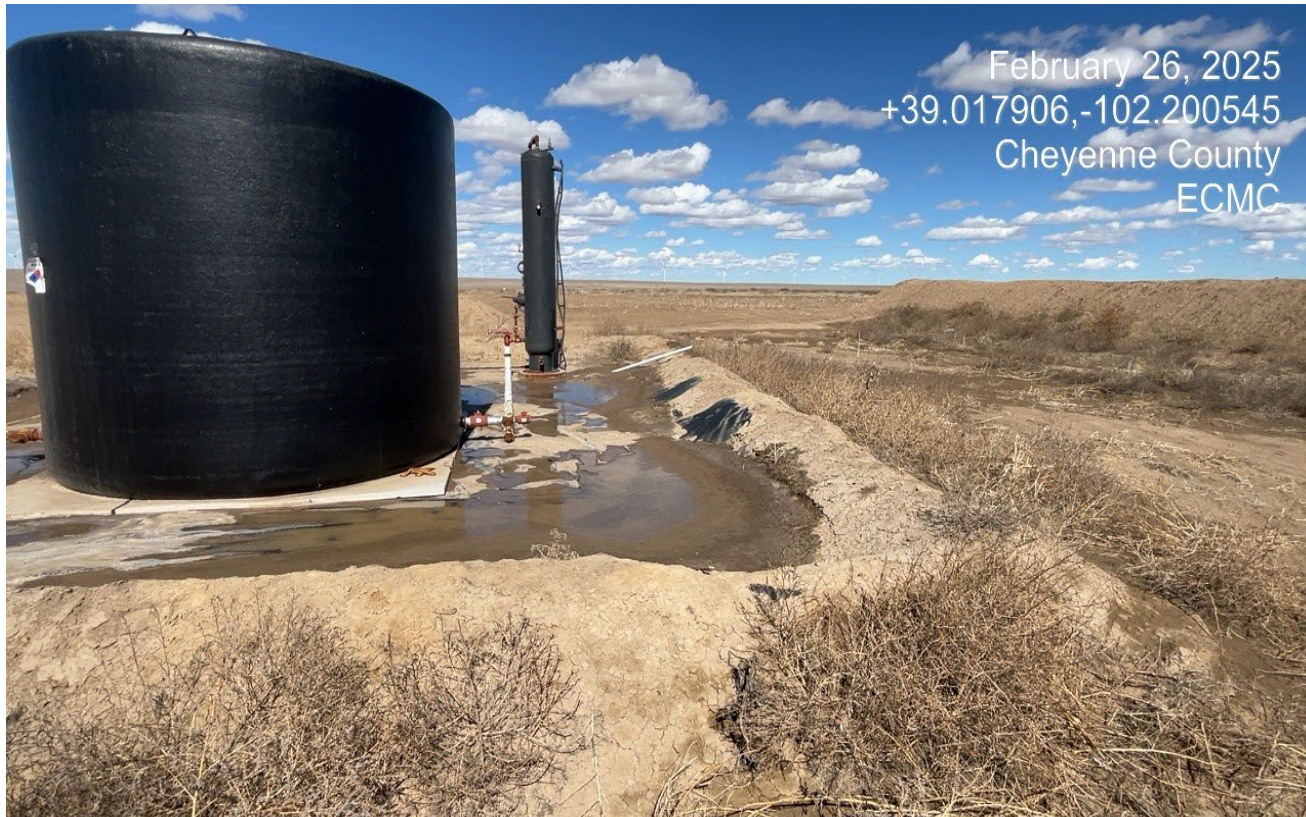
Photo 2. The berm is worn down in this area. This berm is not designed to resist degradation from erosion and there are weeds growing along the berm.

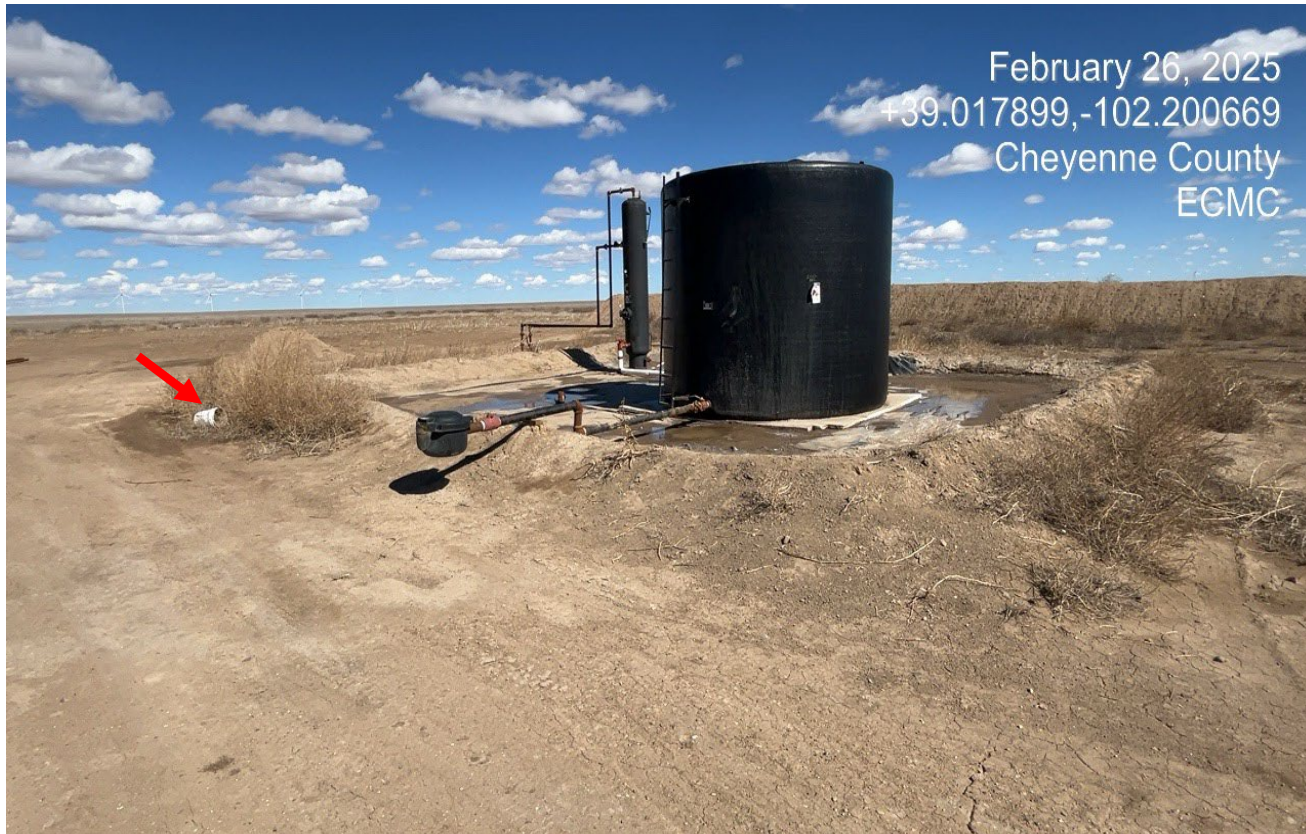
Photo 3. There are undesirable weeds growing along the berm that must be controlled. The white bucket needs to be removed as well. Previous CA was not completed.

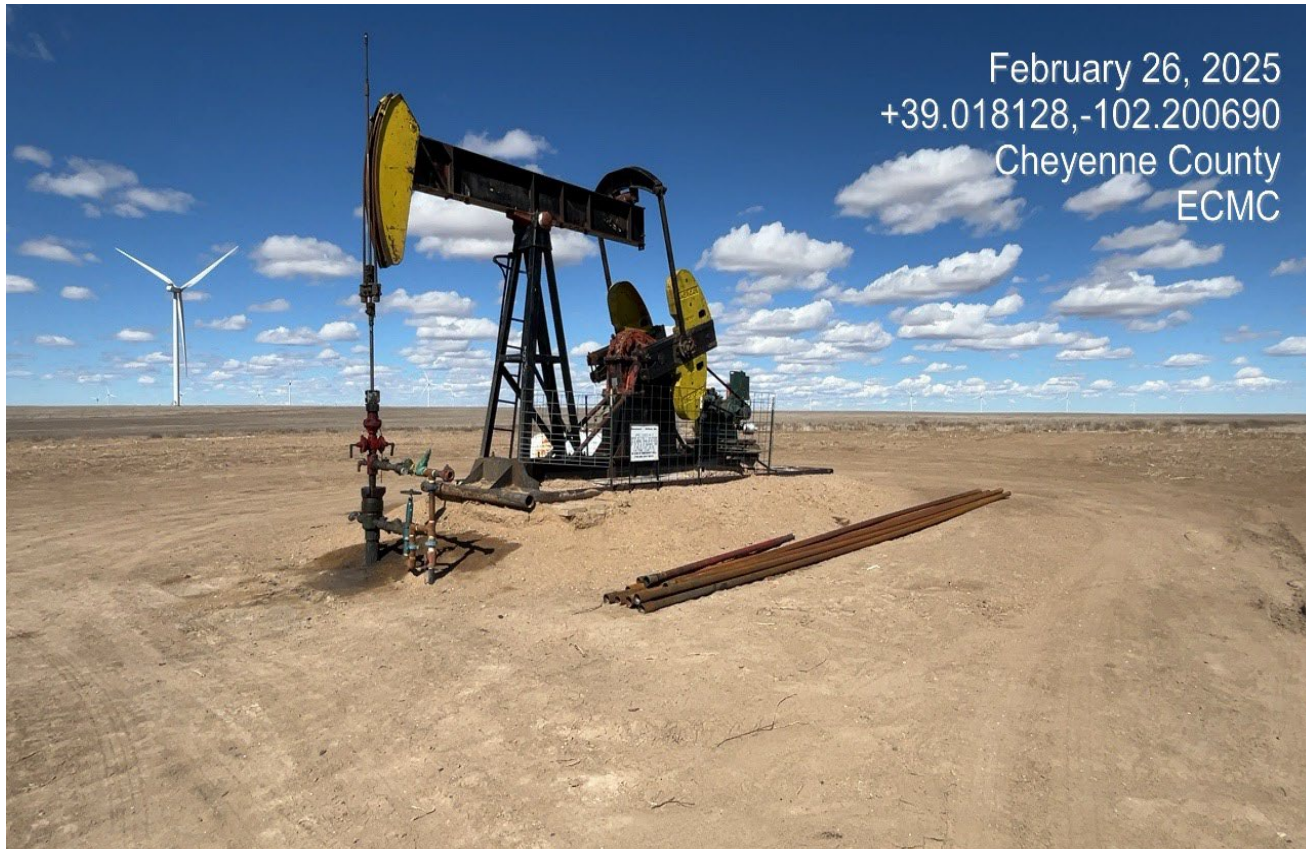
Photo 4. Facing toward the producing well. There are stained soils at the wellhead that must be cleaned up. Previous CA was not completed.

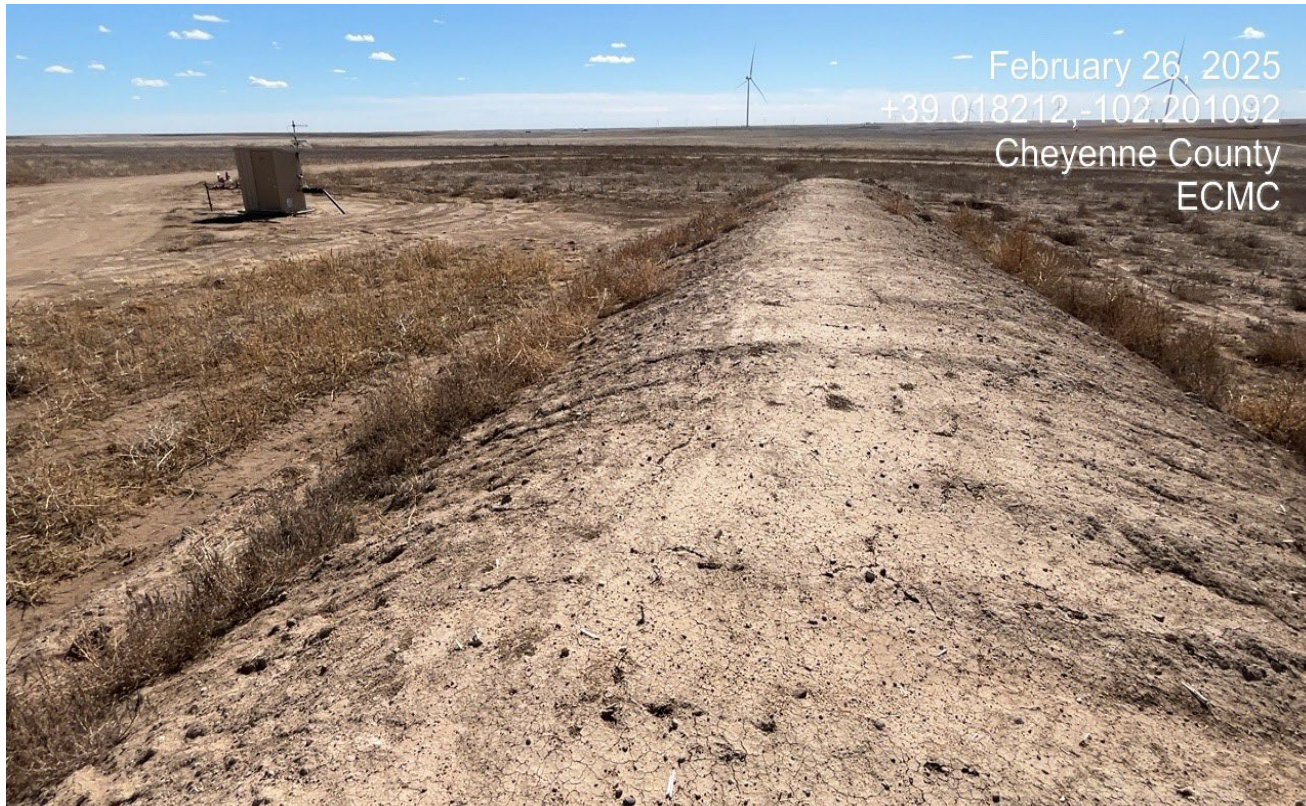
Photo 5. Facing south at the topsoil pile at the west side of the location. Topsoil is not being protected and needs to be replaced for interim reclamation.

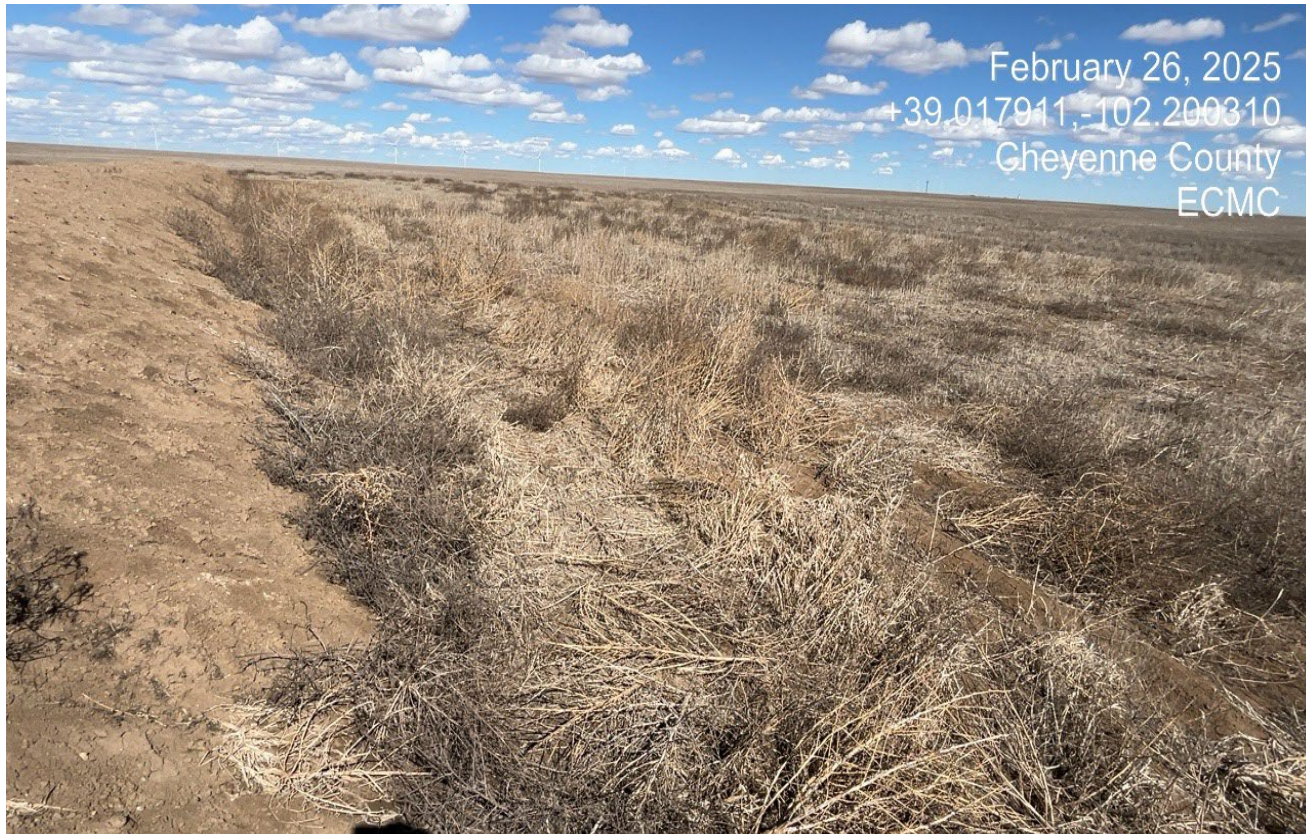
Photo 6. View of undesirable weeds growing throughout the disturbance area. The weed debris will need to be removed and weed control will need to be performed.
