Inspection Photos
Location: MPU Press Maint and Inject Facility
Location ID: 255968
Spill ID # 489244

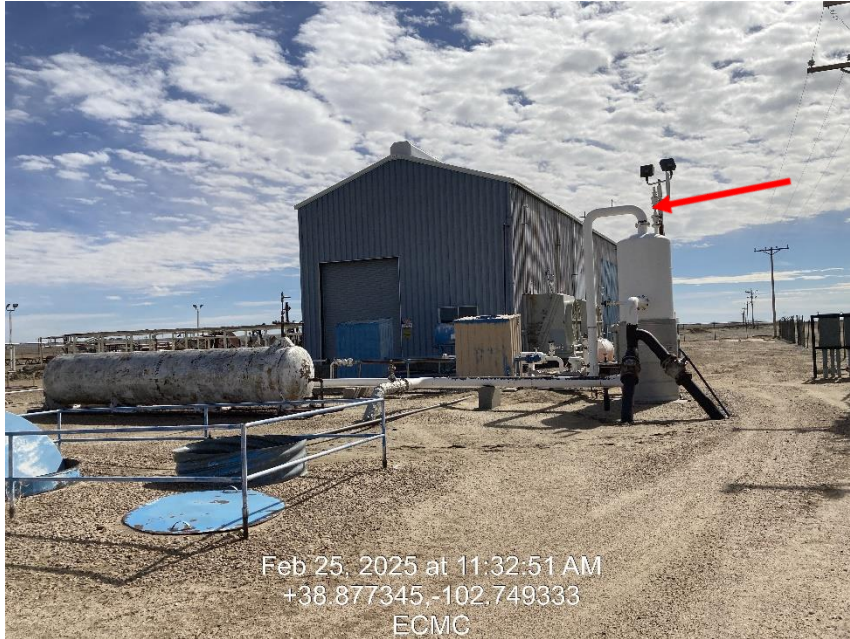
Photo 1 – MPU Press Maint and Inject Facility

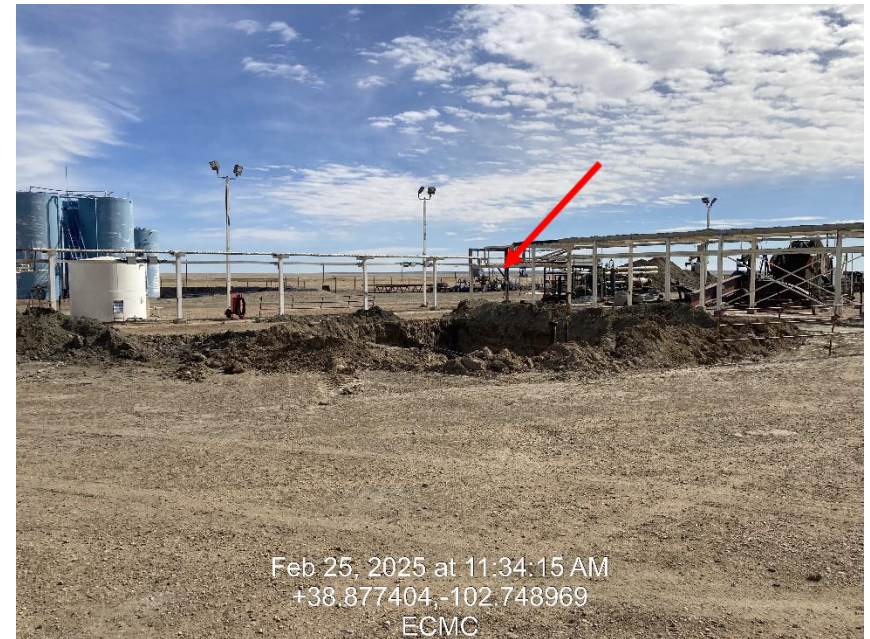
Photo 2 – Excavation area 1

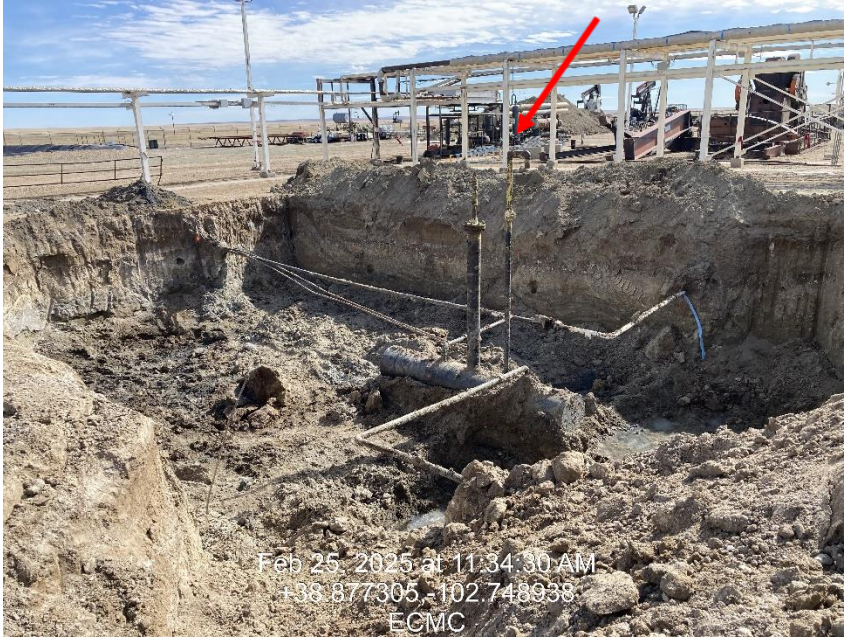
Photo 3 – Excavation area and equipment

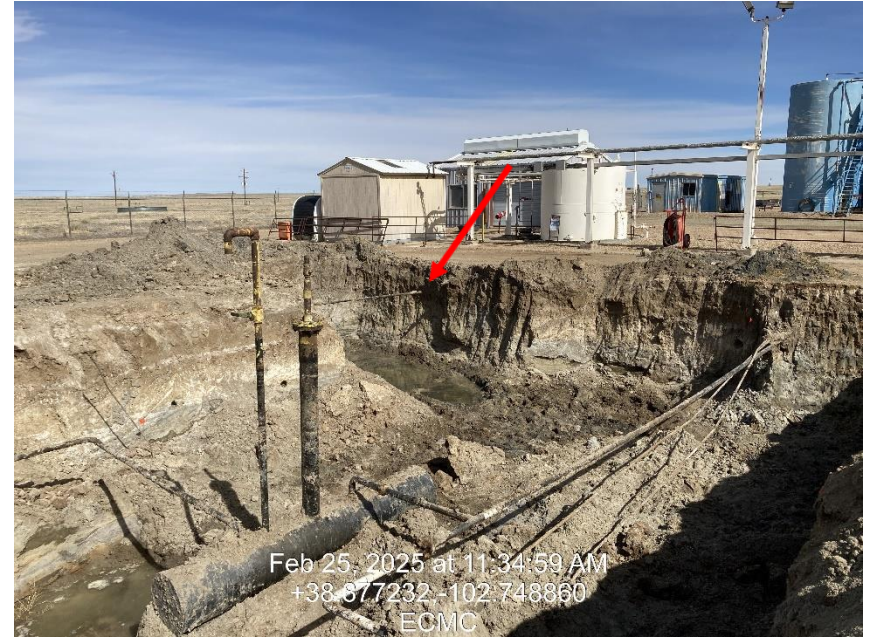
Photo 4 – Excavation area and equipment

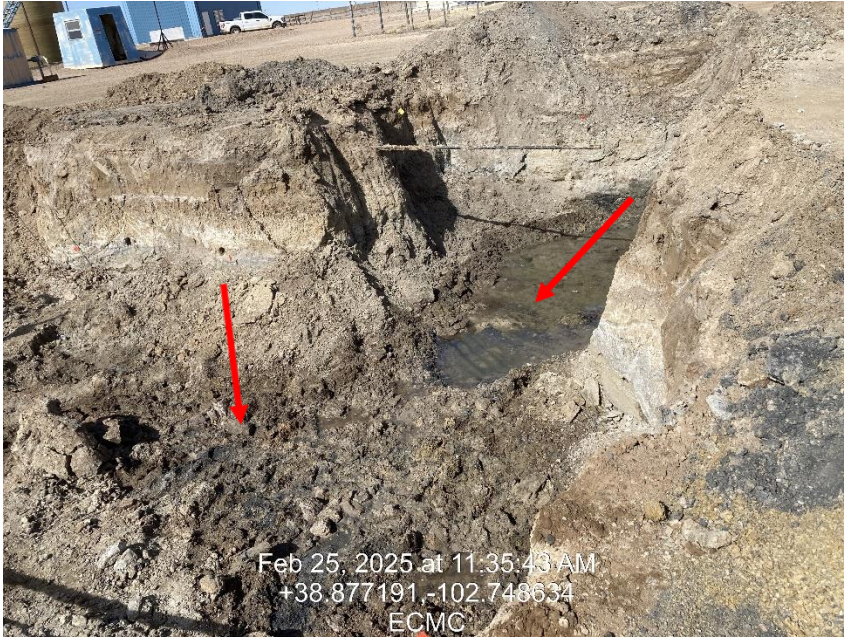
Photo 5 –Excavation with impacts present

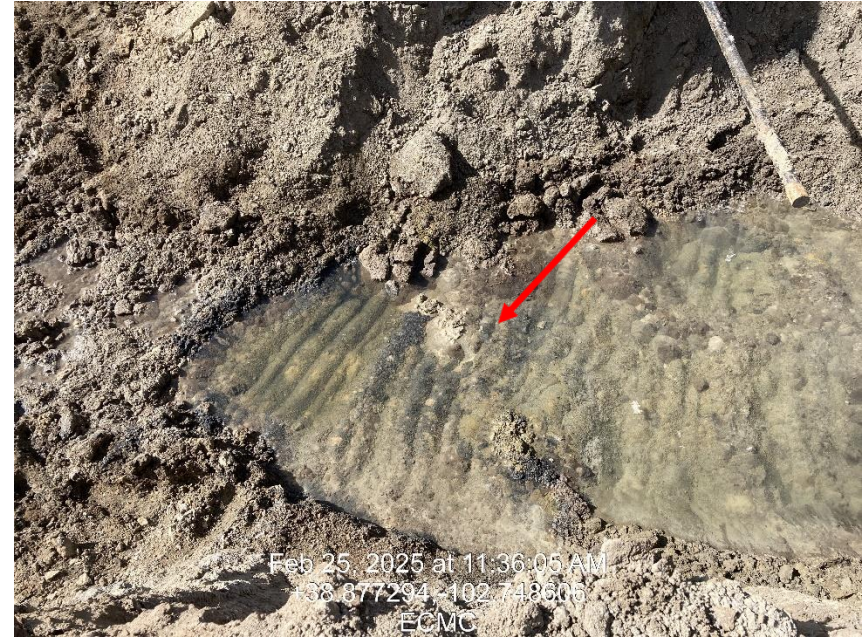
Photo 6 – Impacted soils in excavation, water was present at the time of inspection.

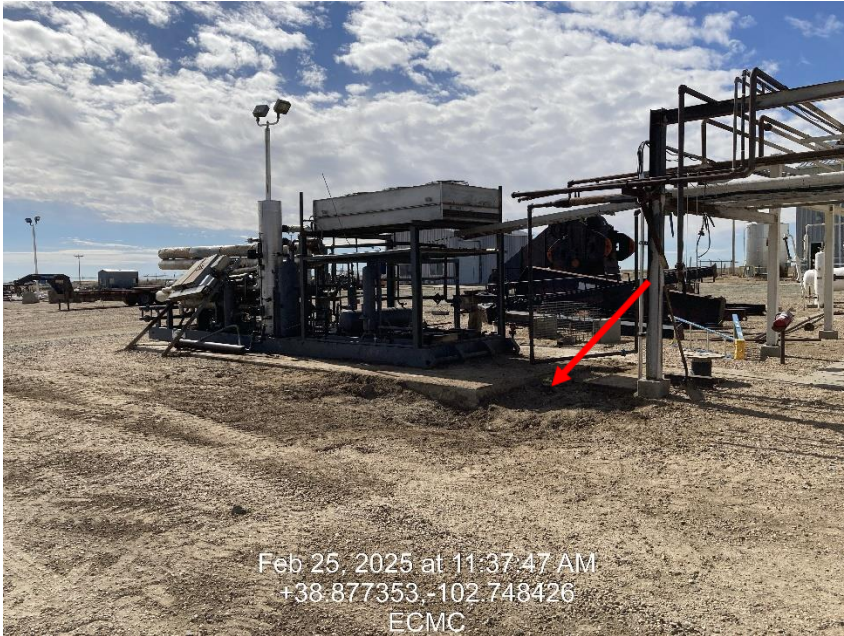
Photo 7 –Excavation area 2 next to equipment

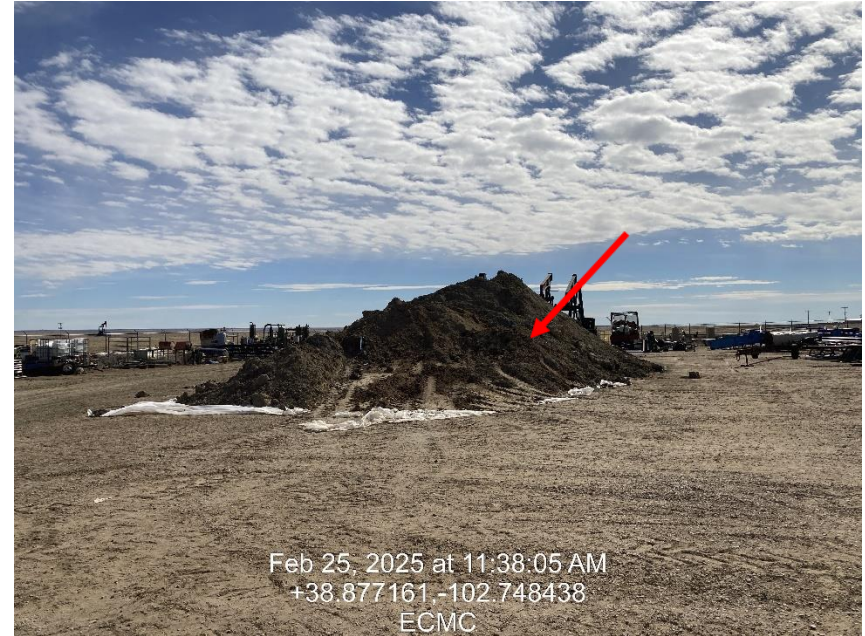
Photo 8 – Spoil pile on liner

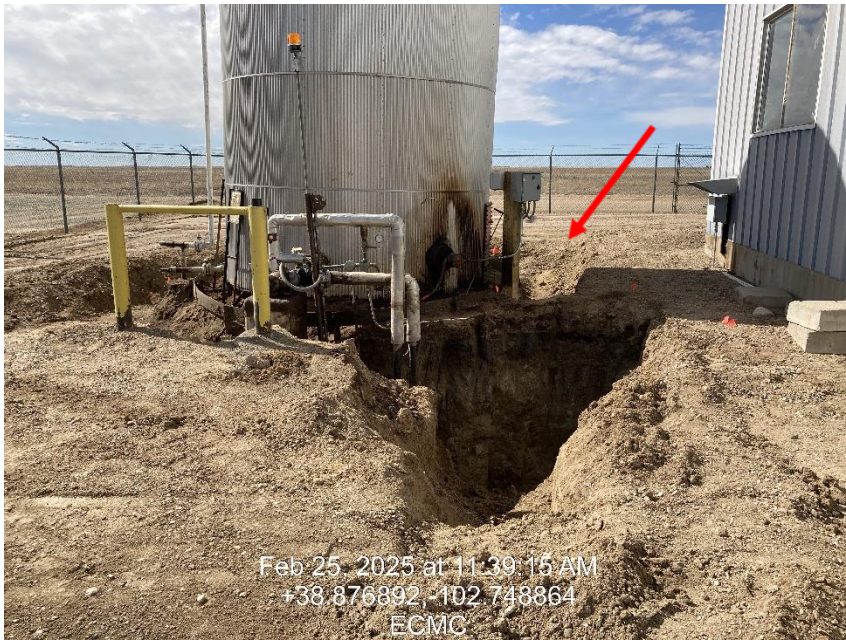
Photo 9 –Excavation area 2 at tank

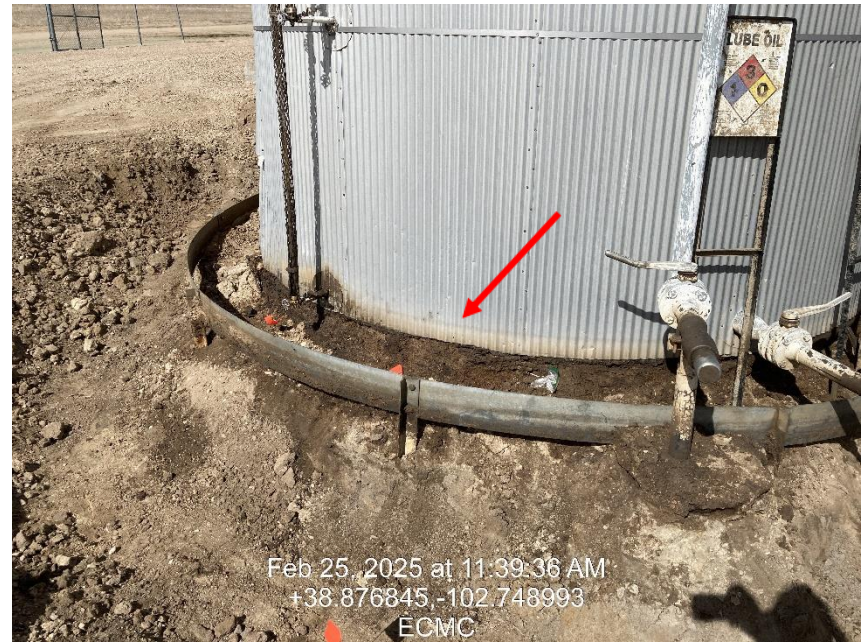
Photo 10 – Impacted soils present under tank
