Inspection/Audit Photos

Location: TEP ROCKY MOUNTAIN LLC UNOCAL-67S96W/1SWSE (GM 34-1 PAD)

Location ID: 334905

Date: 02/26/2025

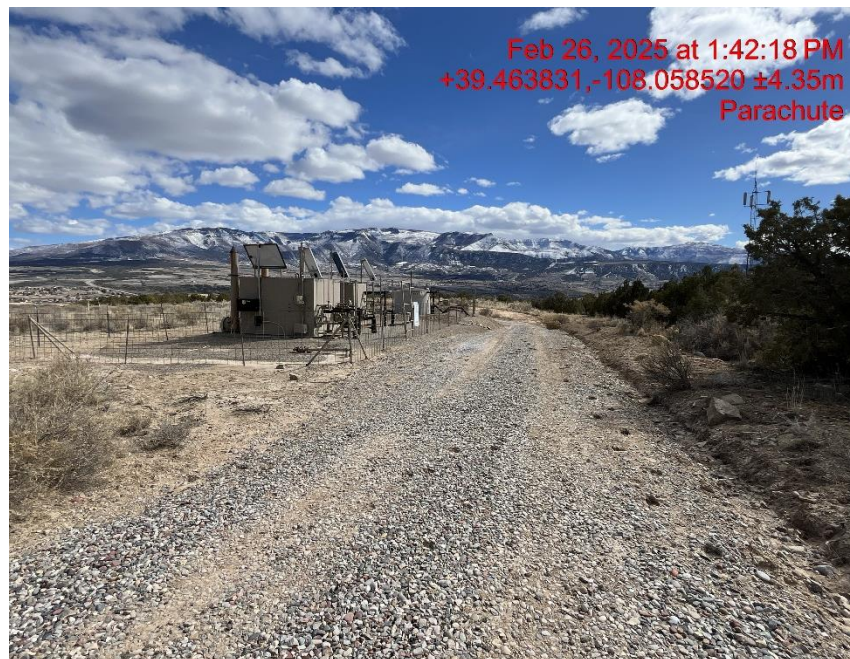
Photo # 5851 Entrance to location

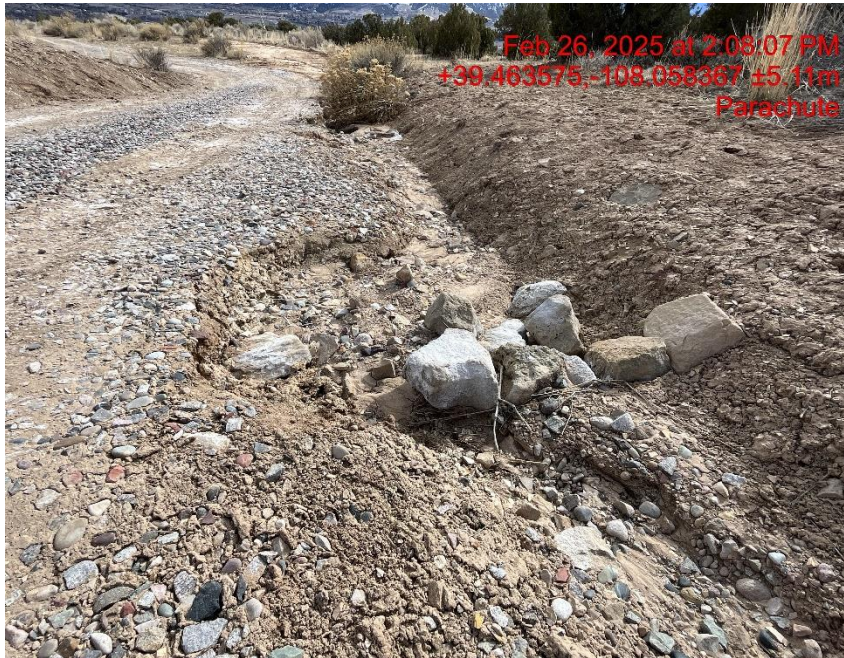
Photo # 5878 Erosion in ditch/road needs maintenance/insufficient BMP's

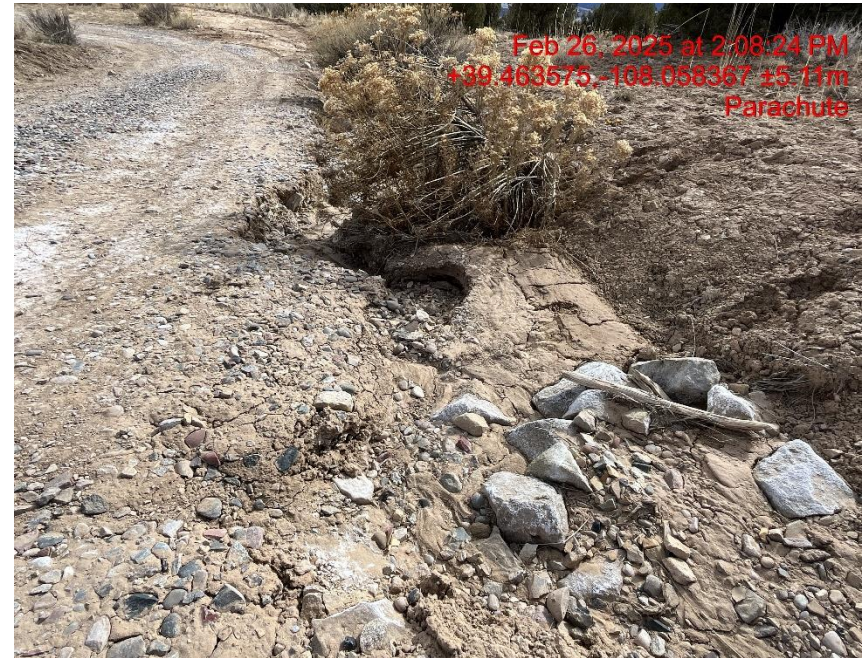
Photo # 5879 Erosion in ditch/road needs maintenance/insufficient BMP's

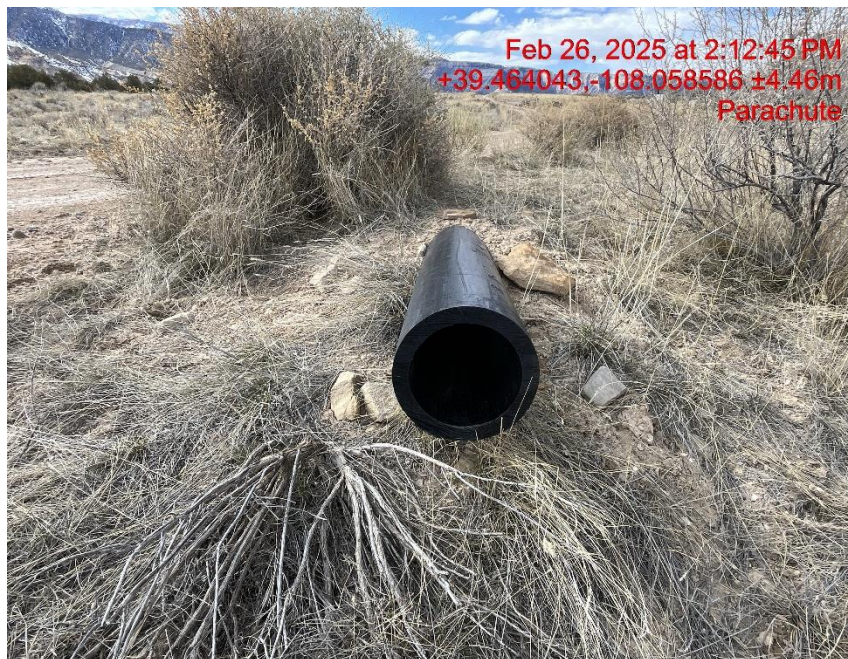
Photo # 5885 Open ended poly pipe/wildlife hazard NW of location on lease road

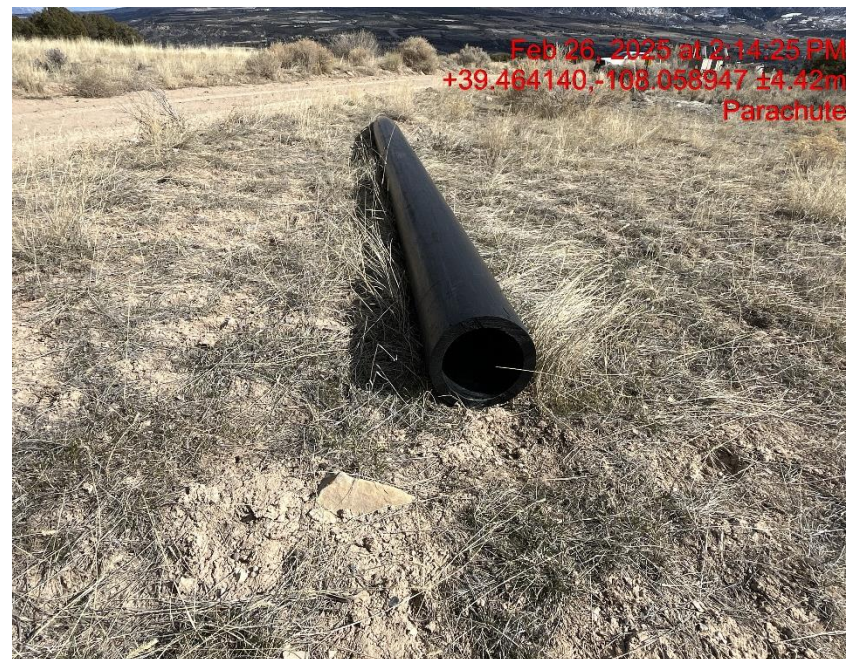
Photo # 5889 Open ended poly pipe/wildlife hazard NW of location on lease road

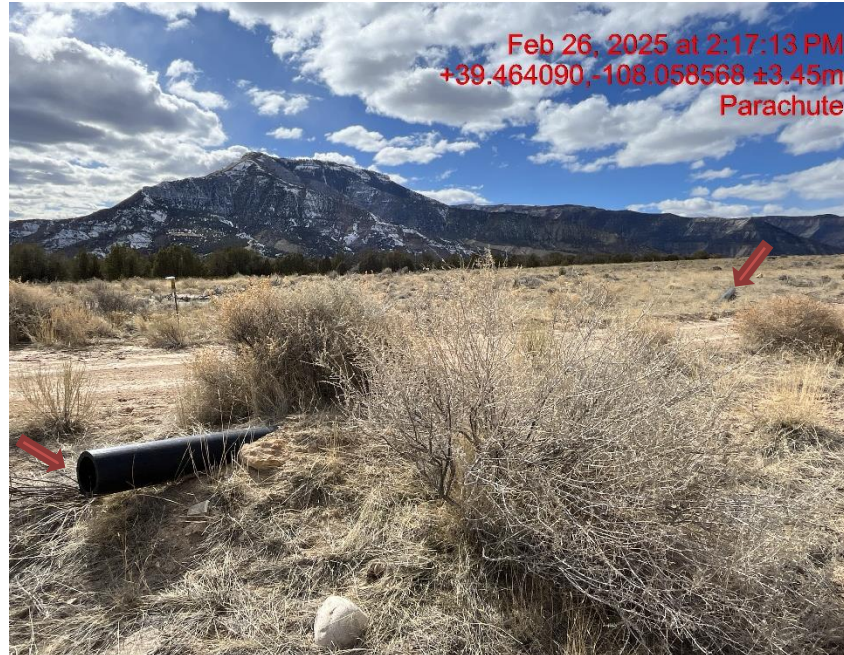
Photo # 5894 Open ended poly pipe/wildlife hazard NW of location on lease road
