Inspection/Audit Photos

Location: TEP ROCKY MOUNTAIN LLC UNOCAL-67S96W/1NESW (GM 249-1 PAD)

Location ID: 324154

Date: 02/26/2025

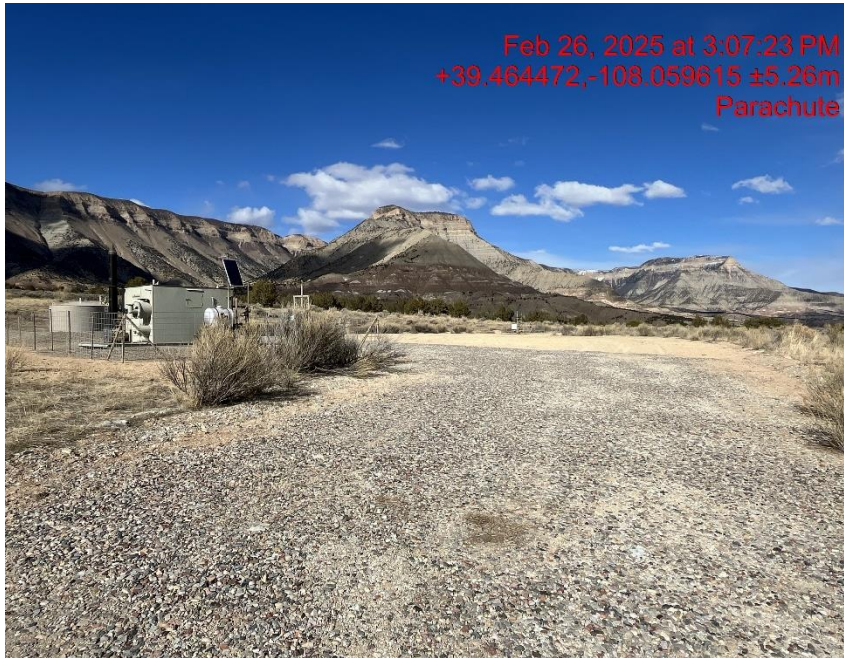
Photo # 5933 Entrance to location

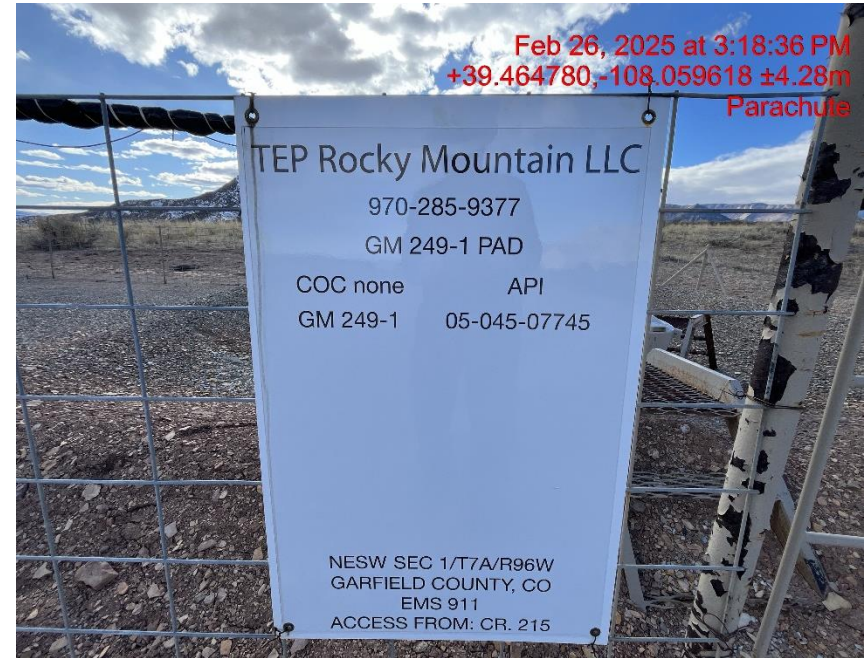
Photo # 5950 Location

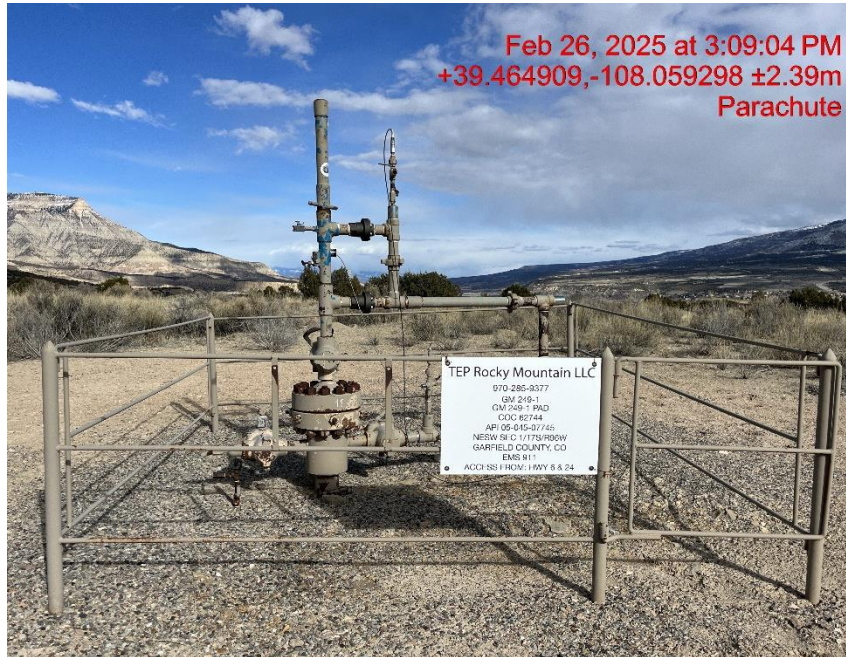
Photo # 5935 Location

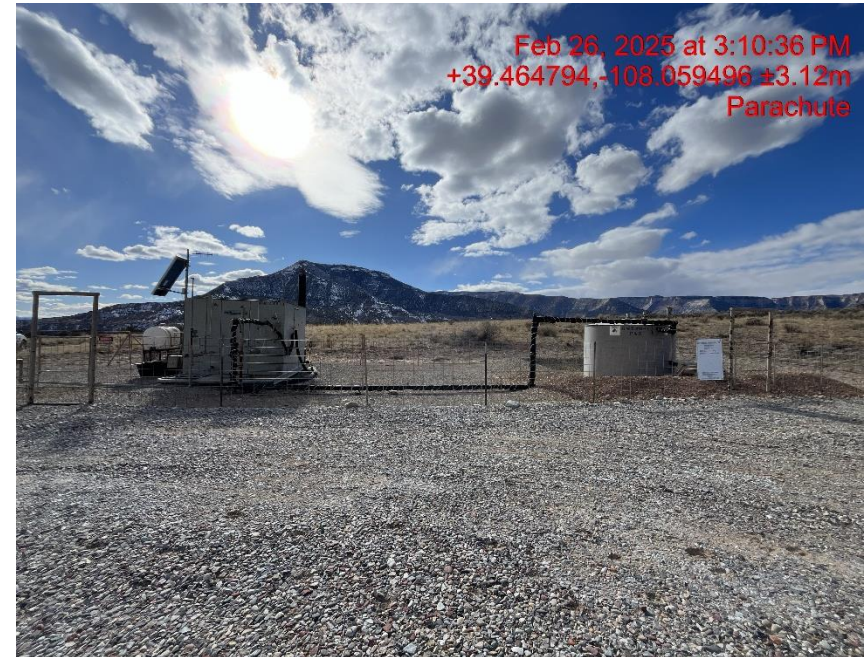
Photo # 5937 Location

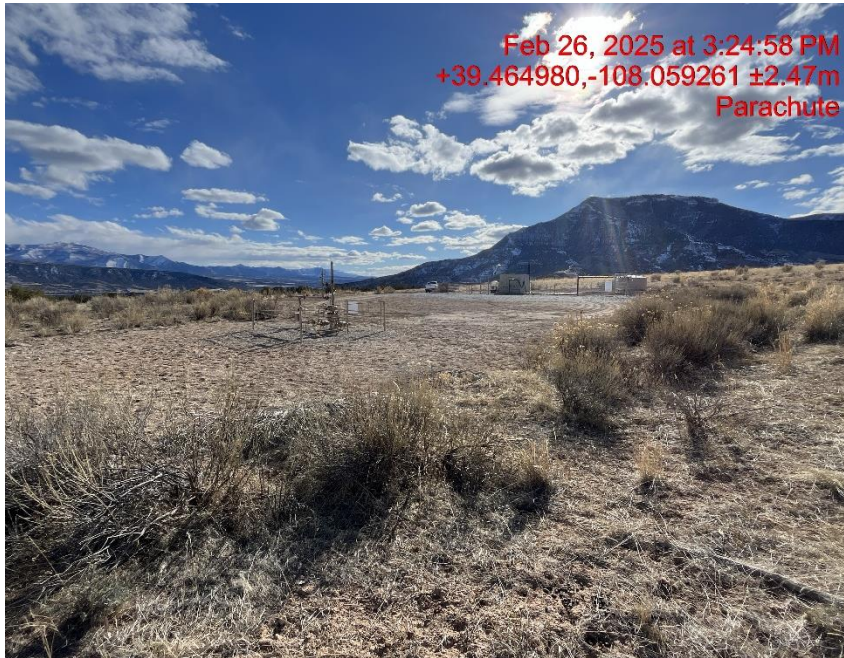
Photo # 5956 NE corner of location

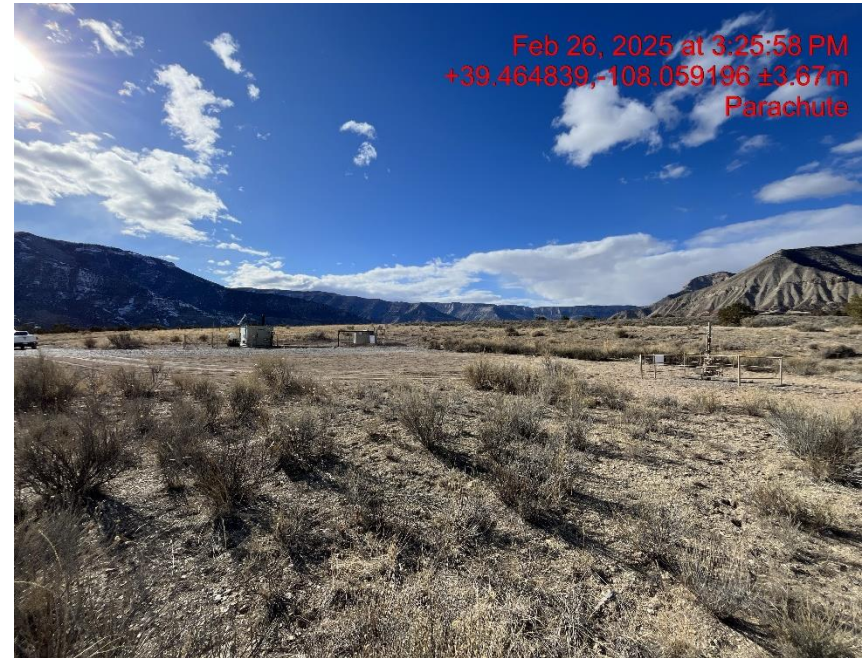
Photo # 5957 SE corner of location

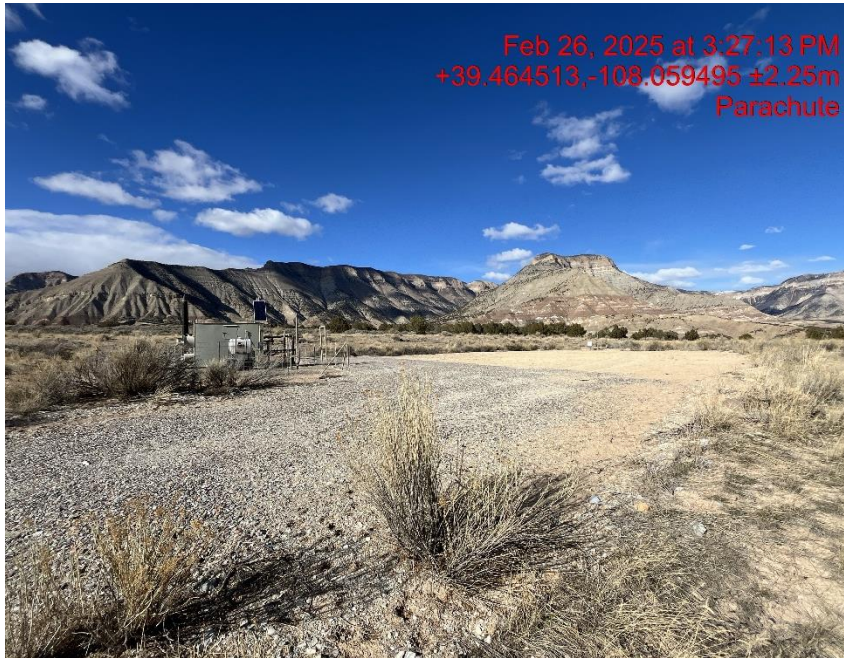
Photo # 5958 SW corner of location

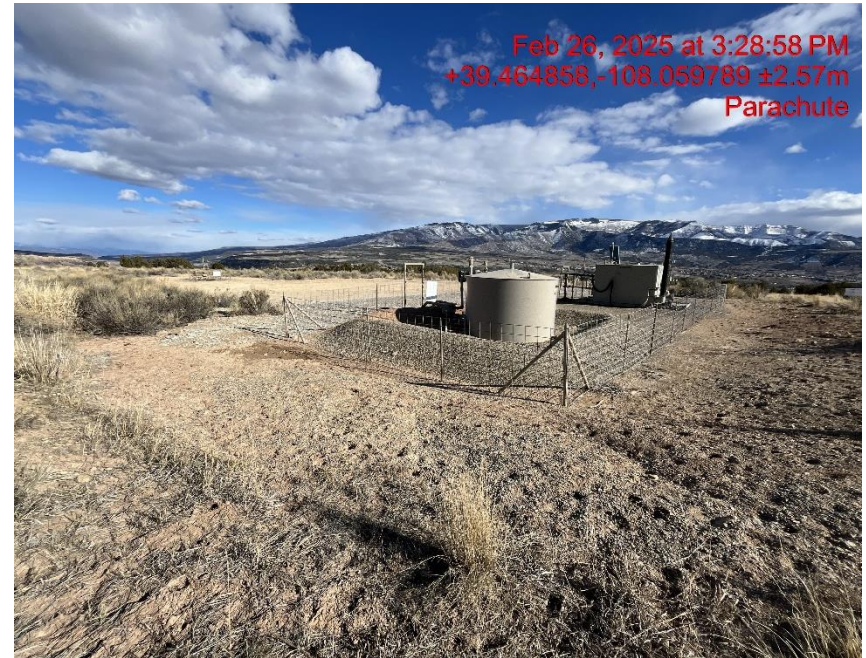
Photo # 5960 NW corner of location

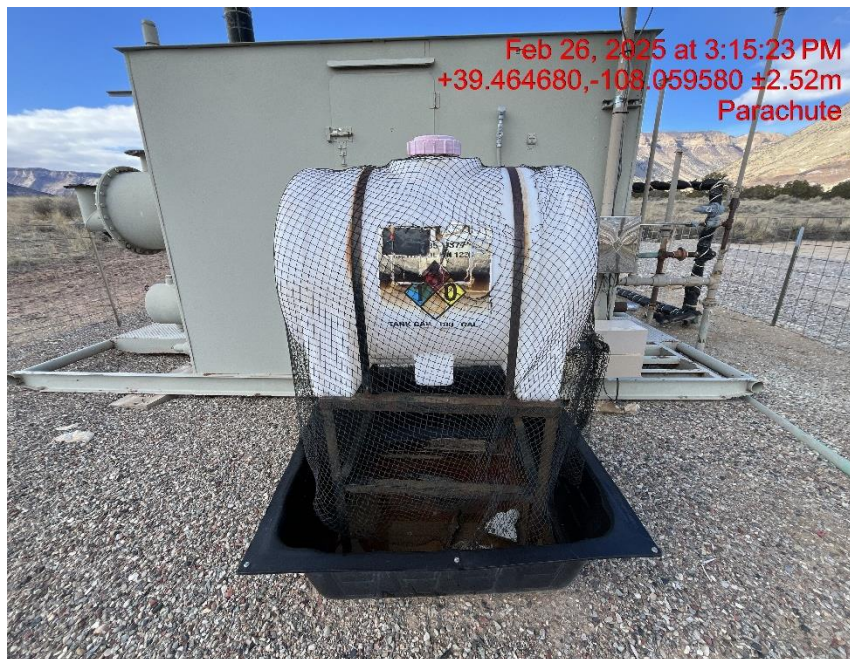
Photo # 5944 Tank lacks required labeling/do not comply with CECMC rules

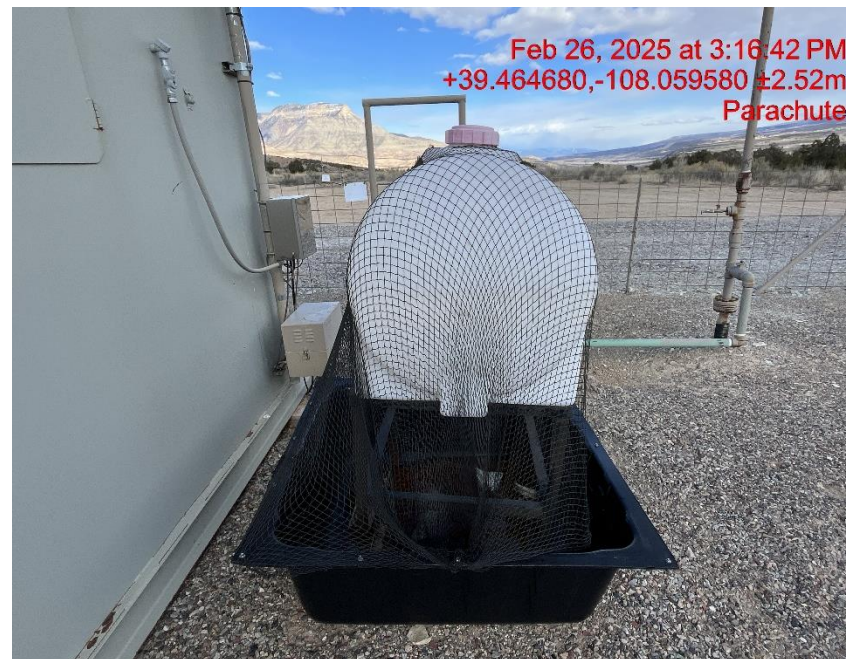
Photo # 5947 Wildlife protection for chemical containment needs maintenance/netting is damaged and open to wildlife

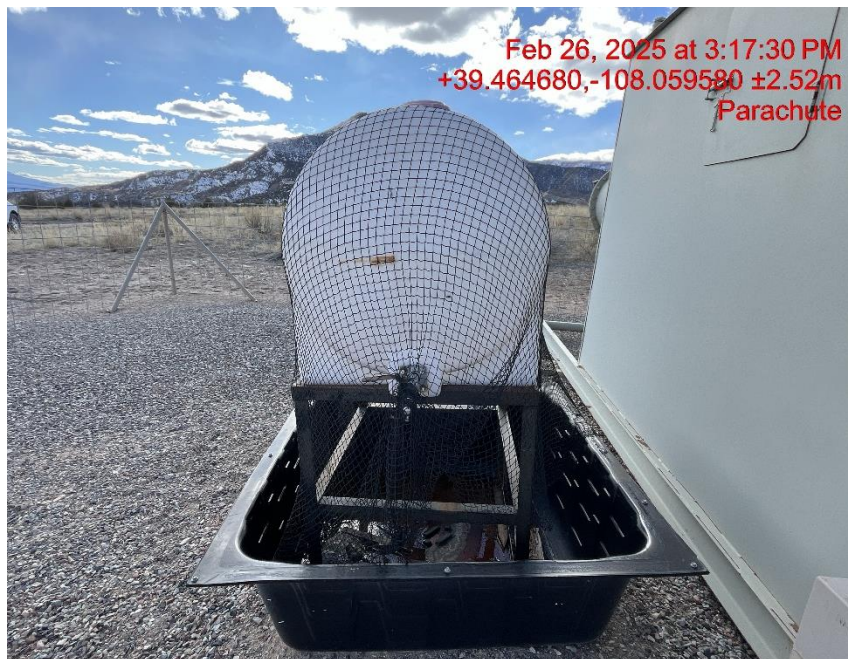
Photo # 5948 Wildlife protection for chemical containment needs maintenance/netting is damaged and open to wildlife

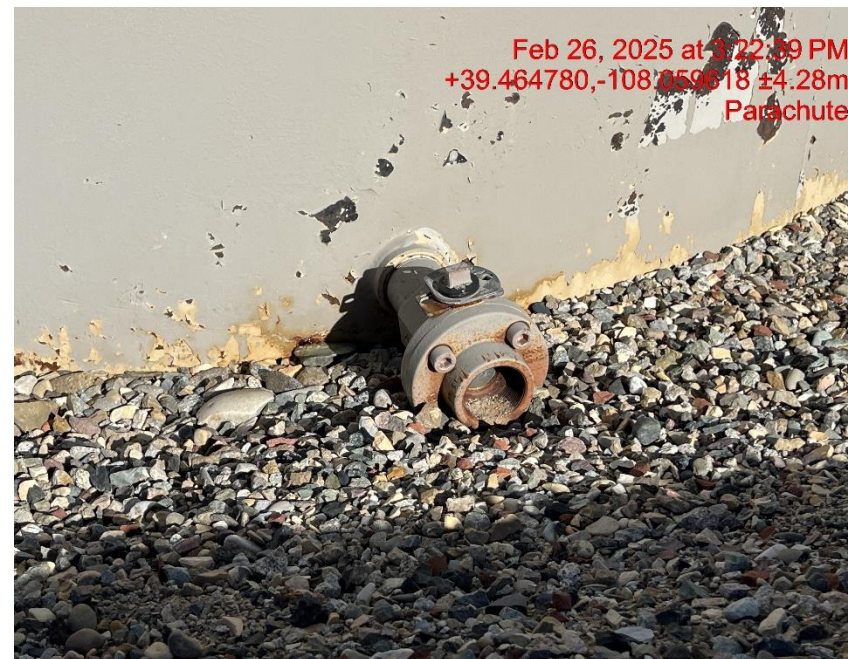
Photo # 5955 Open ended load line
