Inspection/Audit Photos

Location: TEP ROCKY MOUNTAIN LLC EXXON-67S96W/1SESW (GM 24-1 PAD)

Location ID: 334878

Date: 02/27/2025

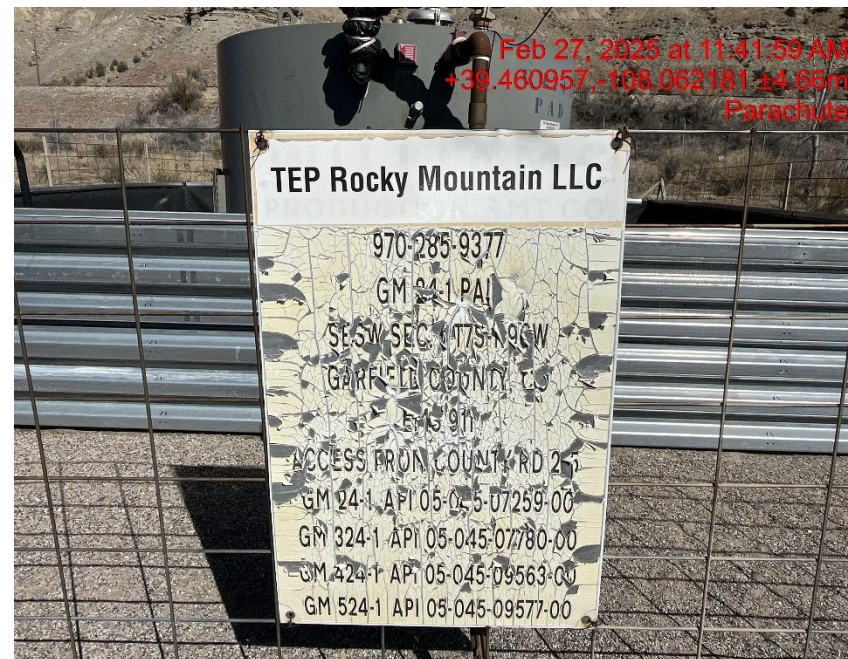
Photo # 6044 Battery sign is weathered & illegible

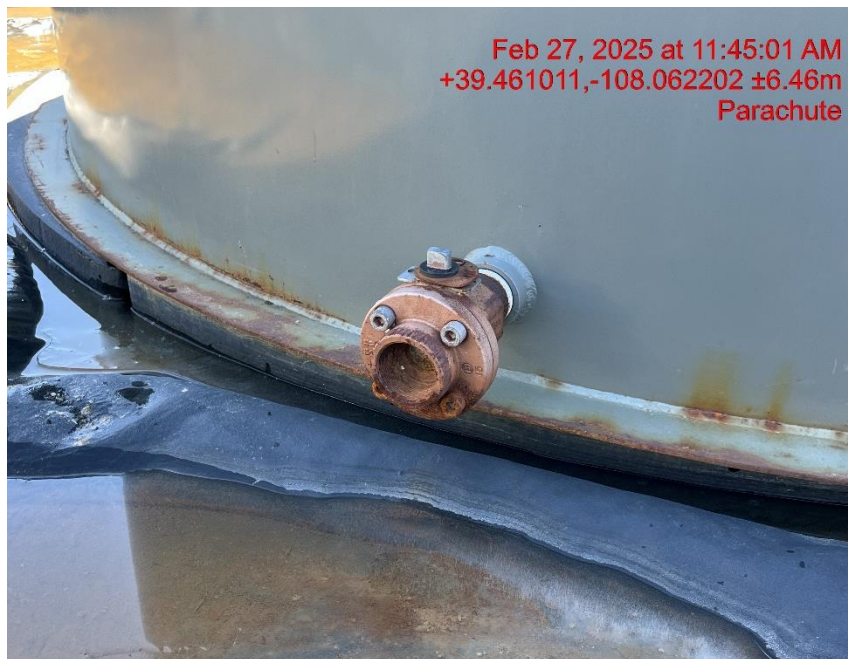
Photo # 6047 Open ended load line

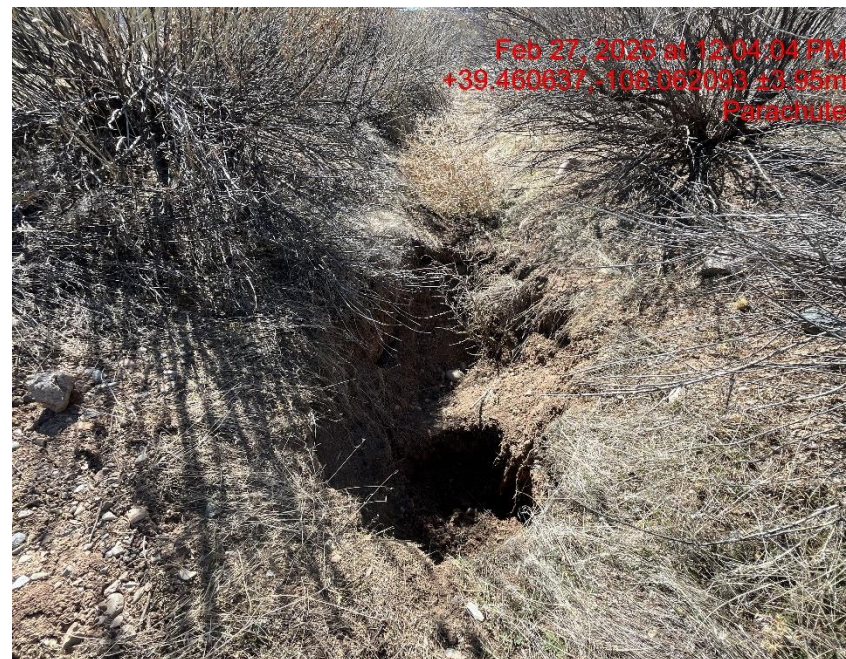
Photo # 6055 Subsidence in ditch/ditch needs maintenance on SE side of location, additionally is a wildlife hazard/personnel safety hazard

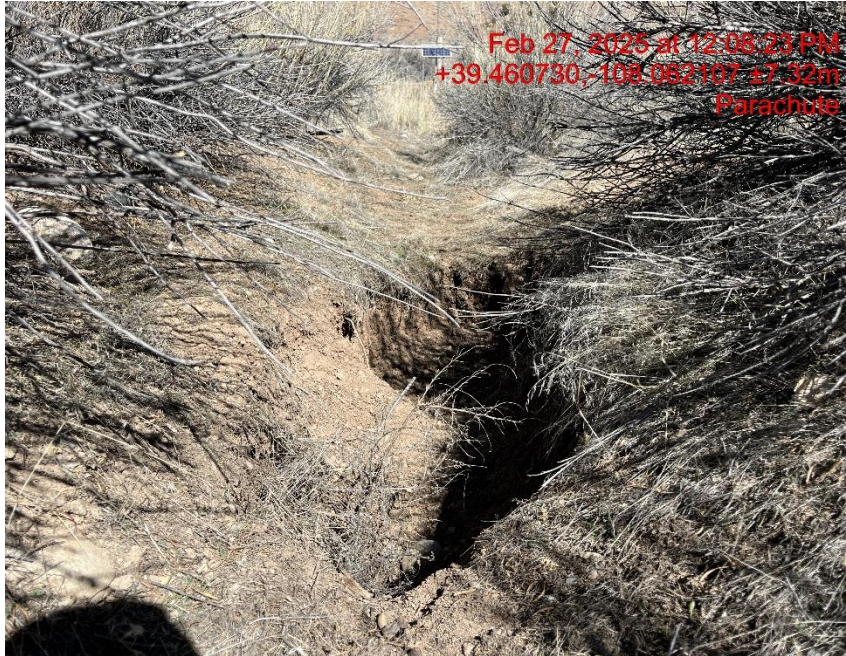
Photo # 6059 Subsidence in ditch/ditch needs maintenance on SE side of location, additionally is a wildlife hazard/personnel safety hazard

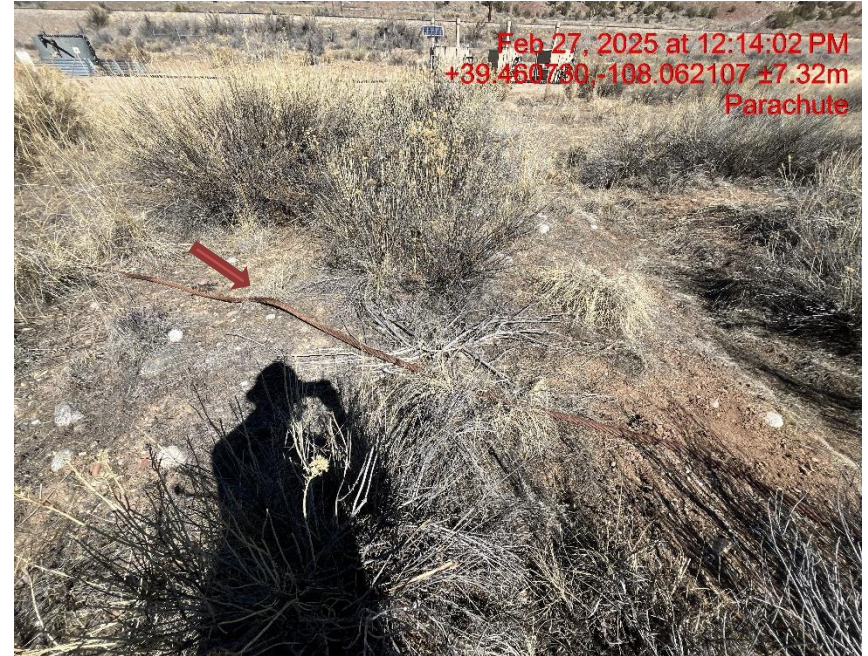
Photo # 6064 Debris

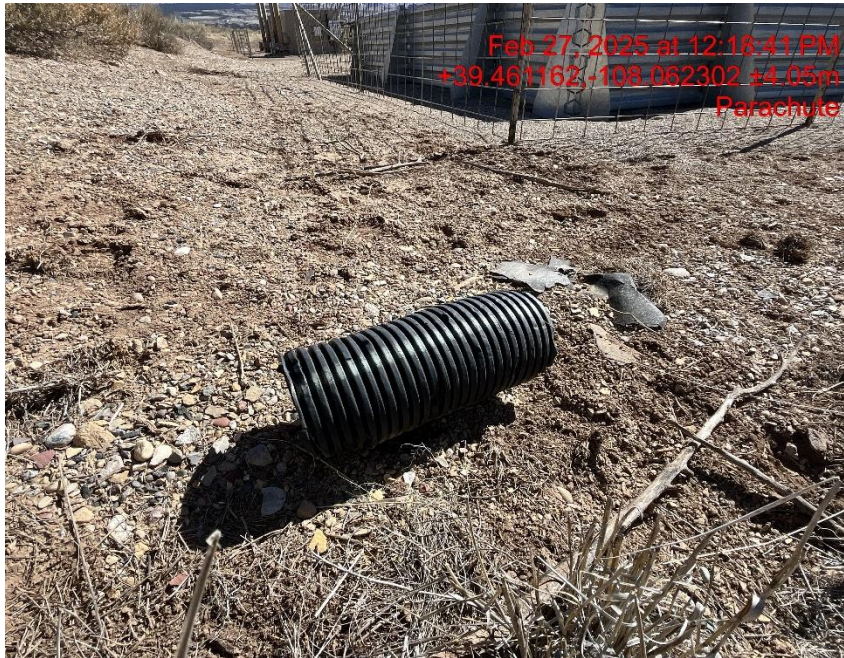
Photo # 6066 Debris

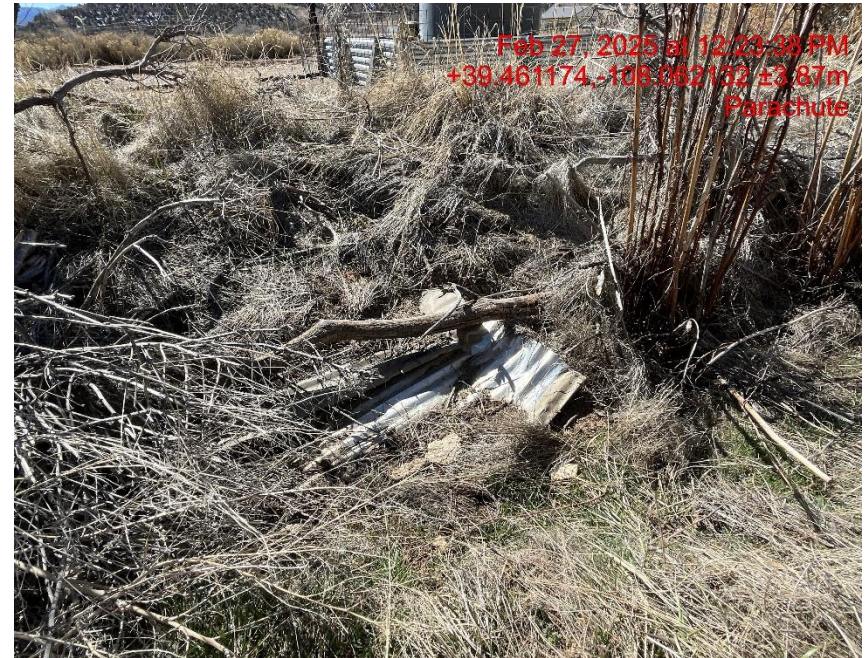
Photo # 6068 Debris

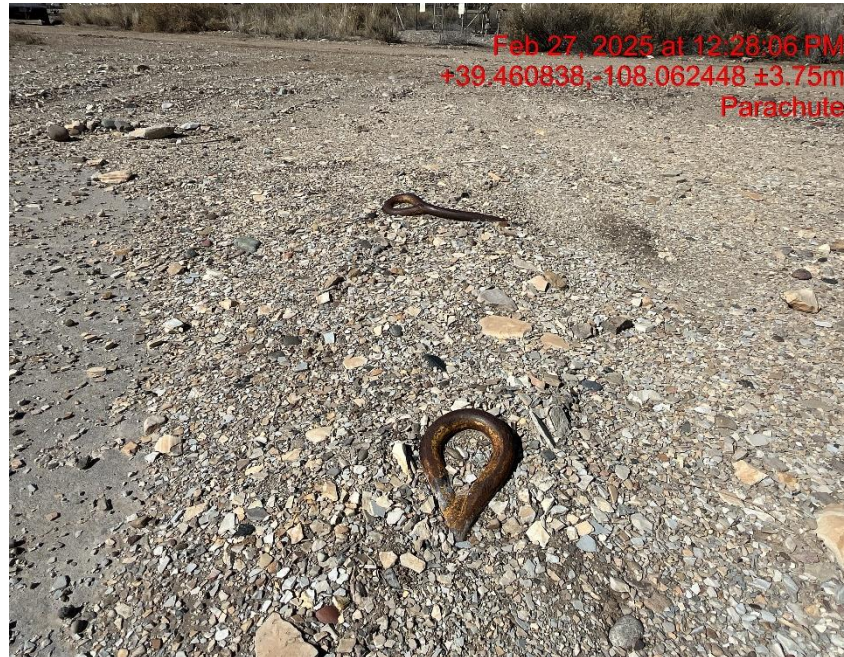
Photo # 6073 Unmarked deadman
