# Inspection Photos

Loc: 321940

Operator: CITATION OIL & GAS CORP

Inspection Date: 2/26/2025

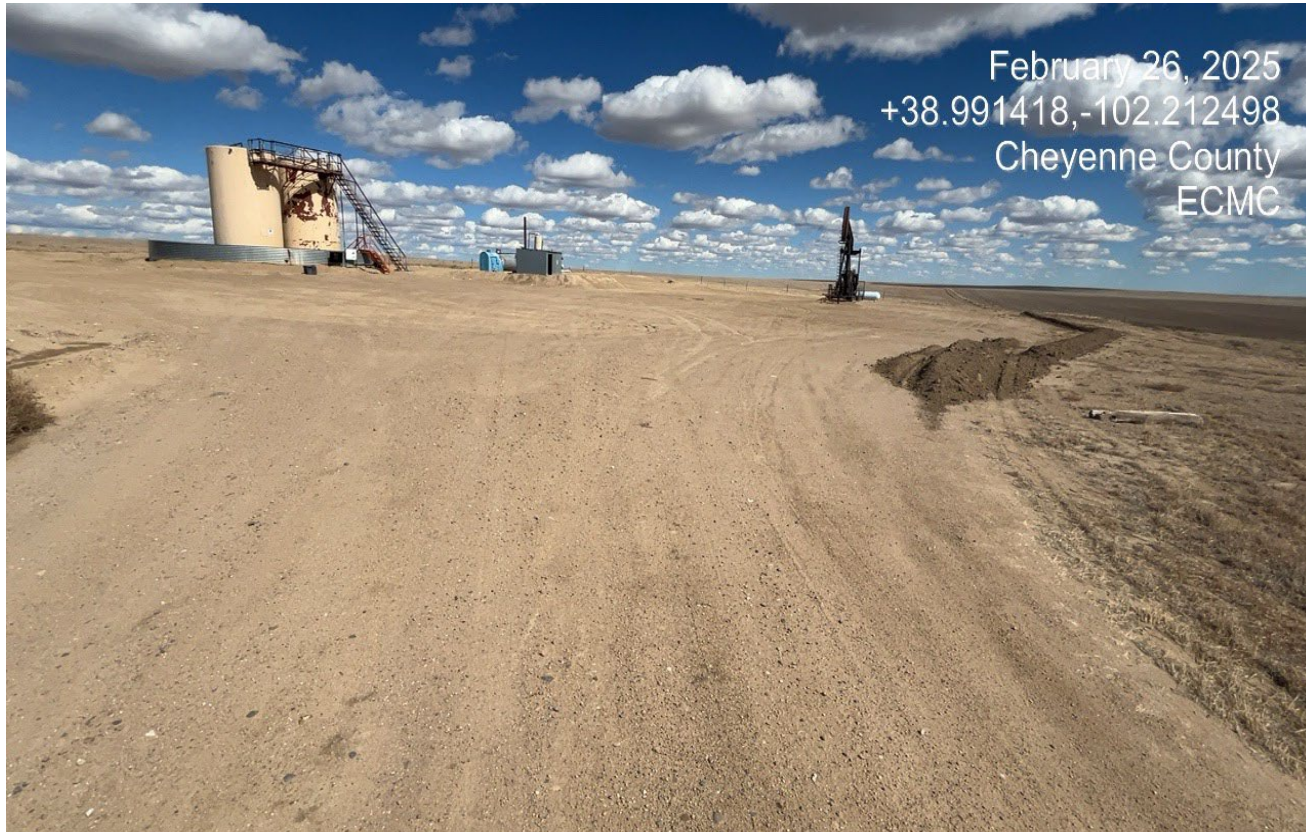
**Photo 1.** Facing northeast toward the location.

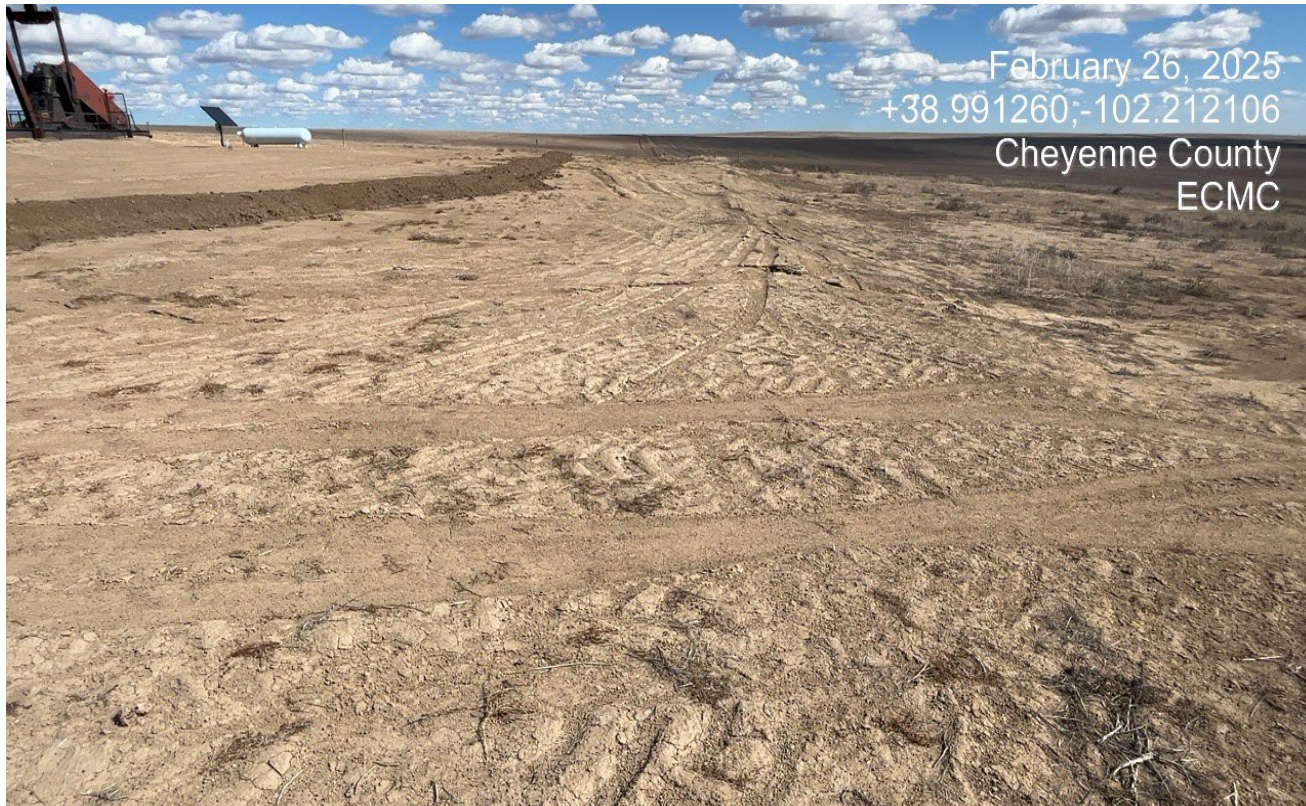
**Photo 2.** Facing east at the south side of the location. This area is not reclaimed or stabilized.

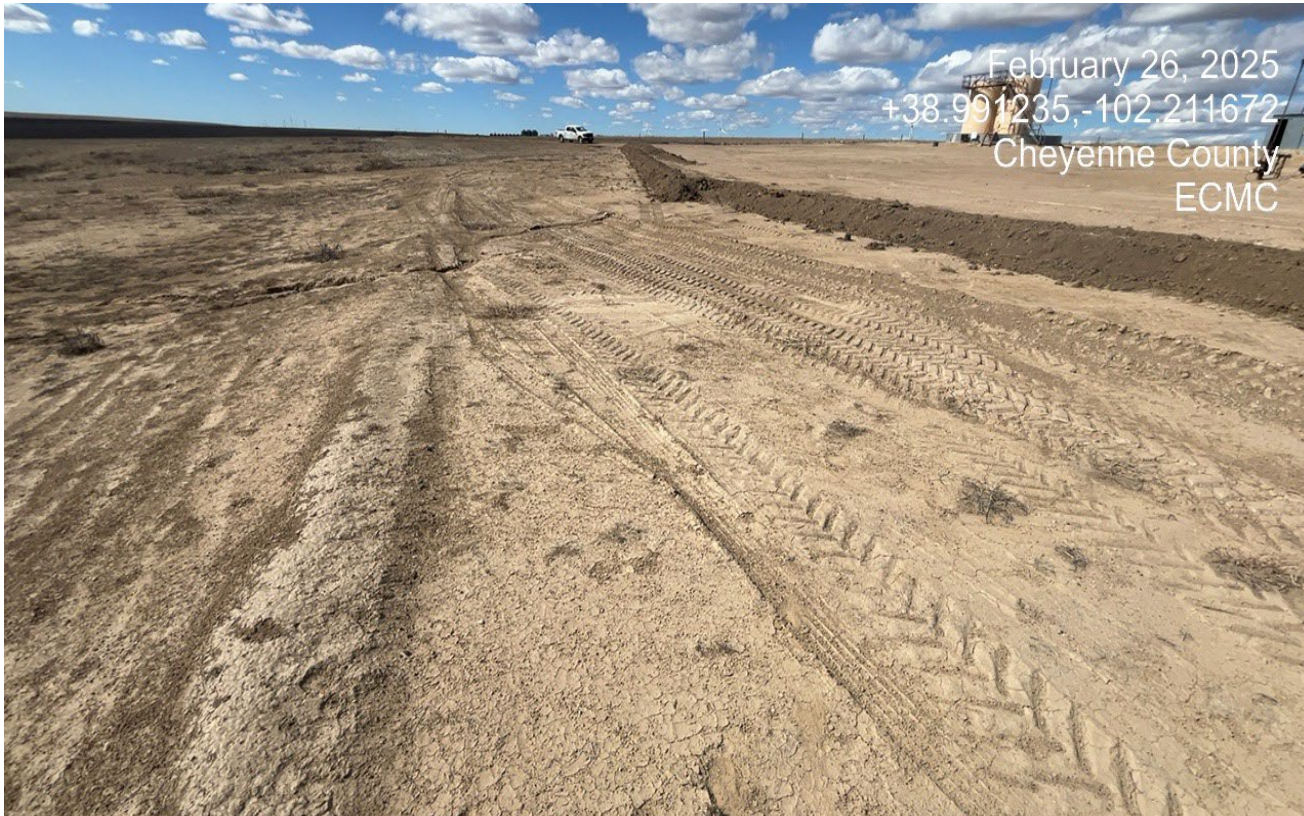
**Photo 3.** There is erosion along the south side of the location and soils are not stabilized.

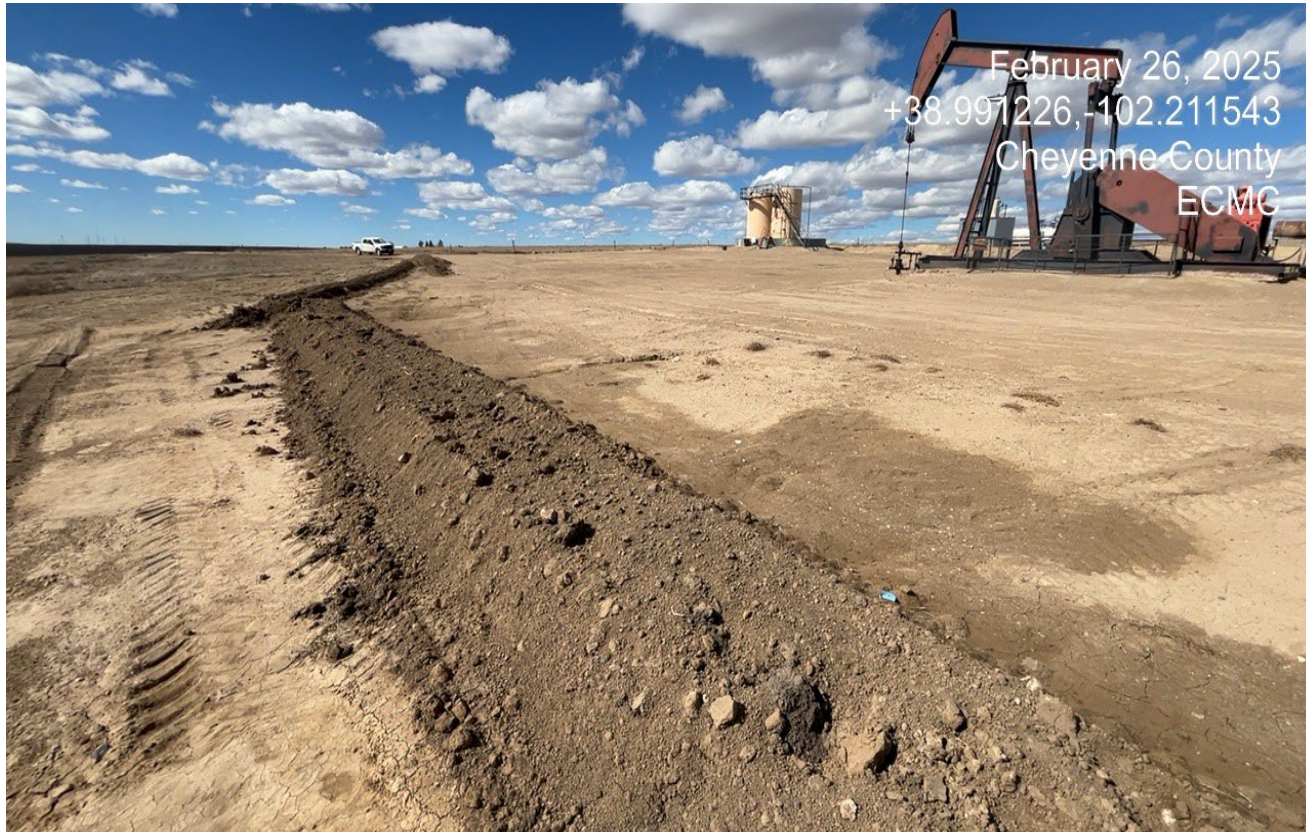
**Photo 4.** There is a soil berm along the south side of the location. It is unknown if this material is being used as a berm or for reclamation. A berm must be compacted and stabilized and stormwater will still need a route to take with BMP's such as a sediment trap or rock rip/rap outlet.

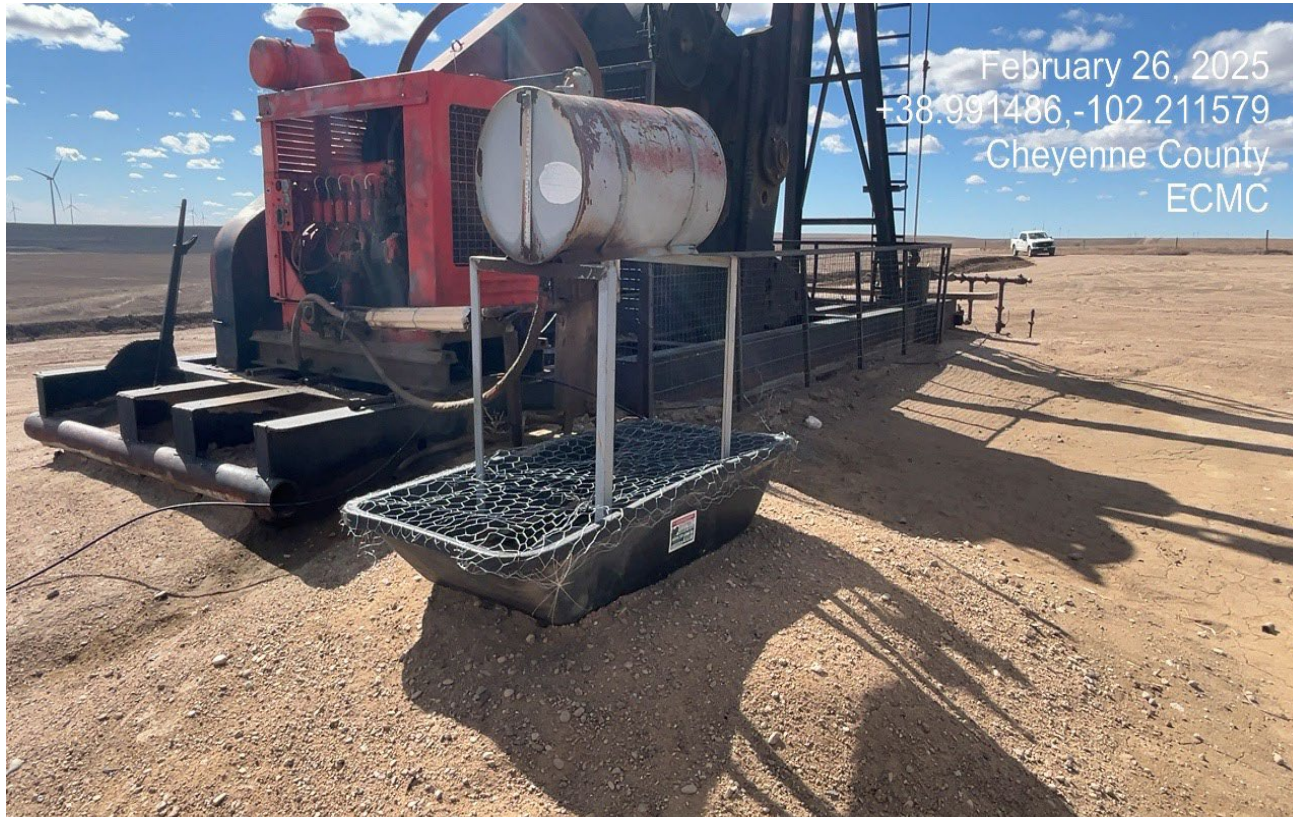
**Photo 5.** The containment has woven wire for wildlife protections.

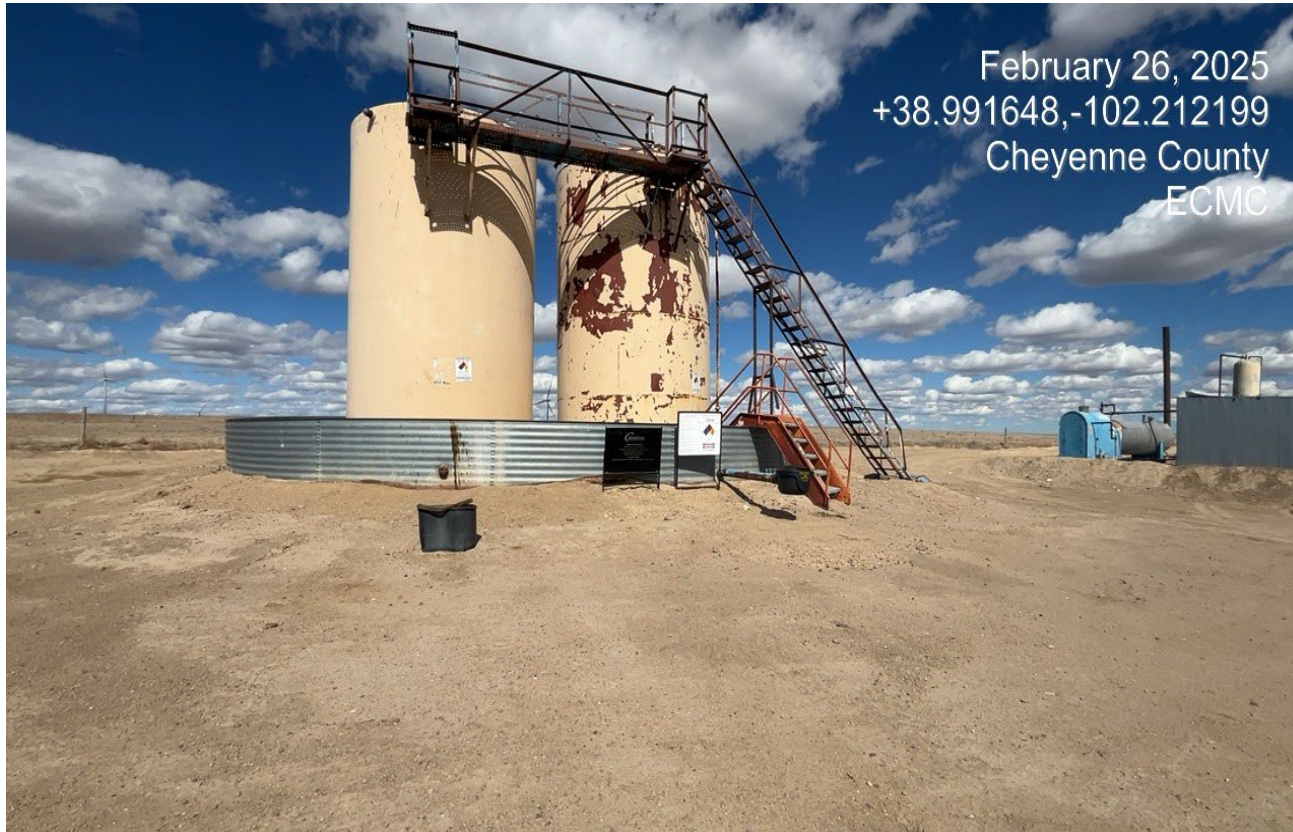
**Photo 6.** Facing toward the tank battery.

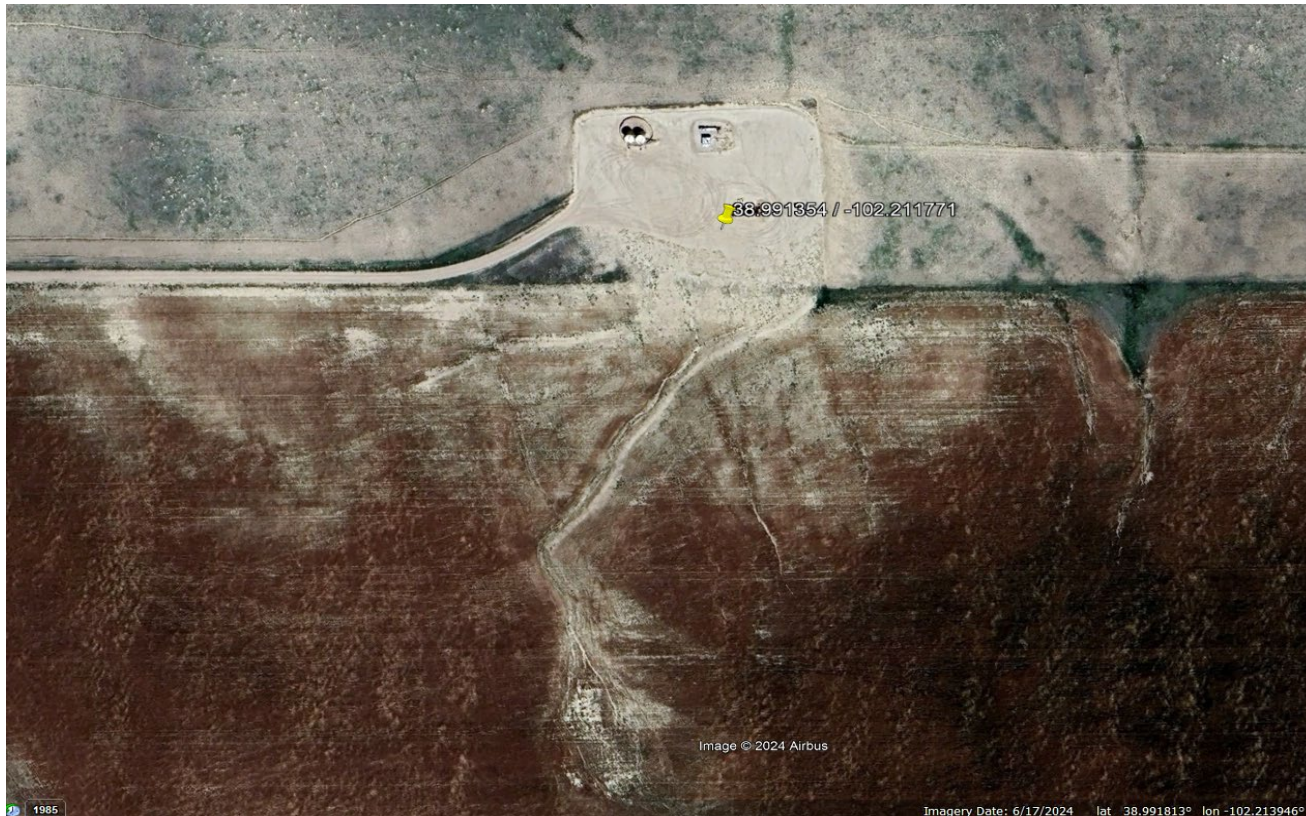
**Photo 7.** 2024 aerial view of the location shows unused areas of the location are not reclaimed and stormwater erosion is transporting sediment offsite.
