Inspection/Audit Photos

Location Name: TEP ROCKY MOUNTAIN LLC CB-TG Land NW 11D-20-692 Pad

Location #: 418555

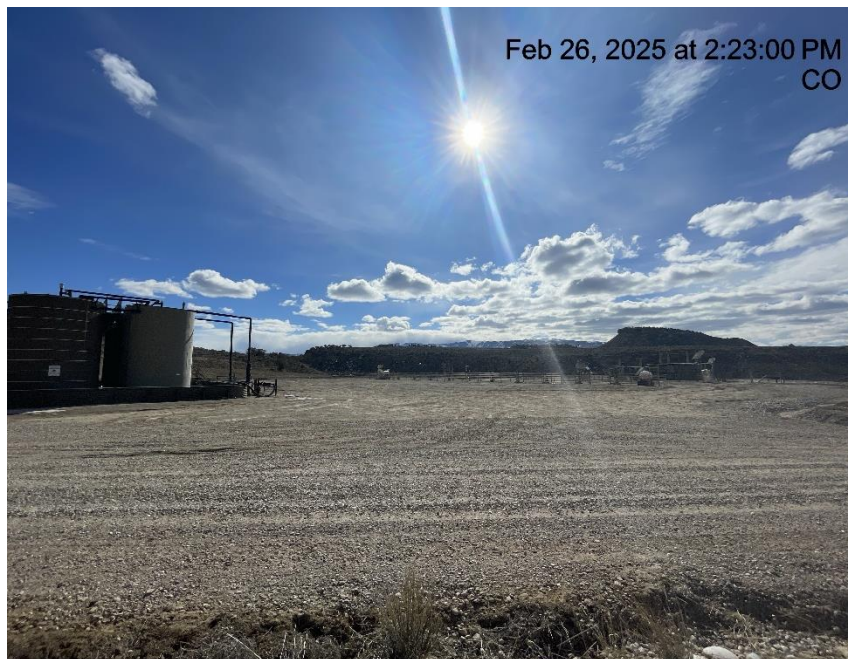
Photo # 9708 From entrance to location

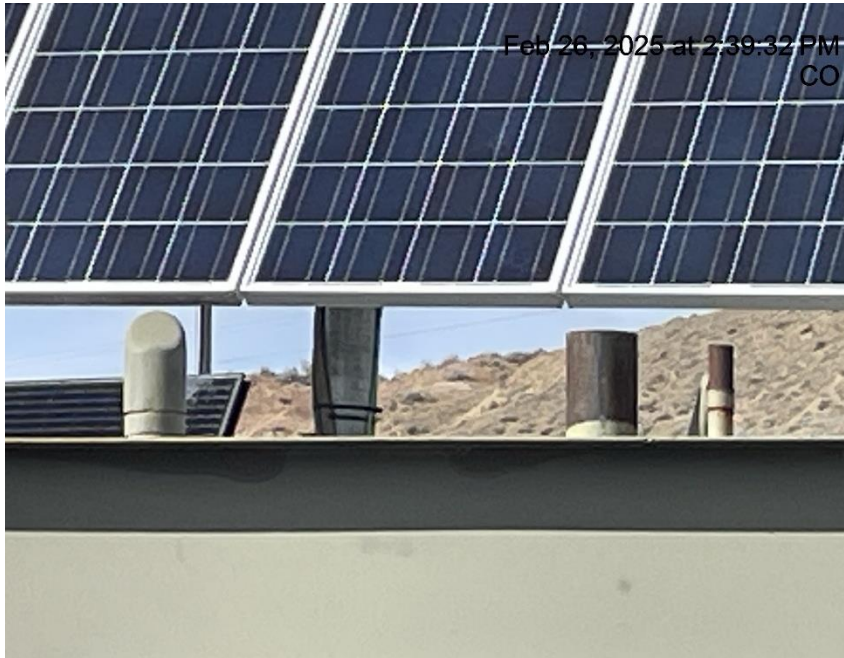
Photo # 9718 PRV vent line does not comply with CECMC pressure safety device rules

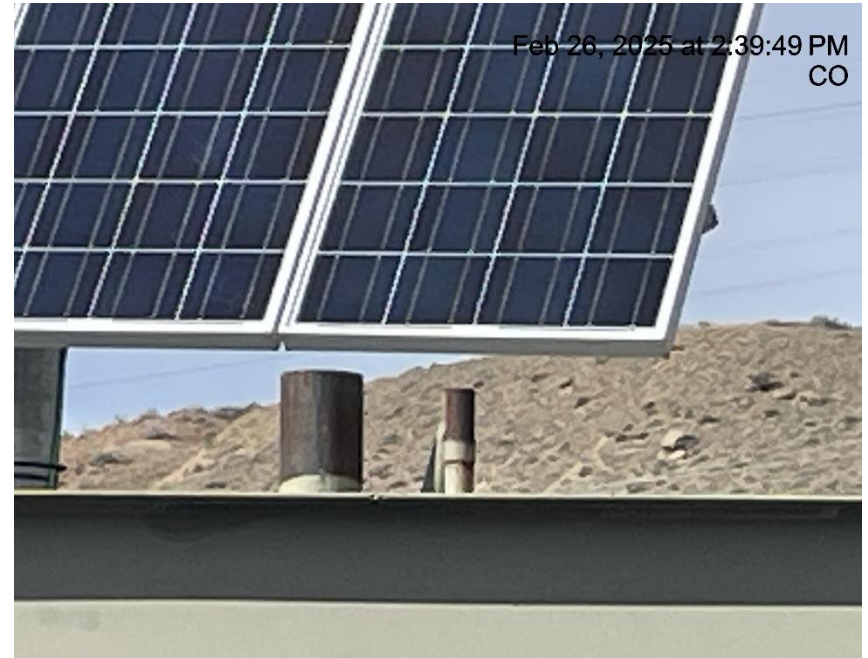
Photo # 9719 PRV vent line does not comply with CECMC pressure safety device rules
