Hilcorp Energy Company
ALLISON UNIT 147
FORMATION FRC
LATITUDE N 37.00248
LONGITUDE W 107.56014
SE/SW, 800' FSL & 1849' FWL
SEC.24 T032N R007W
LEASE NO. FEE
API NO. 05-067-DR350
LA PLATA COUNTY, COLORADO
EMERGENCY CONTACT (505) 324-5170 OR 911
NO SMOKING NO TRESPASSING

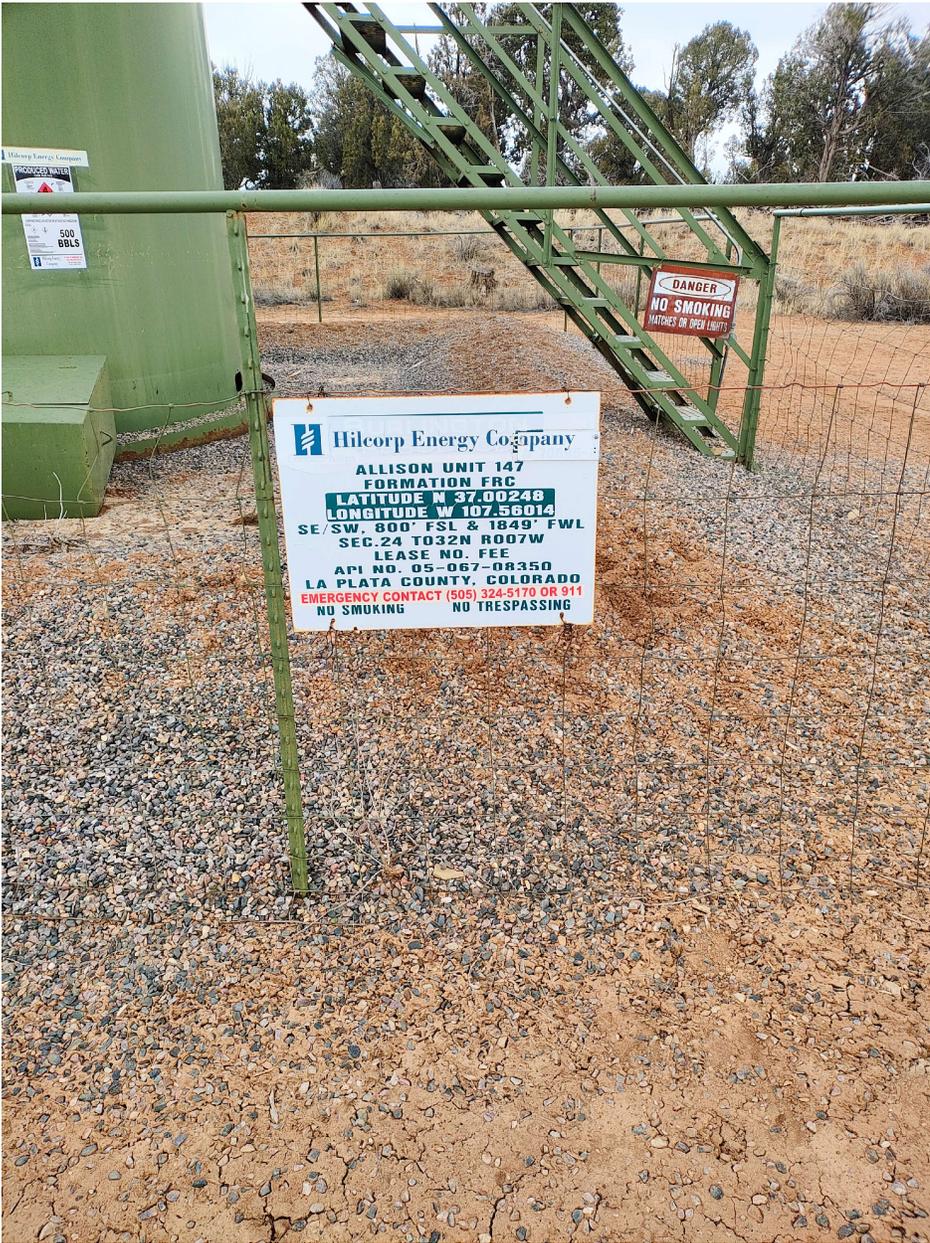
Comment: Produced water tank labels are not displaying capacity.

Corrective Action: Comply with rule 605. Install or repair sign. Date: 03/25/2025.

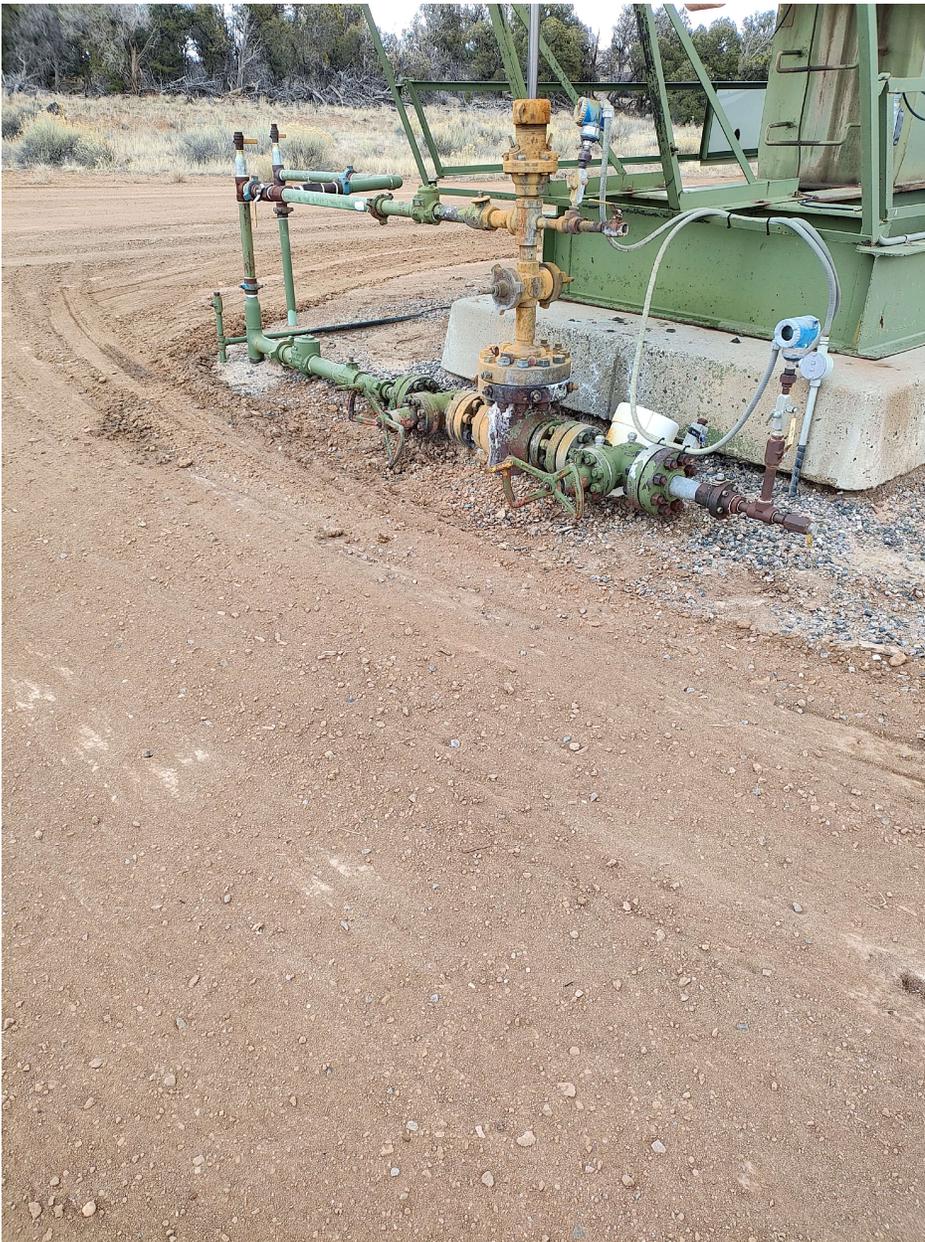
Comment: Rutting occurring at access road and active pad. Additional stabilization/grading efforts are needed to minimize degradation to the active pad.

Corrective Action: Comply with rule 1002f. Install or repair required BMPs.
