Inspection Photos
Location: Rhoades 22-35 # 2
Location ID: 321621, Spill ID 488346
API # 05-017-06479

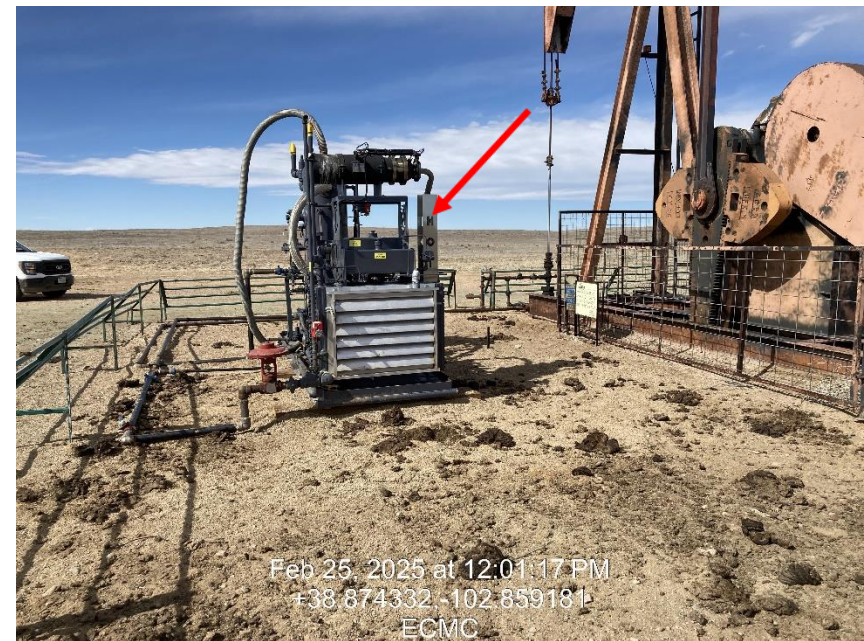
Photo 2 – Compressor unit, evidence of cows inside guarding

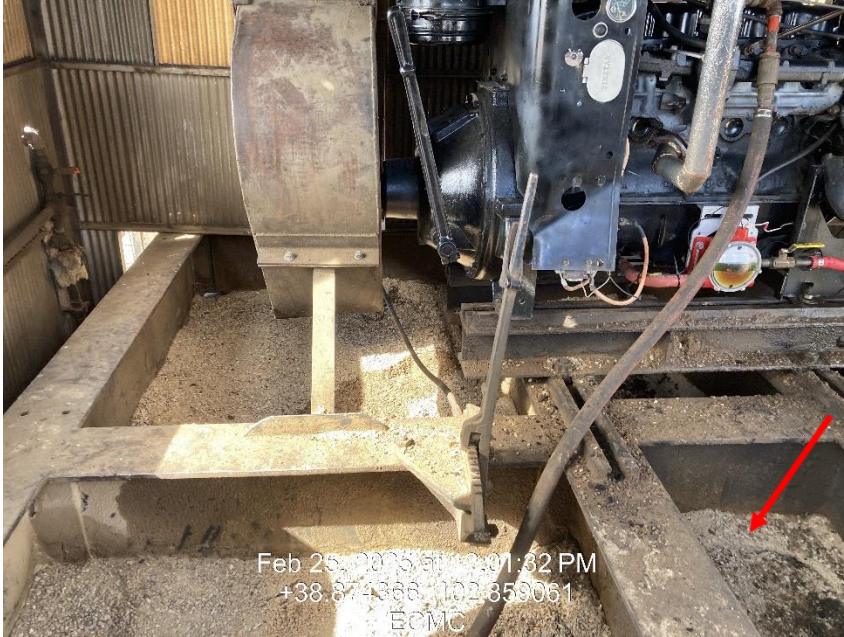
Photo 3 – Impacted soils in engine shed

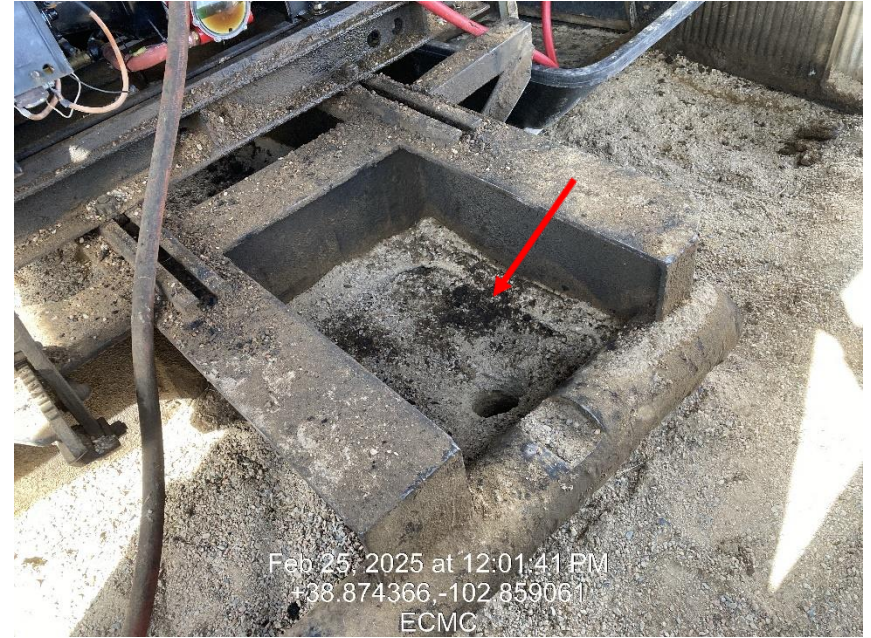
Photo 4 – Impacted soils in engine shed

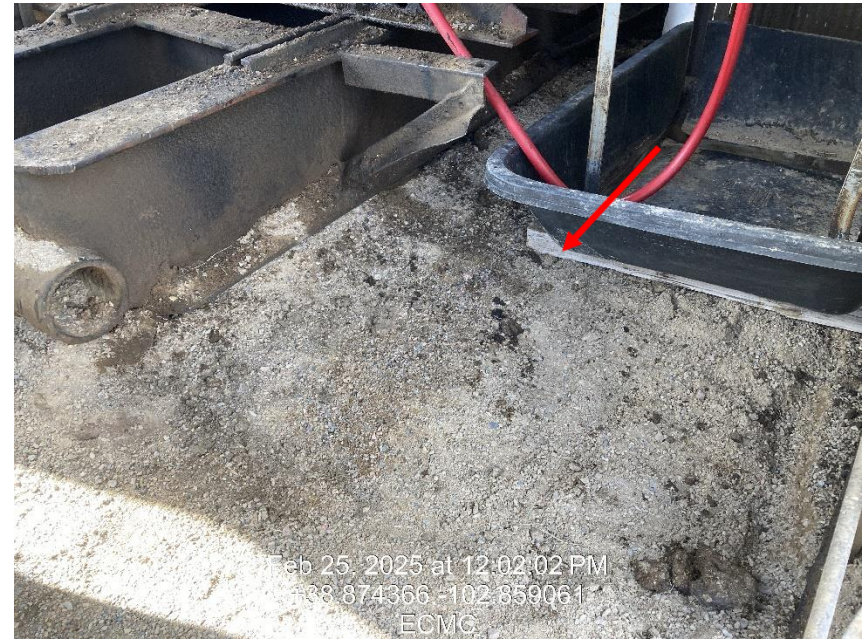
Photo 6 – Impacted soils in engine shed
