Interim Reclamation and Stormwater Inspection

Date: 02/26/2025

Operator: STRACHAN EXPLORATION INC - 83130

Inspection Photos
Location Name: Wickstrom 6 CTB
Location ID: 435380

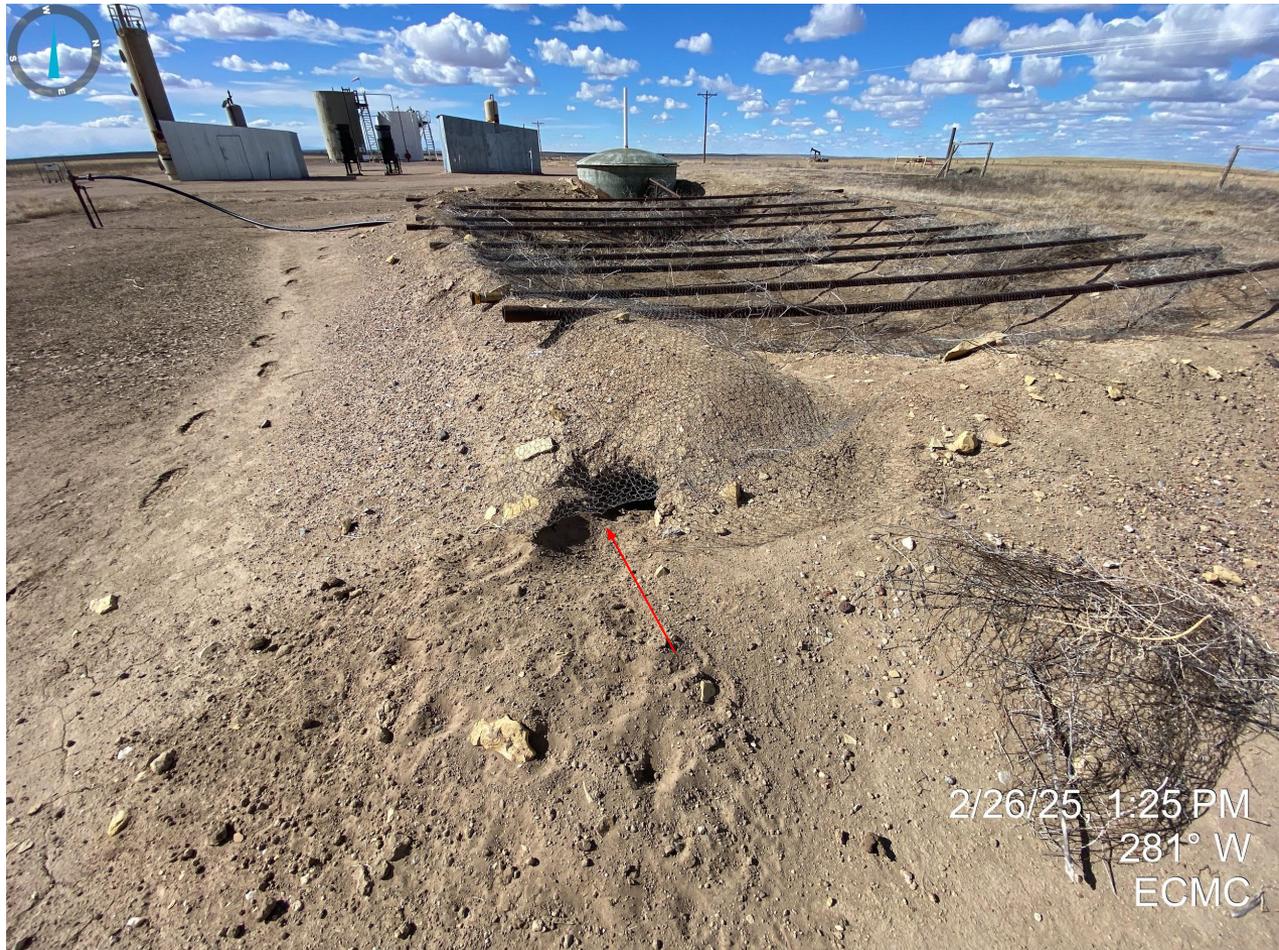
Photo 1. Animal burrow observed at pit berm.

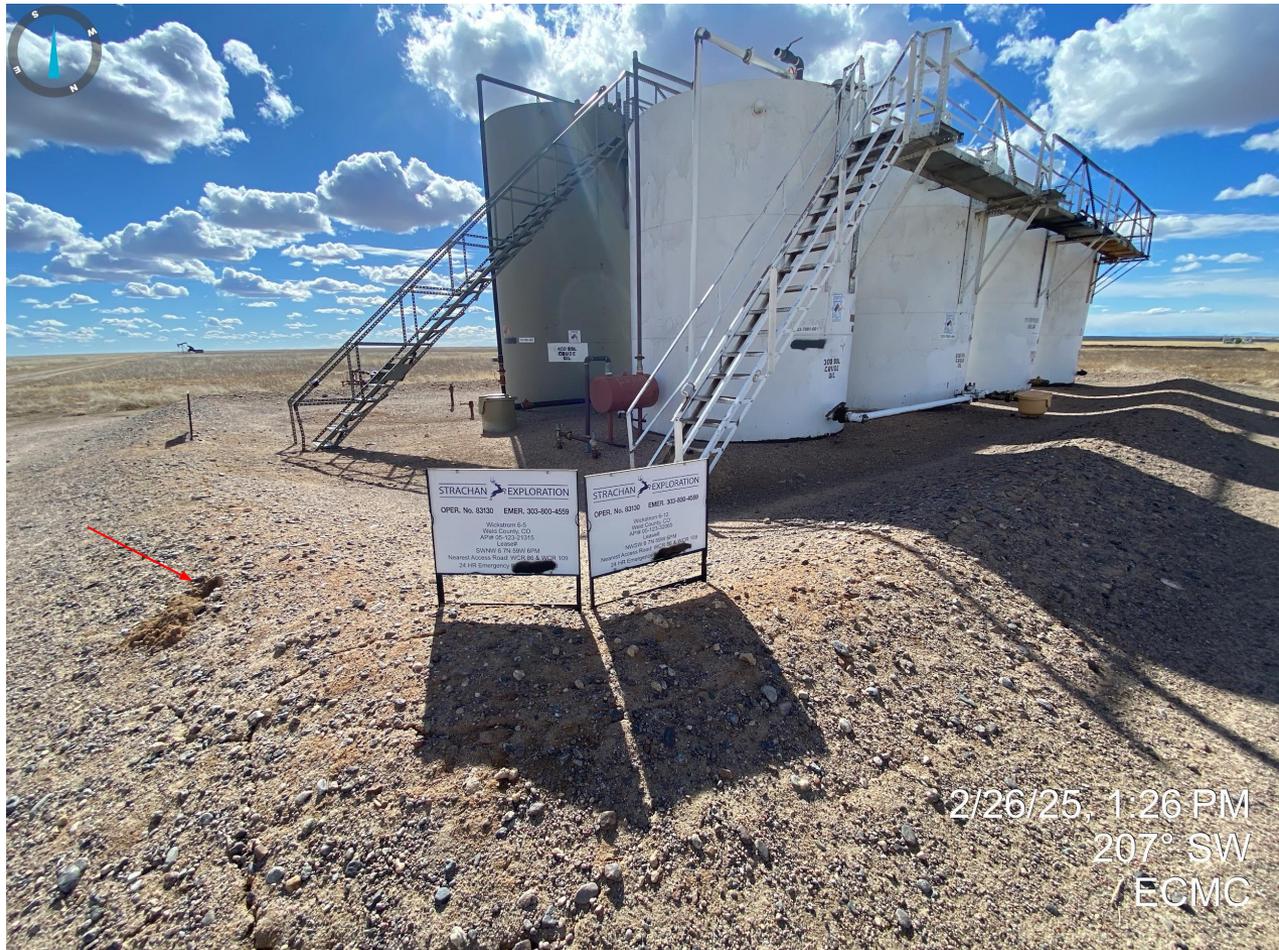
Photo 2. Animal burrow observed at tank battery berm.

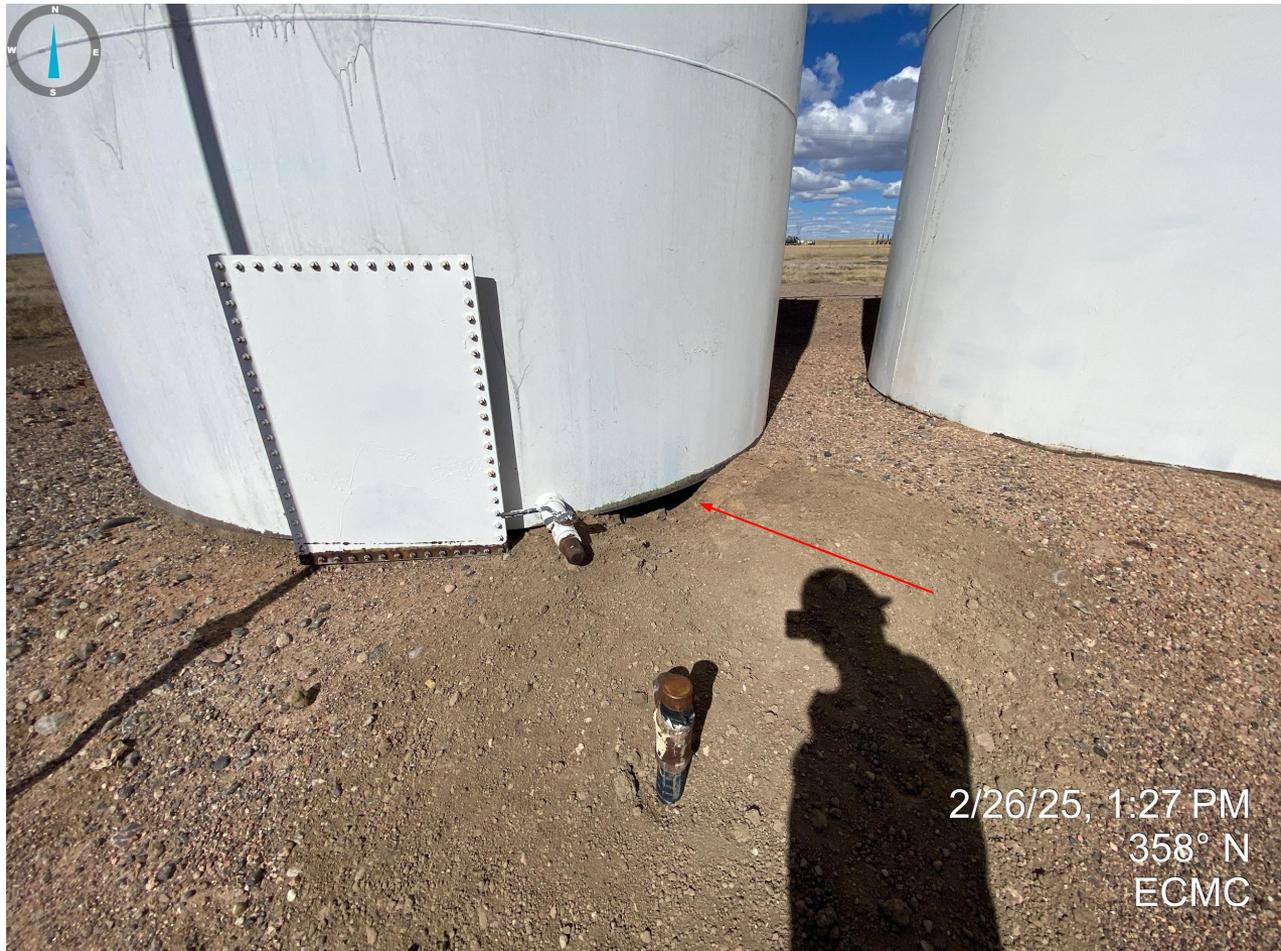
Photo 3. Animal burrow observed at AST.

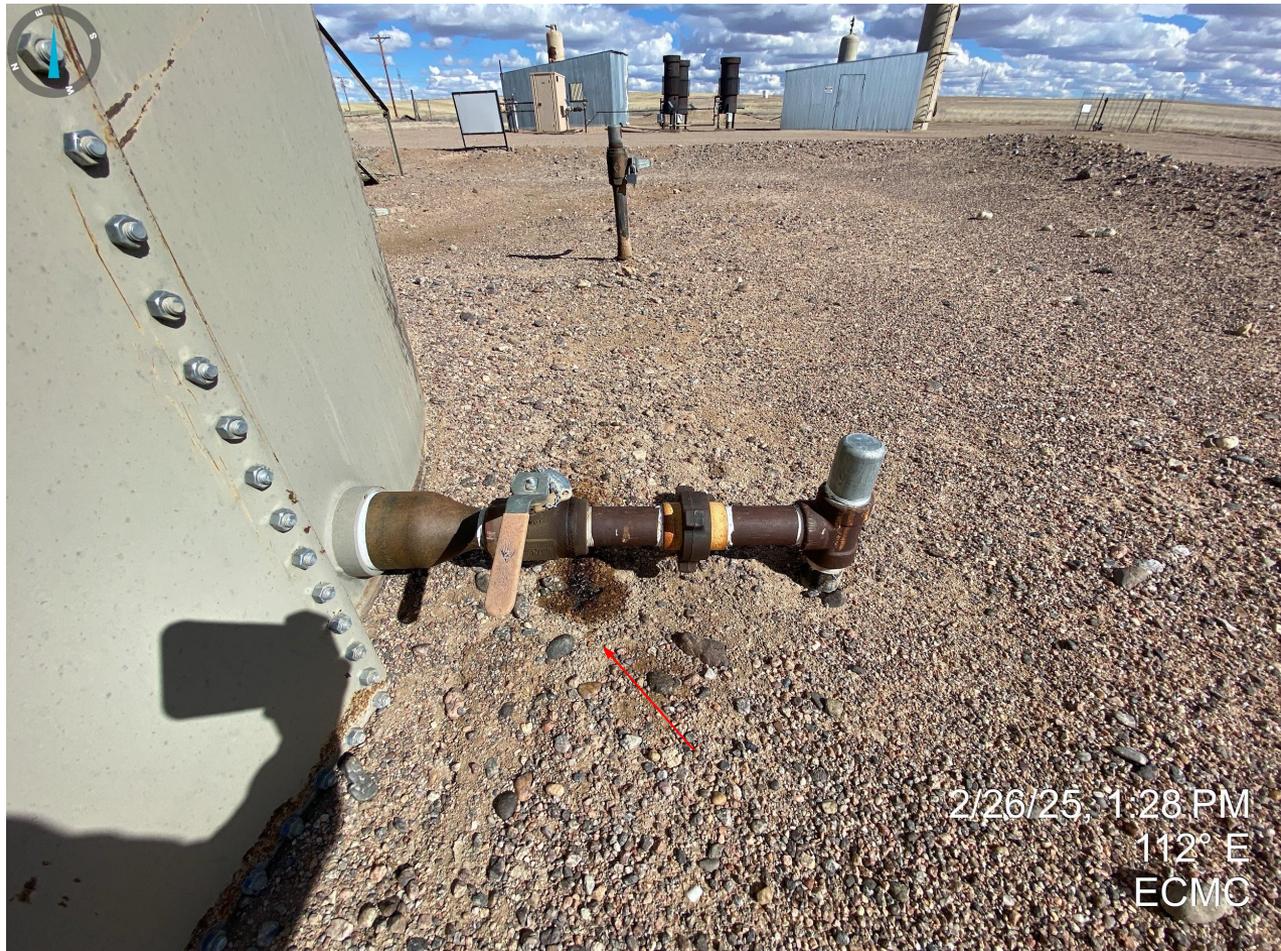
Photo 4. Stained soil and leaky valve at AST.

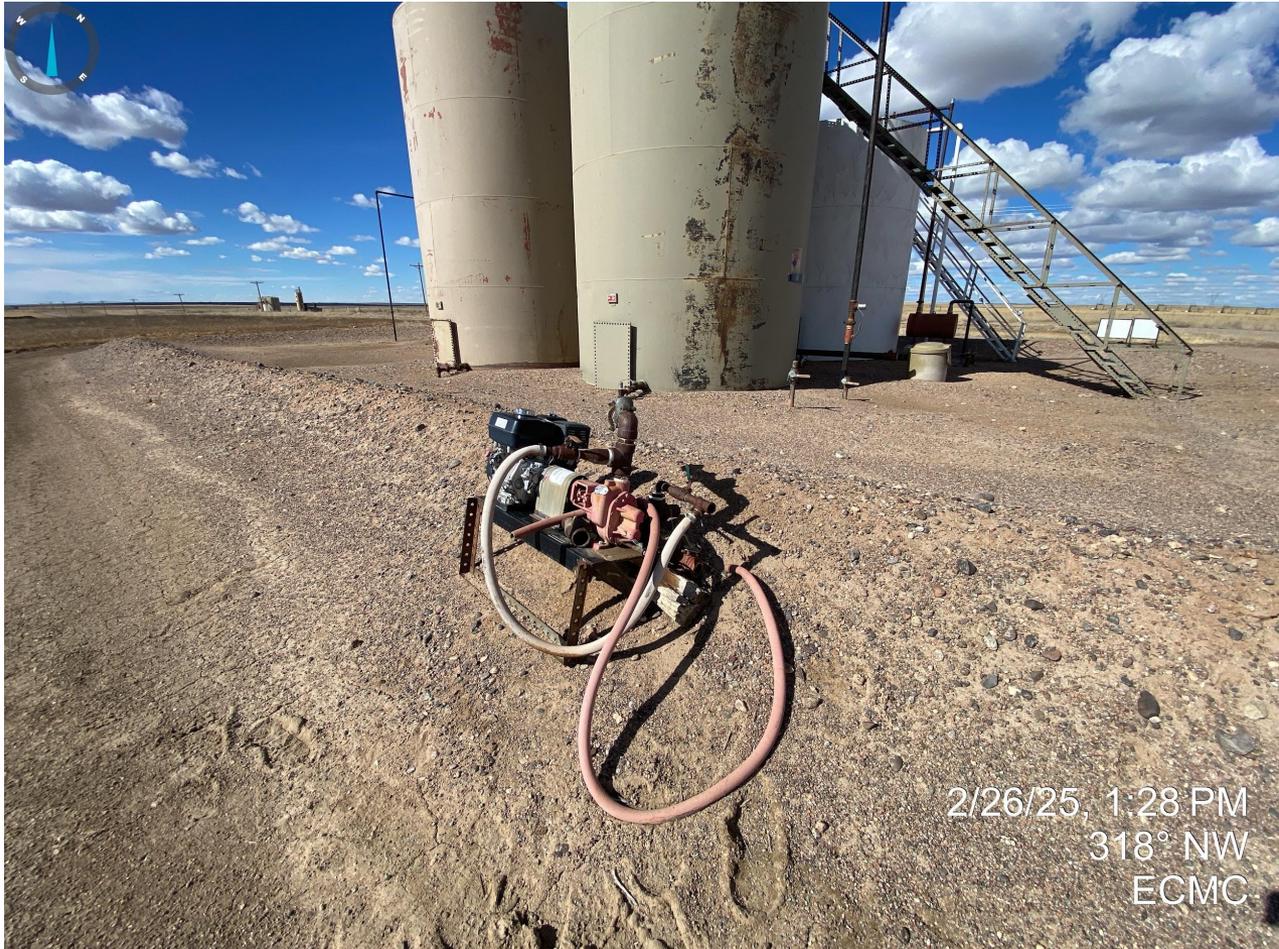
Photo 5. Unused equipment (motor/pump) observed on south side of tank battery.

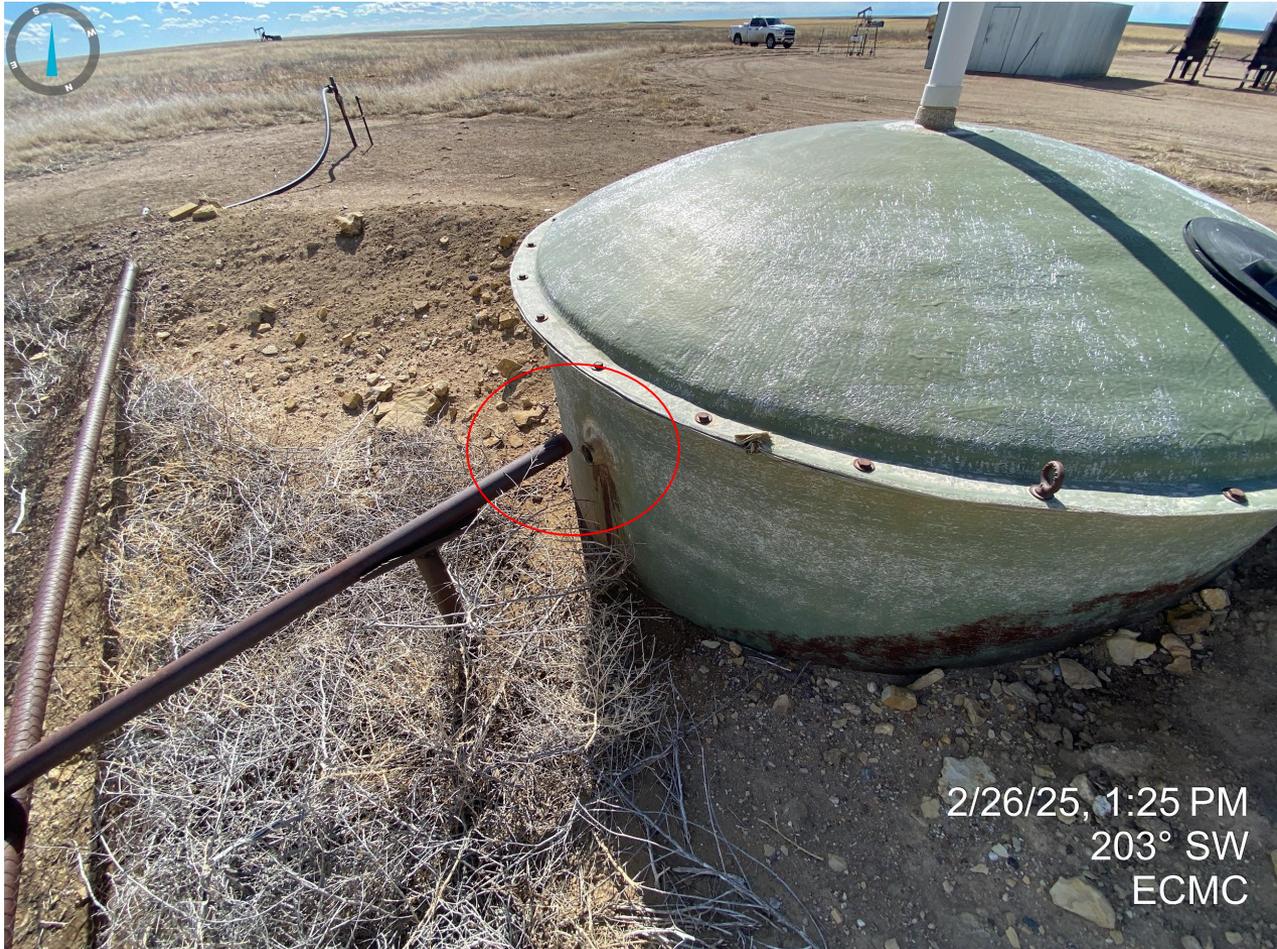
Photo 6. Fitting at partially buried vessel does not appear to be properly connected.

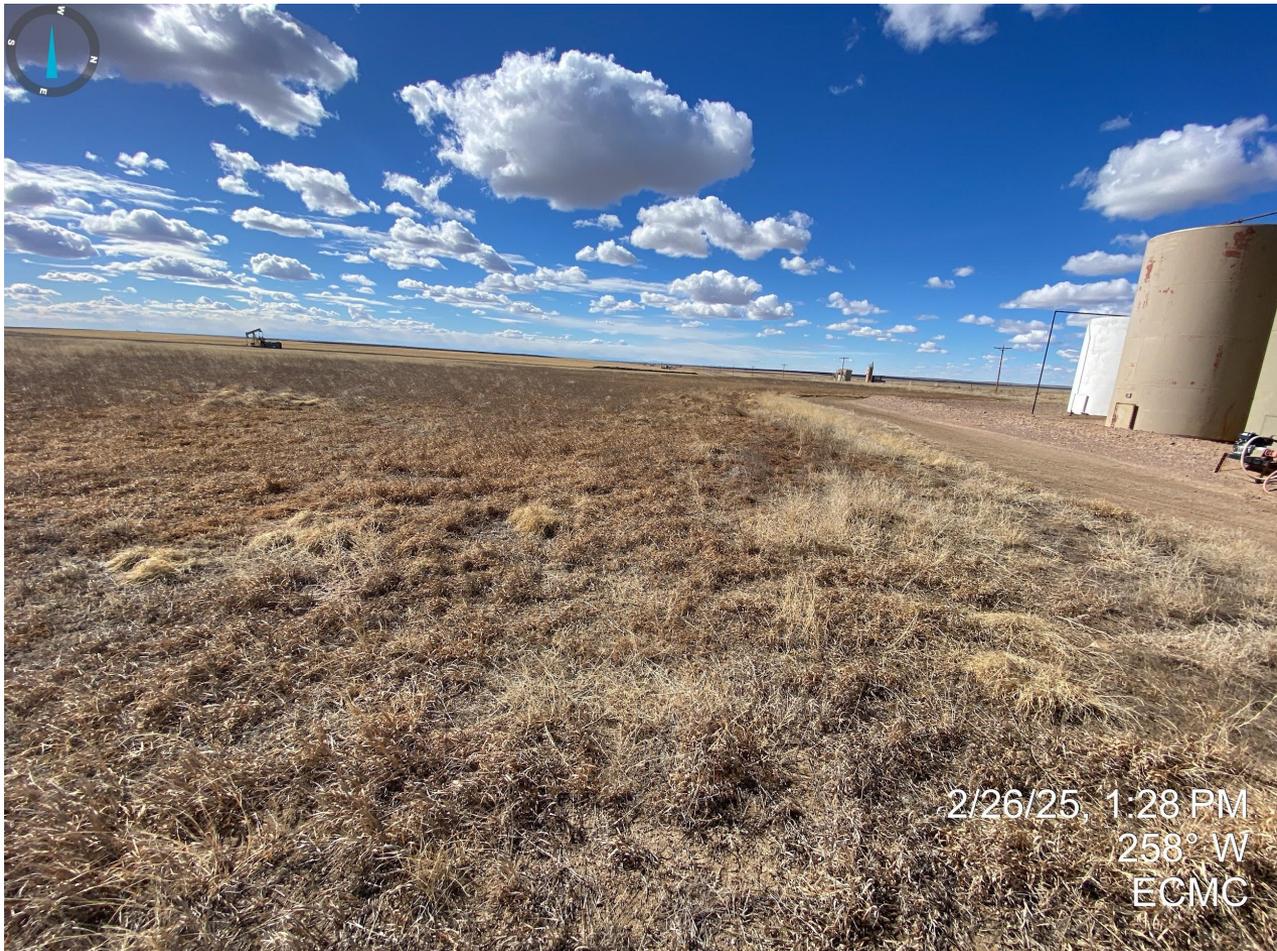
Photo 7. Southern interim areas. Appears interim reclamation activities have been performed to reduce disturbance areas only needed for production operations. A vegetative assessment will be performed at a later date during the active growing season to verify interim reclamation regulations and standards and will therefore remain "In-Process".

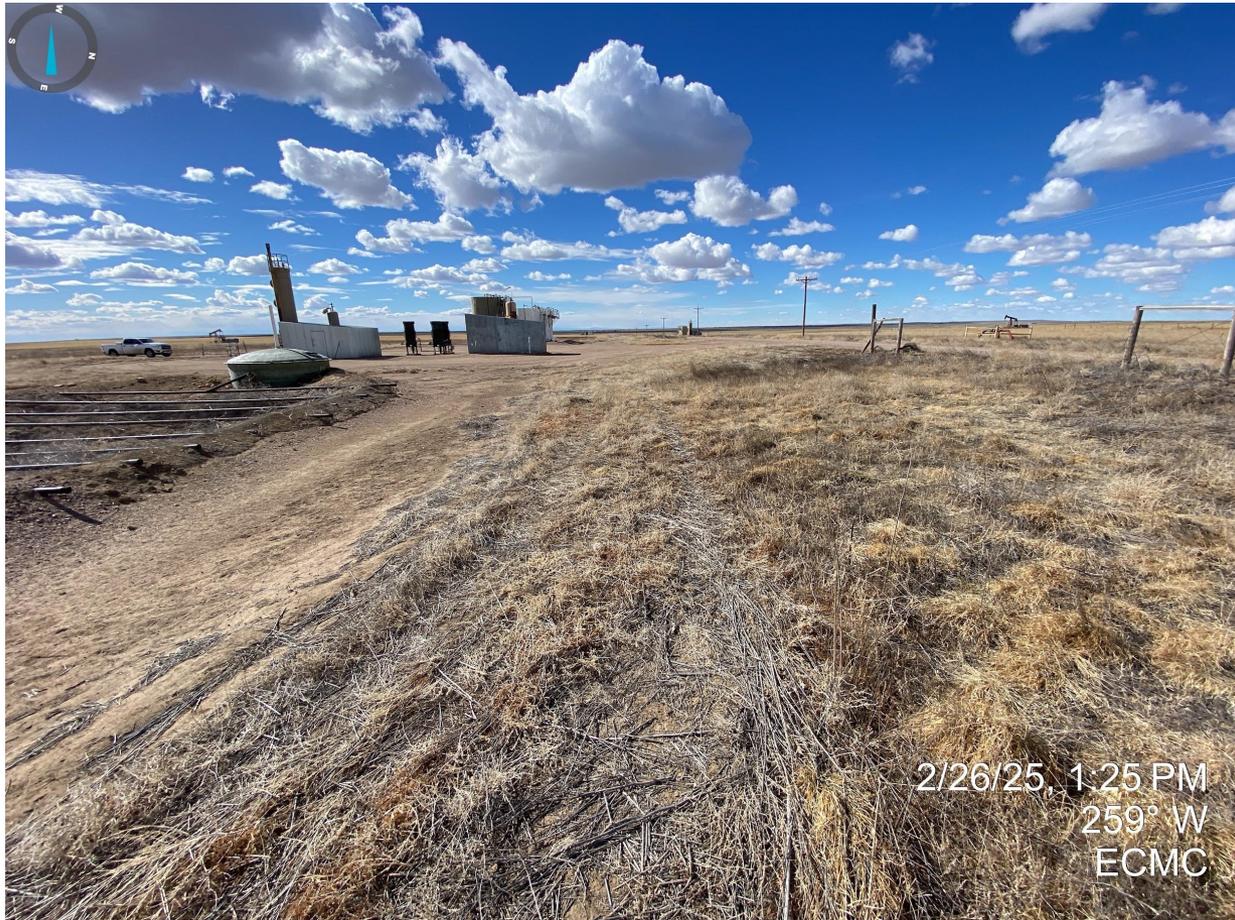
Photo 8. Northeastern interim areas; see comments in Photo 7.

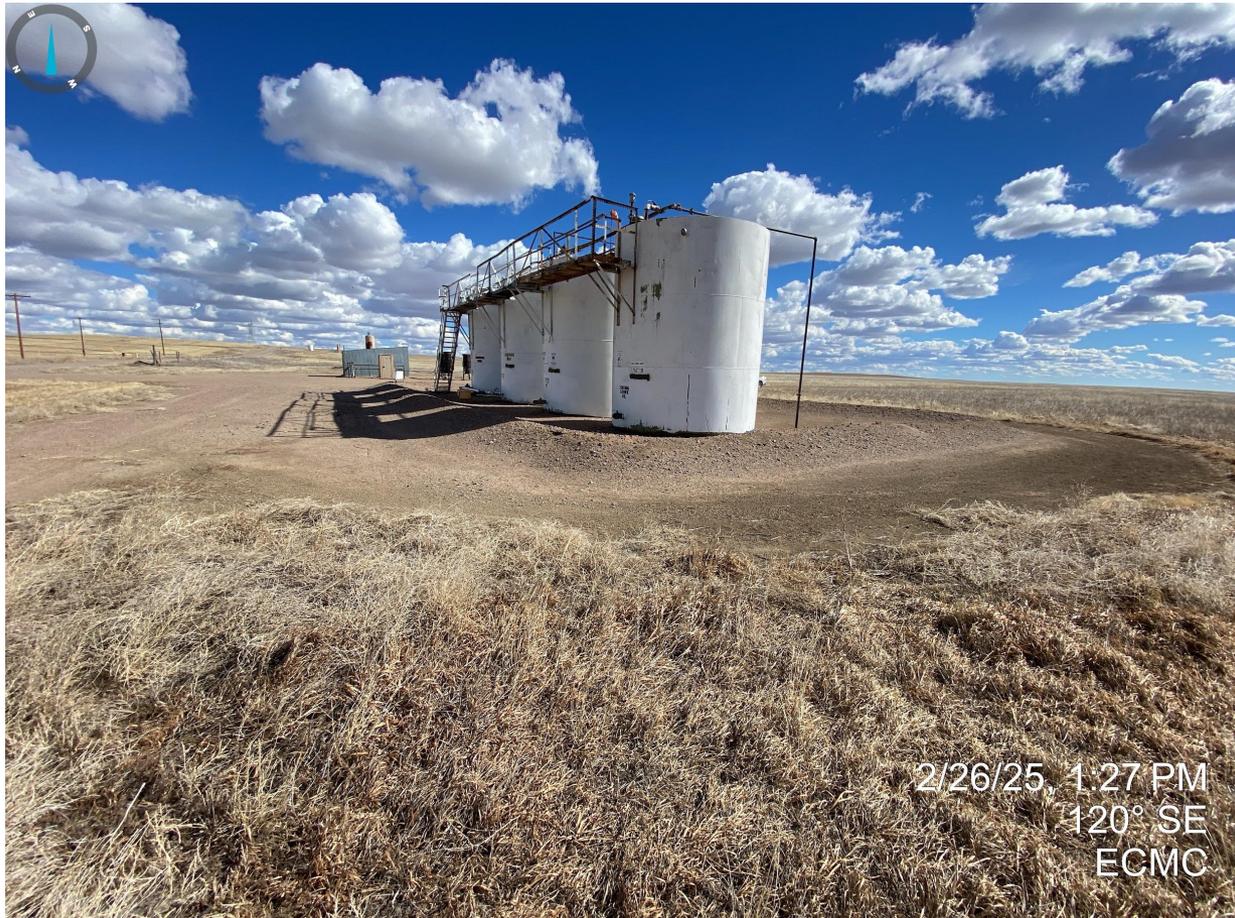
Photo 9. Northwestern interim areas; see comments in Photo 7.
