Interim Reclamation and Stormwater Inspection

Date: 02/26/2025

Operator: STRACHAN EXPLORATION INC - 83130

Inspection Photos
Location Name: Chalk 31-13
Location ID: 413187

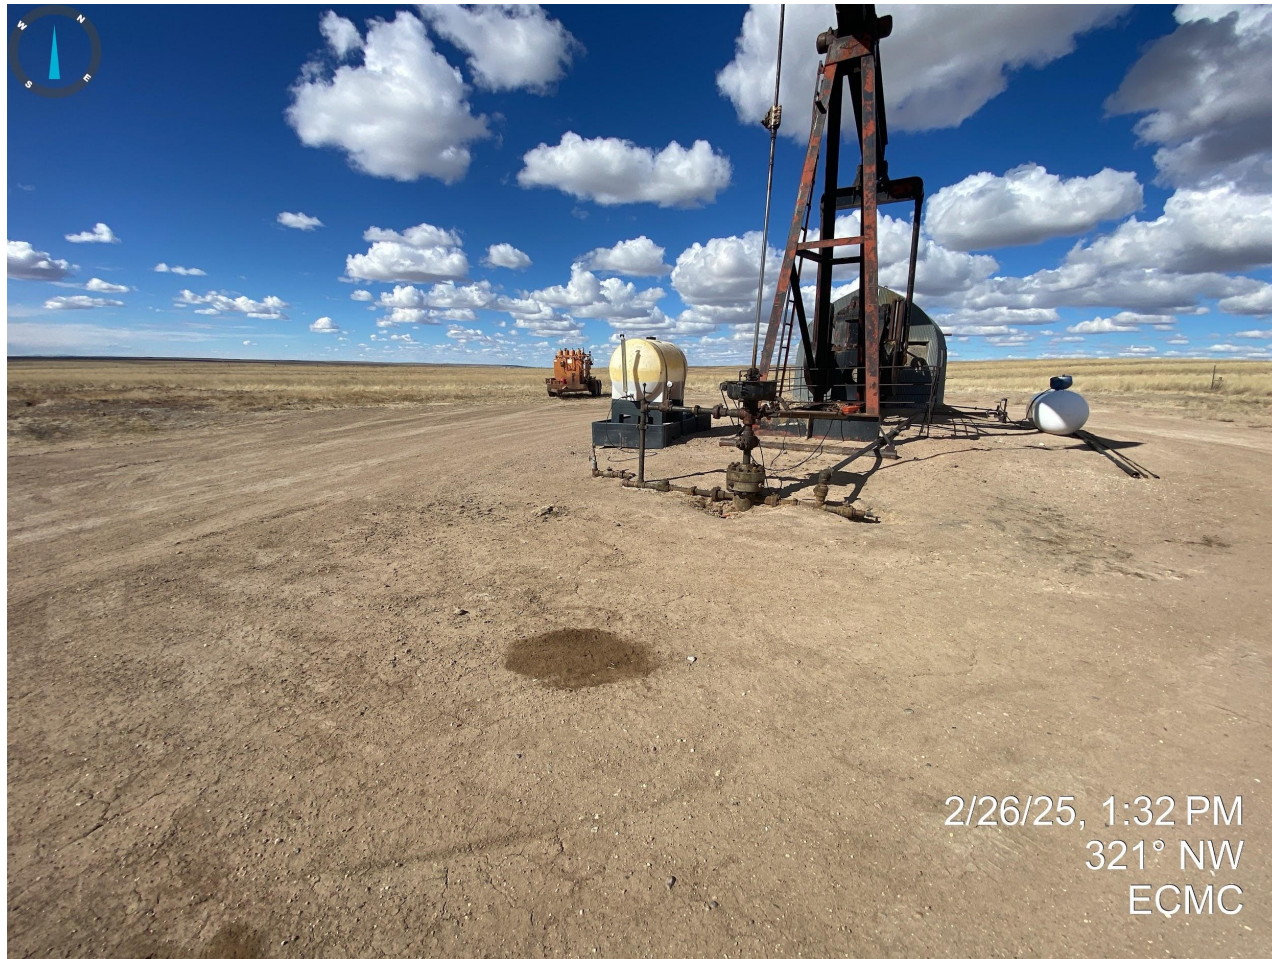
Photo 1. Stained soil observed near wellhead.

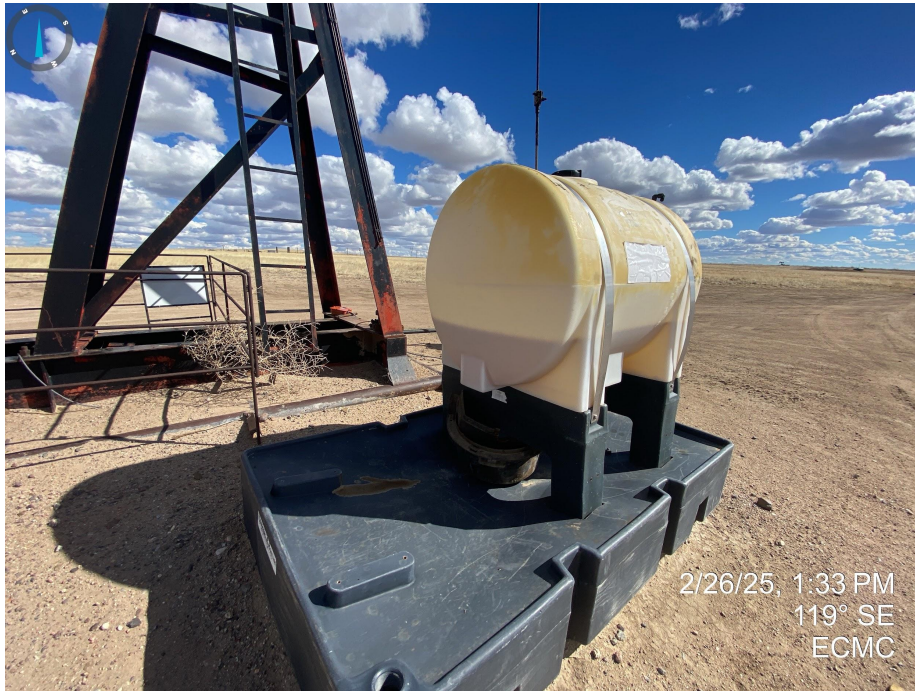
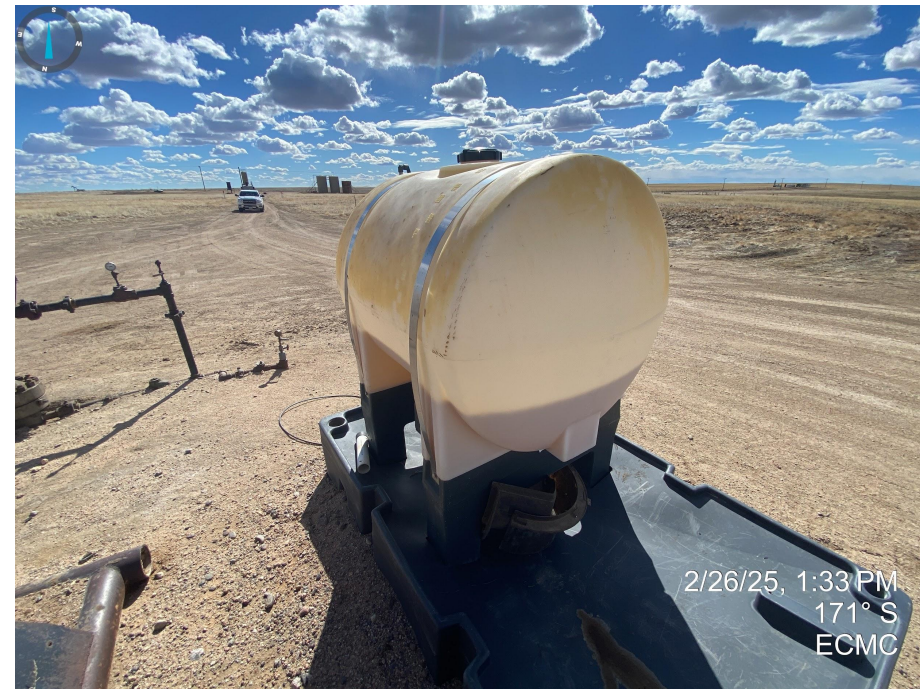
Photos 2 & 3. Tank labels not adequate at day tank.

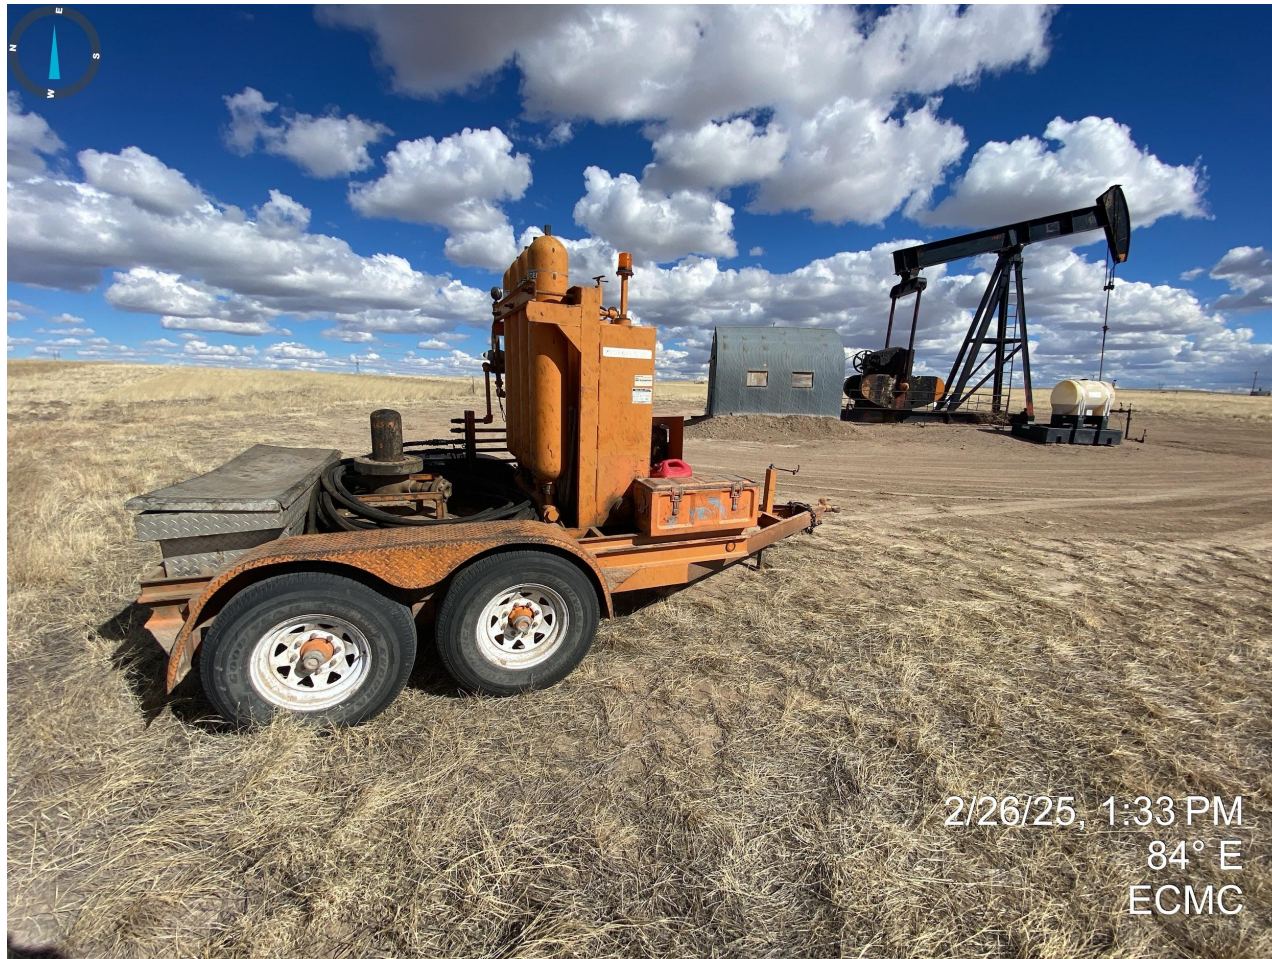
Photo 4. Unused equipment stored northwest of wellhead/pumpjack.

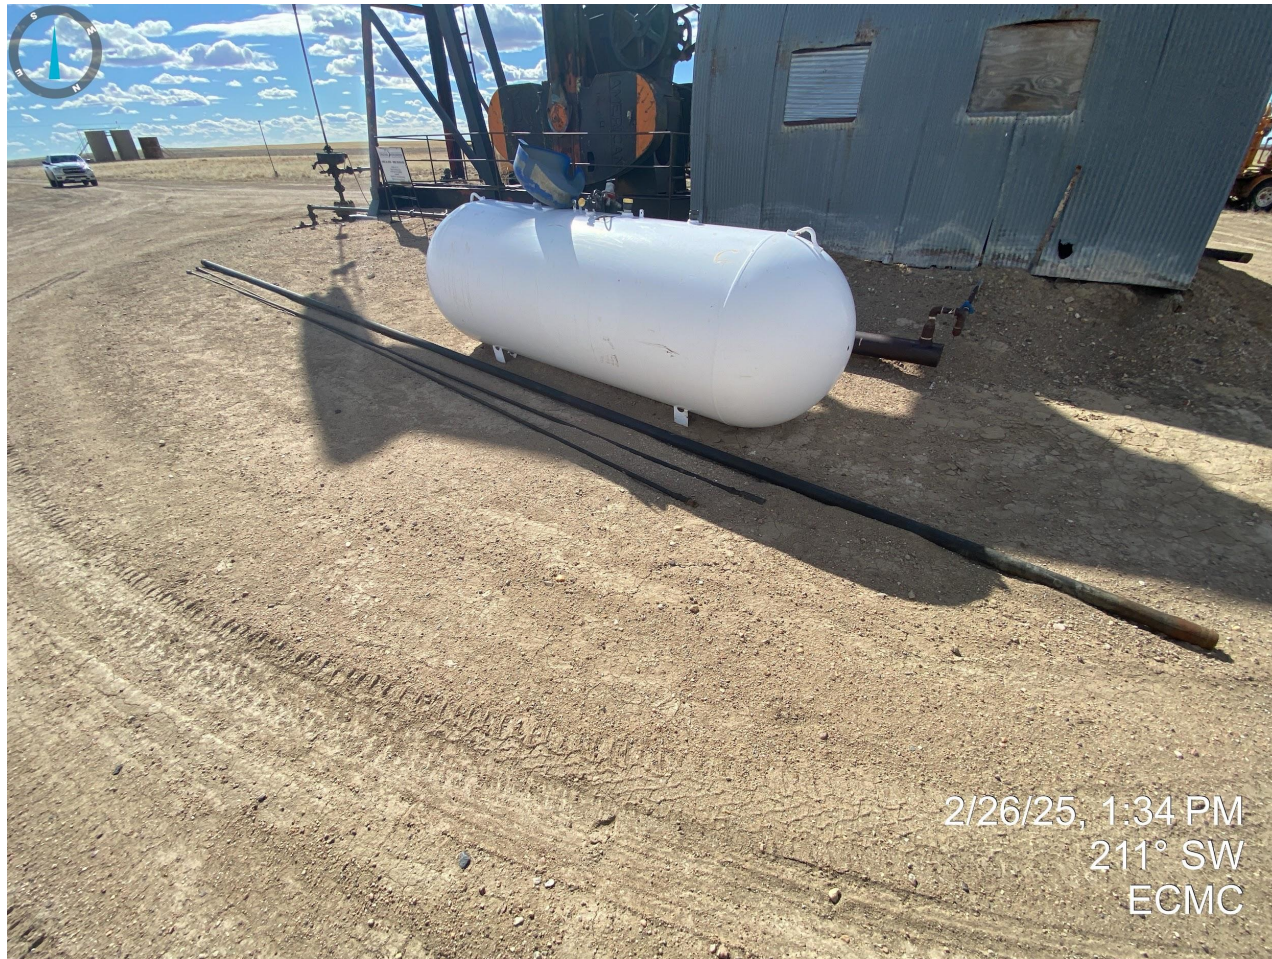
Photo 5. Unused equipment near pumpjack unit.

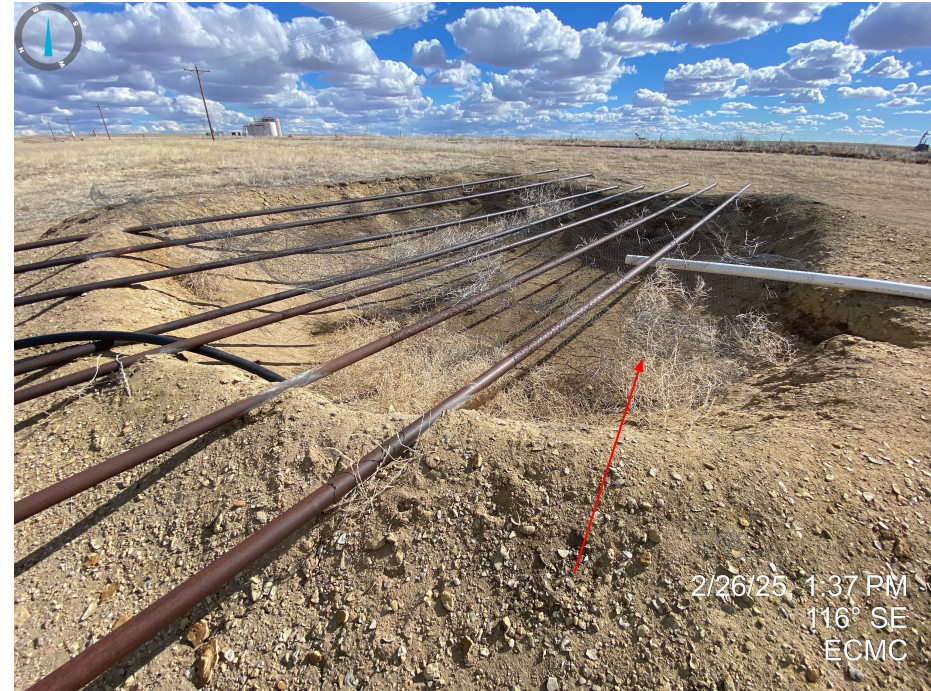
Photos 6 & 7. Wildlife netting at partially buried vessel and pit does not appear adequate.

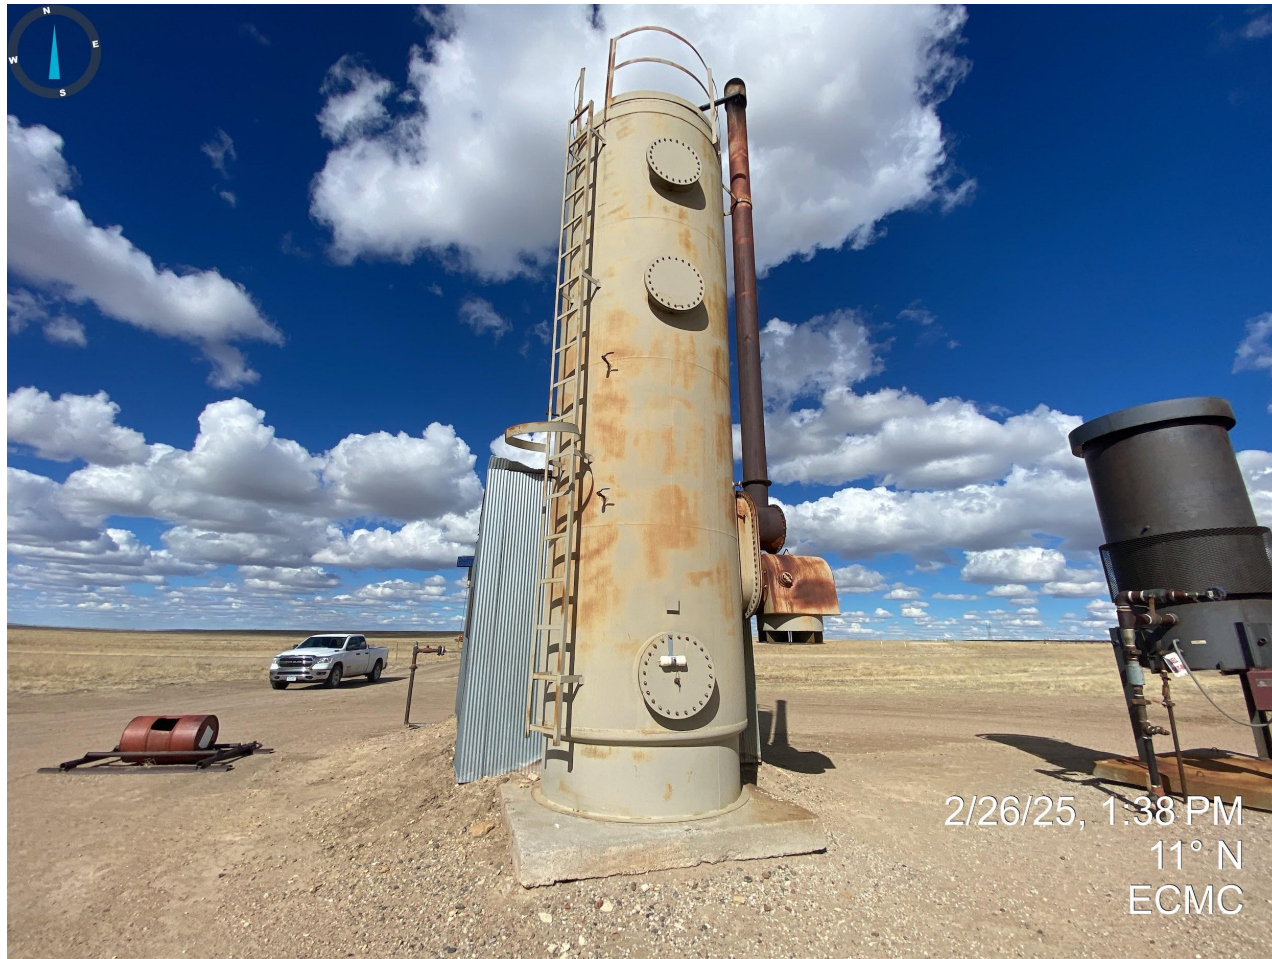
Photo 8. No NFPA placard at vertical heater treater.

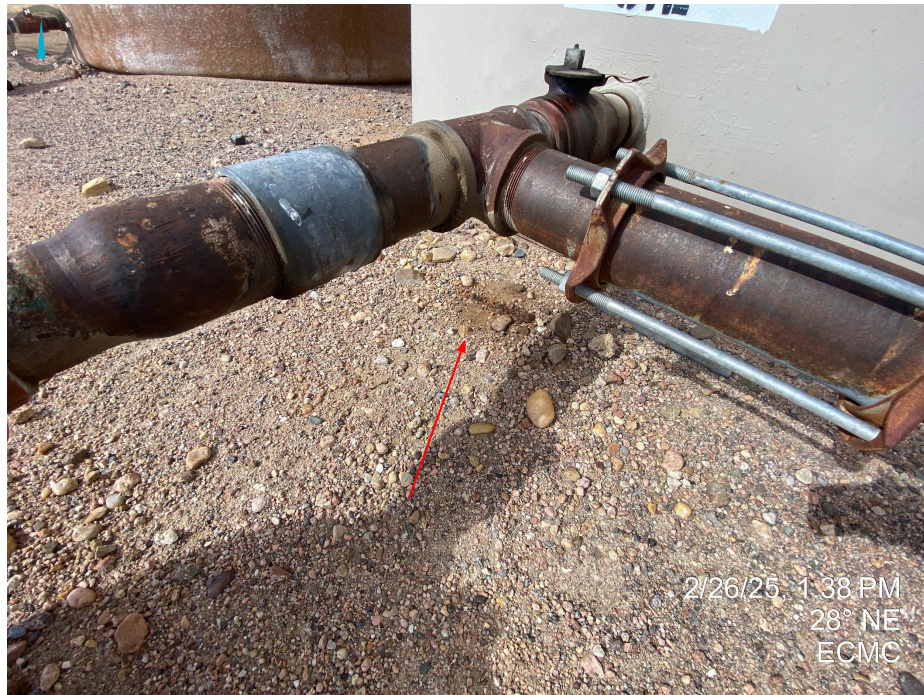
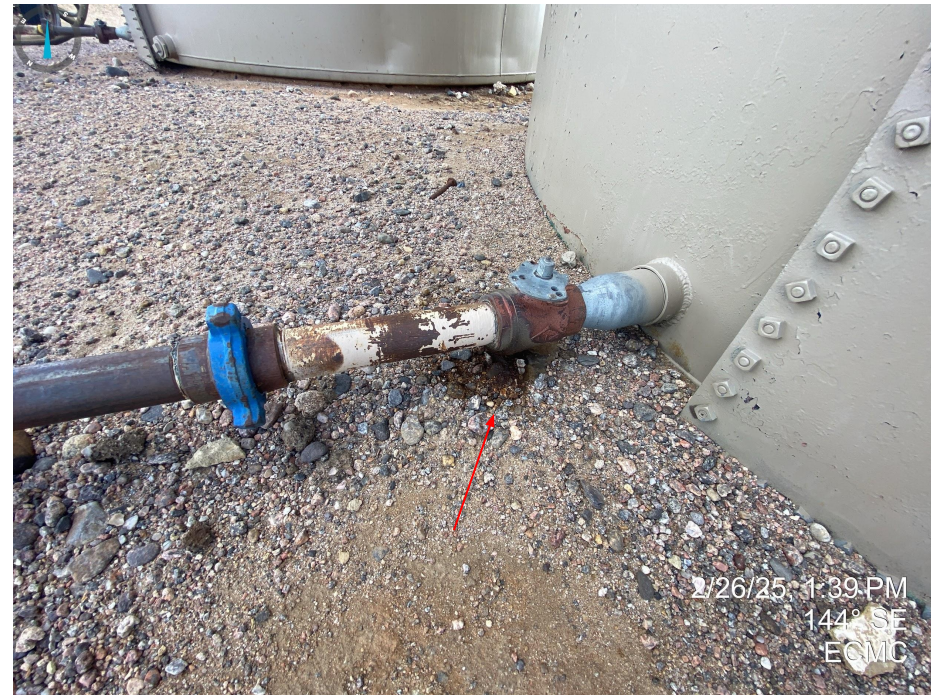
Photo 9 & 10. Stained soil and leaky valves at AST.

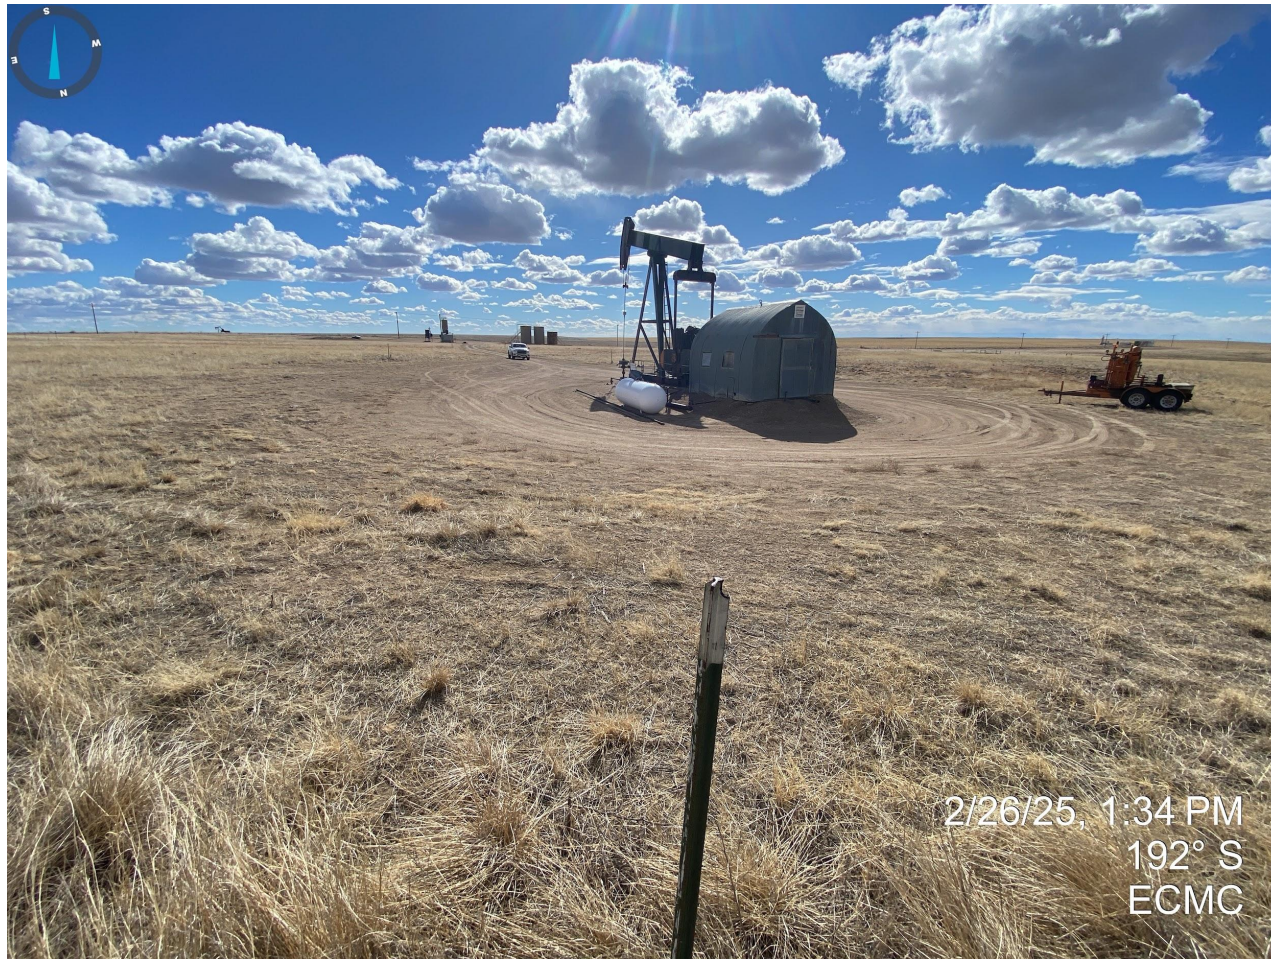
Photo 11. Northern interim areas, near well. Appears interim reclamation activities have been performed to reduce disturbance areas only needed for production operations. A vegetative assessment will be performed at a later date during the active growing season to verify interim reclamation regulations and standards and will therefore remain "In-Process".

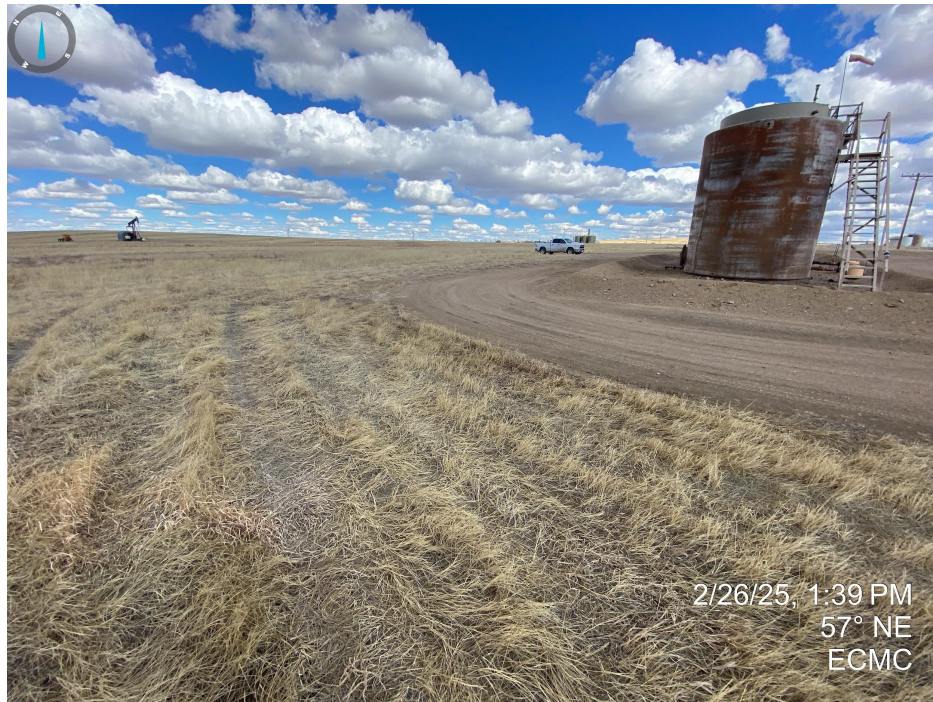
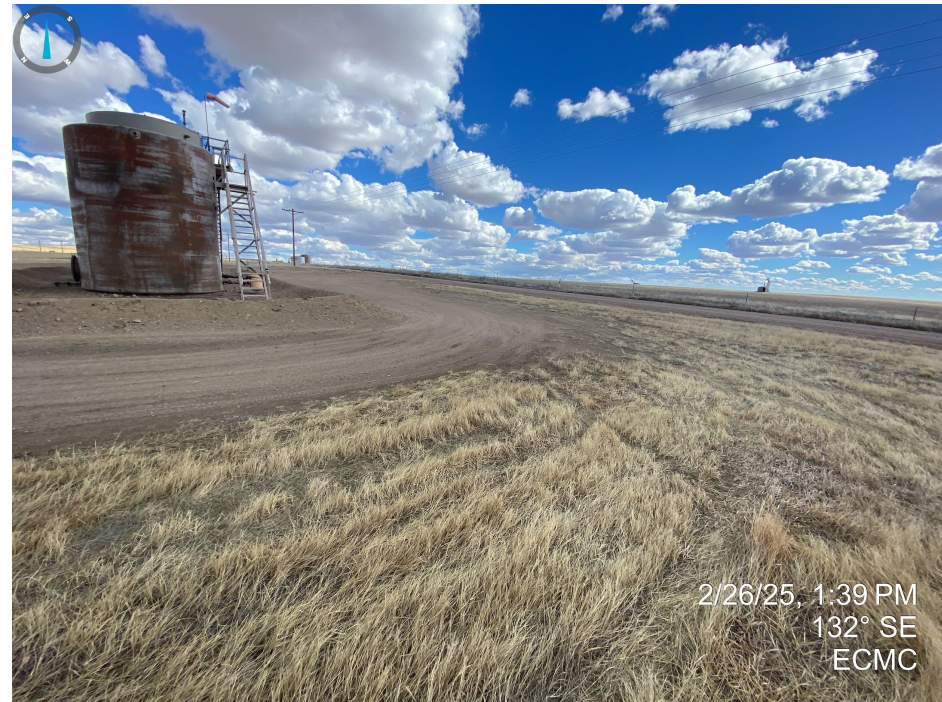
Photo 12 & 13. Western interim areas, near tank battery. See comments in Photo 11 for additional information.

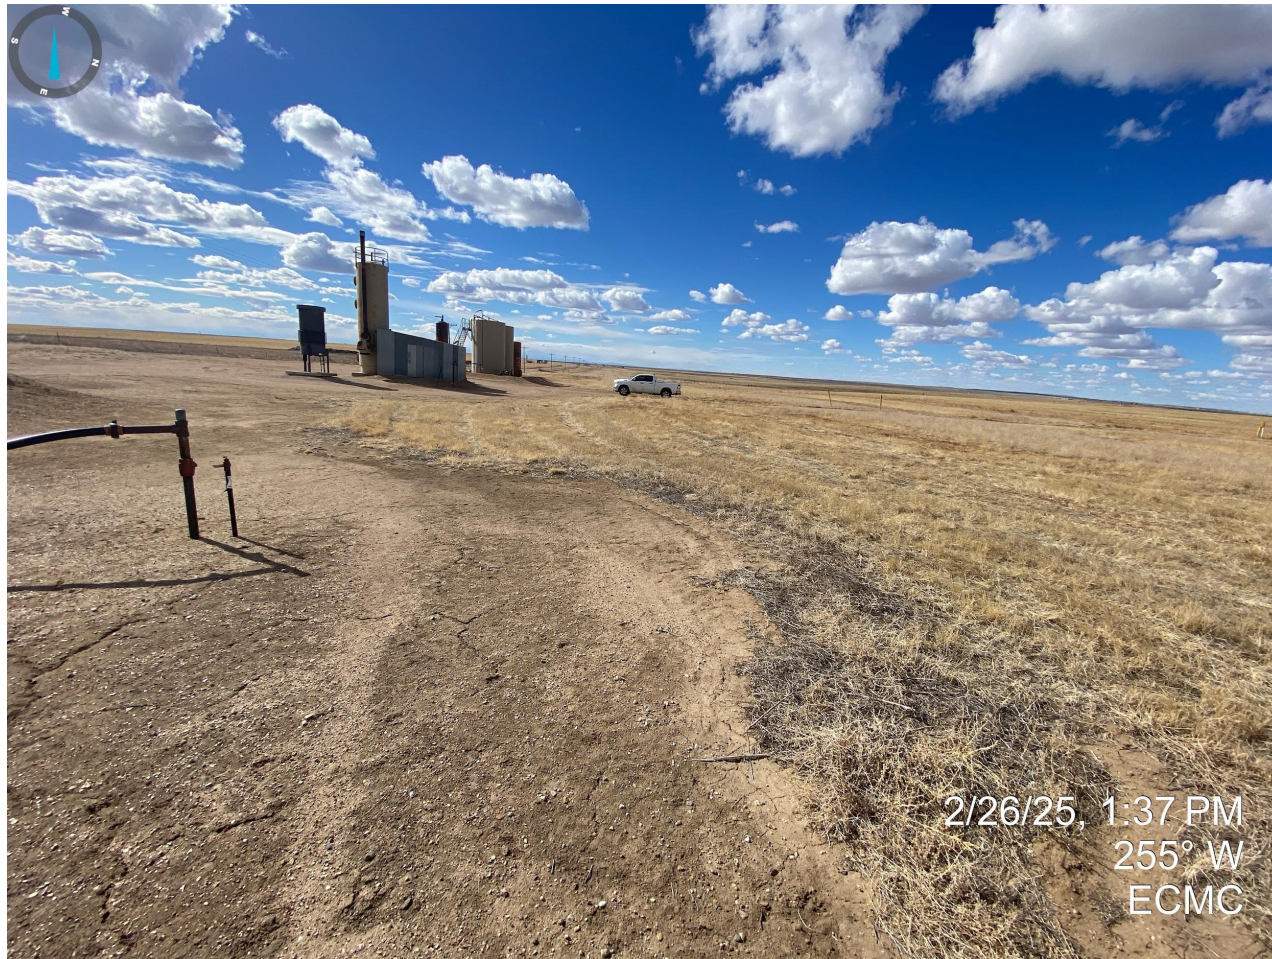
Photo 14. Eastern interim areas, near pit. See comments in Photo 11 for additional information.
