Inspection Photos
Location: Craig 8-1
Location ID: 309619
API # 05-073-06320

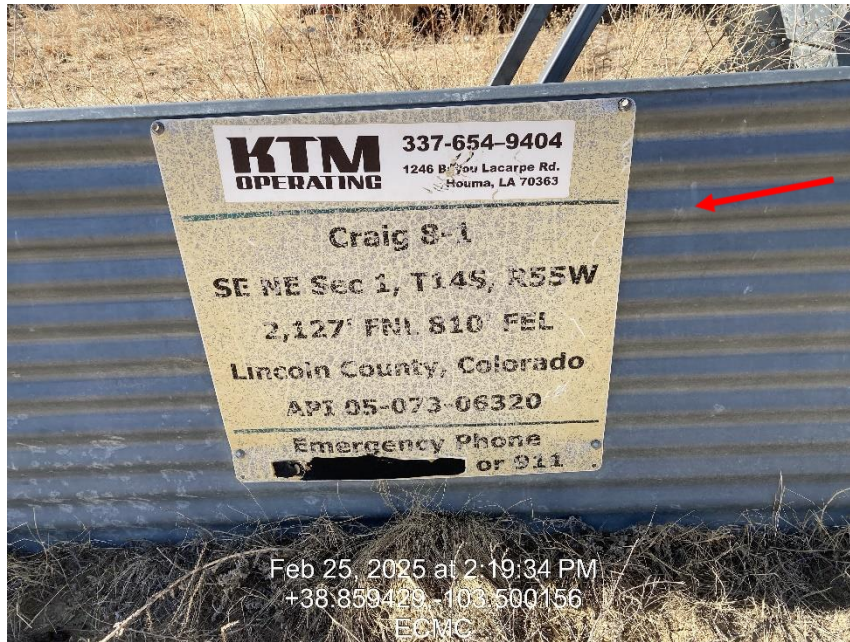
Photo 1 –Placard at tank battery

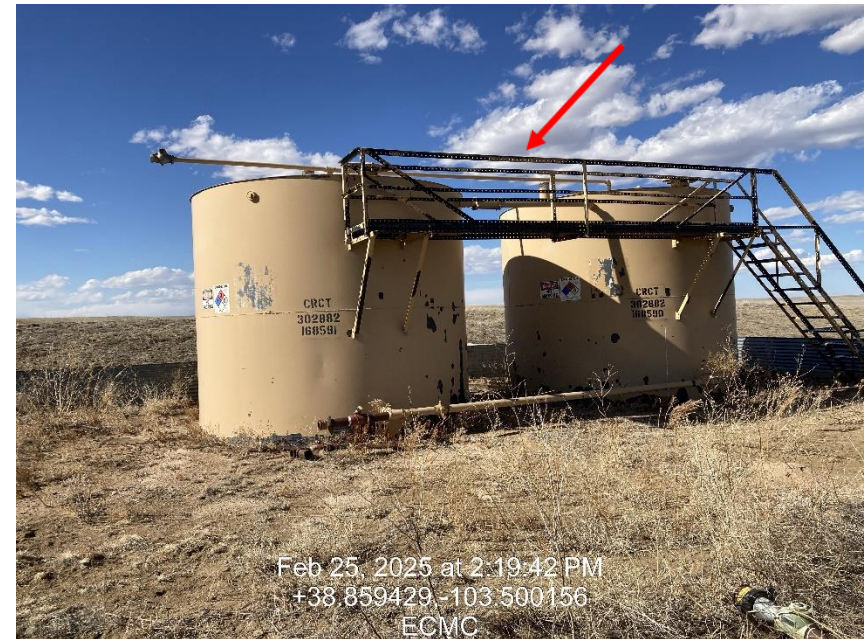
Photo 2 – Tanks

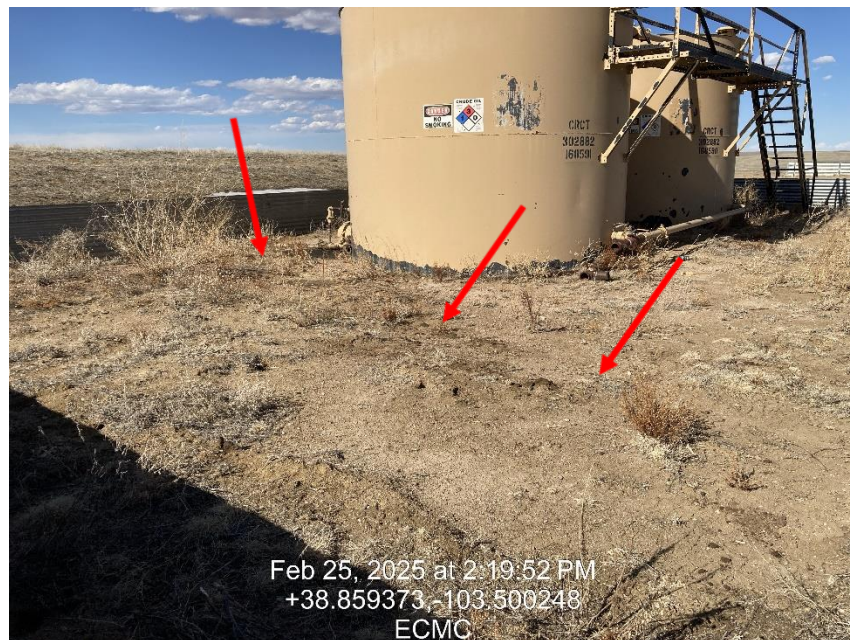
Photo 3 – Impacted soils

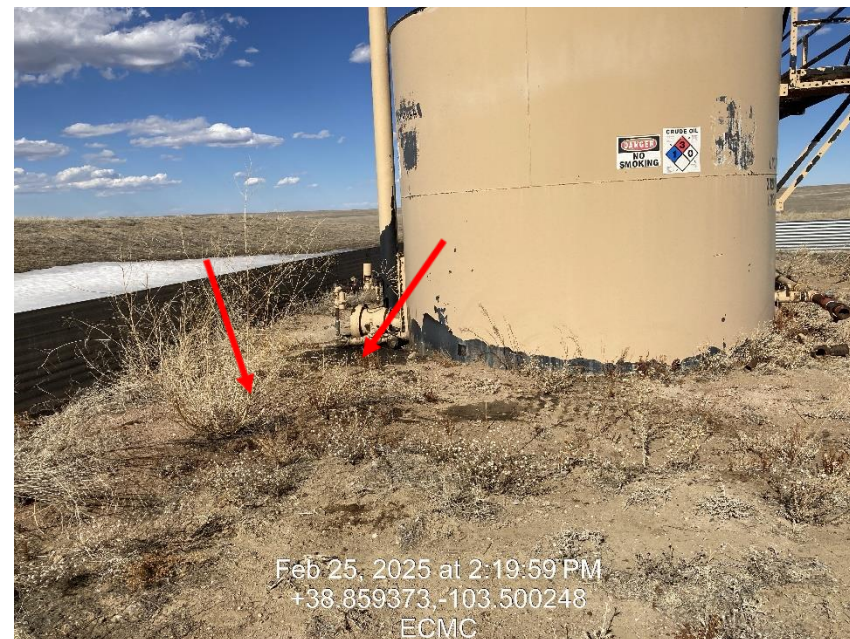
Photo 4 – Impacted soils

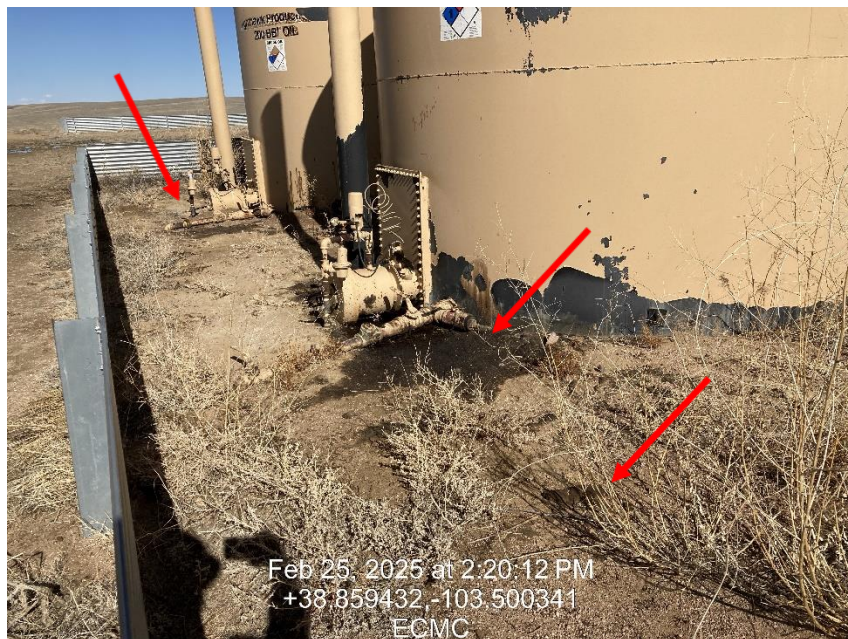
Photo 5 –Impacted soils

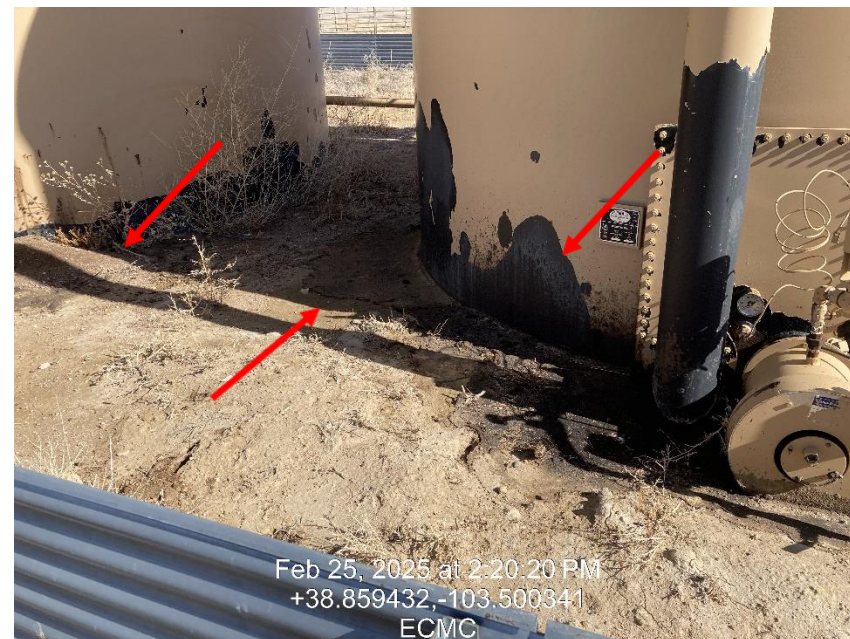
Photo 6 – Impacted soils

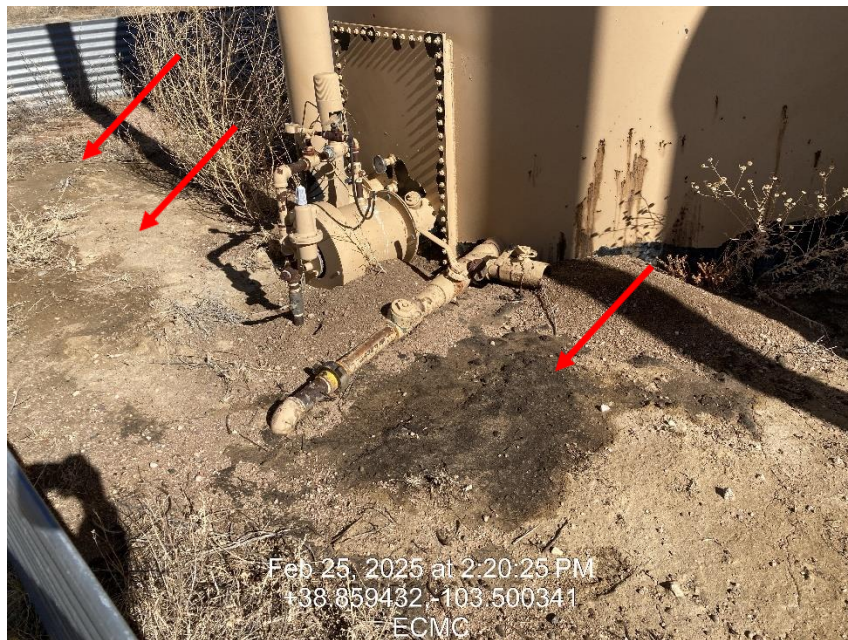
Photo 7 – Impacted soils

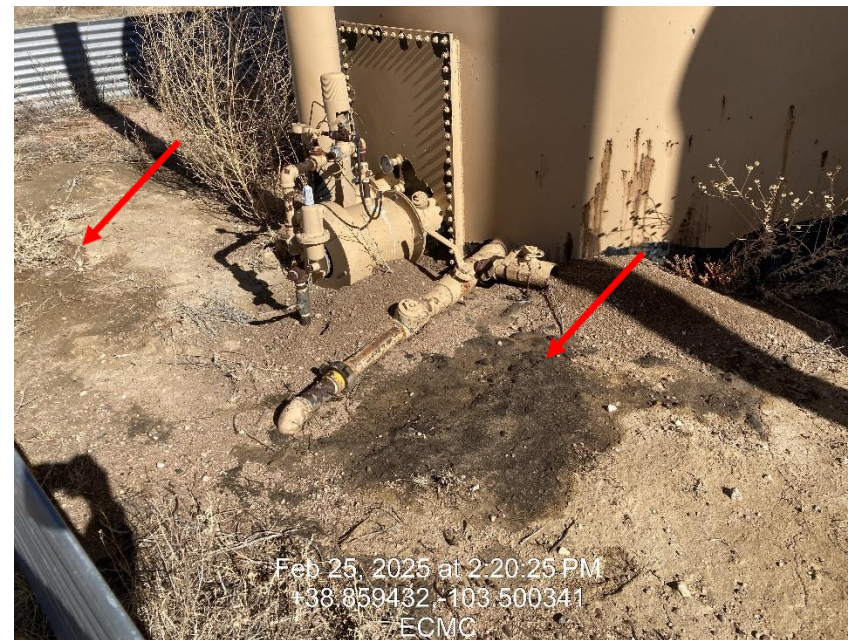
Photo 8 – Impacted soils

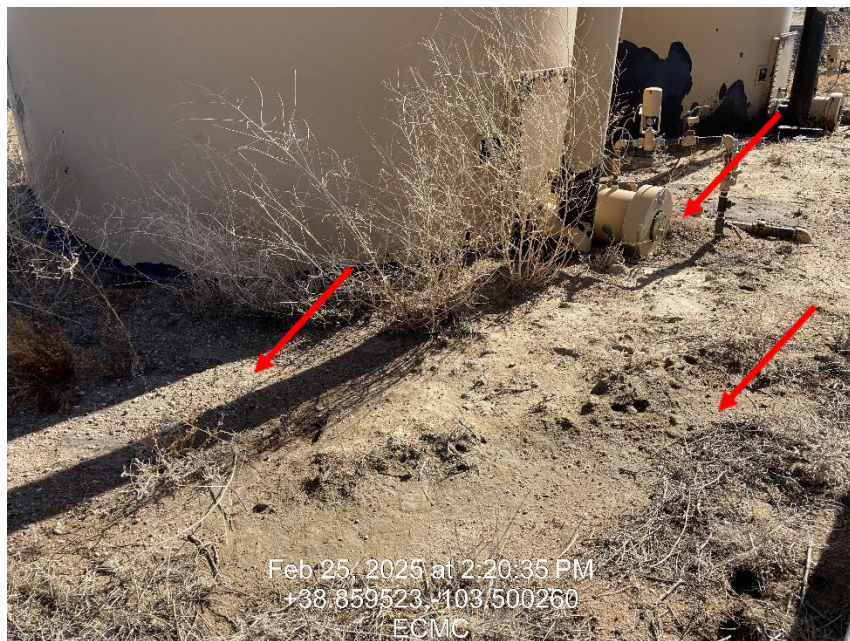
Photo 9 – Impacted soils

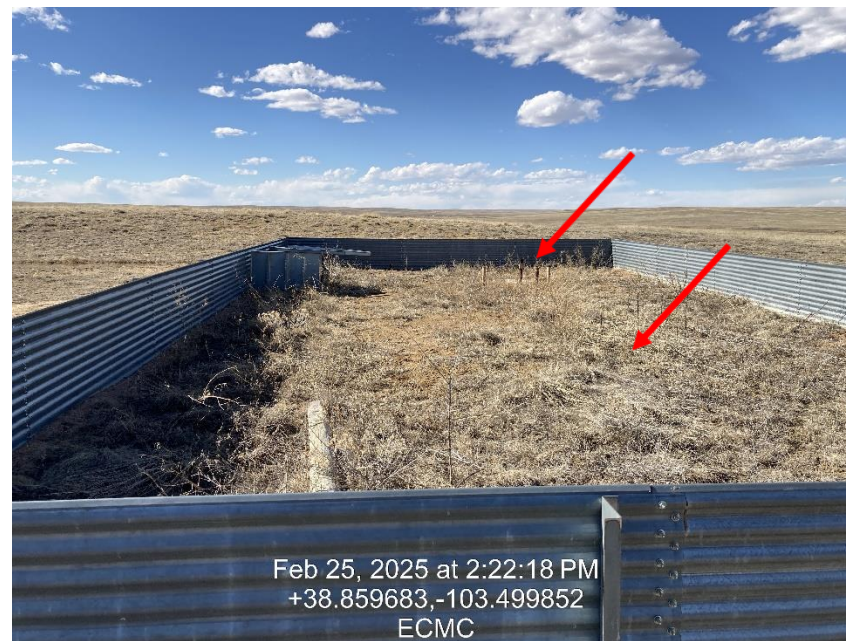
**Photo 10 – Unused secondary containment,
Unmarked pipes at upper arrow**

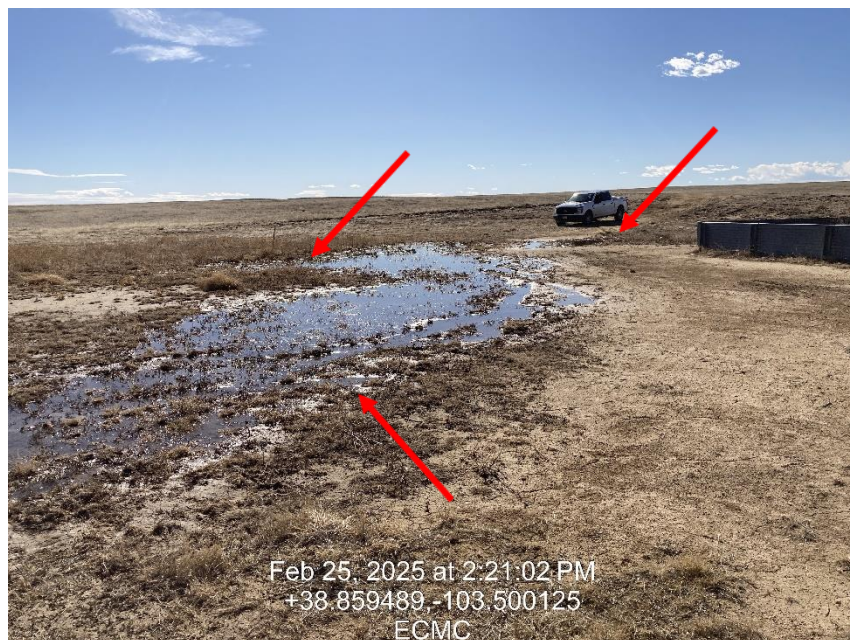
Photo 11 – Stormwater issues, vehicle rutting

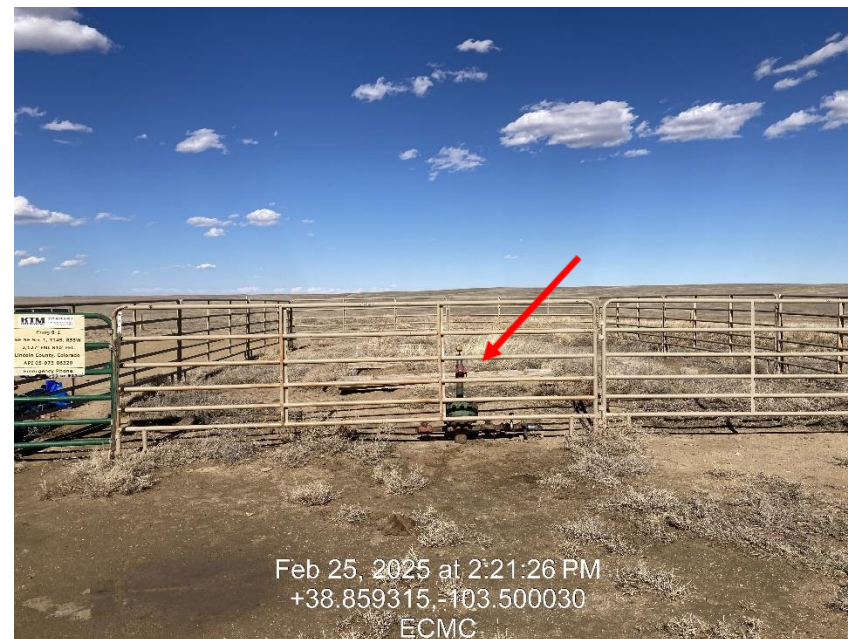
Photo 12 – Wellhead in fenced area
