KT Resources LLC
Ant Hill Unit-62N97W 36NWNW
Location ID: 336462

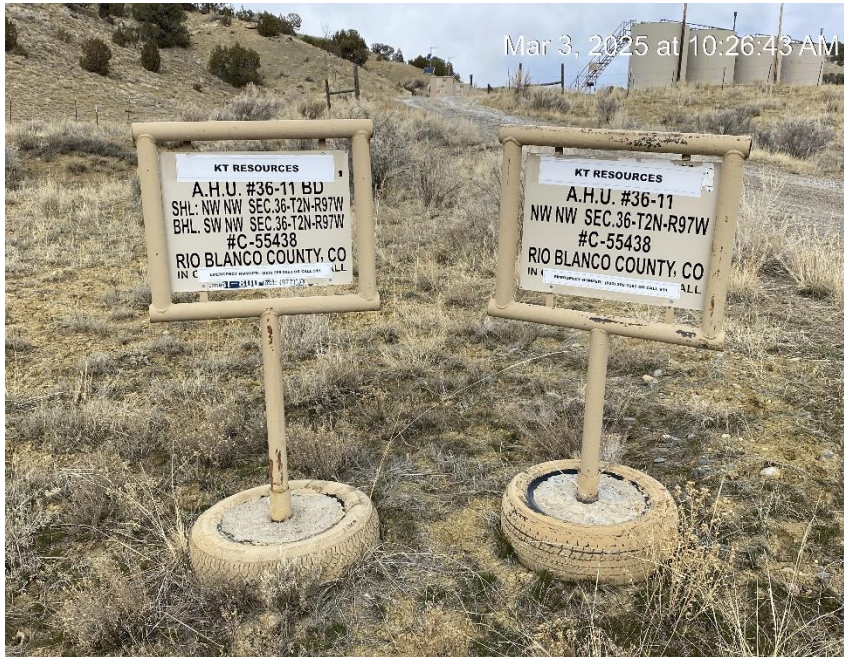
Information missing

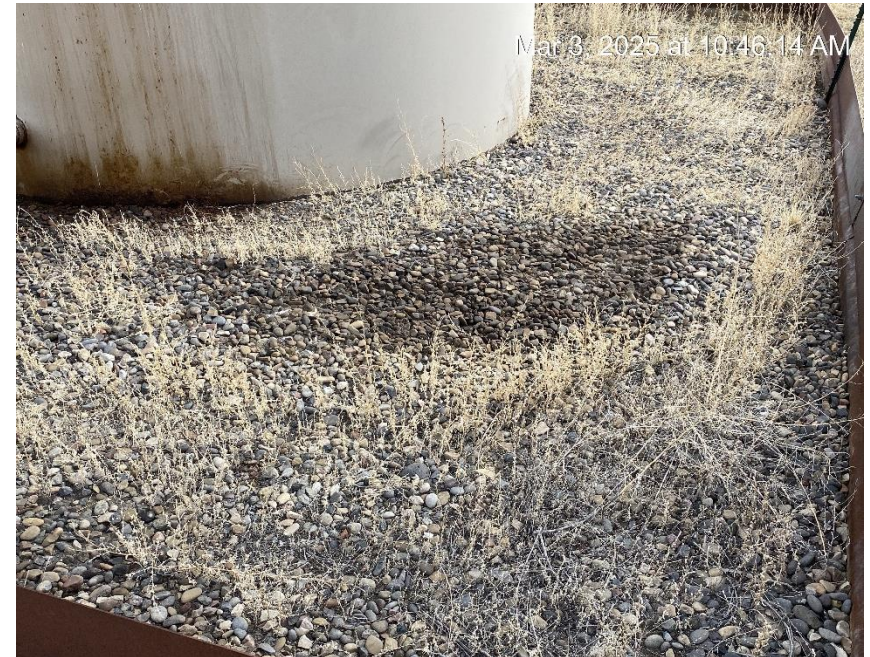
Stained soil

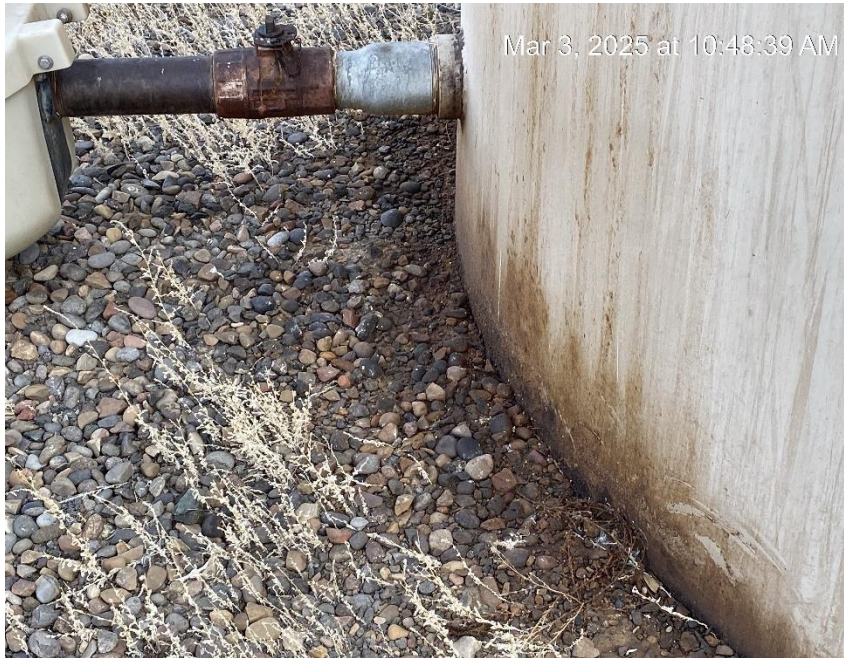
Stained soil

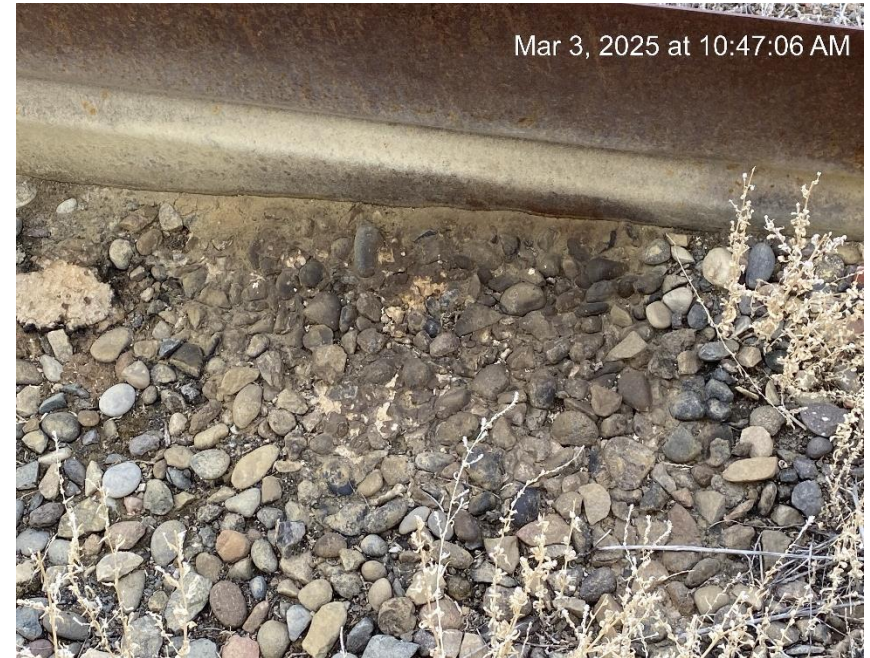
Oily waste and staining

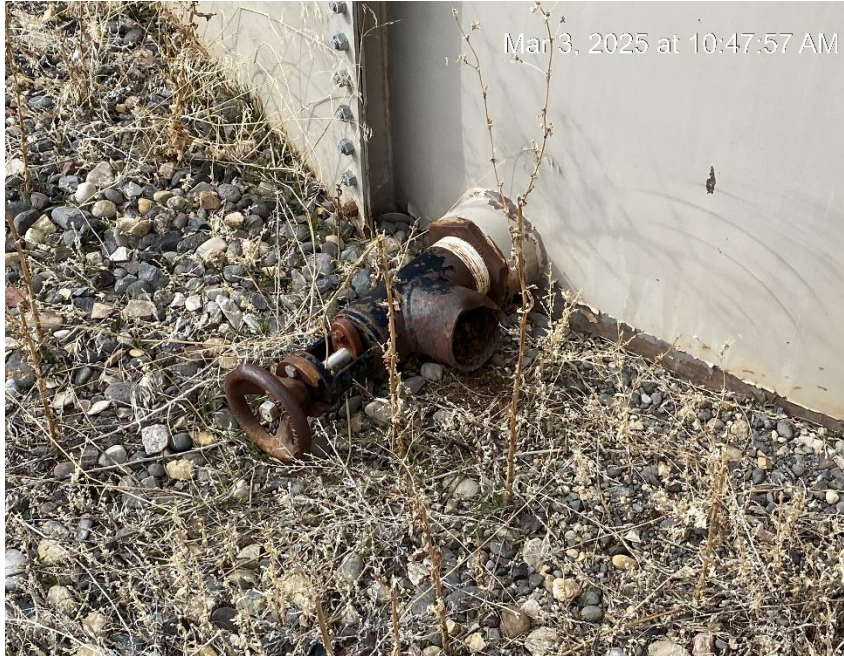
Open end tank valve

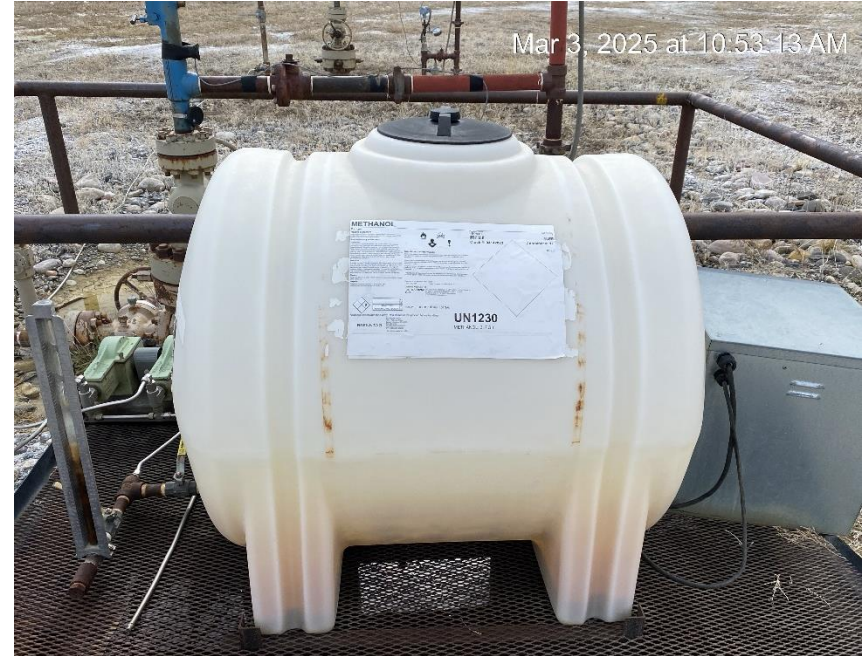
Faded label

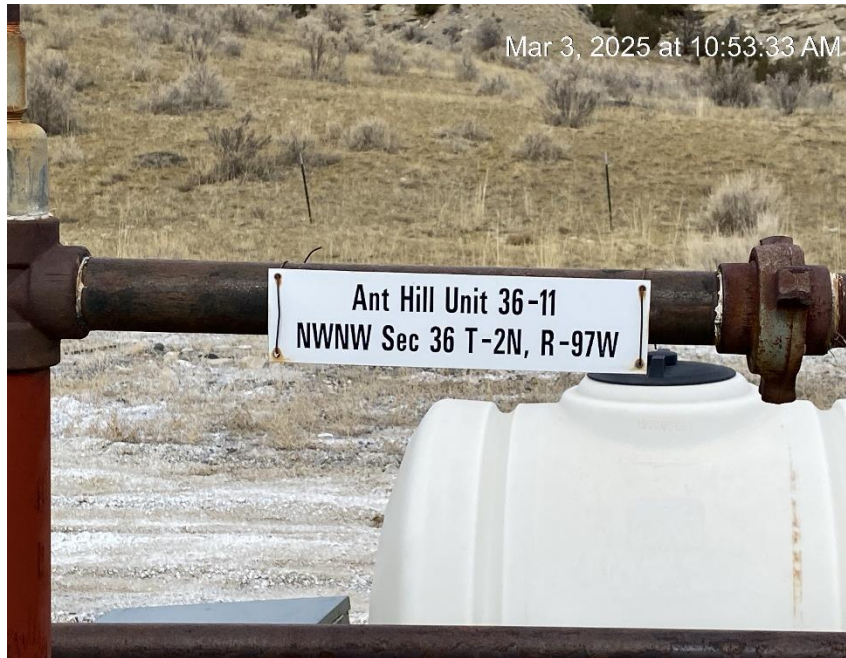
Missing required information

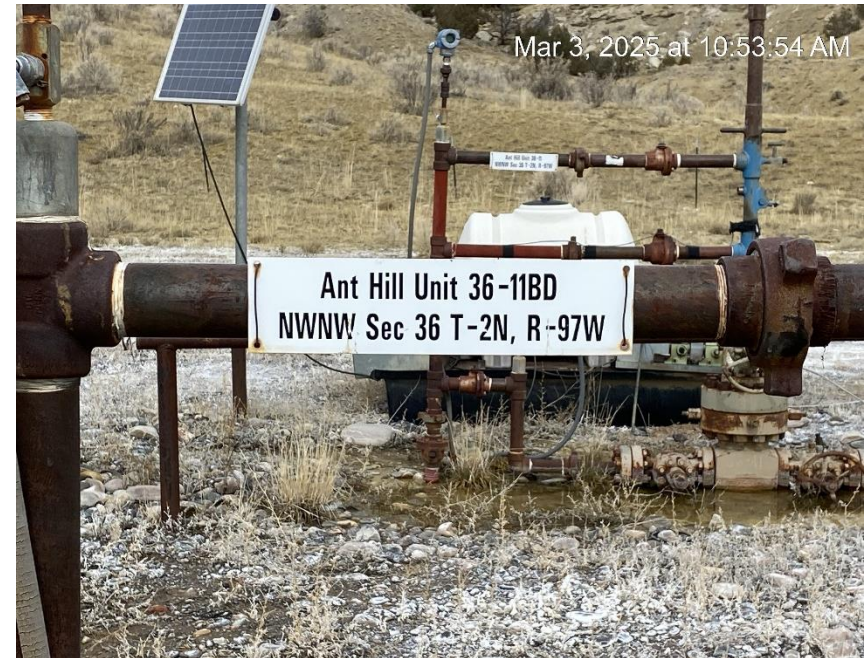
Missing required information

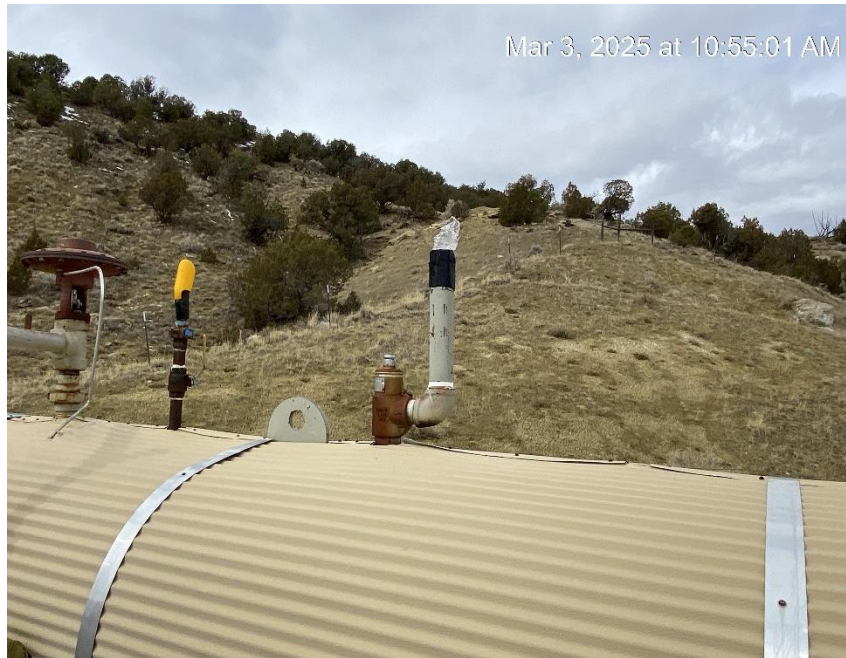
Inadequate riser protection

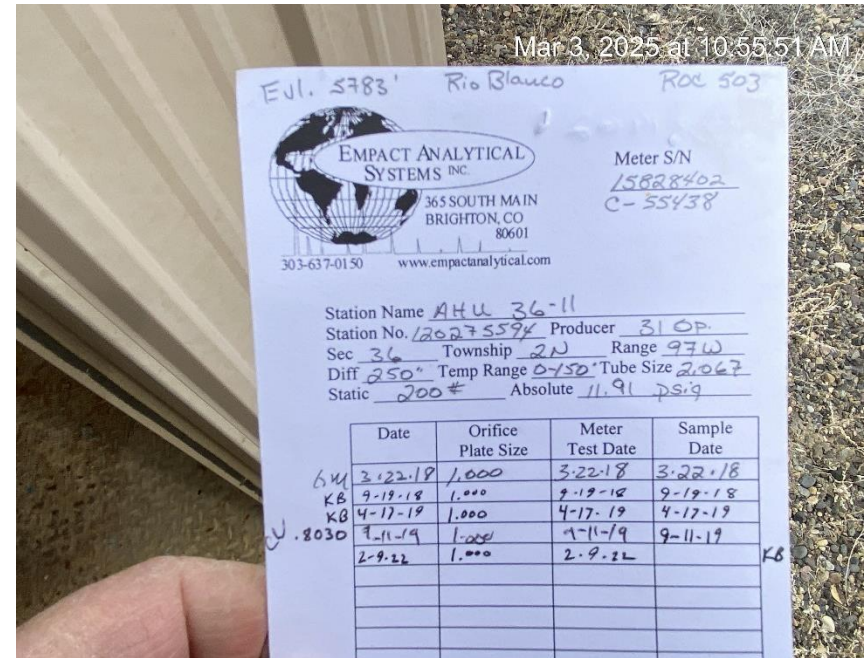
Gas calibration overdue

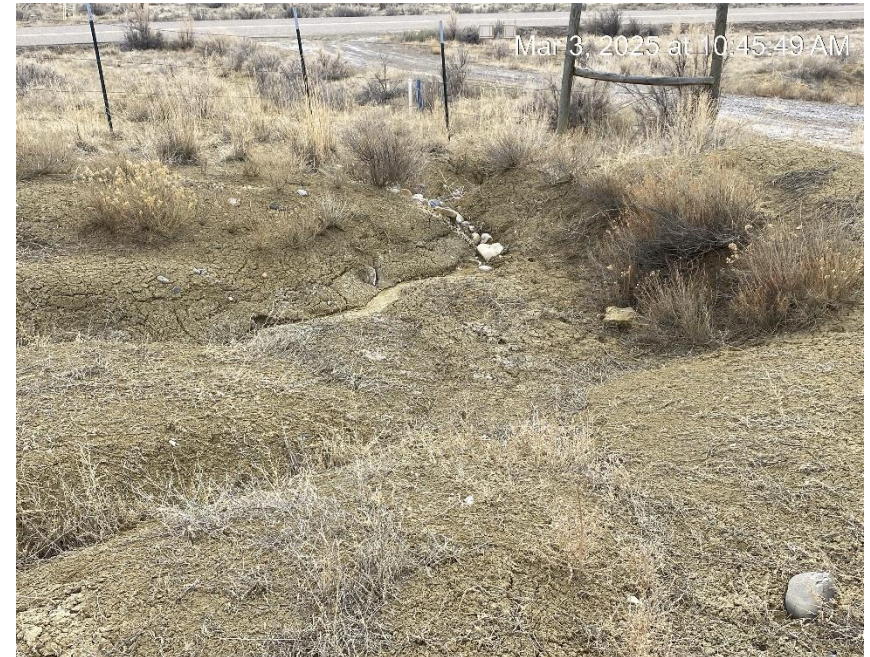
Gas calibration overdue

Washed out sediment trap

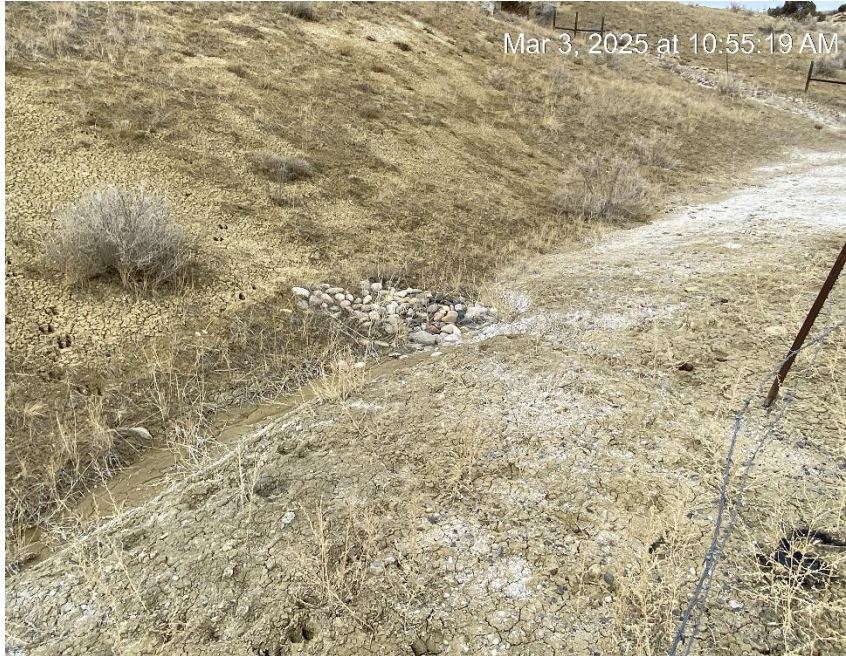
Washed out check dam

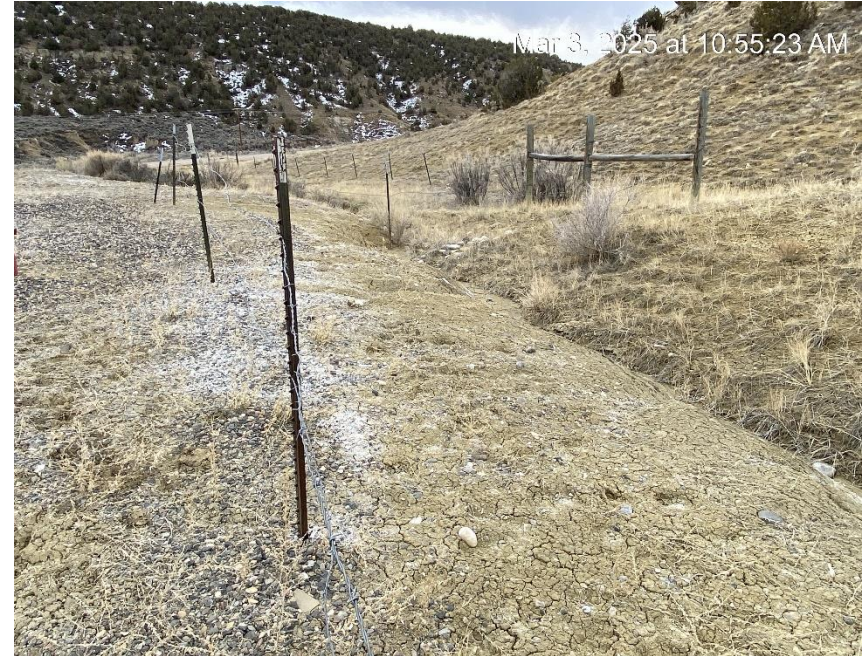
Washed out check dams

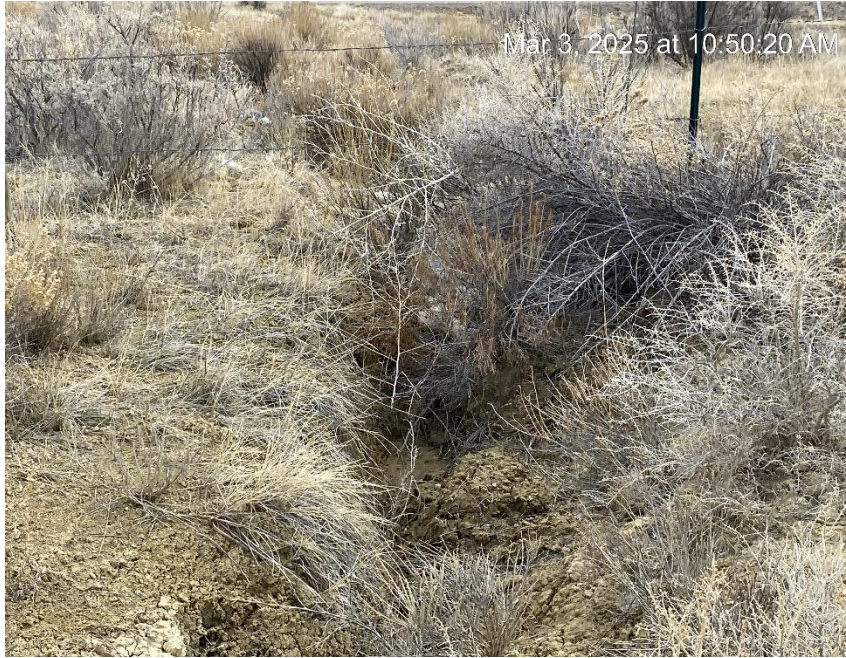
Erosion and check dam washed out
