Interim Reclamation and Stormwater Inspection

Date: 02/26/2025

Operator: RED HAWK PETROLEUM LLC - 10503

Location ID: 427144

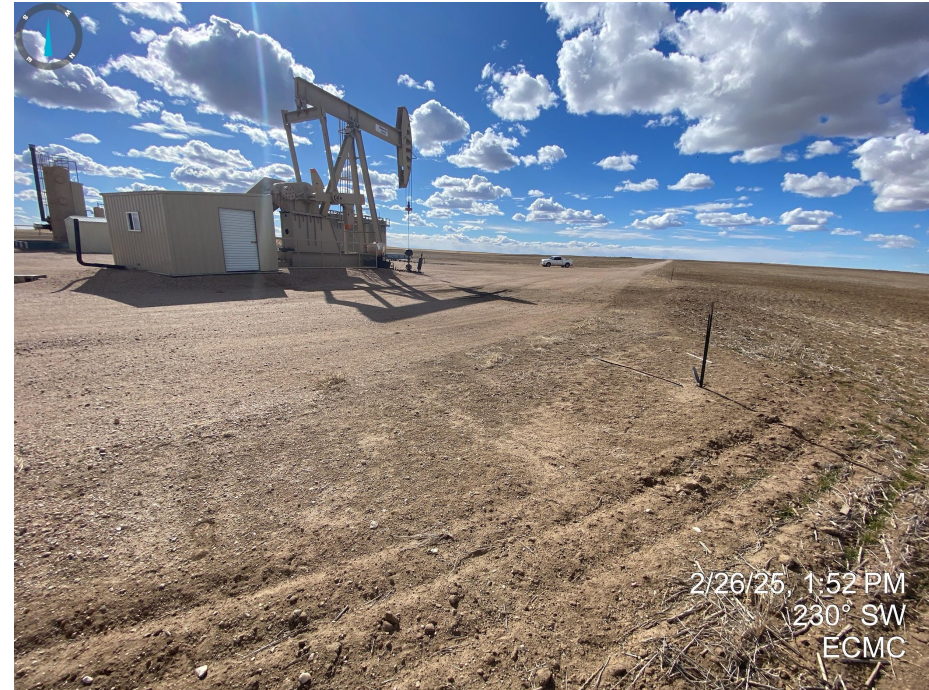
Photos 1 & 2. Northern interim areas. Appears interim reclamation activities have been performed to reduce disturbance areas only needed for production operations. A vegetative assessment will be performed at a later date during the active growing season to verify interim reclamation regulations and standards and will therefore remain "In-Process".

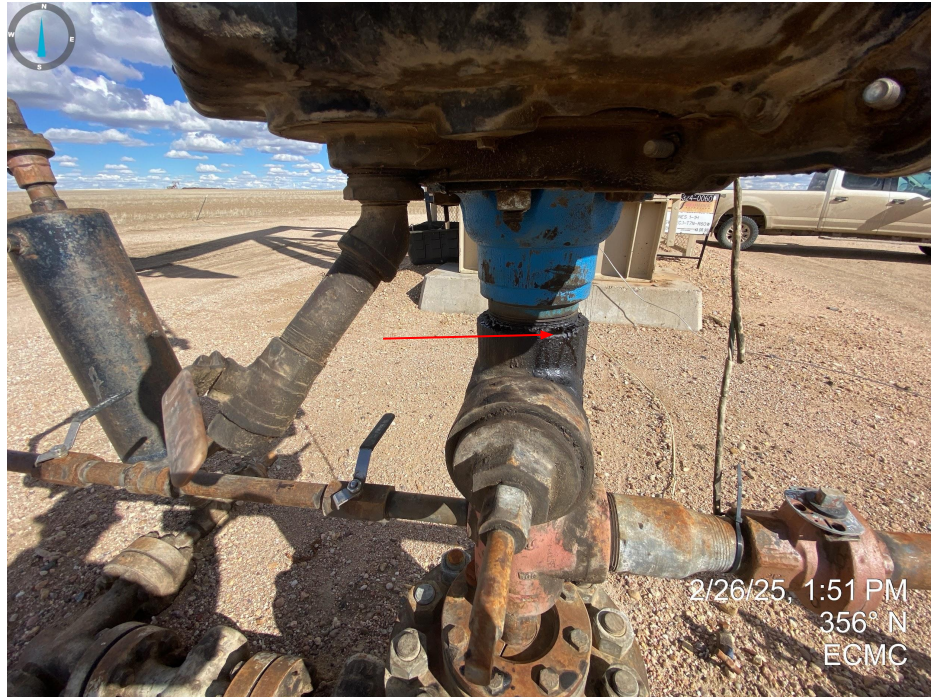
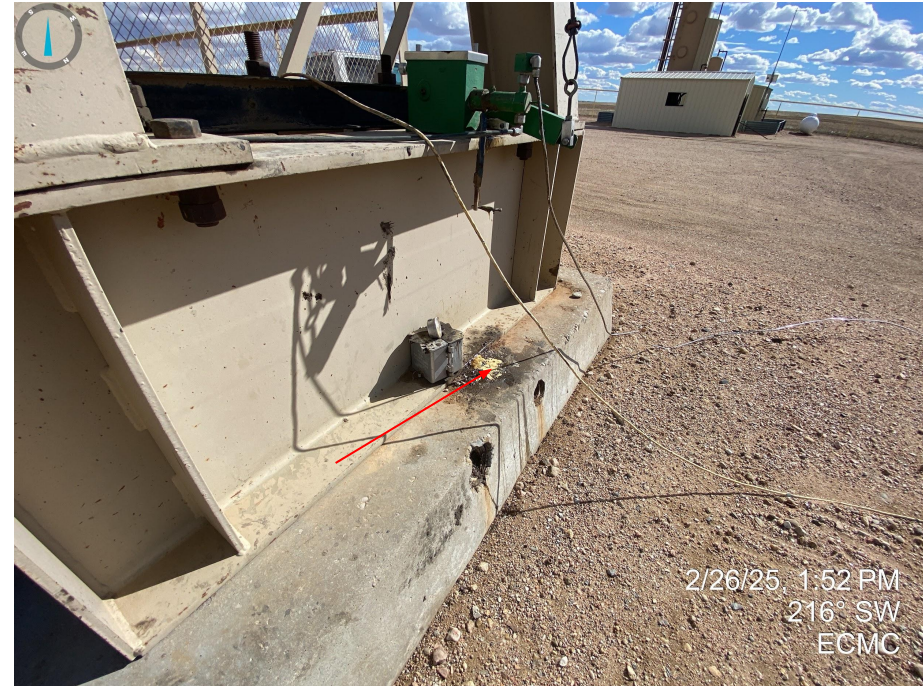
Photos 3 & 4. Hydrocarbon staining on equipment at wellhead and pump jack unit.

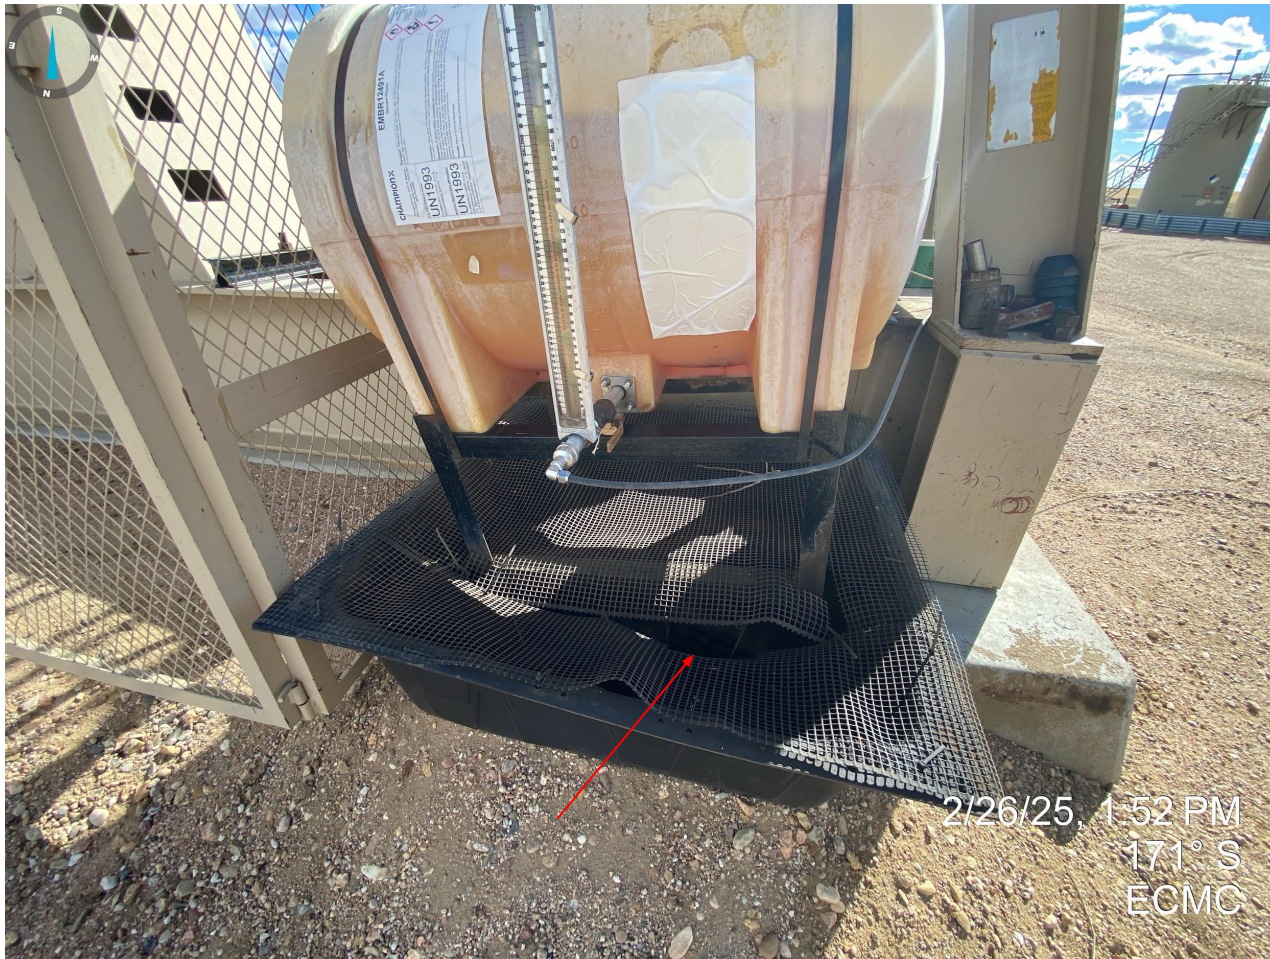
Photo 5. Wildlife netting inadequate at day tank.

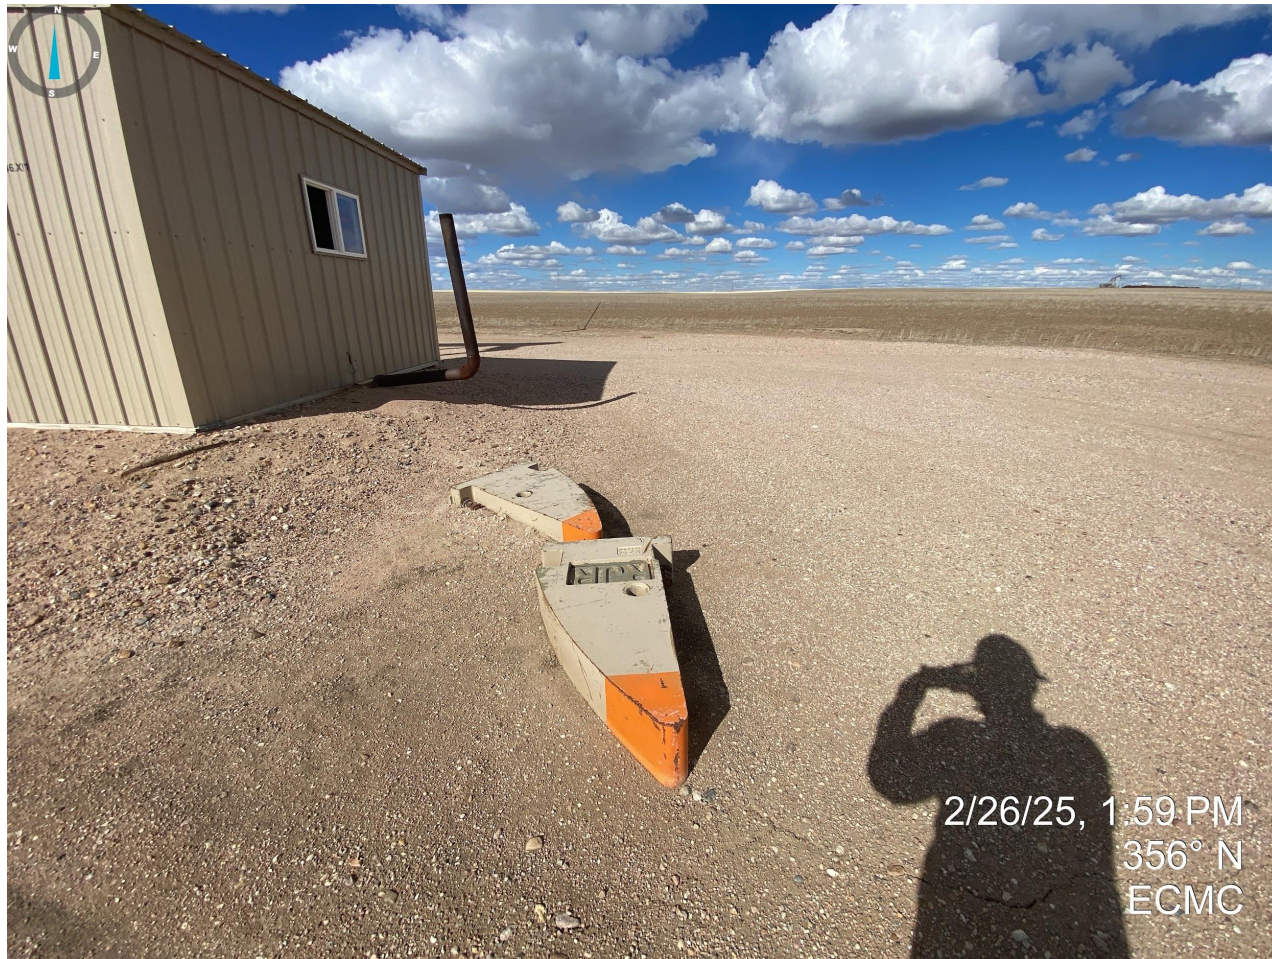
Photo 6. Pump jack weights being stored on location.

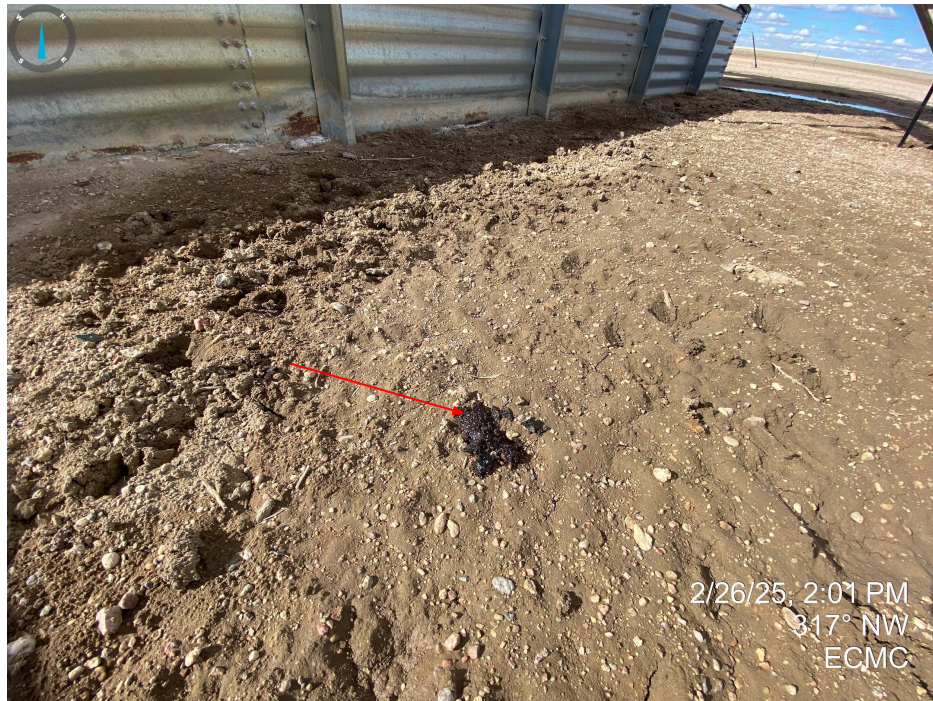
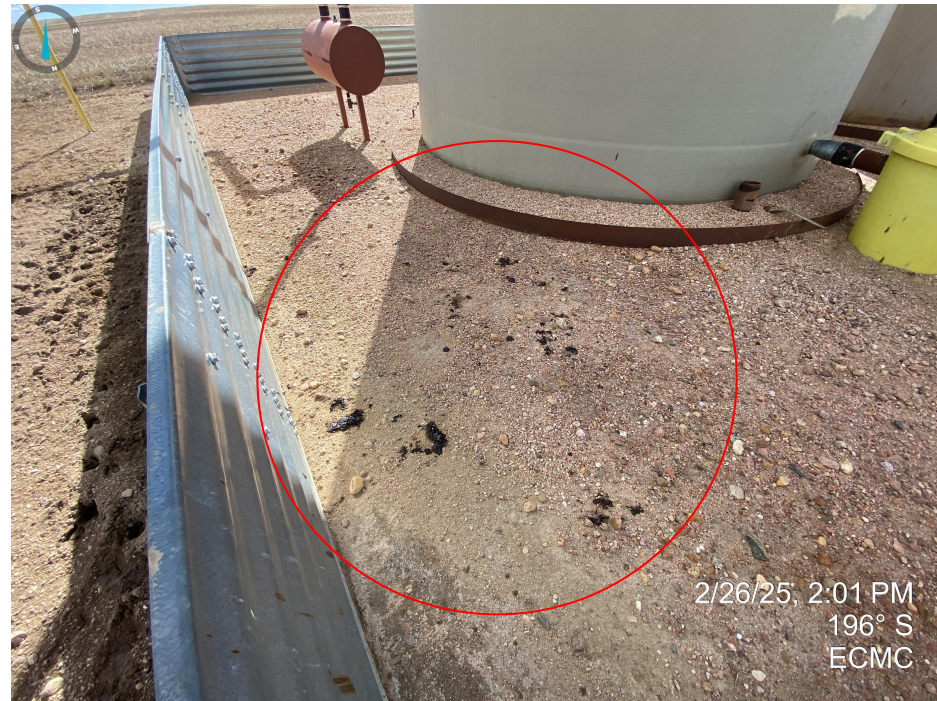
Photos 7 & 8. Hydrocarbon staining outside of secondary containment (left; Photo 7) and within tank battery area (right; Photo 8).

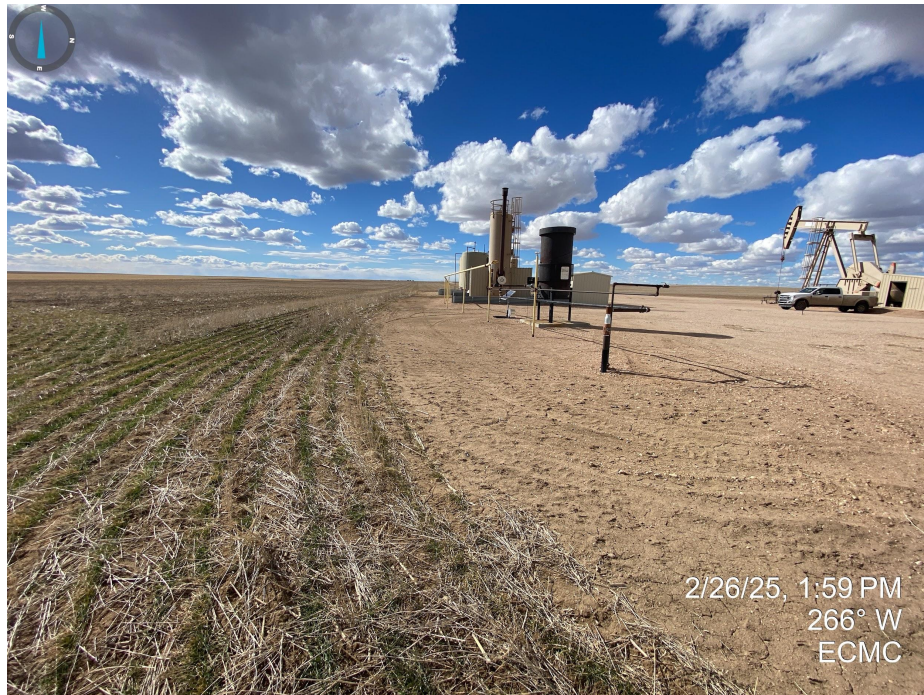
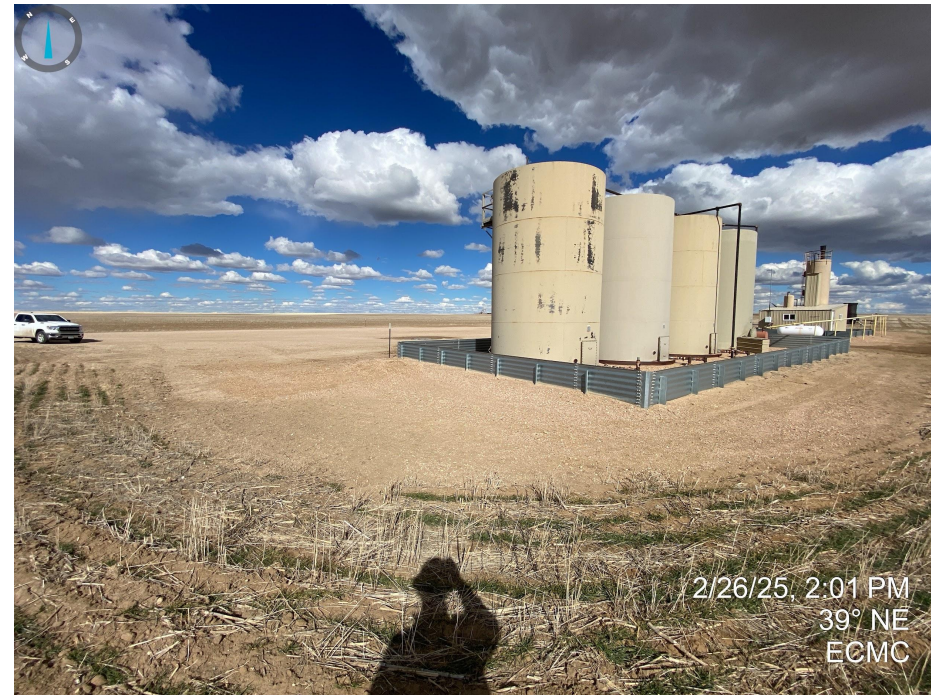
Photos 9 & 10. Southern interim areas. Appears interim reclamation activities have been performed to reduce disturbance areas only needed for production operations. A vegetative assessment will be performed at a later date during the active growing season to verify interim reclamation regulations and standards and will therefore remain "In-Process".
