Inspection Photos

API: 009-06087

Operator: DOVER ATWOOD CORPORATION

Inspection Date: 3/4/2025

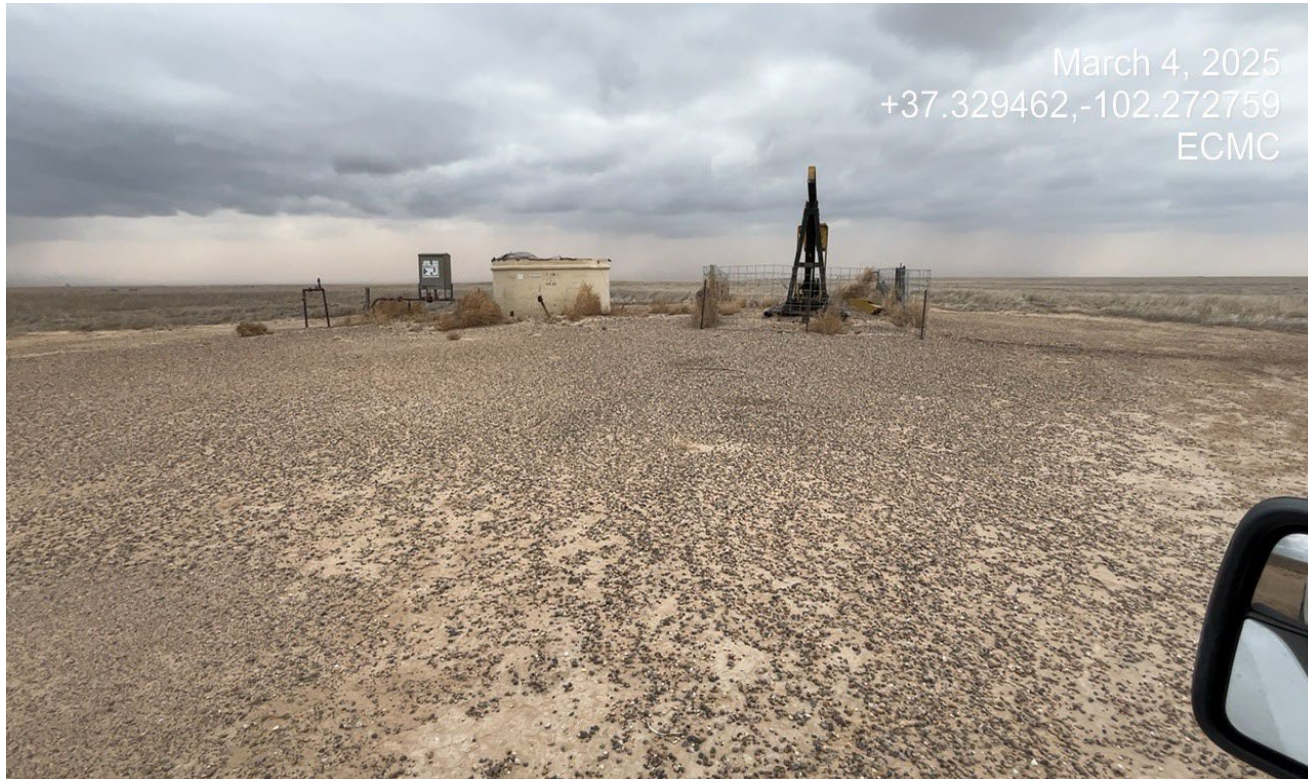
Photo 1. Facing east toward the wellsite.

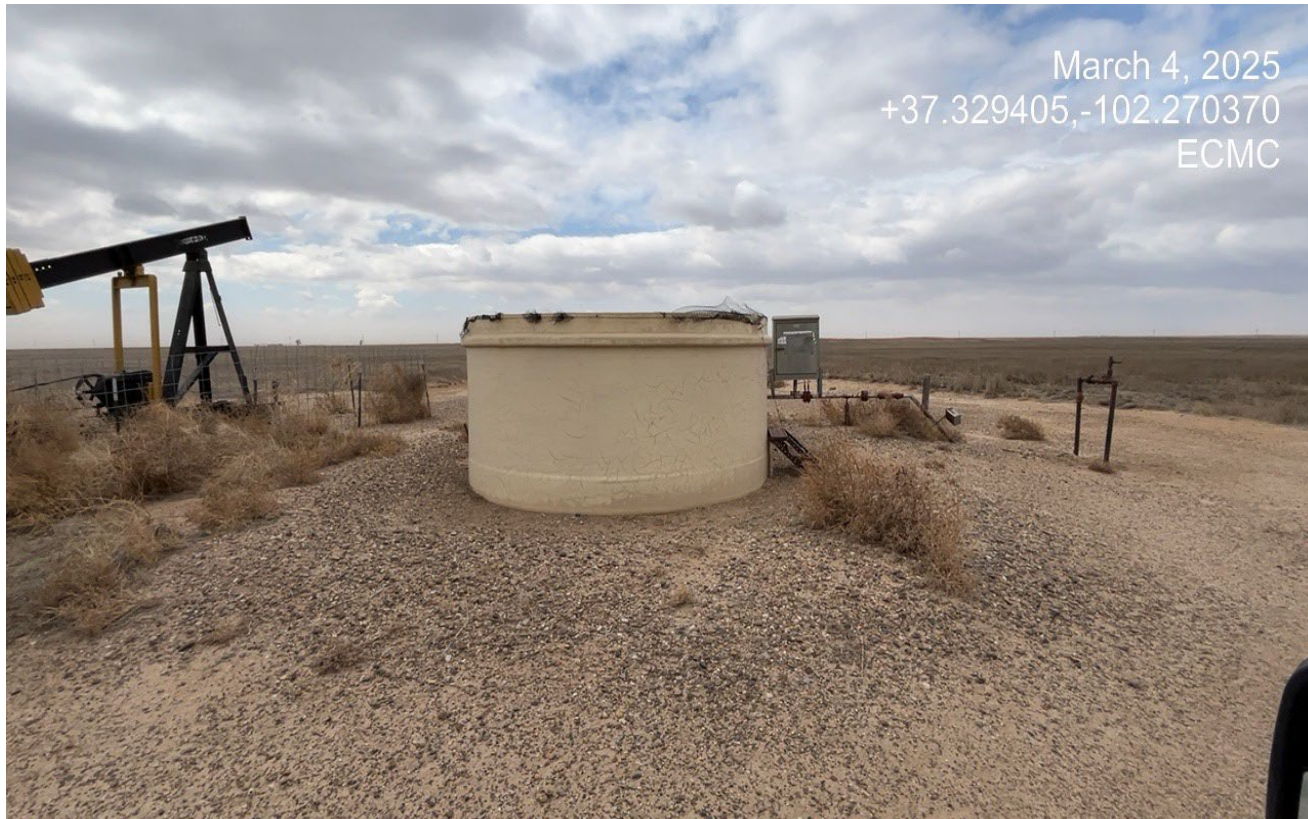
Photo 2. The secondary containment is insufficient to contain a spill.

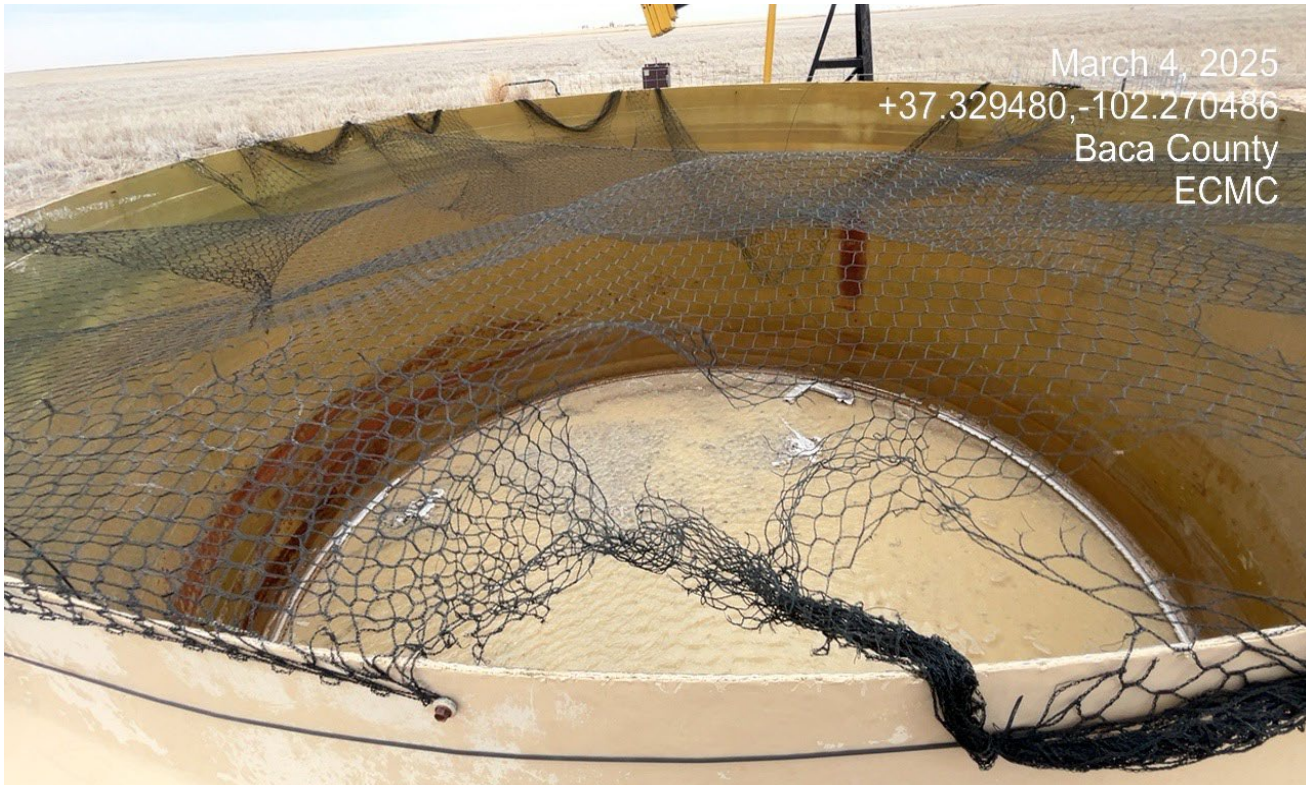
Photo 3. The netting on the tank is not maintained to prevent wildlife entry.
