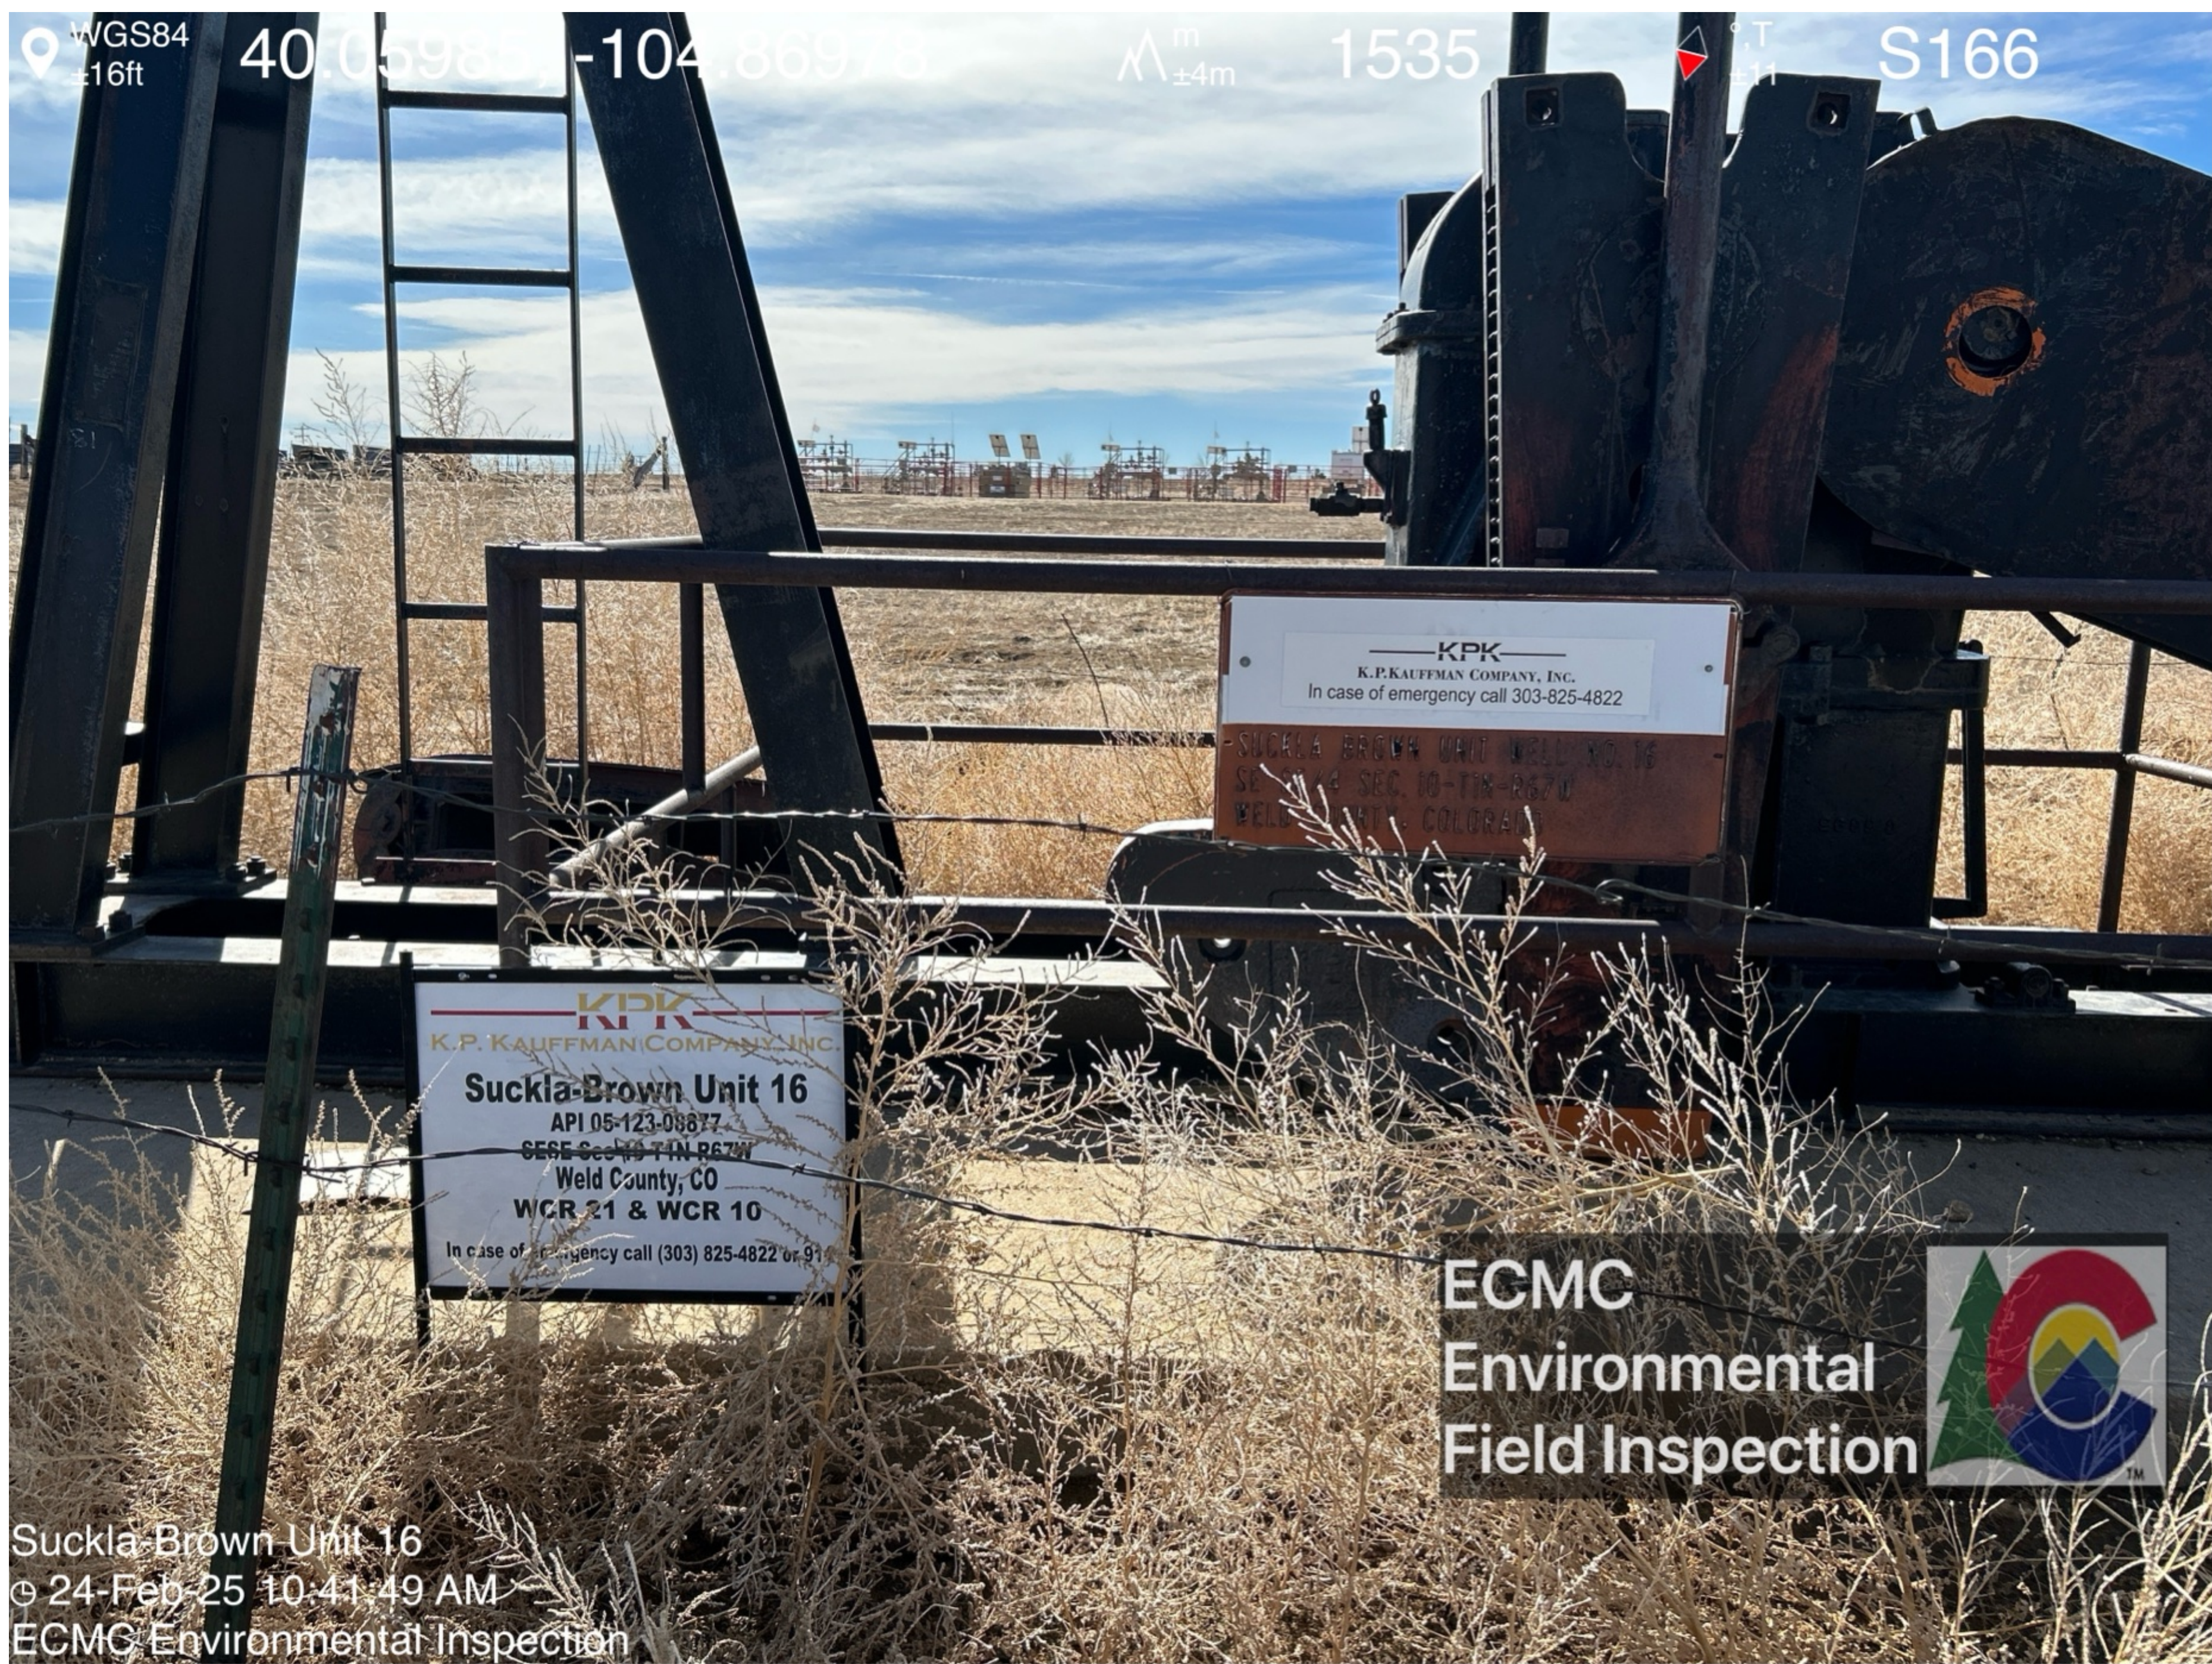
Signage with emergency contact number is visible.

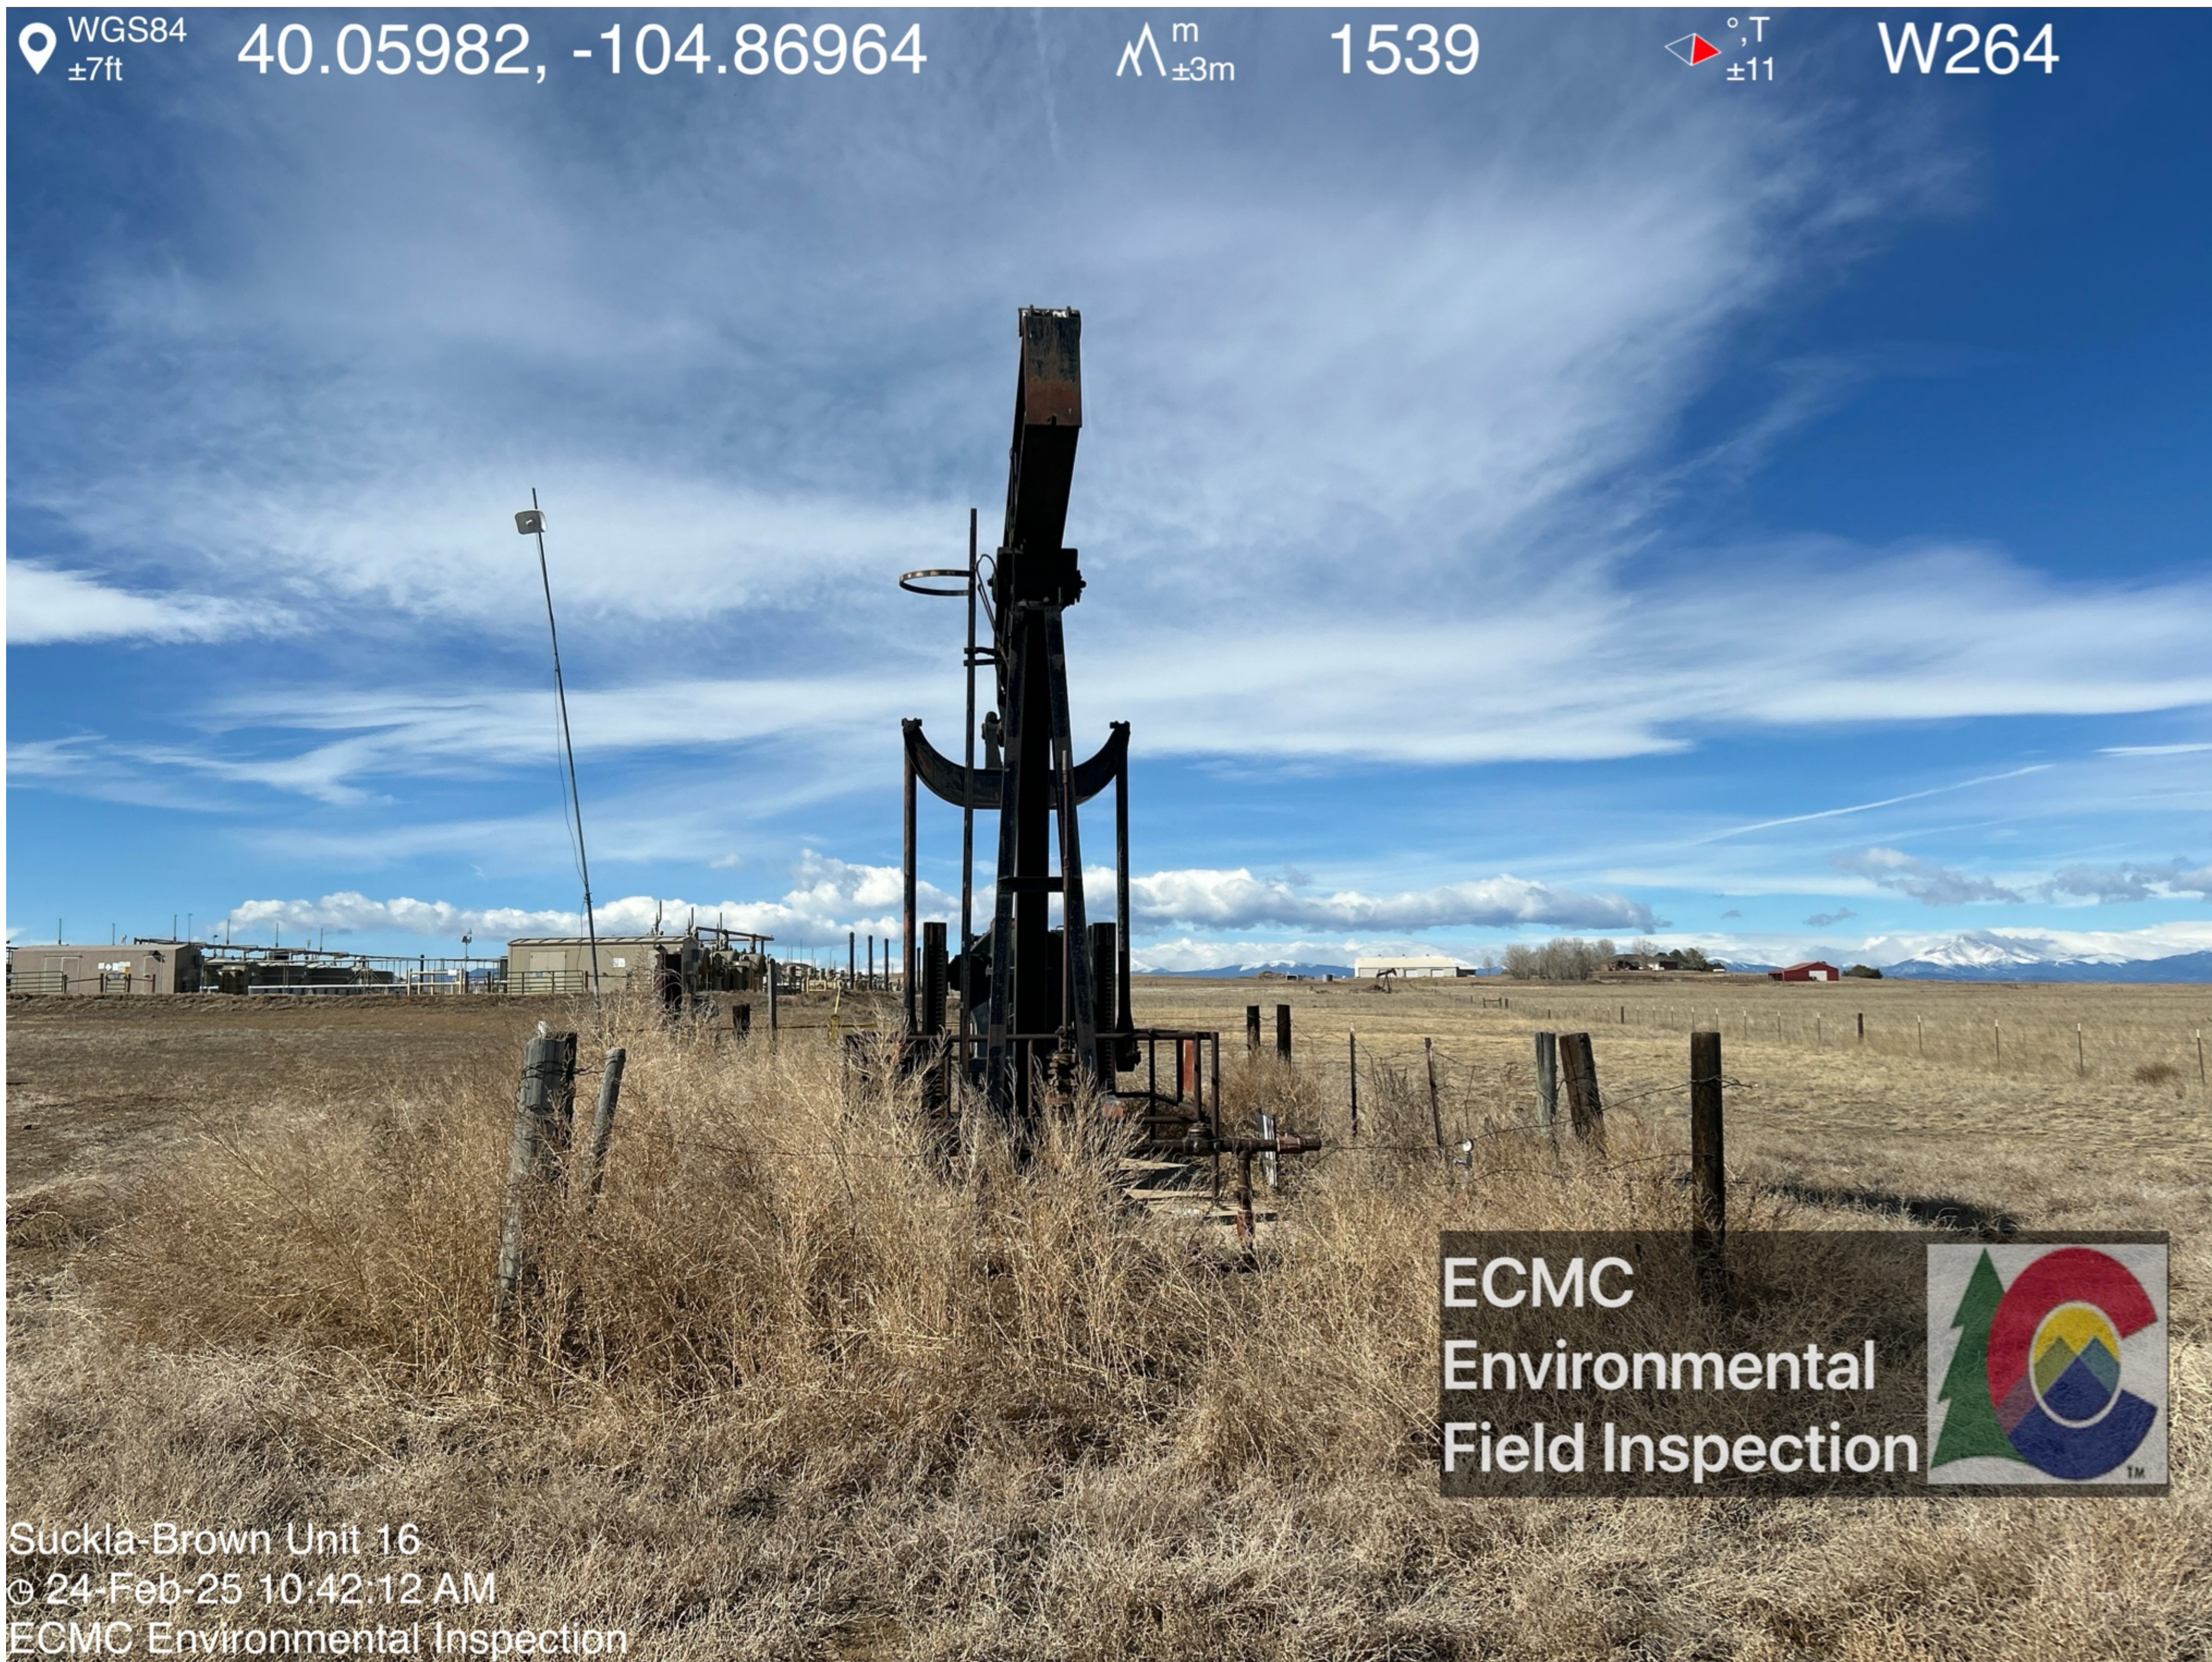
Weeds surround wellhead. Pumping unit is disassembled and does not appear operational.

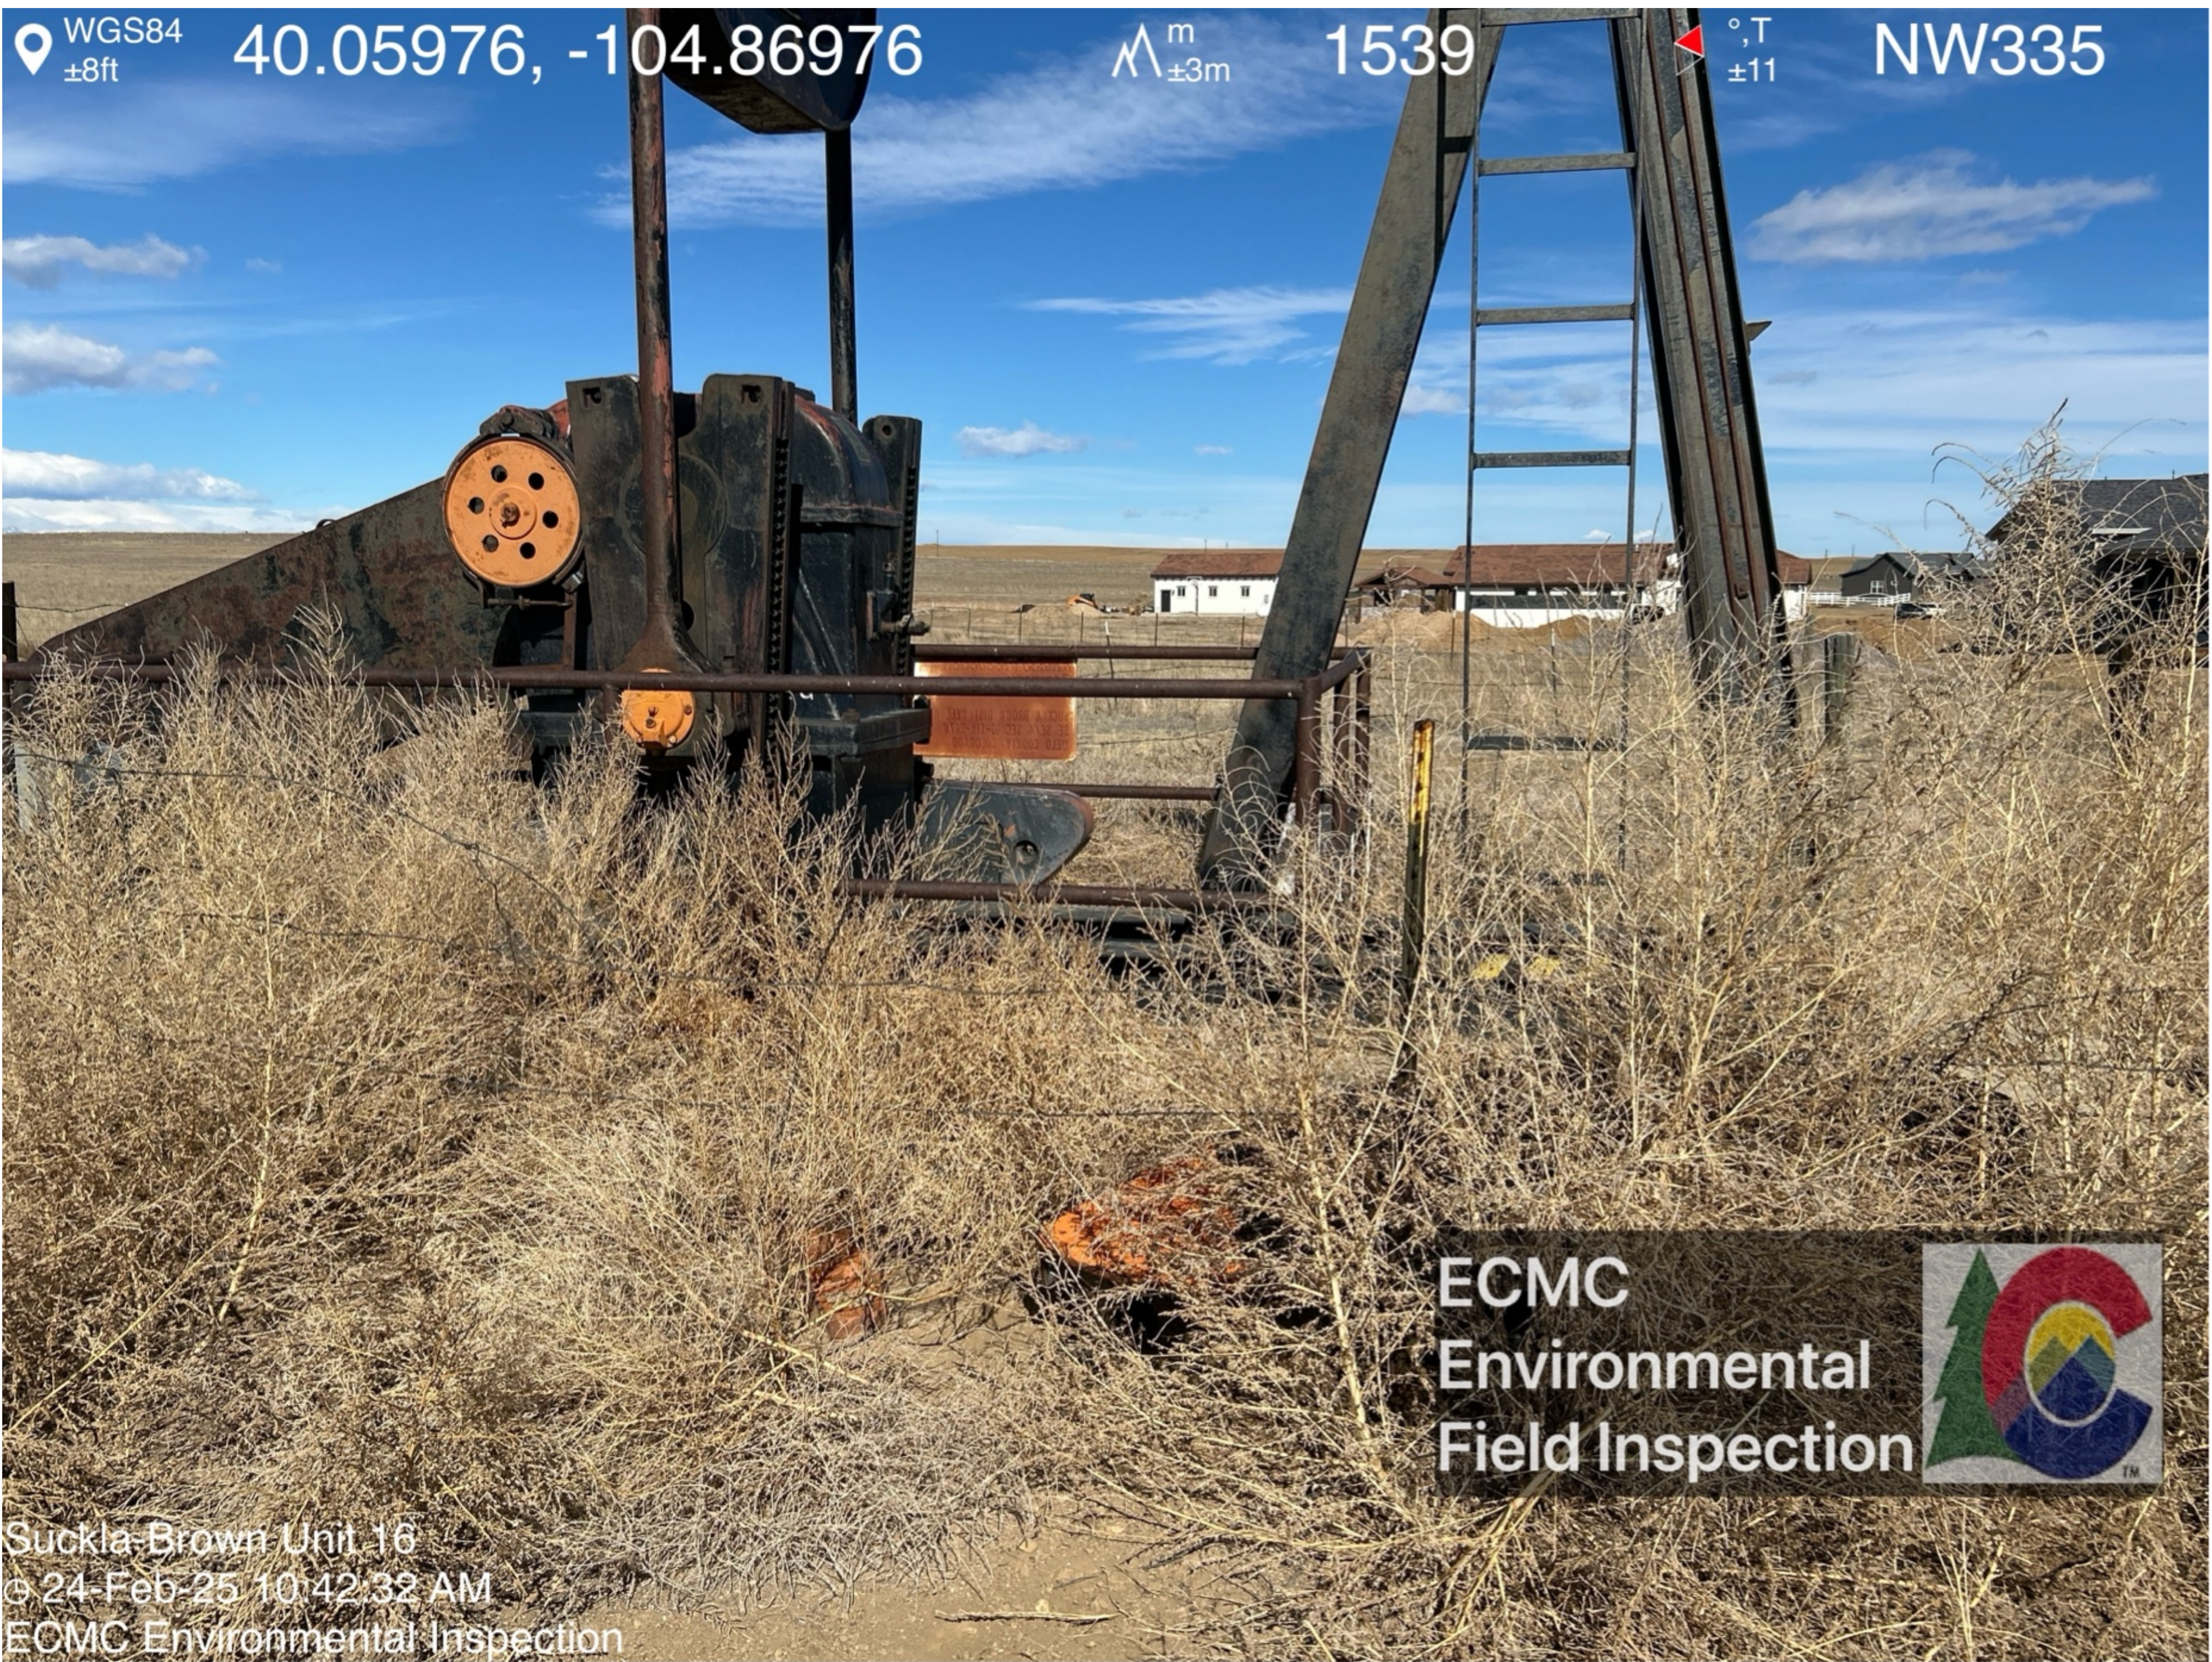
Pumping unit components visible on the ground surface adjacent to the wellhead.

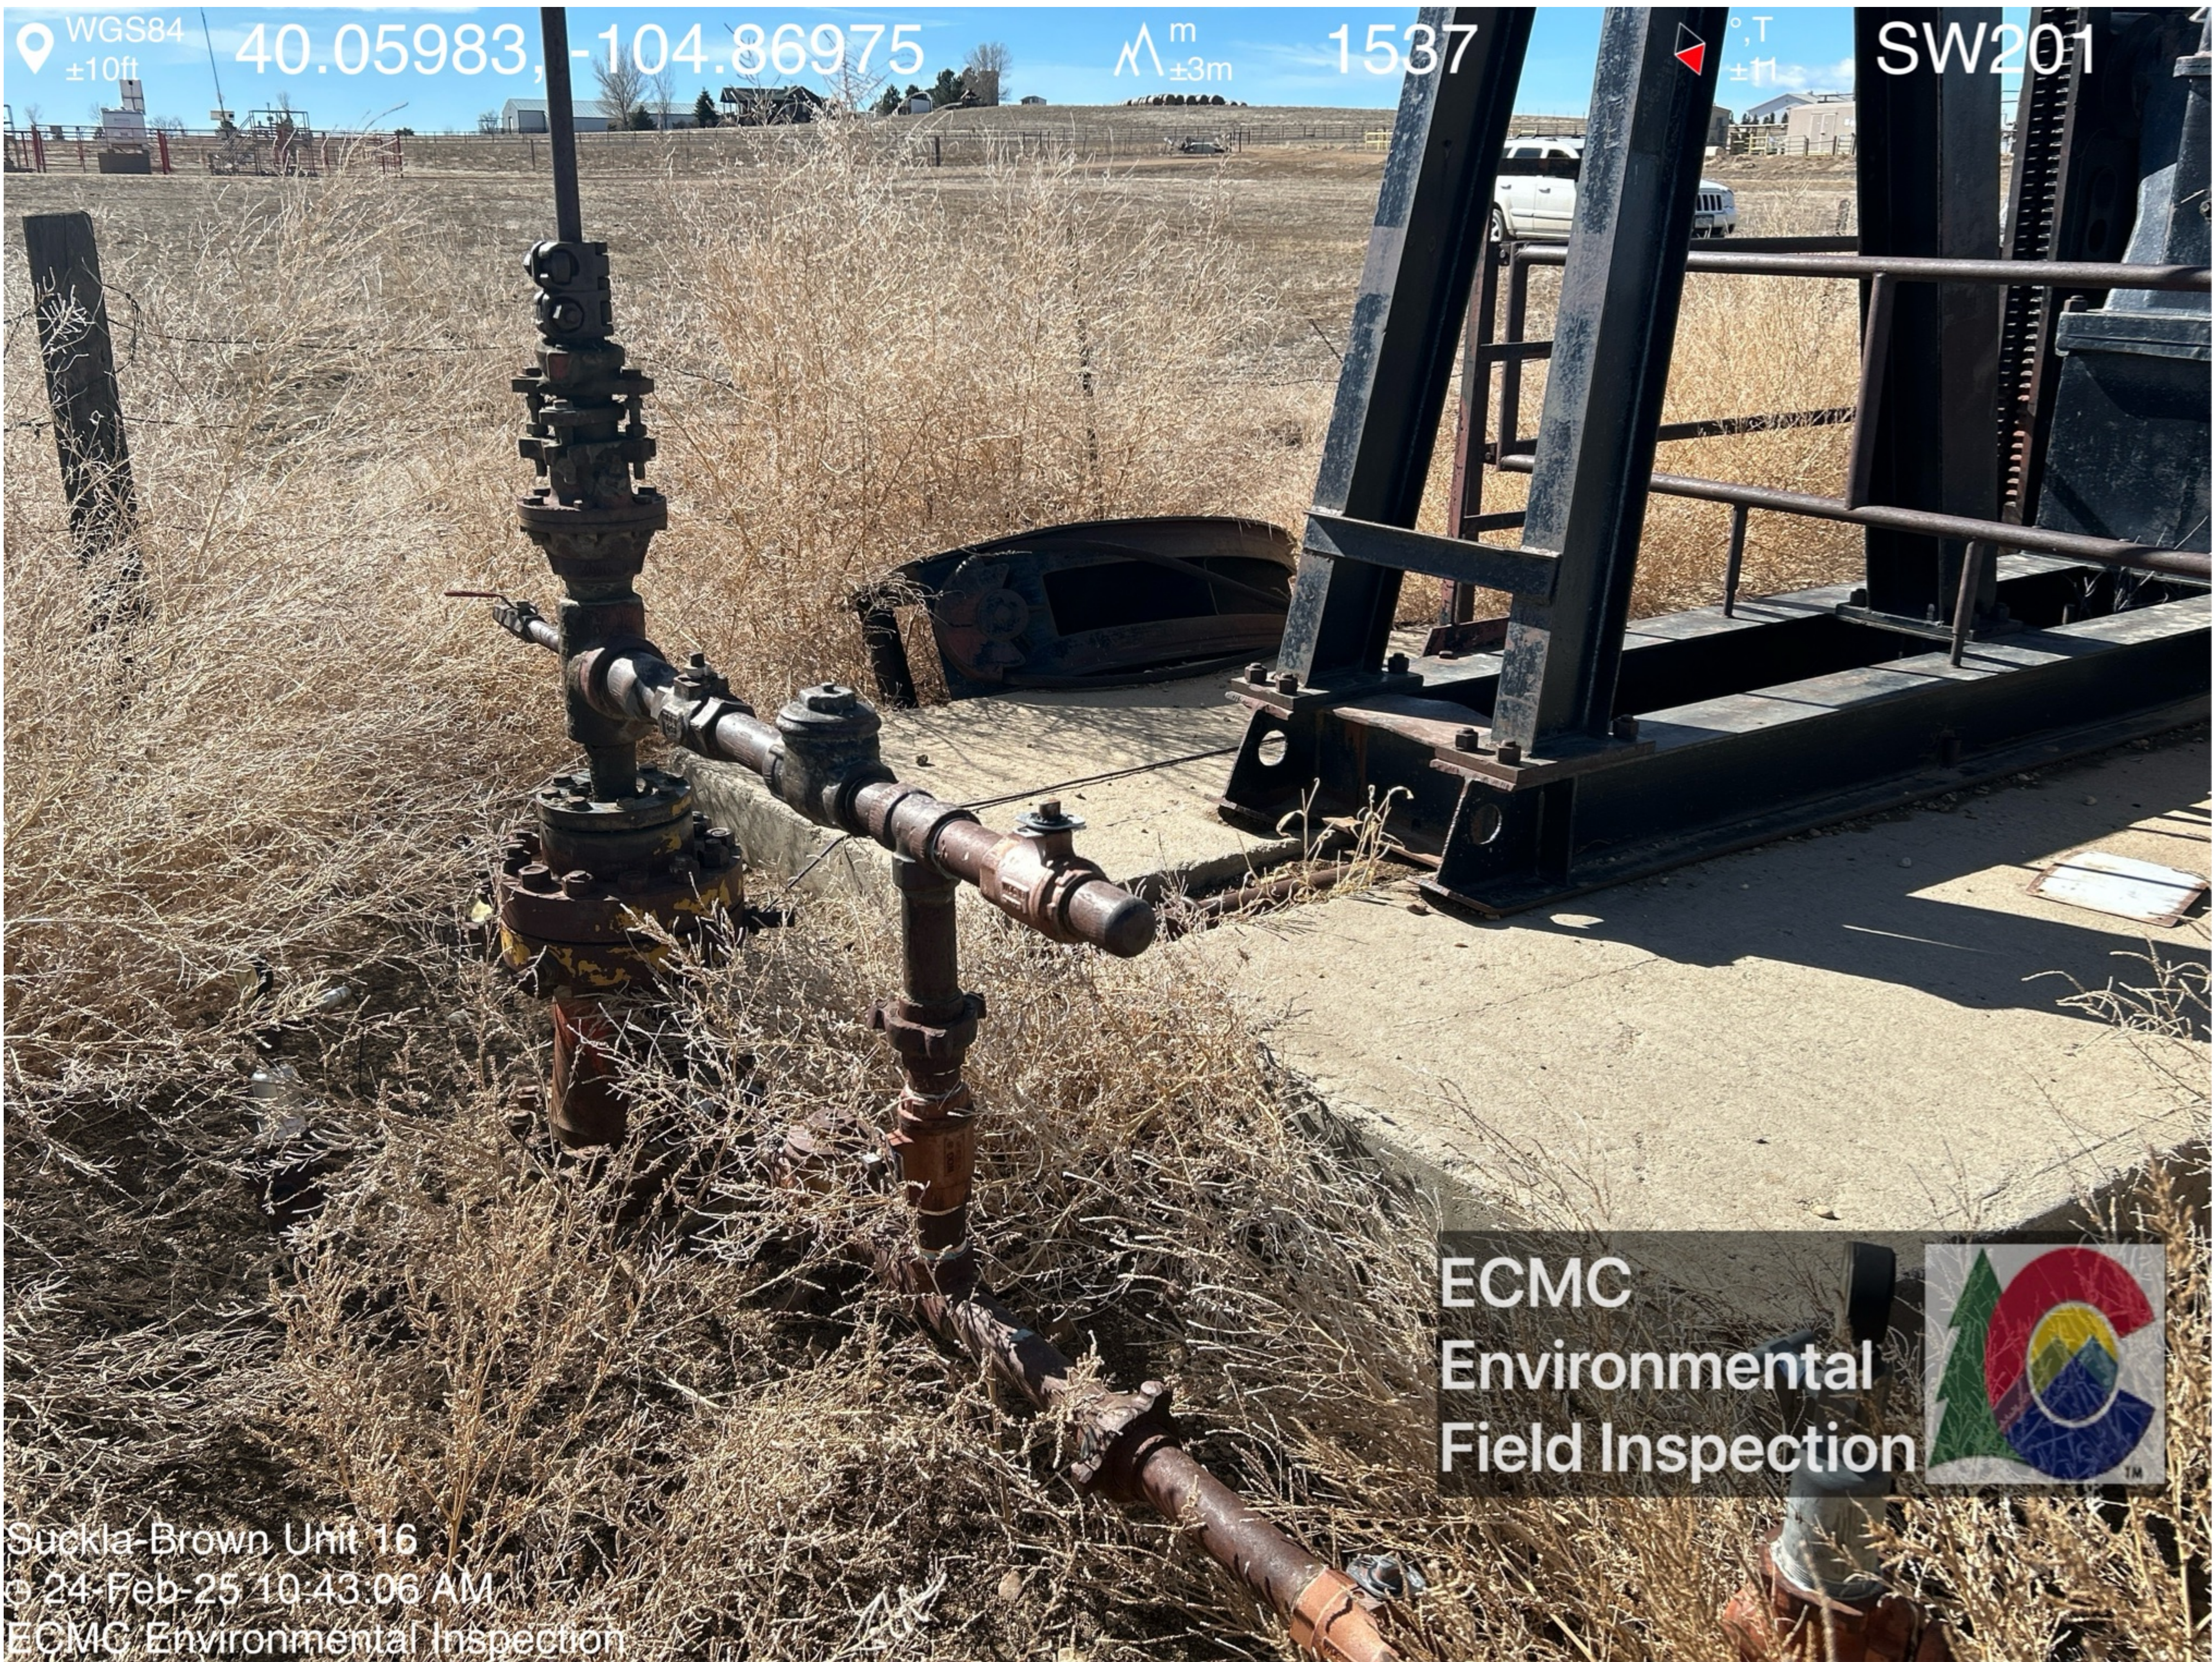
Weeds surround the wellhead.

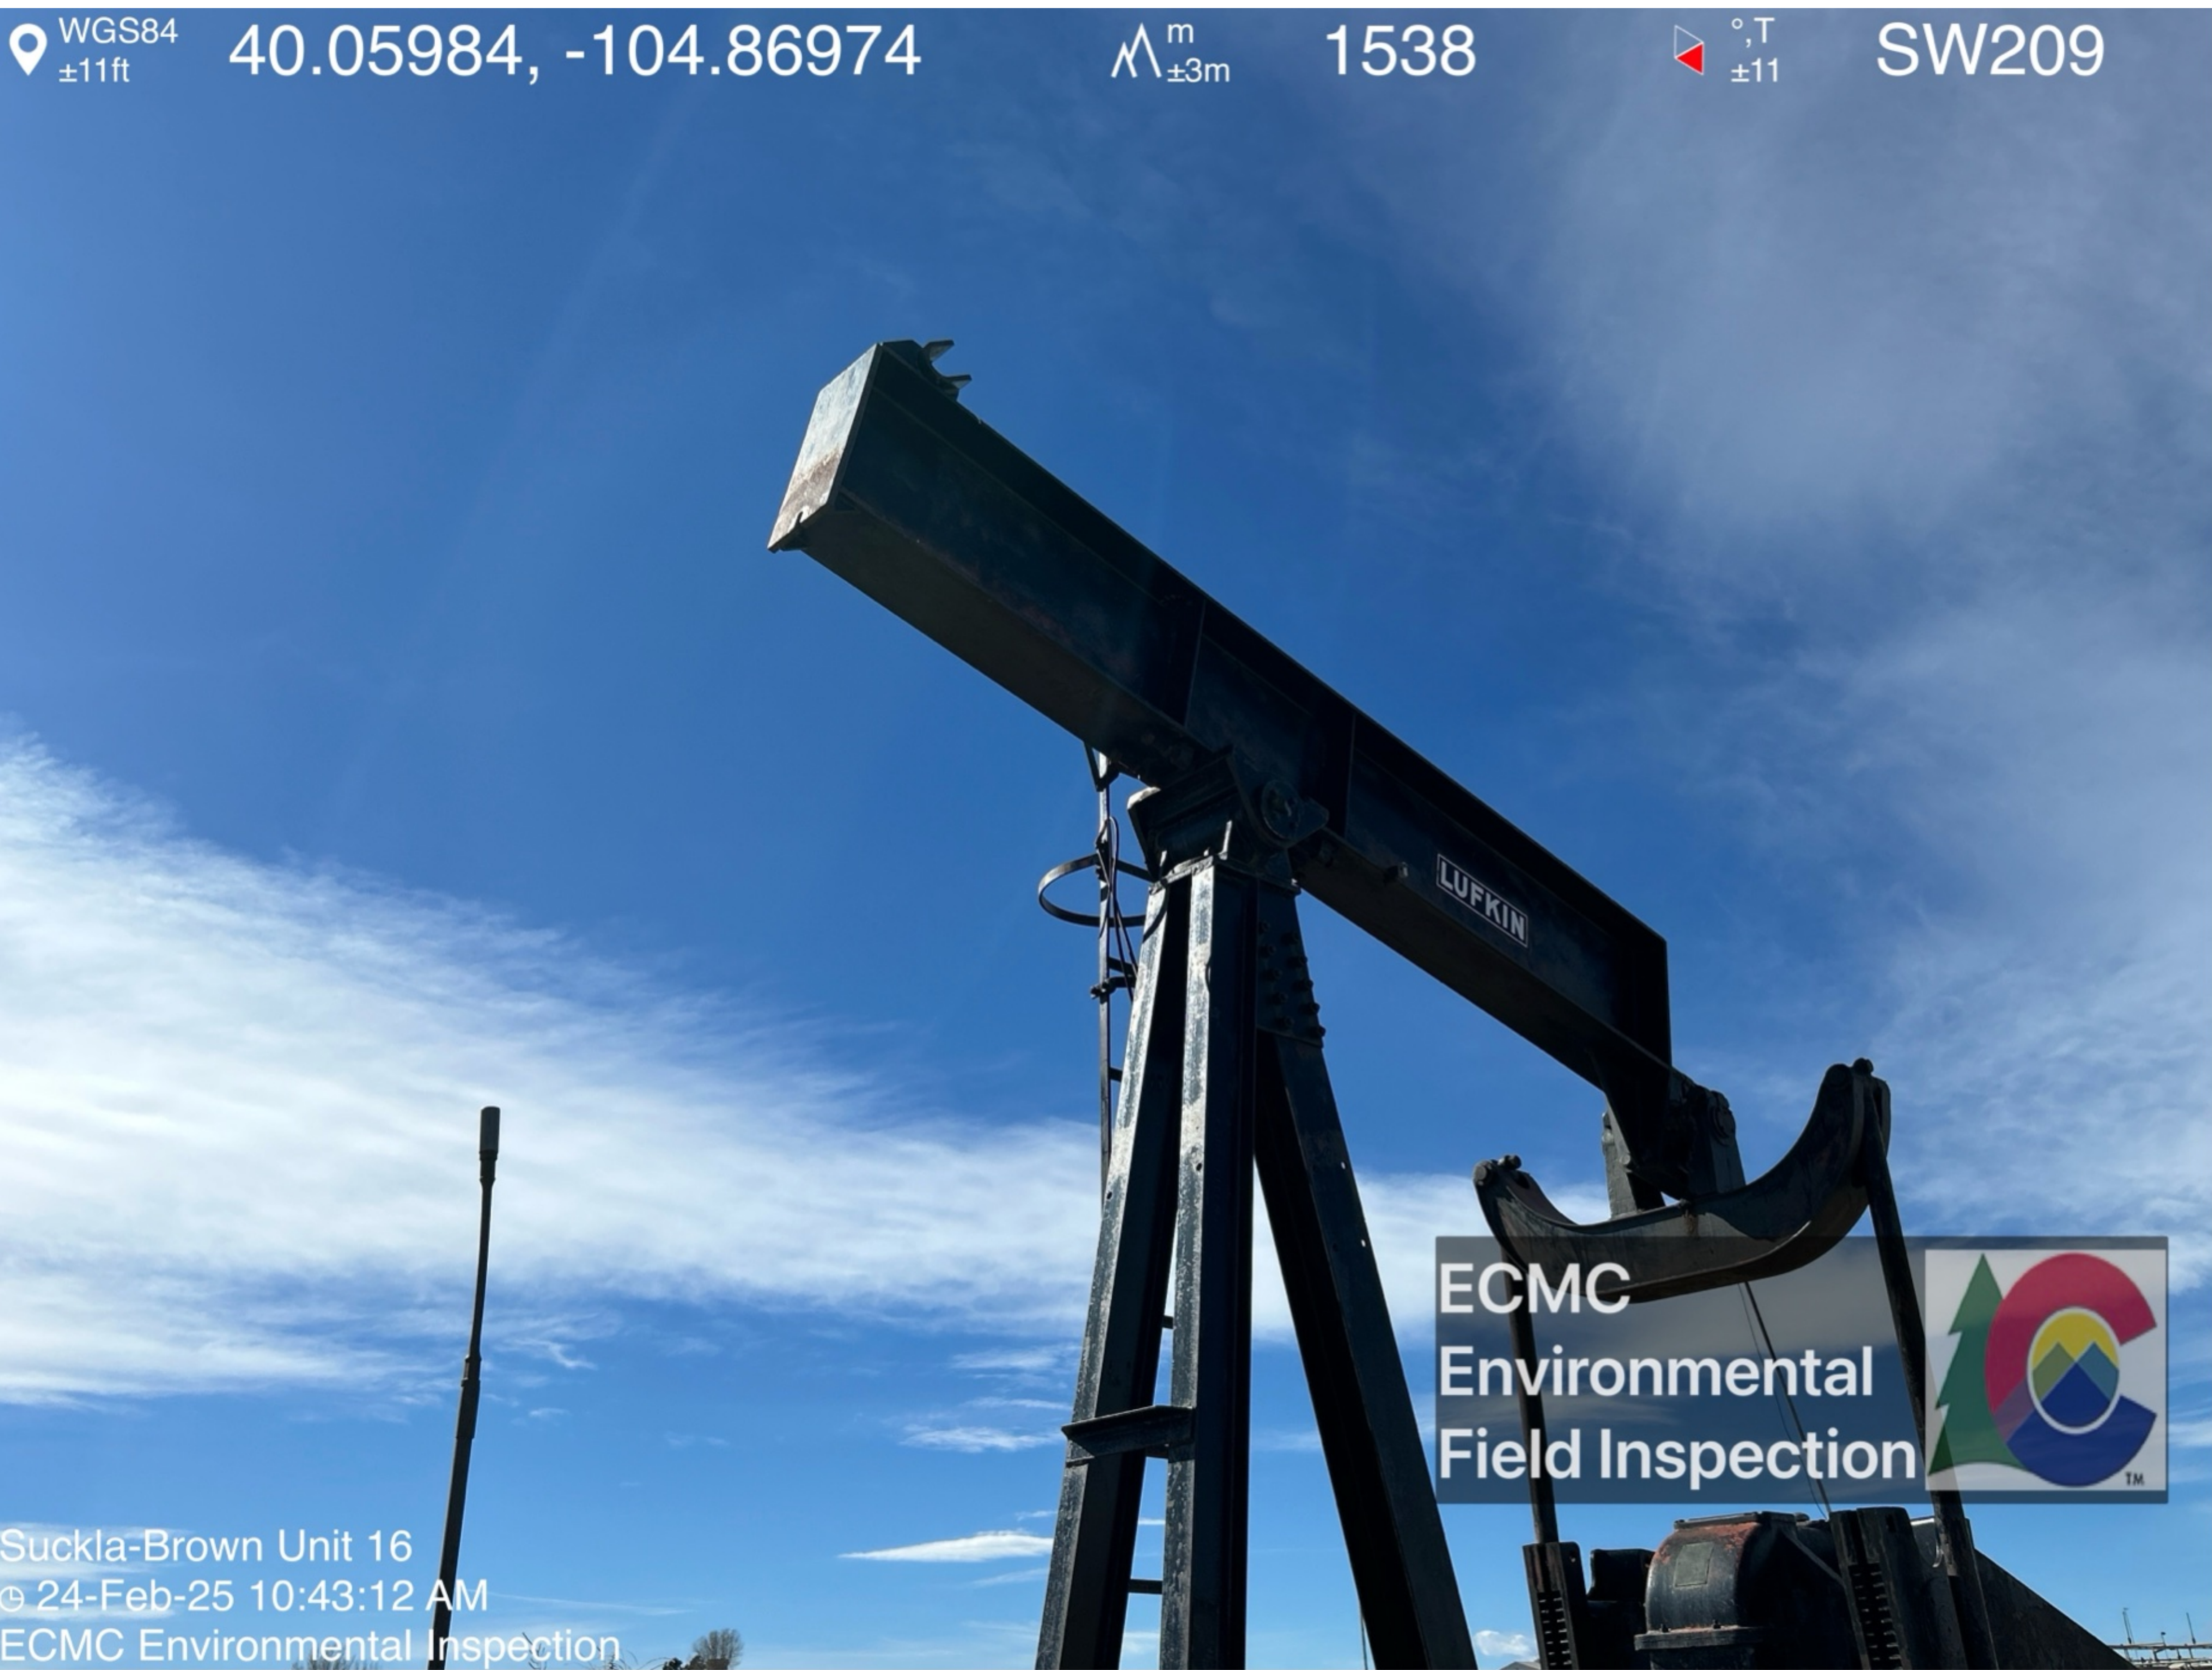
Pumping unit does not appear operational.

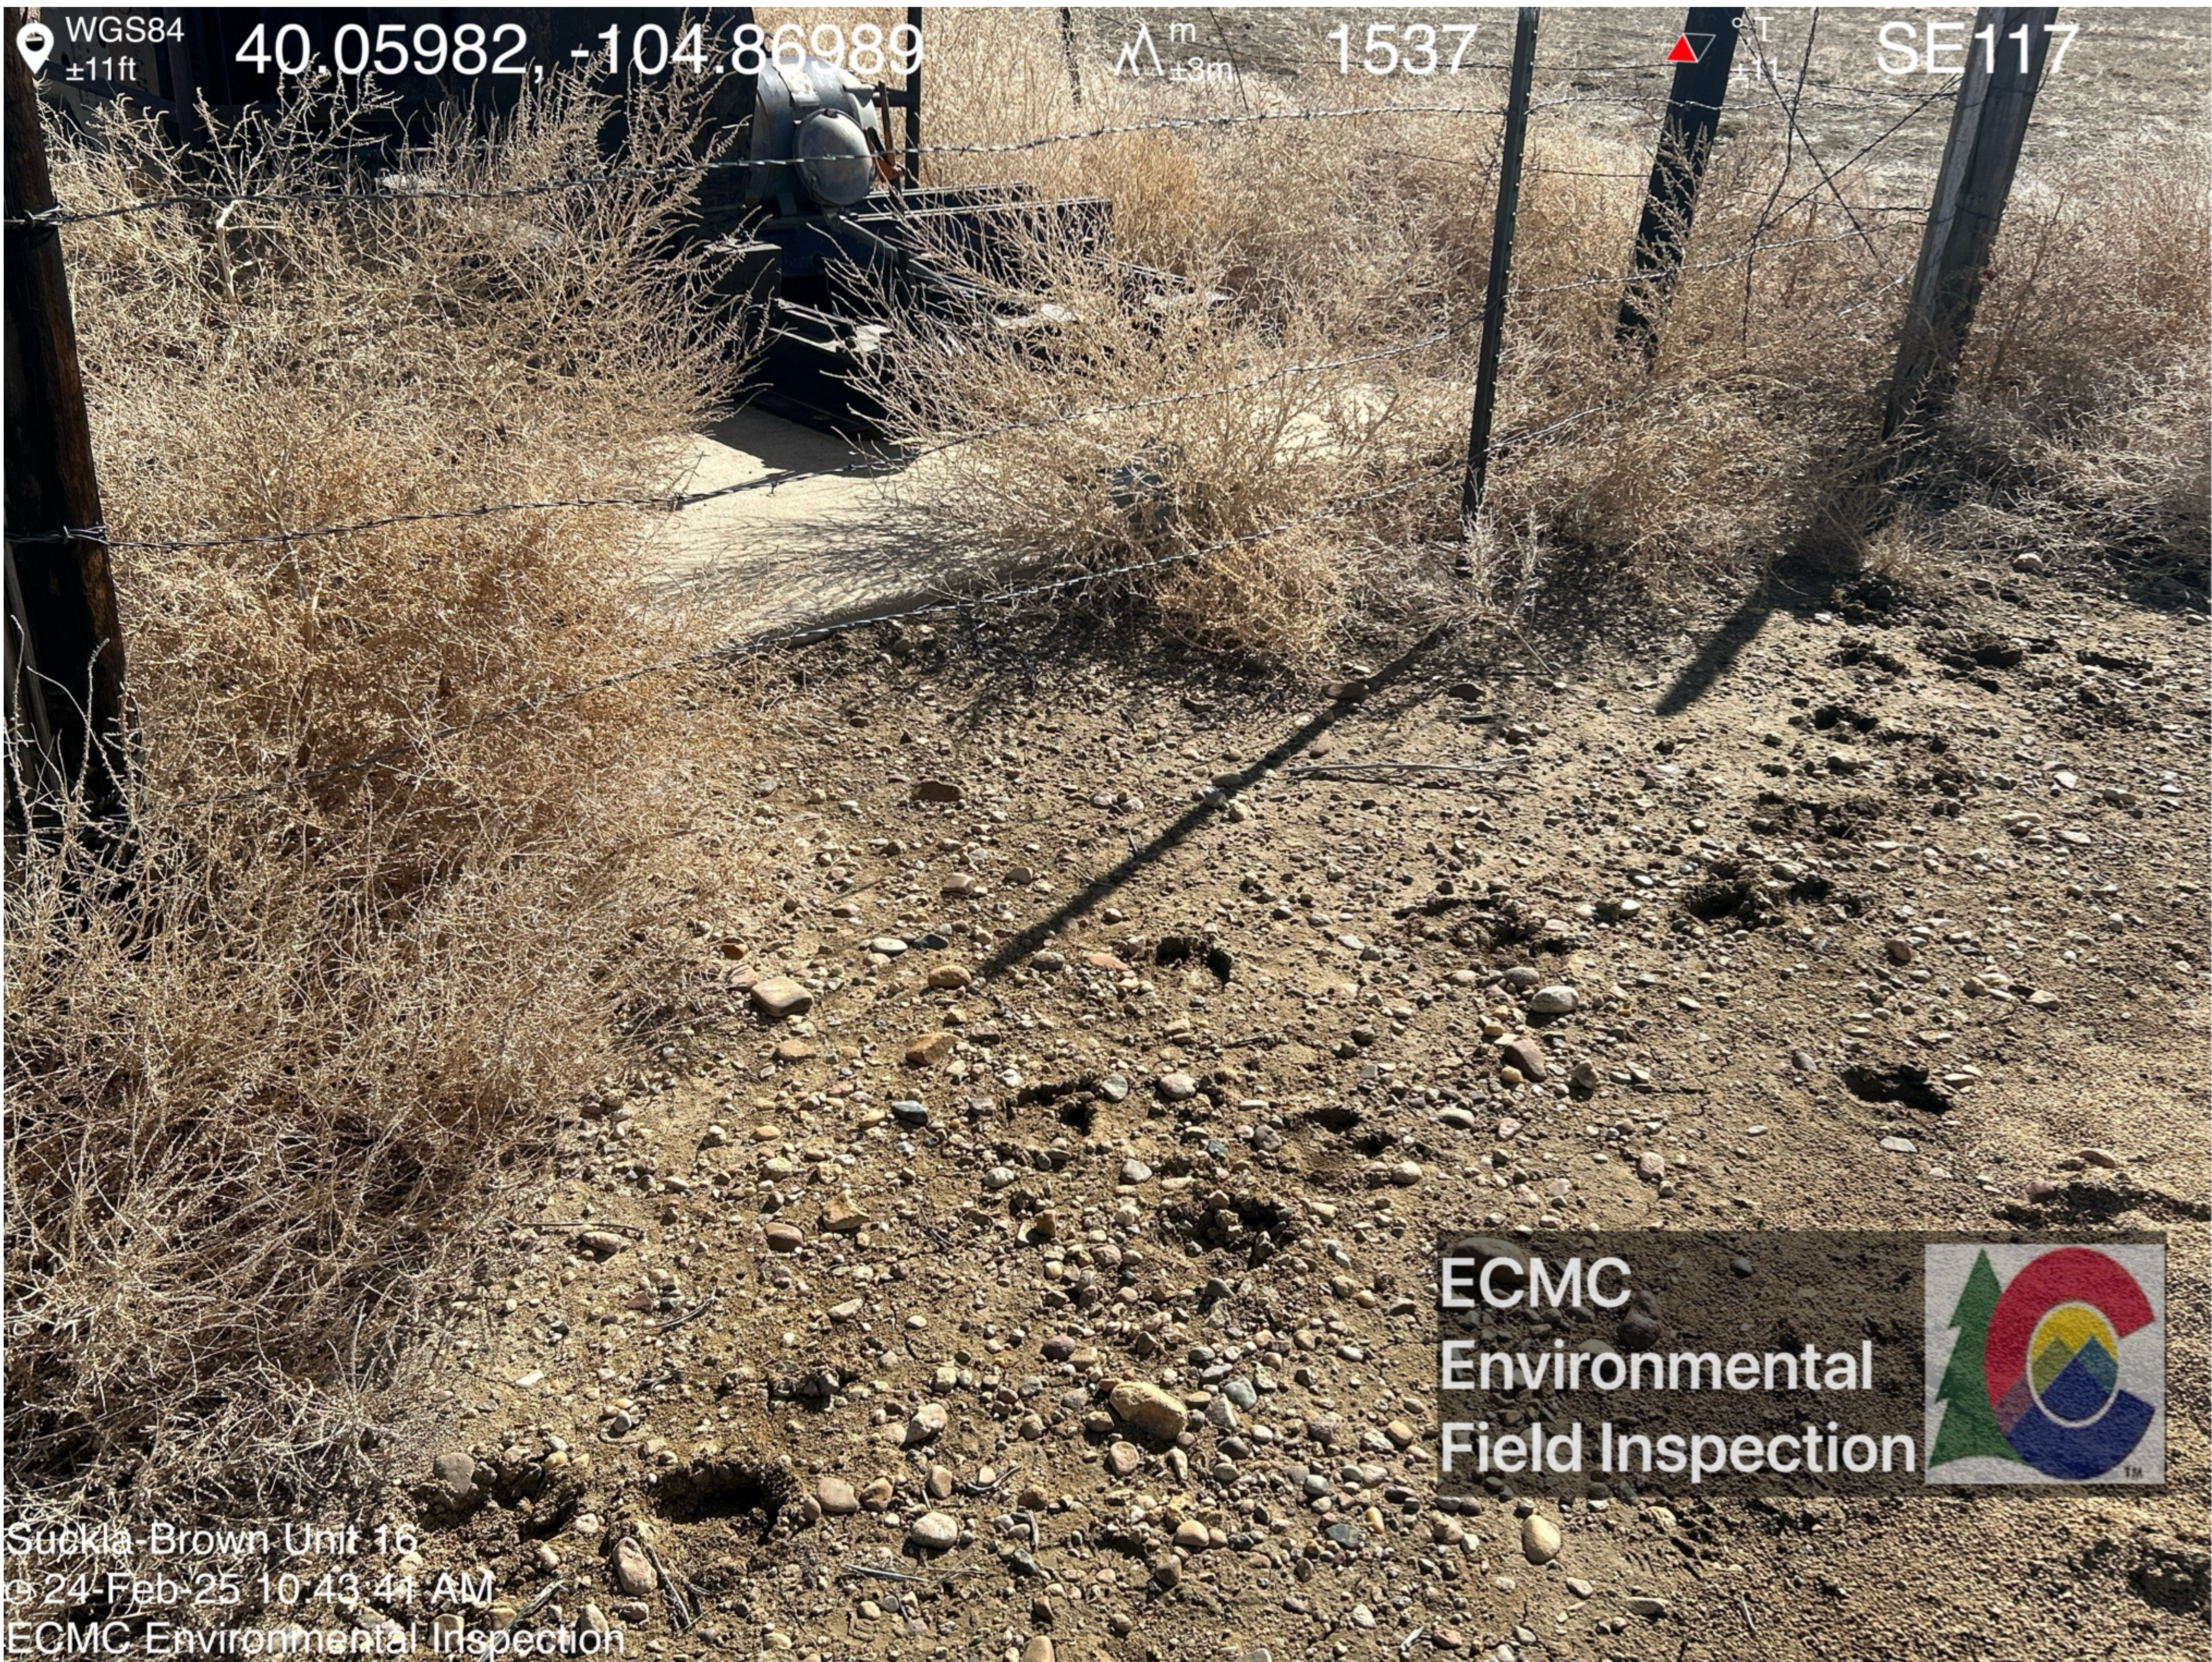
Livestock footprints visible adjacent to the wellhead.
