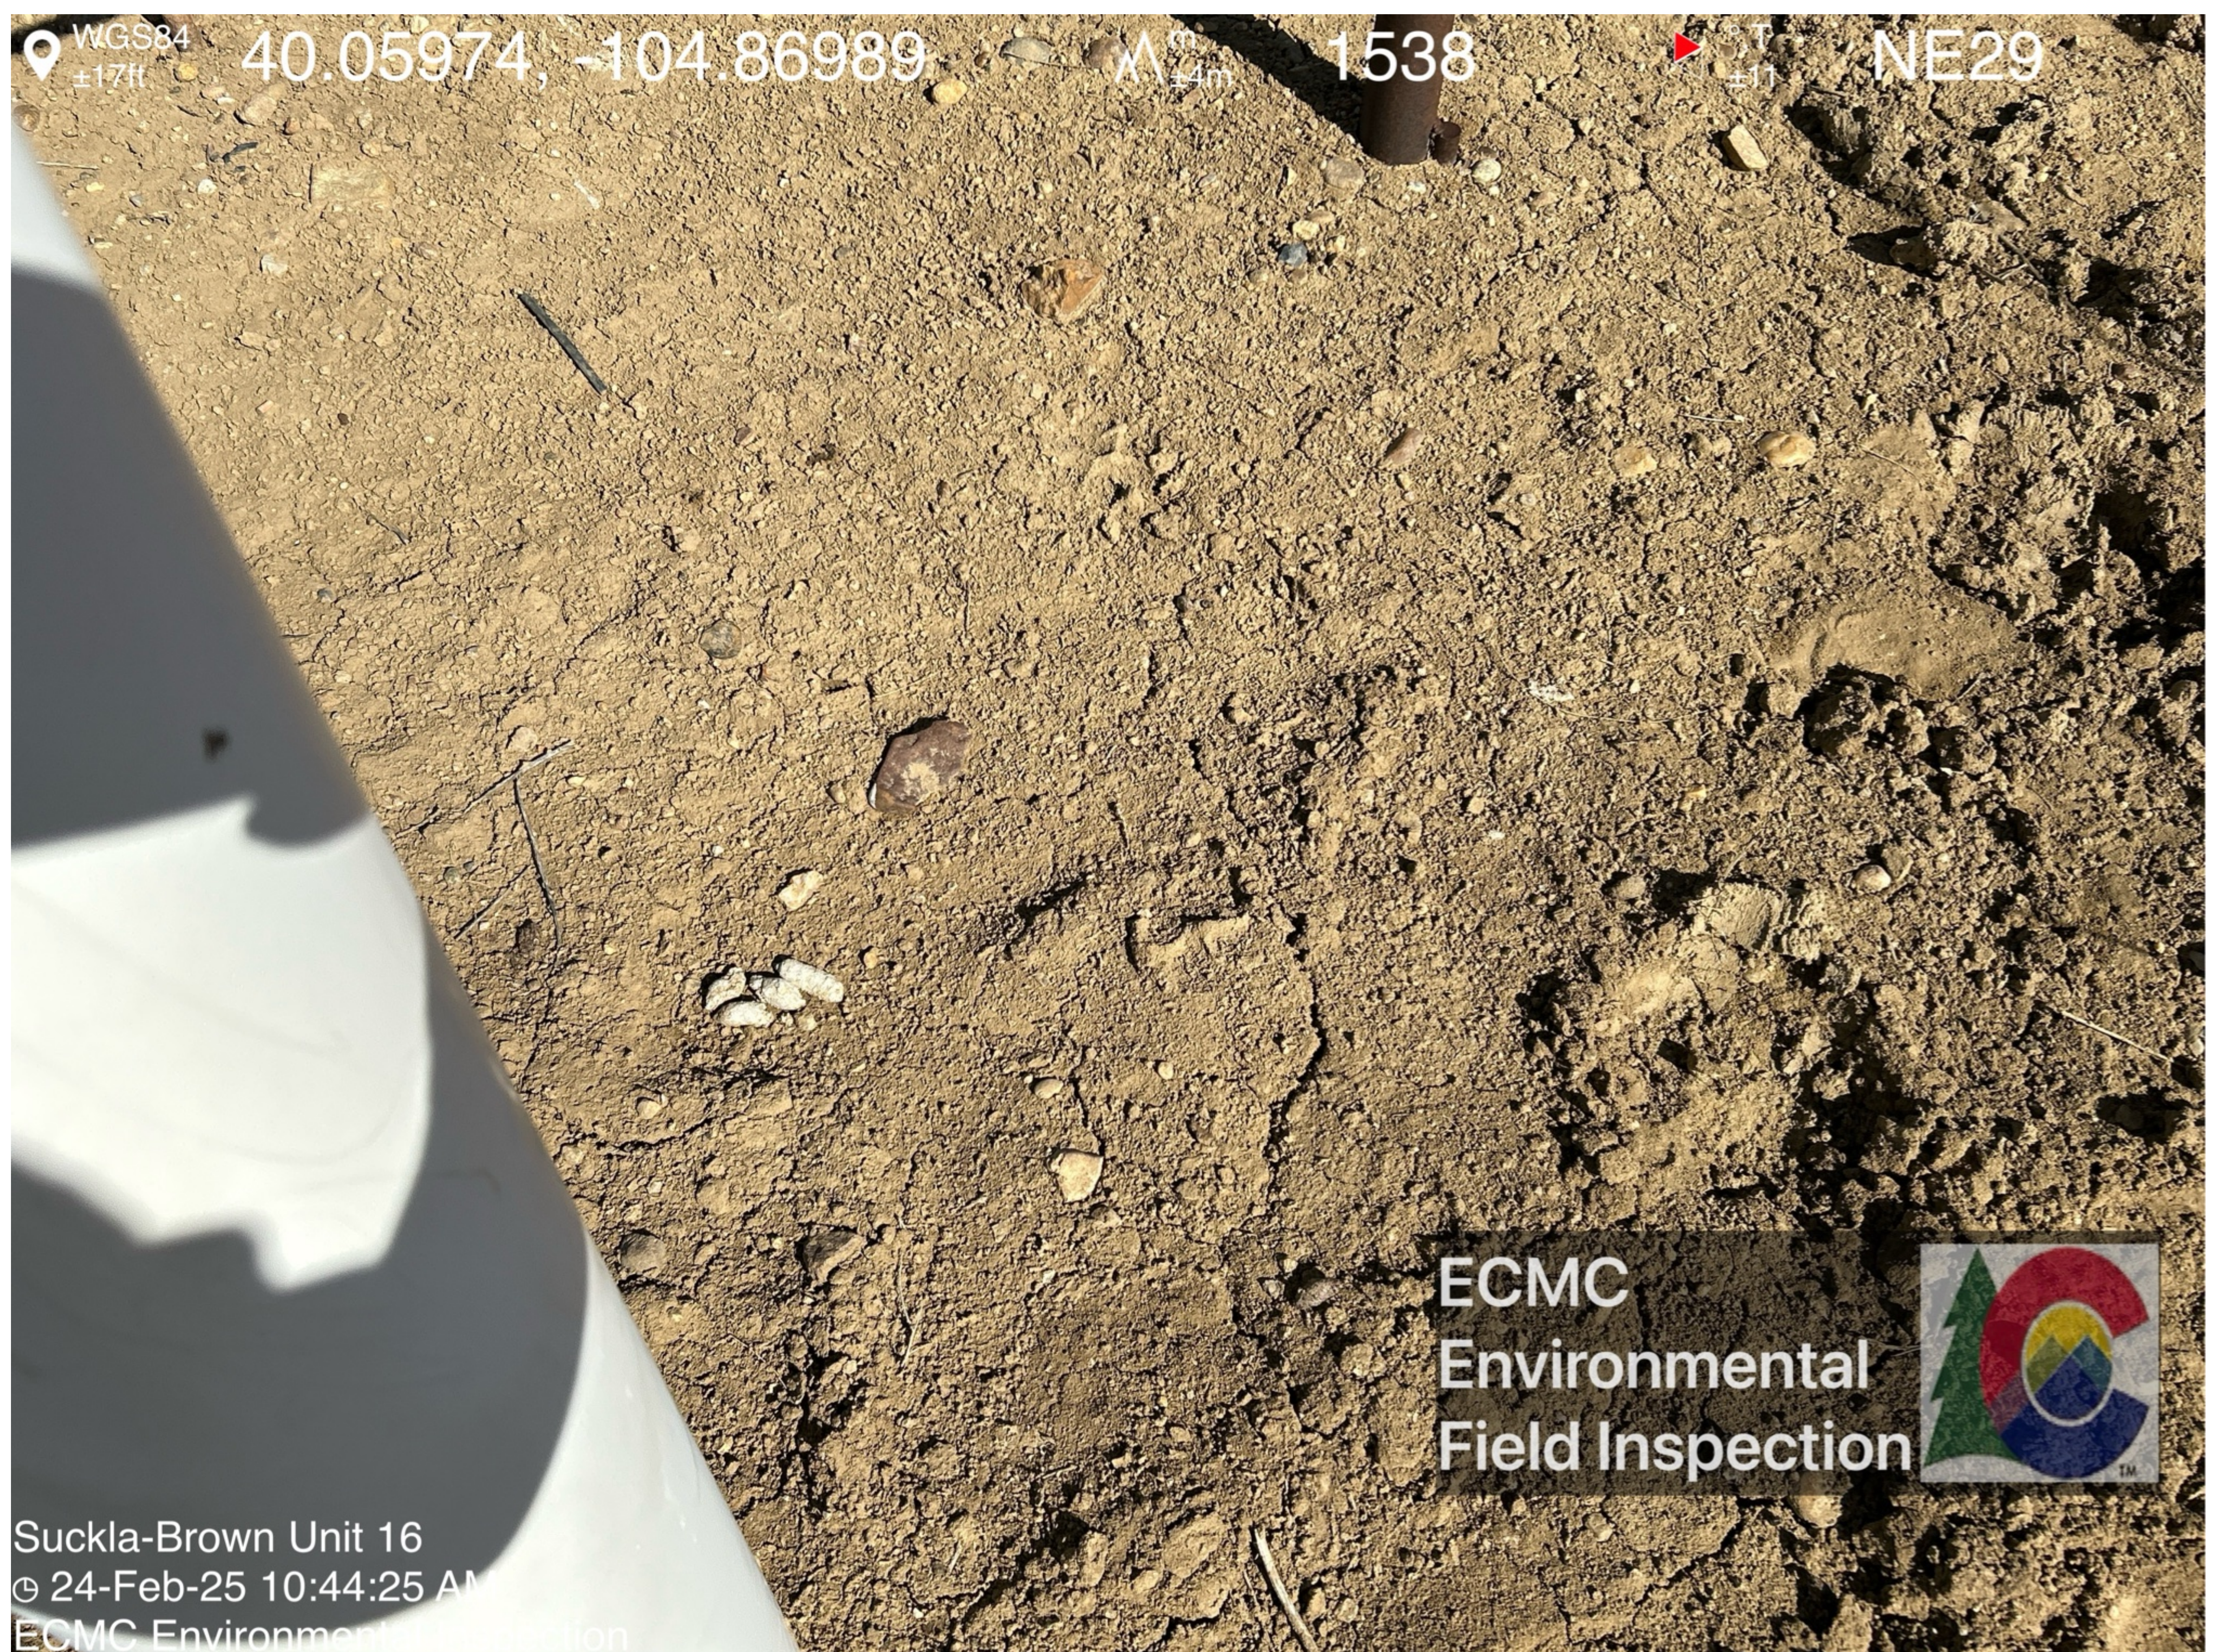
Animal scat observed adjacent to the wellhead.

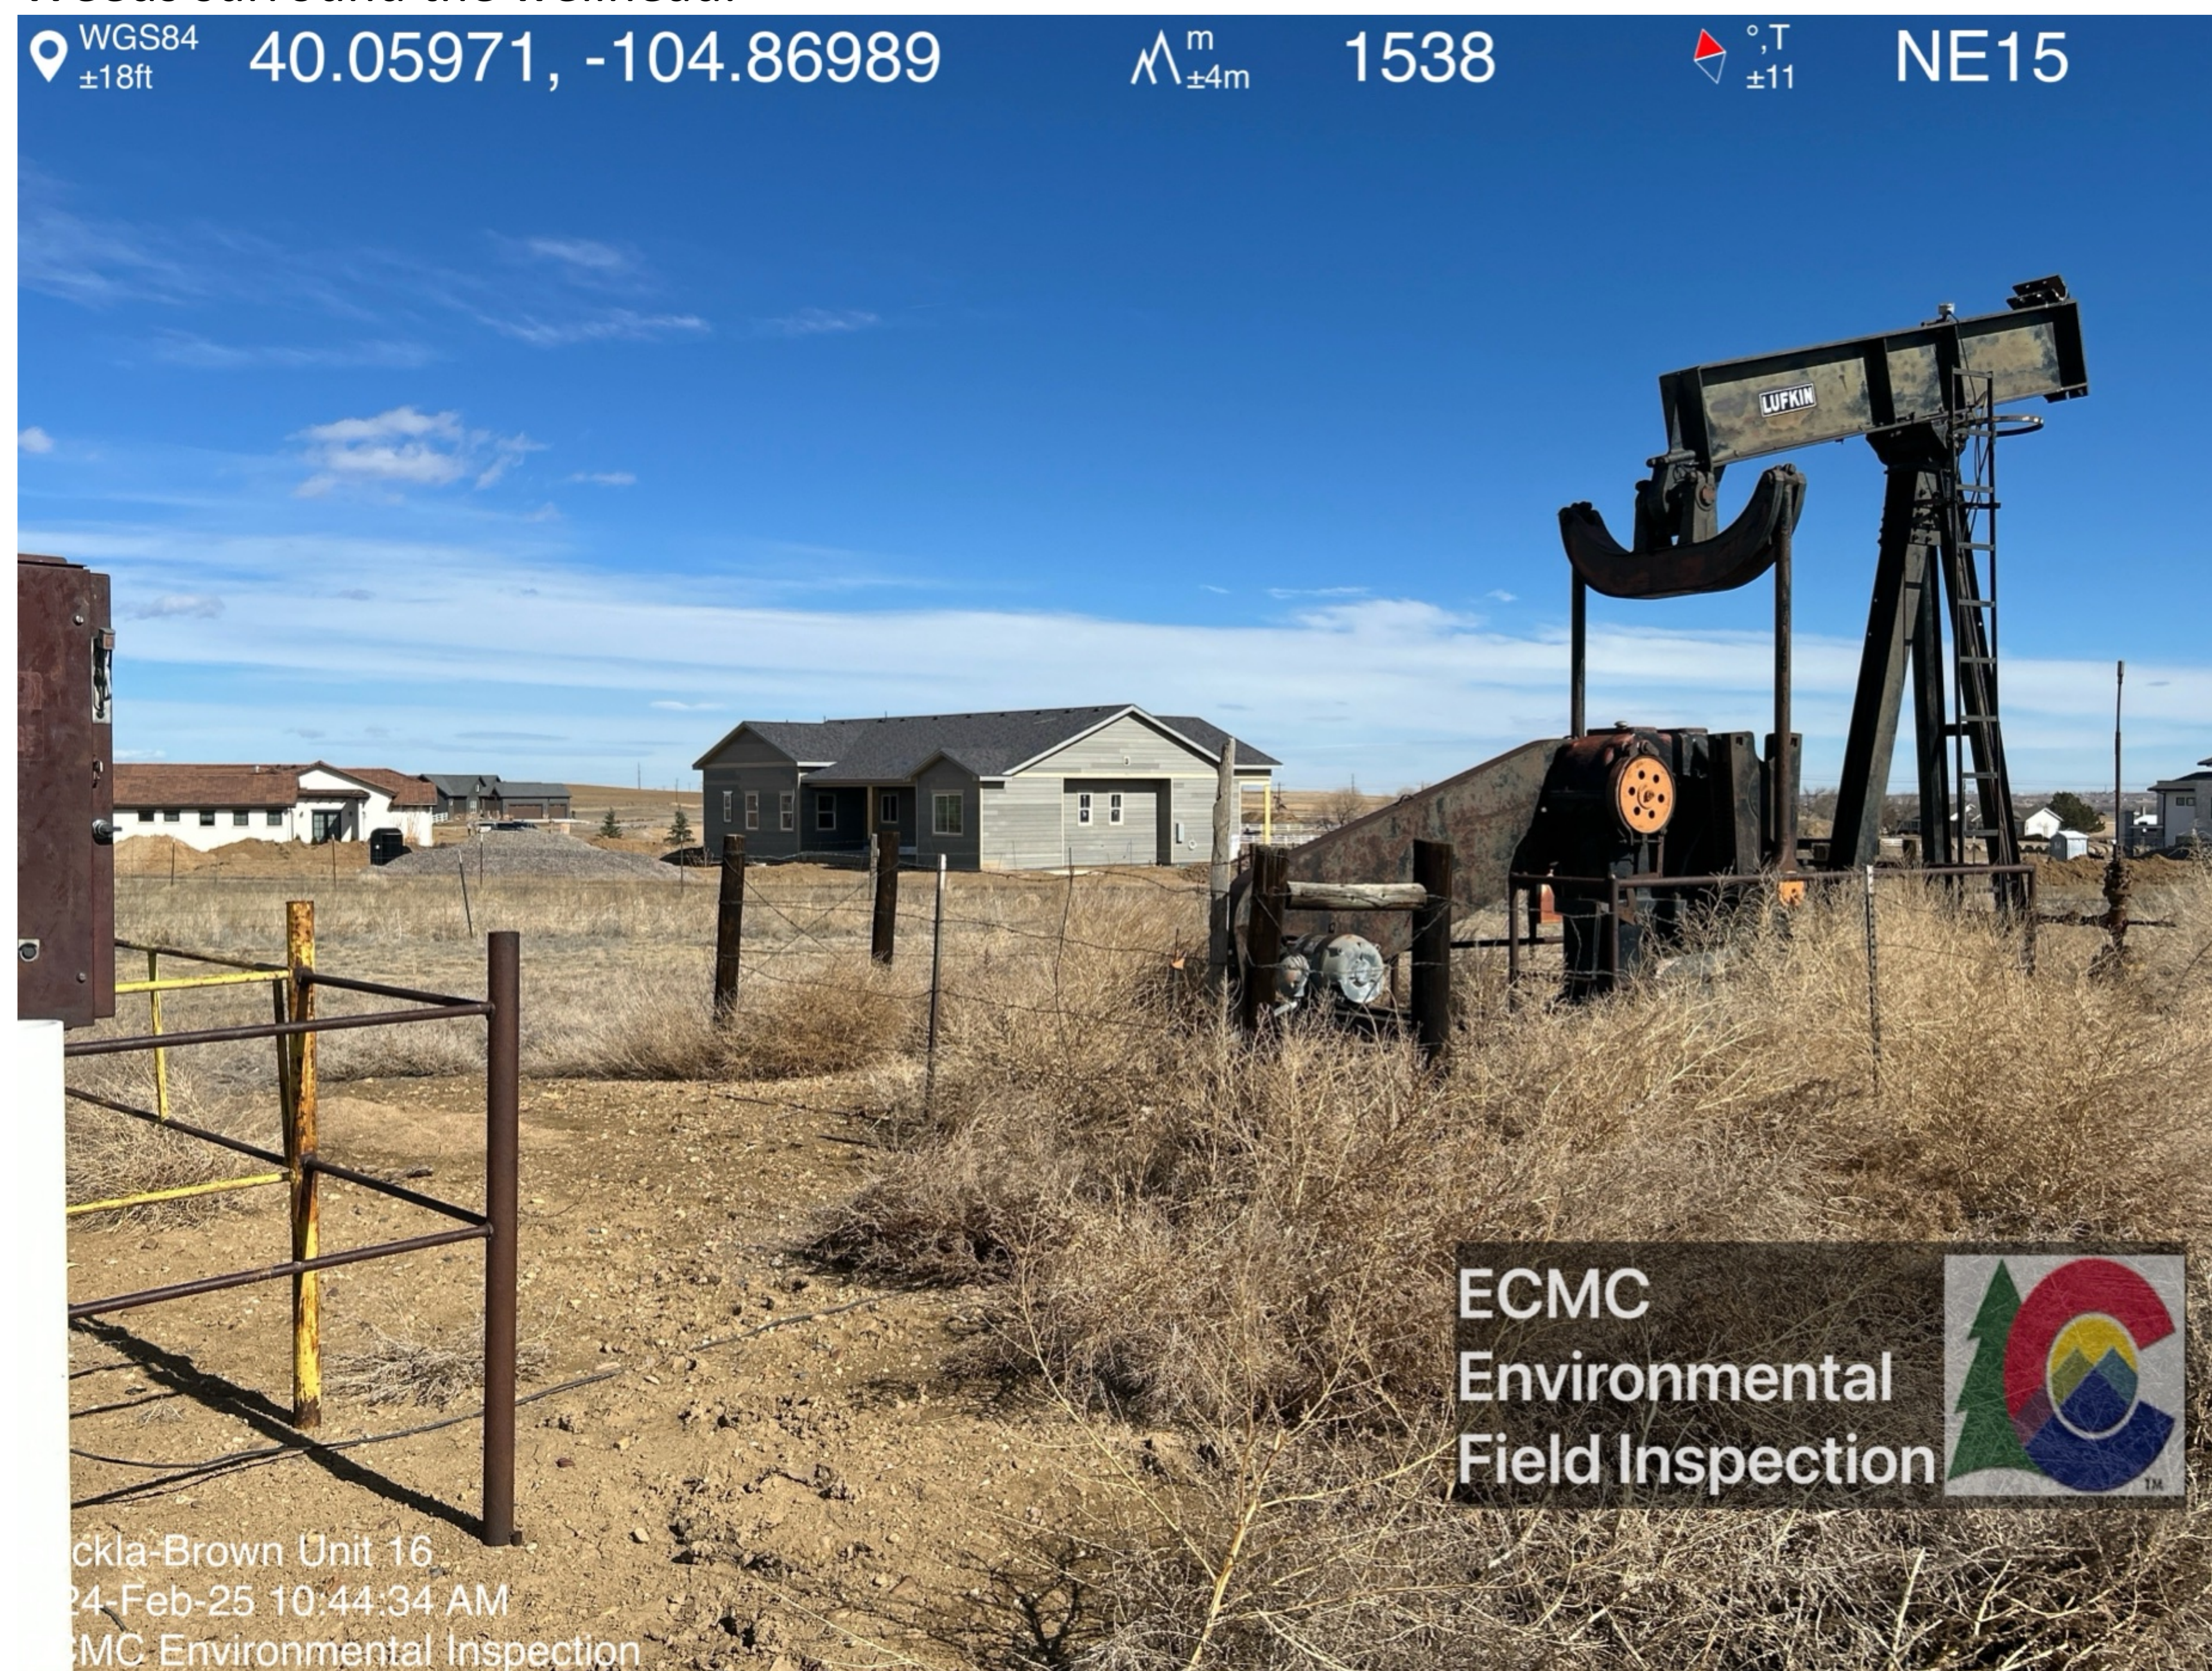
Weeds surround the wellhead.
