**Inspection/Audit Photos**  
**Location Name: QB Energy BENZEL 26-16 (P26NW) Pad**  
**Location ID: 335249**

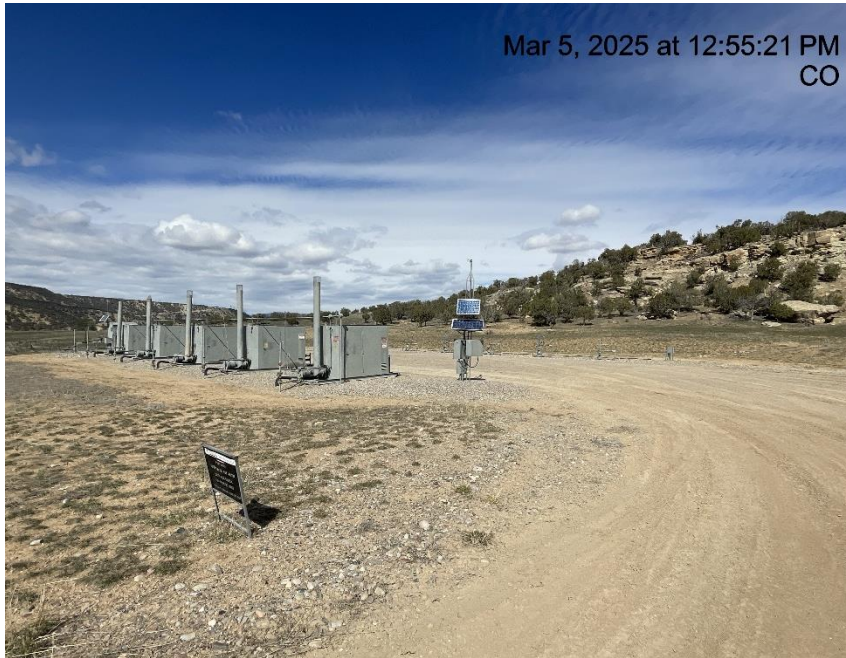
**Photo # 812 From entrance to location**

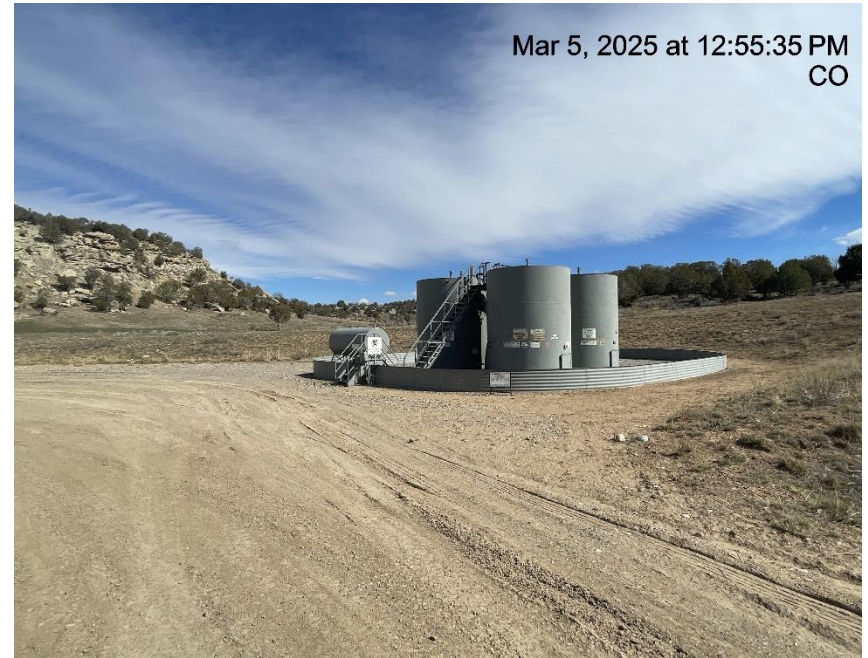
**Photo # 813 From entrance to location**

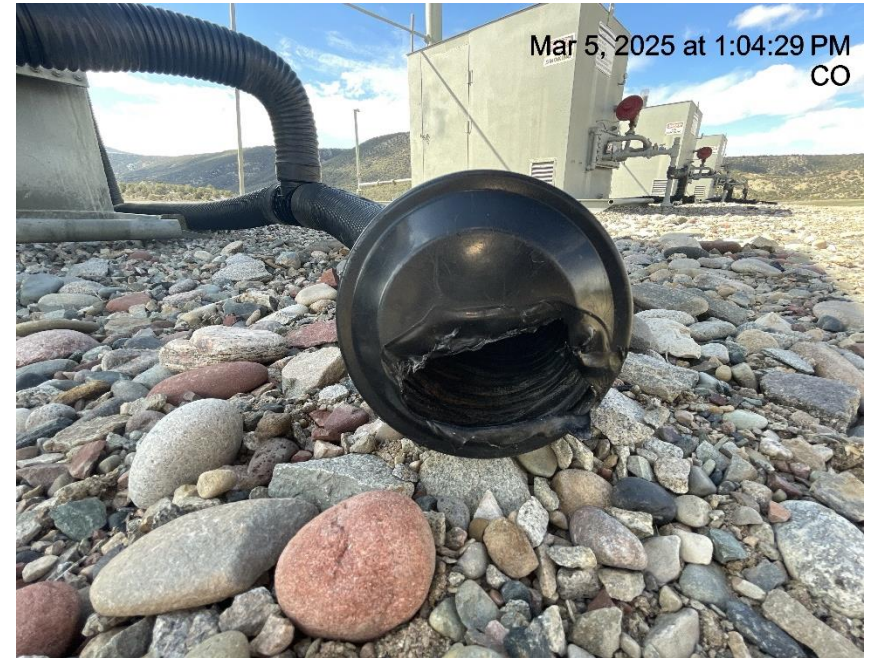
**Photo # 819 Flowline heating insulation cap damaged  
/available for entry by wildlife/wildlife hazard**

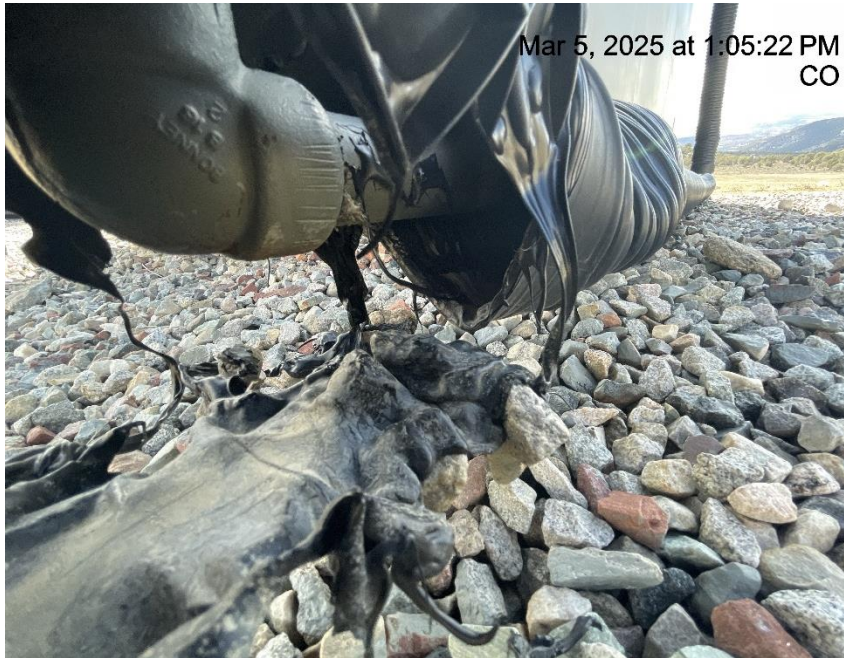
**Photo # 820 Flowline heating insulation damaged/available  
for entry by wildlife/wildlife hazard**
