Inspection Photos
Location Name: Champlin 416 Amoco C 1
Location ID: 322162

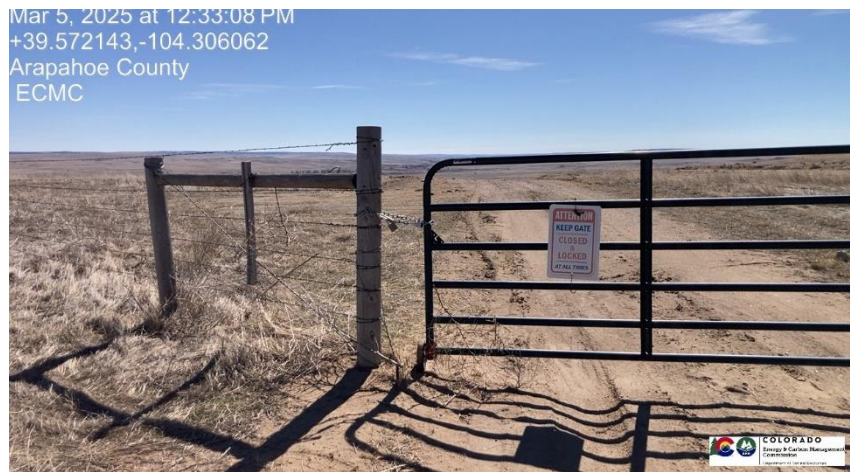
Pic 1 at time of inspection unable to access location due to lock on land owners gate.
