Interim Reclamation and Stormwater Inspection

Operator: BISON IV OPERATING LLC - 10670

Location ID: 437240

Inspection Photos
Location Name: Pronghorn K-12 Pad
Location ID: 437240

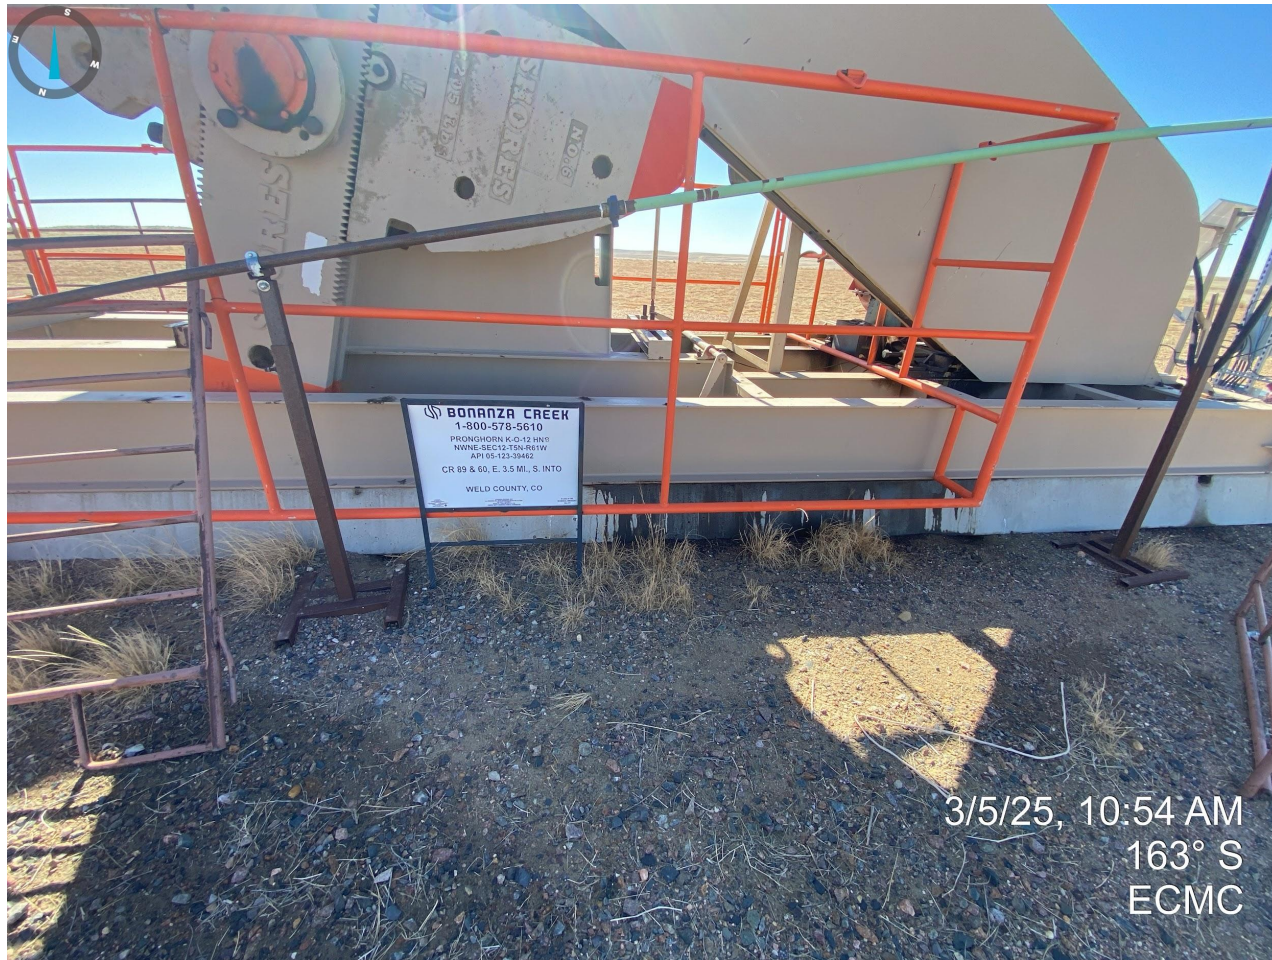
Photo 1. Sign at well does not reflect current operator of record.

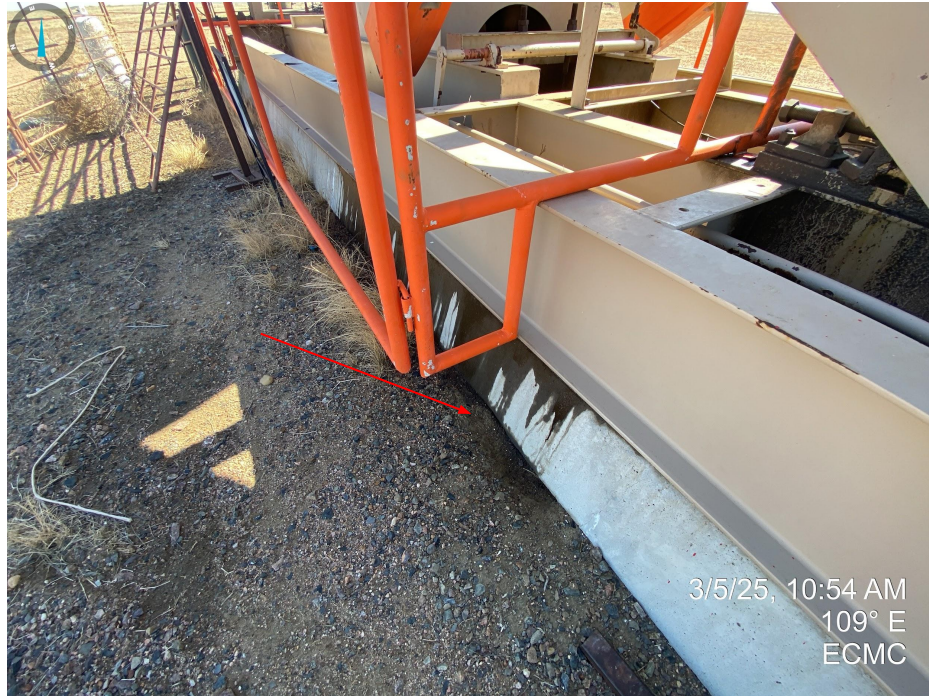
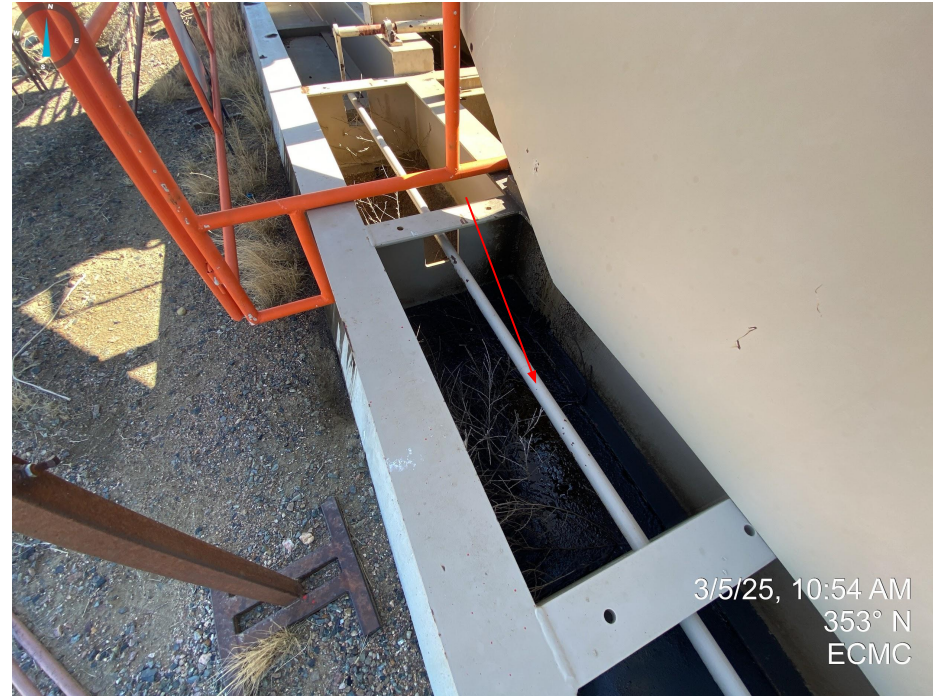
Photos 2 & 3. Hydrocarbon staining observed at pumpjack unit.

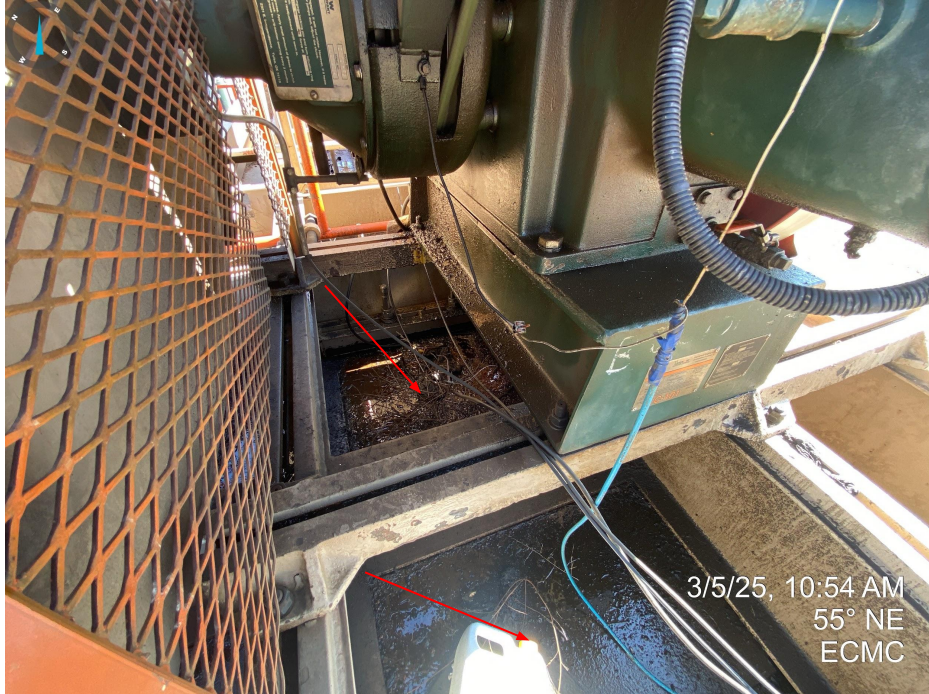
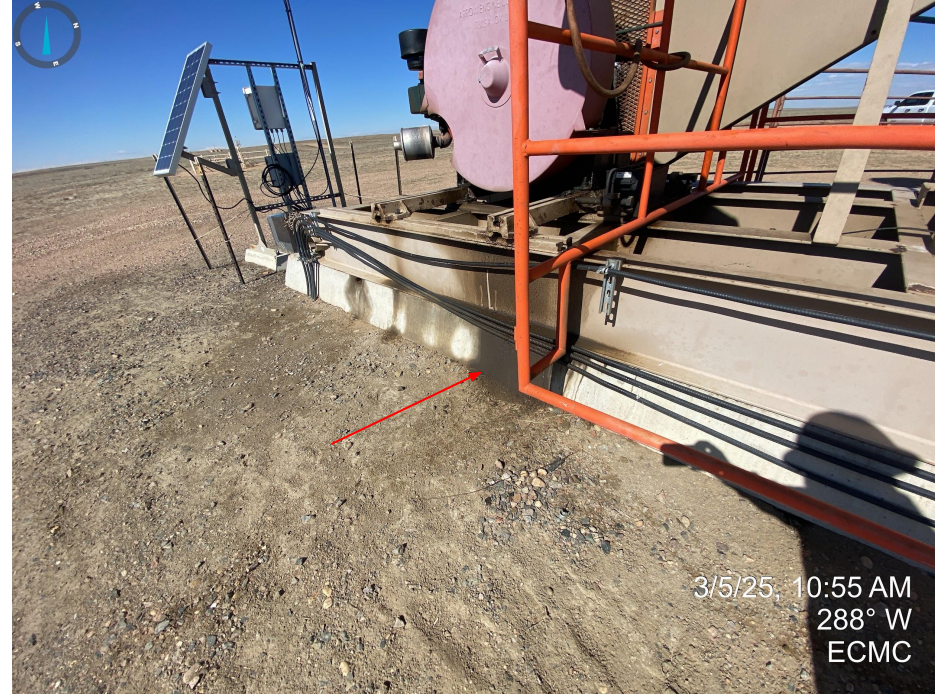
Photos 4 & 5. Hydrocarbon staining observed at pumpjack unit.

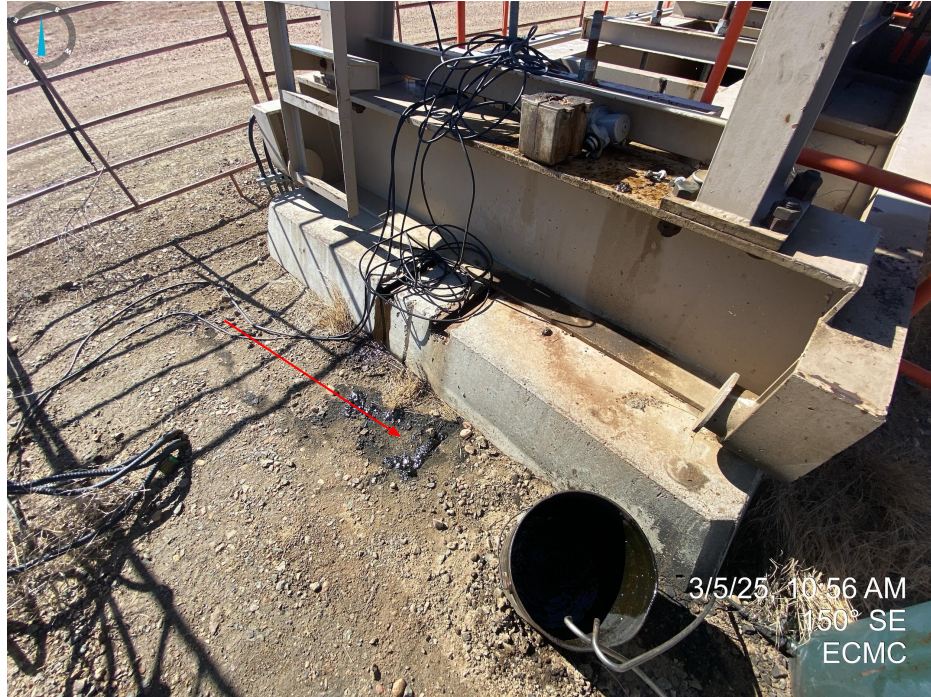
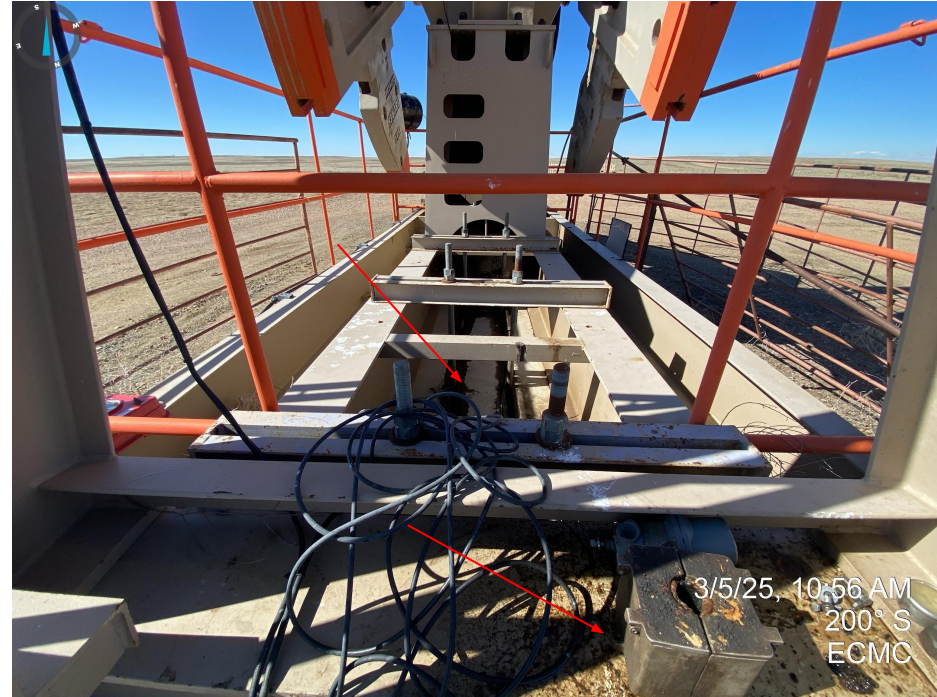
Photos 6 & 7. Hydrocarbon staining observed at pumpjack unit.

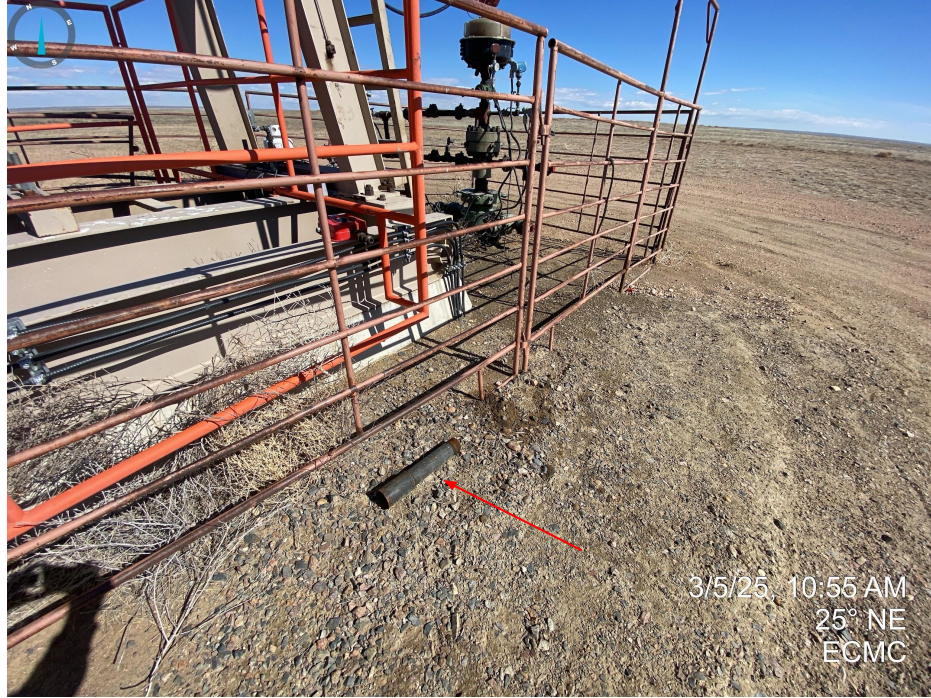
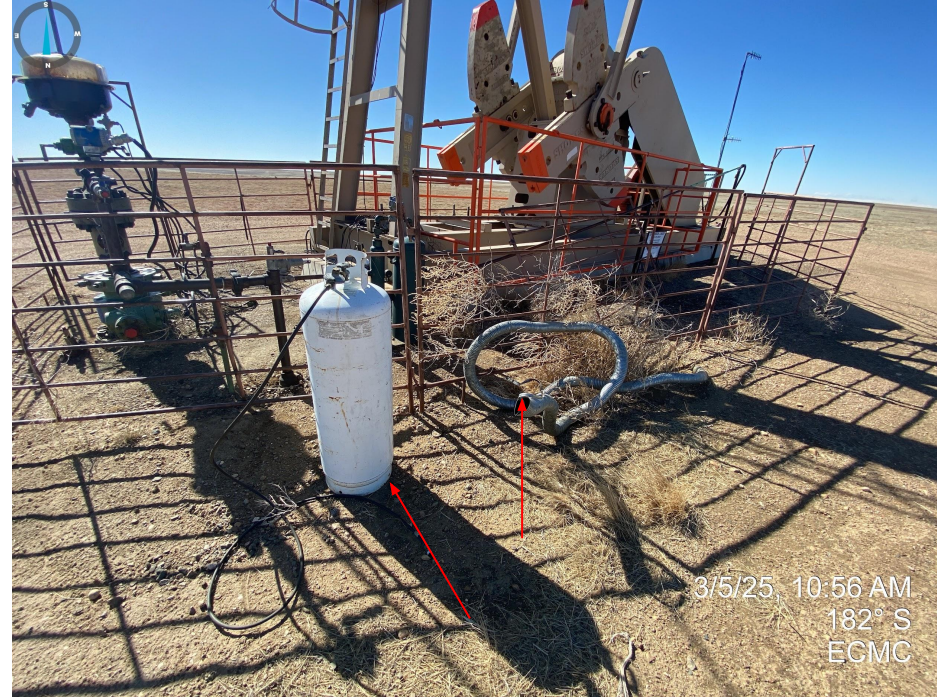
Photos 8 & 9. Unused equipment and tumbleweed debris observed at well.

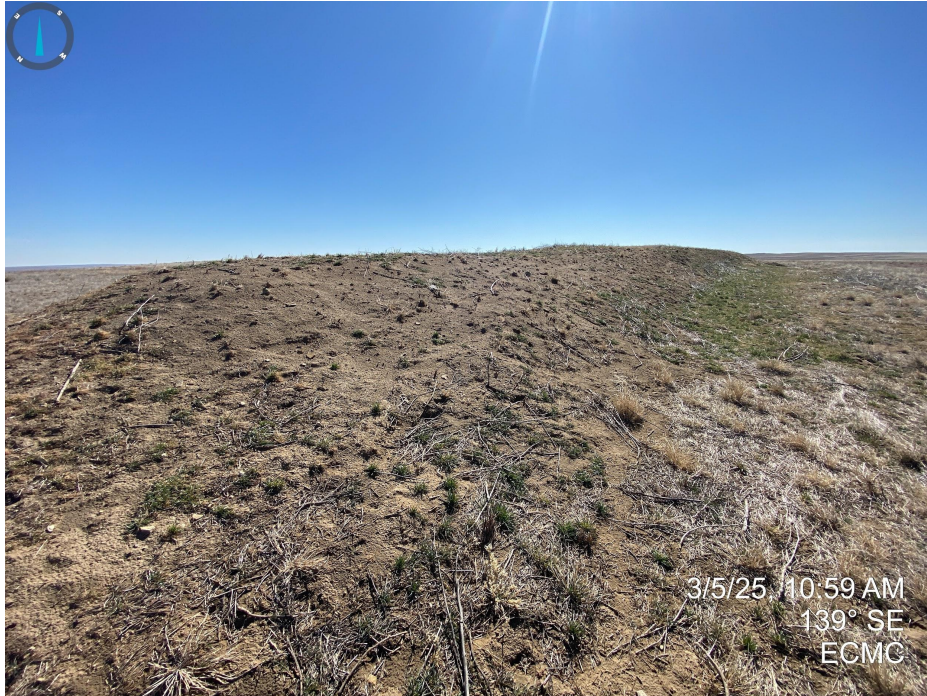
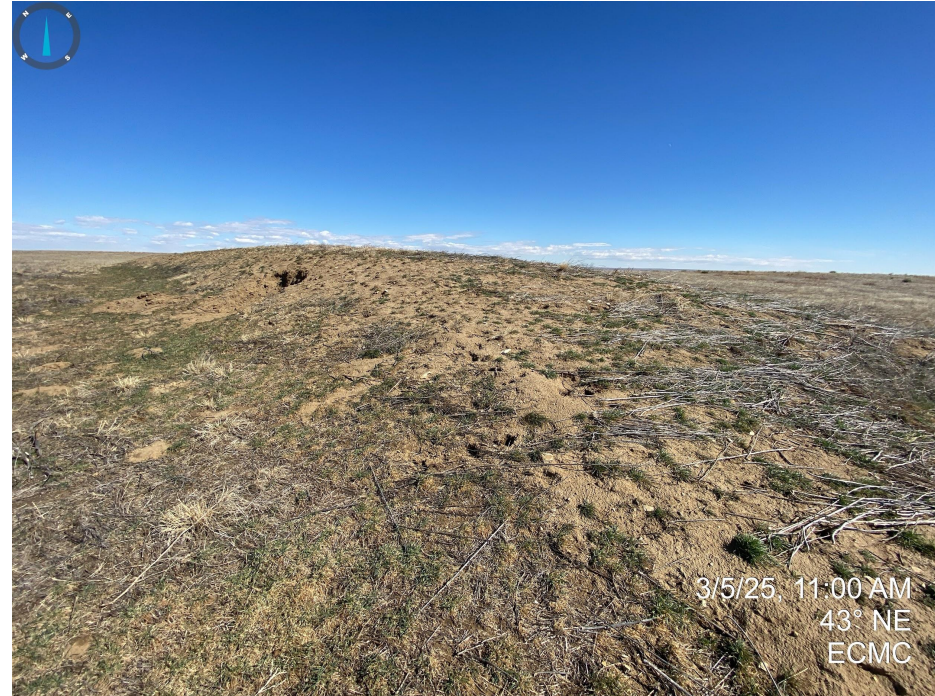
Photos 10 & 11. Topsoil stockpile was observed to be predominantly bare/exposed soils and requires additional reclamation activities to stabilize the stockpile from erosion degradation.

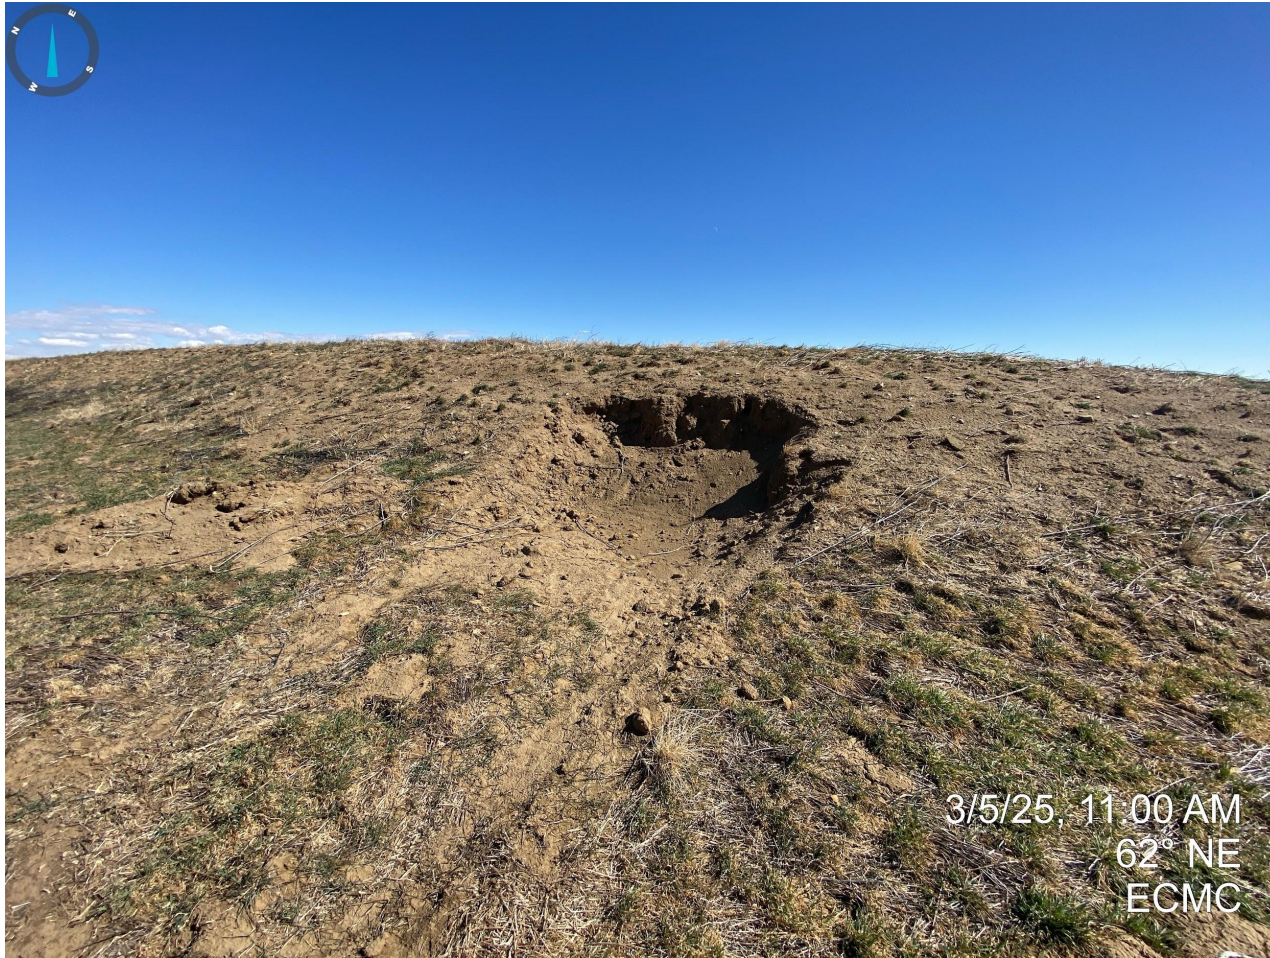
Photo 12. It appears that several cubic yards of topsoil have been removed from the stockpile.
