Final Reclamation Inspection

Operator: KERR MCGEE OIL & GAS ONSHORE LP - 47120

Location ID: 332516

Location Name: THOMPSON #23-6, LUCKY 2 AMOCO #34-6

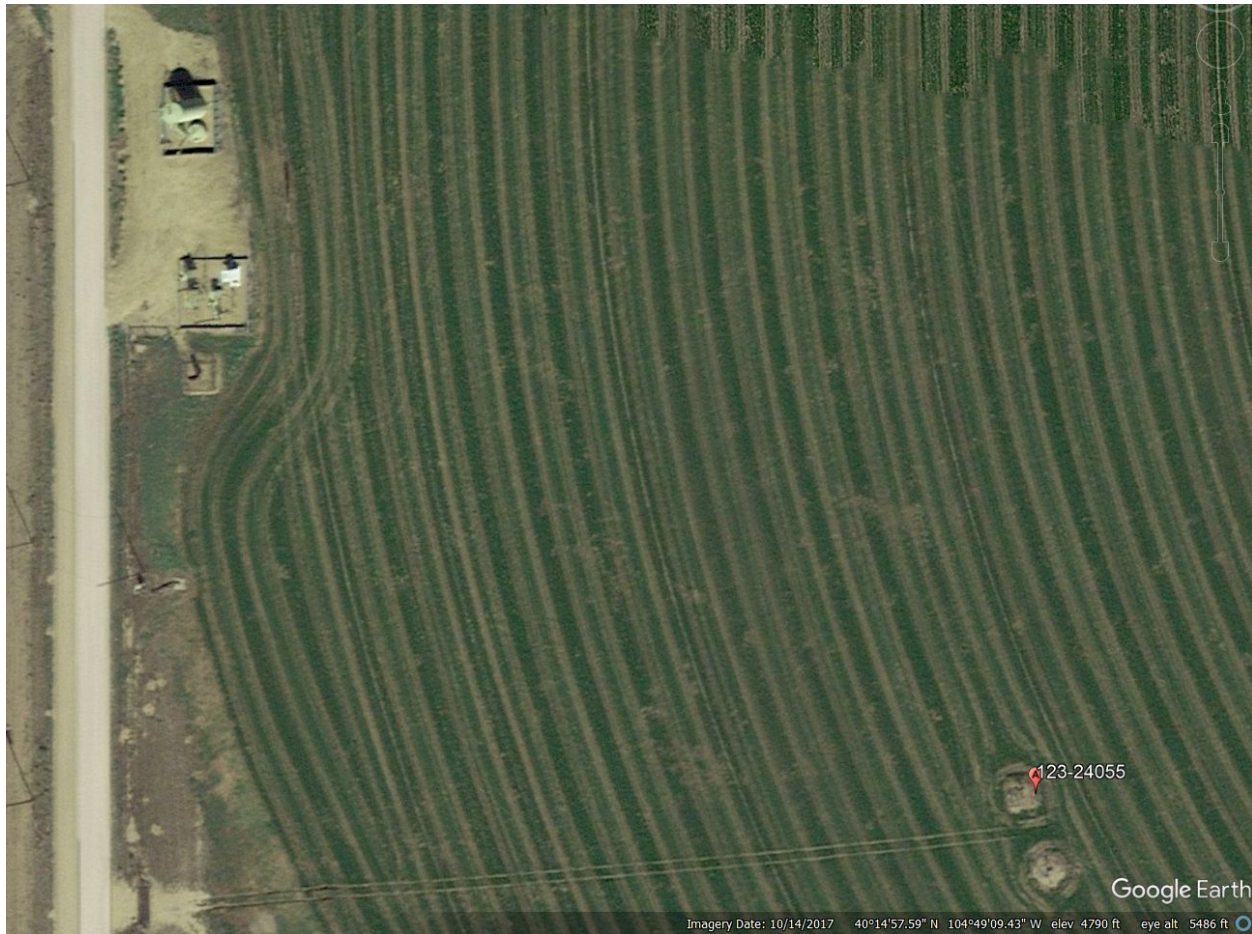
Photo 1. Google Earth aerial imagery from October 14, 2017. Photo illustrates the well location access road and associated off-location tank battery during active operations.

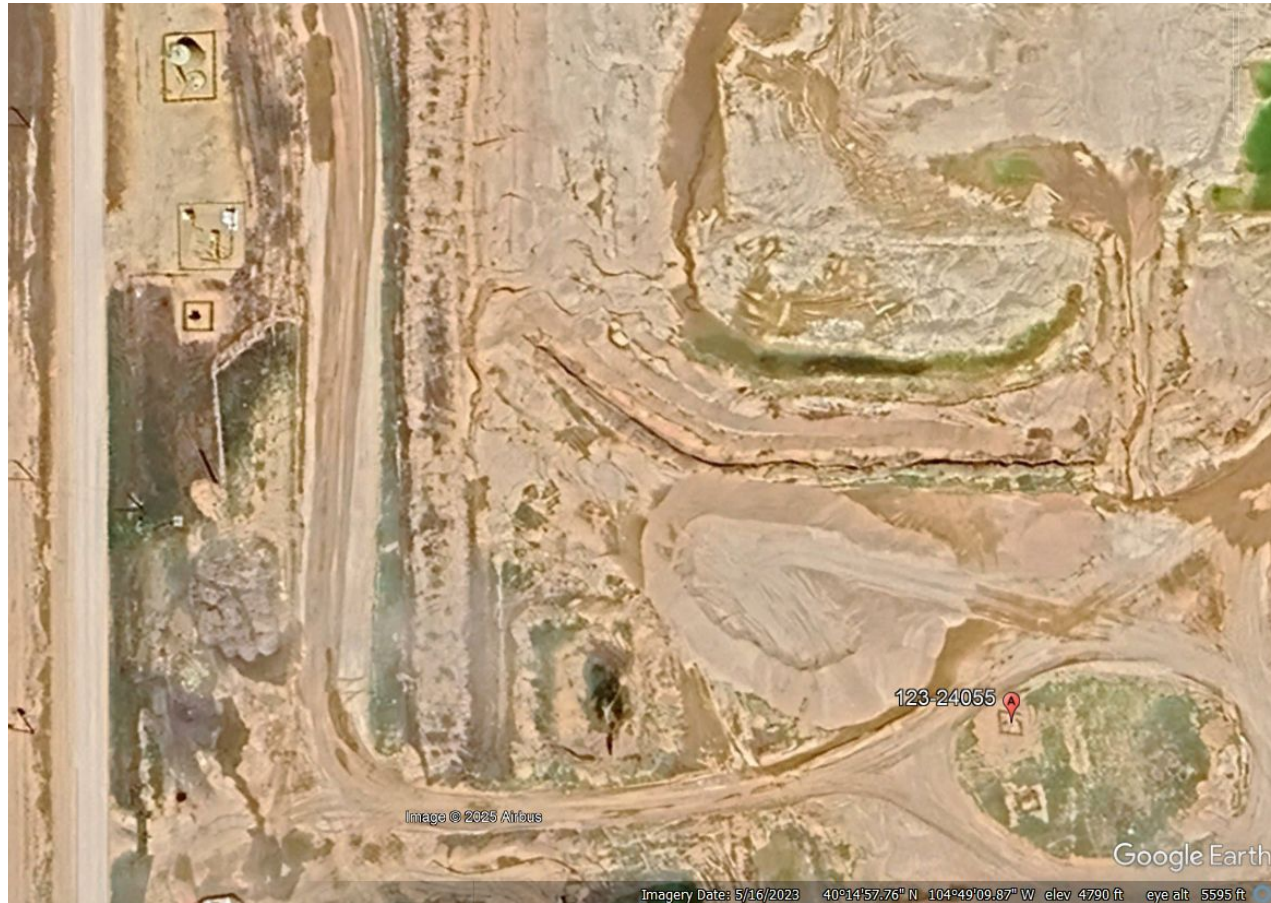
Photo 2. Google Earth aerial imagery from May 16, 2023. Photo illustrates the well location access road and associated off-location tank battery after plugging operations. The associated disturbances are now within an active gravel mine, Mine ID M2018027.

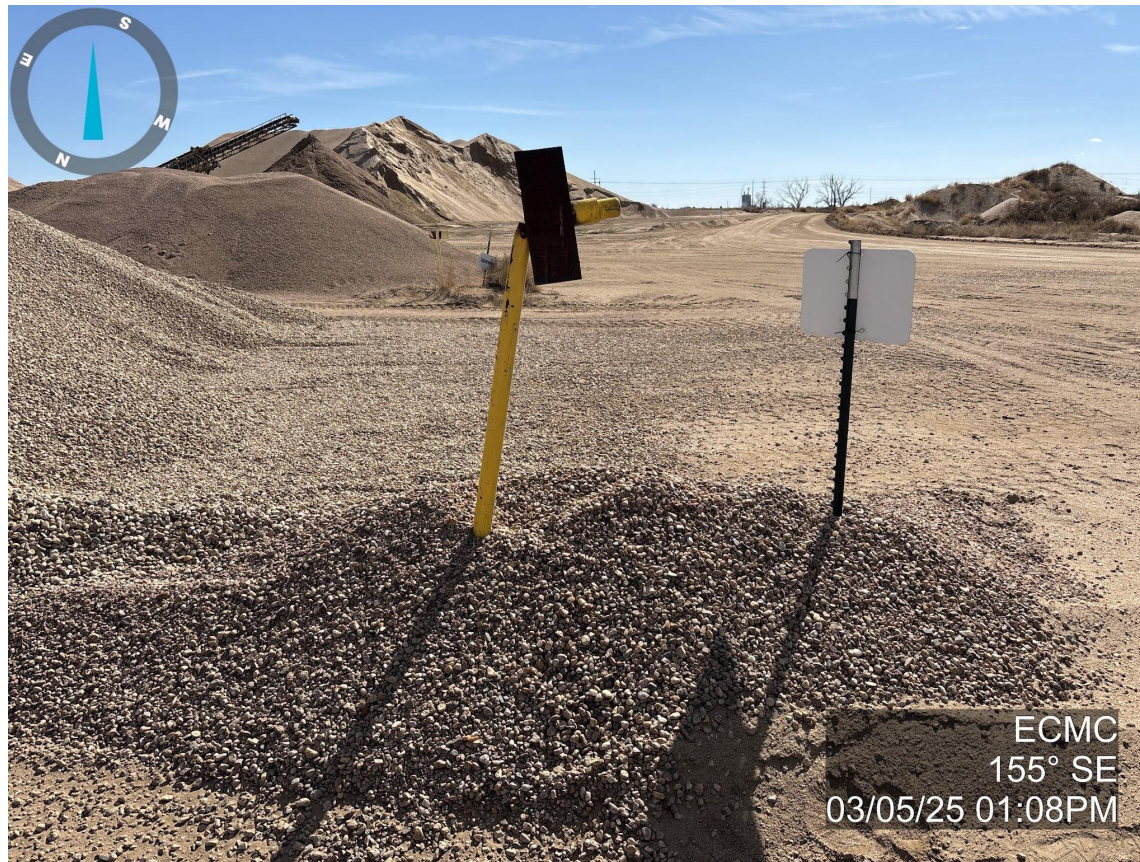
Photo 3. Photo taken from the THOMPSON #23-6 well location, facing Southeast. Photo illustrates that all equipment and stormwater BMPs have been removed and there is no weed growth on the well location. The well location is in a land-use change to an active Gravel Mine, Mine ID M2018027.

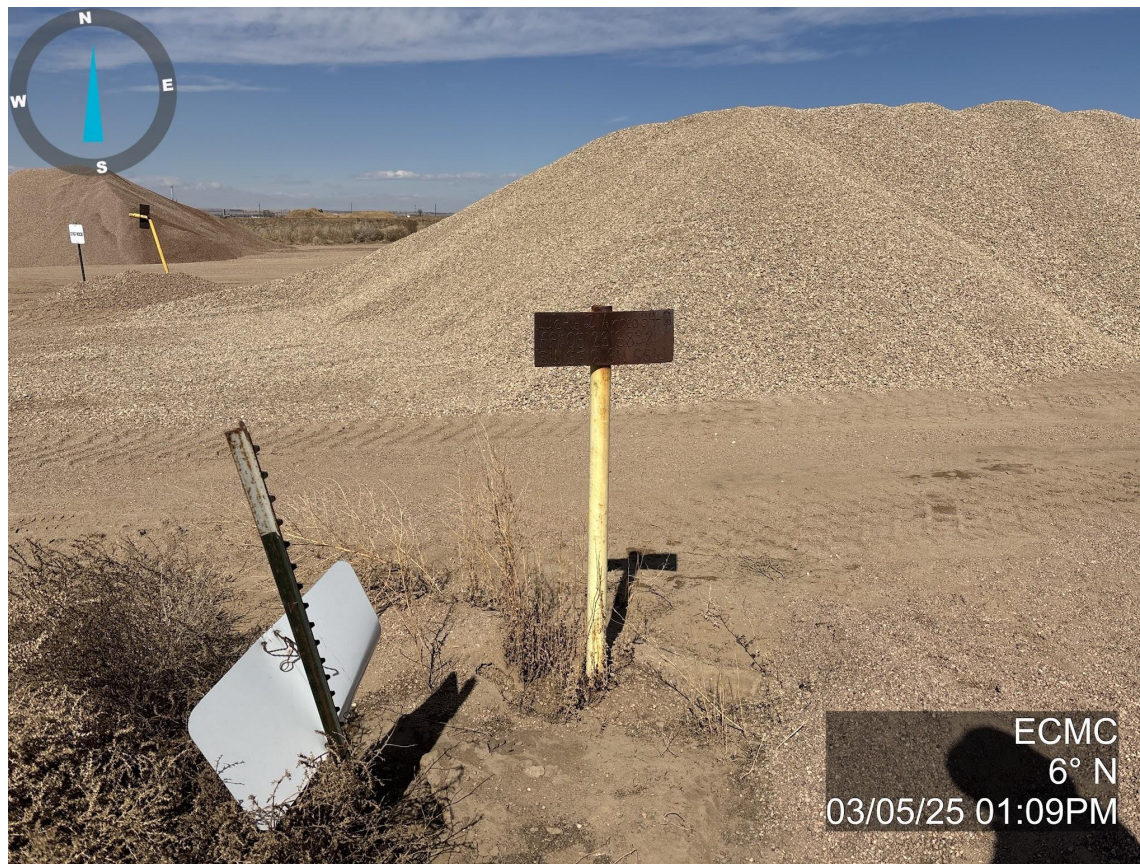
Photo 4. Photo taken from the LUCKY 2 AMOCO #34-6 well location, facing North. See comments under photo 3.

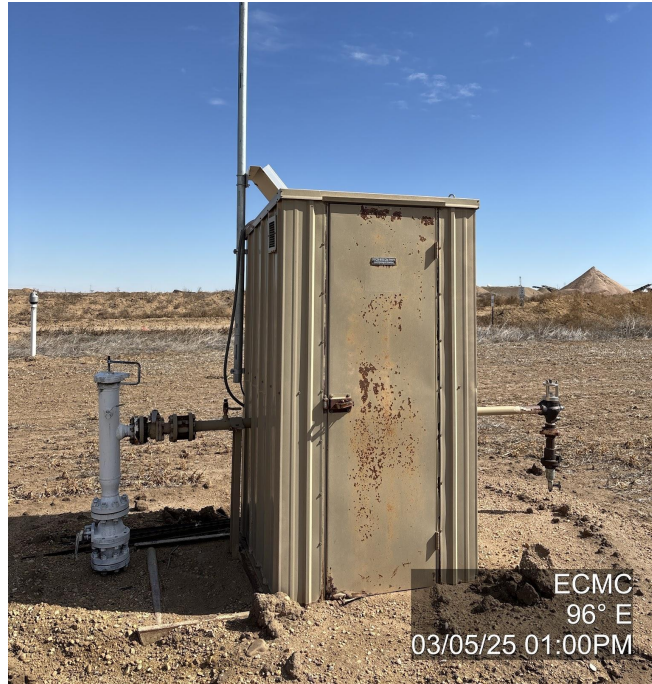
Photo 5. Photo taken at the tank battery location, facing East. Photo illustrates that the meter house remains.

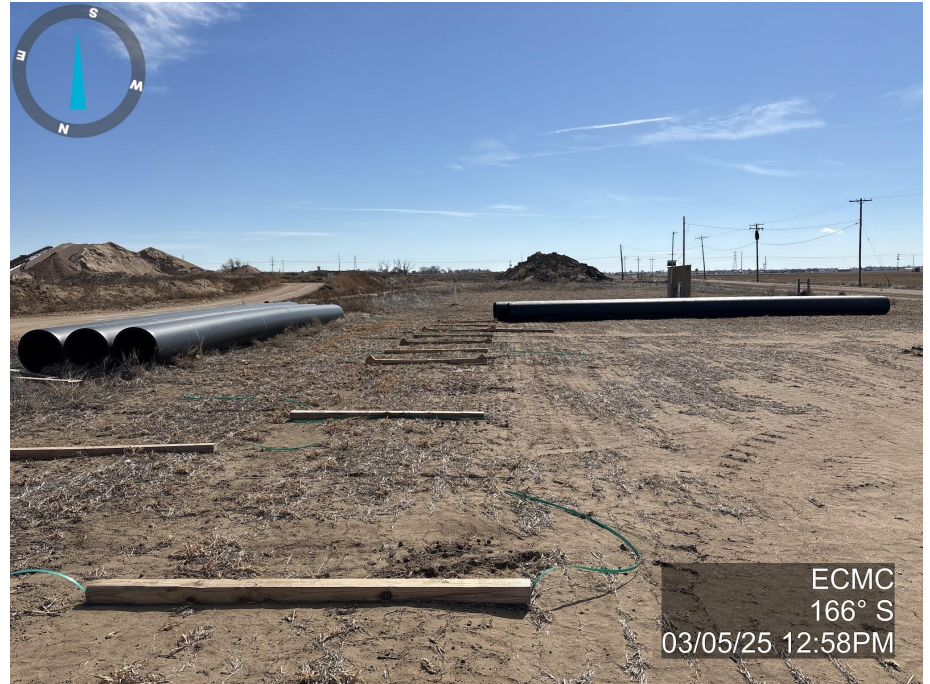
Photo 6. Photo taken from the tank battery location, facing South. Photo illustrates that reclamation has been performed, however, it appears this is being used as a storage area for mining operations.
