**Antler Energy LLC  
USA-Clark – Millison 1  
Location ID: 313122**

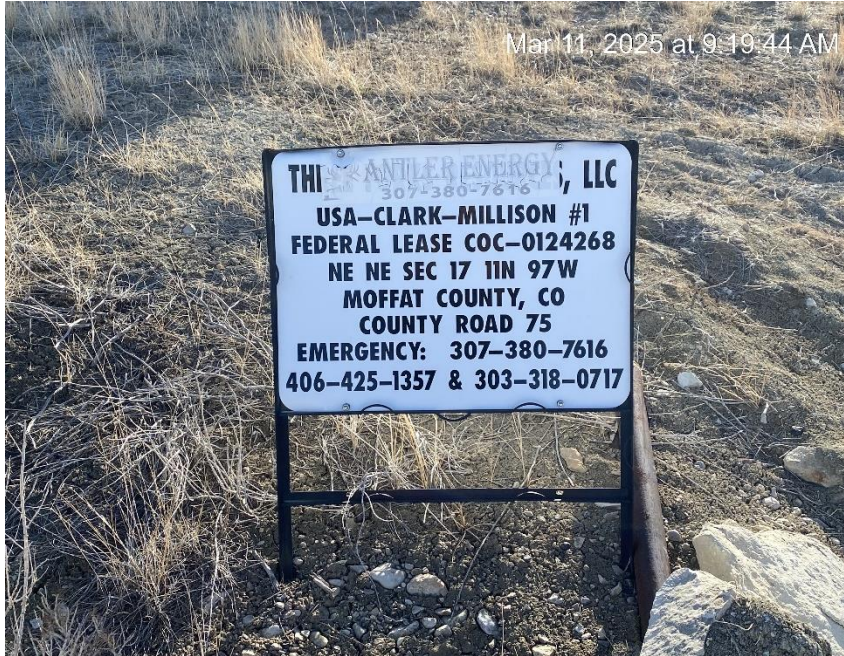
**Missing information**

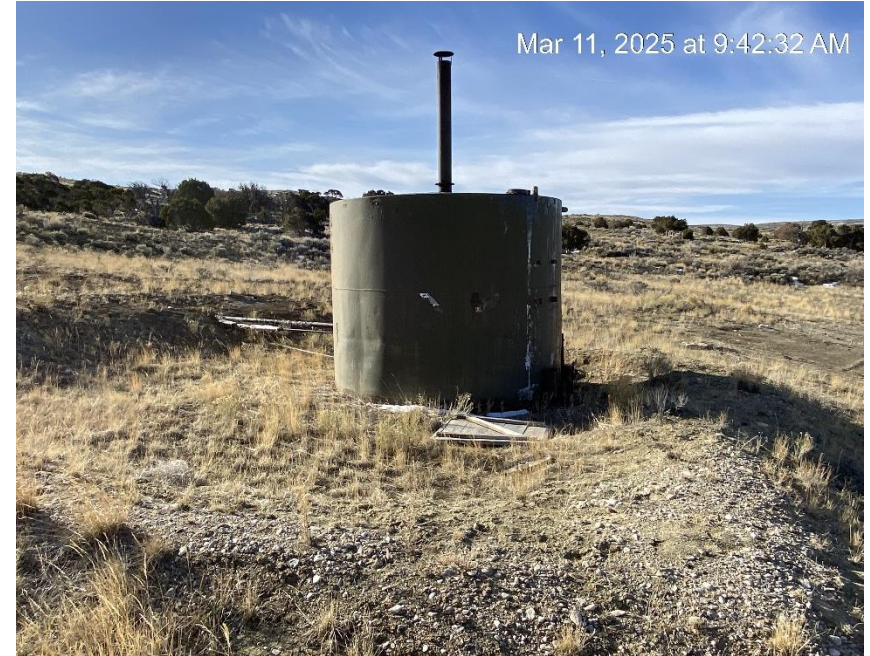
**Unused equipment**

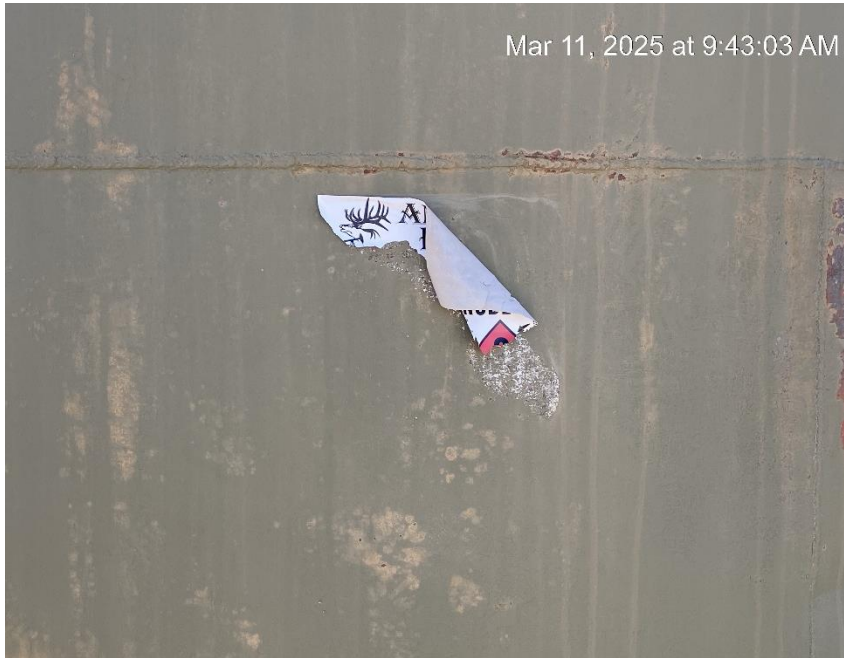
**Damaged label**

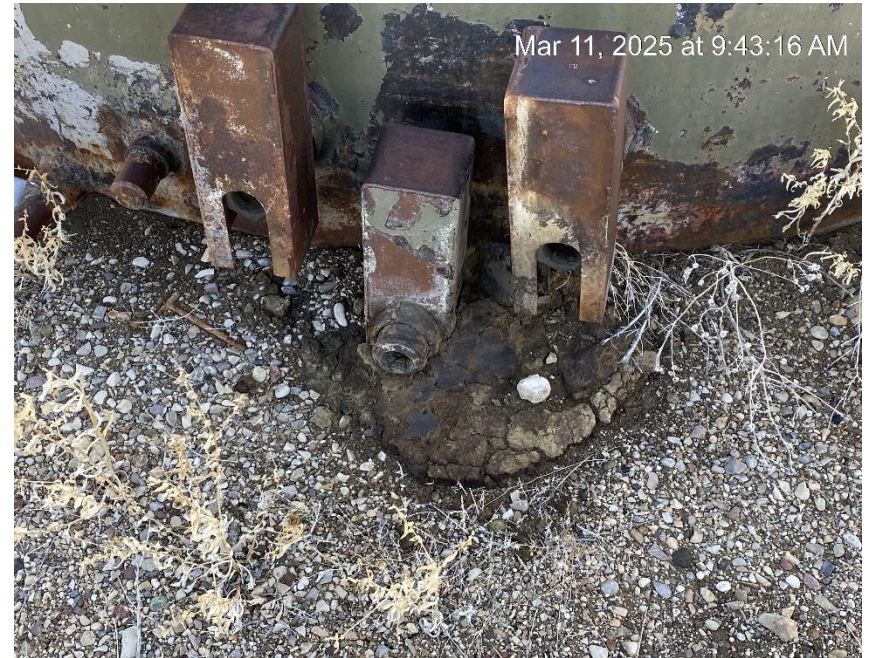
**Oily waste. Staining**

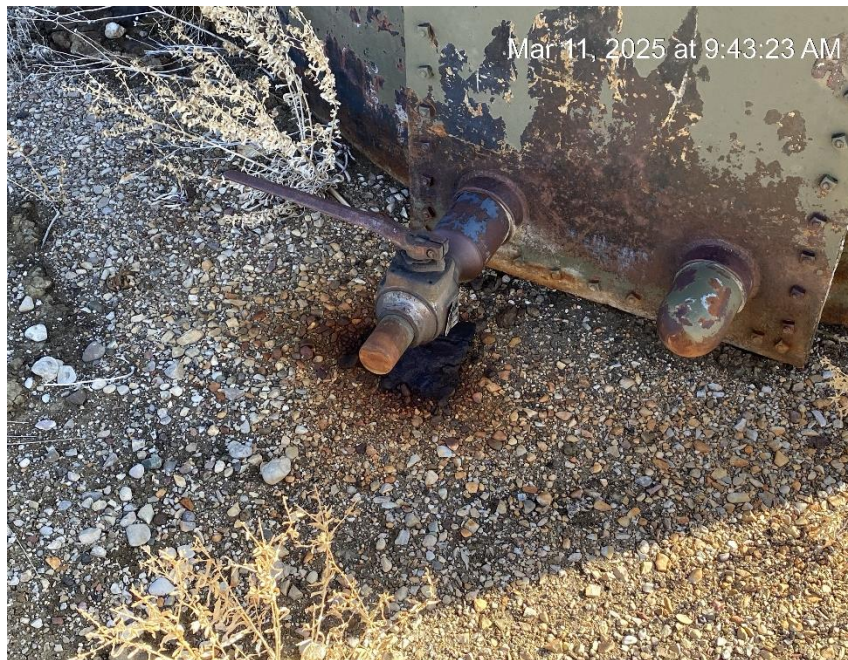
**Staining**

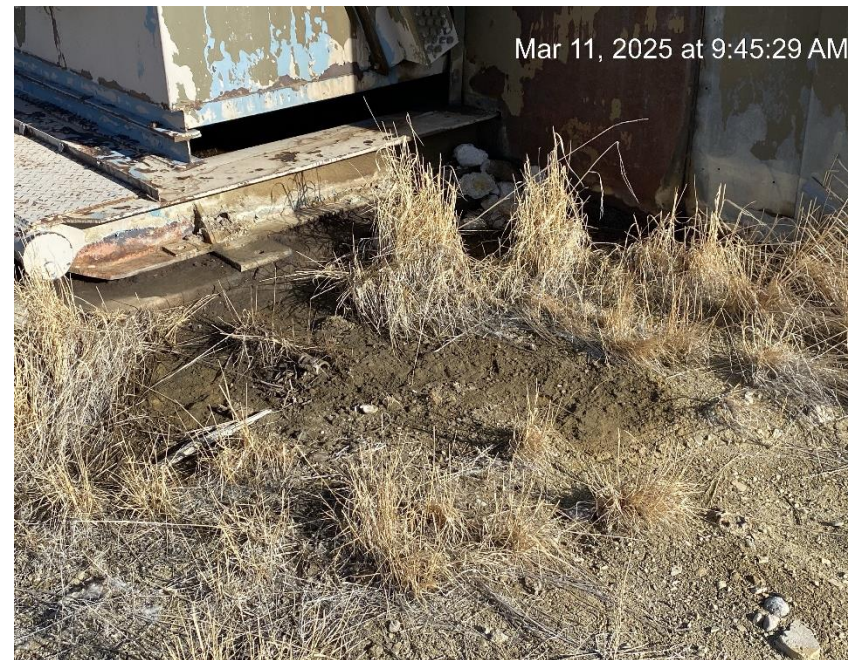
**Staining**

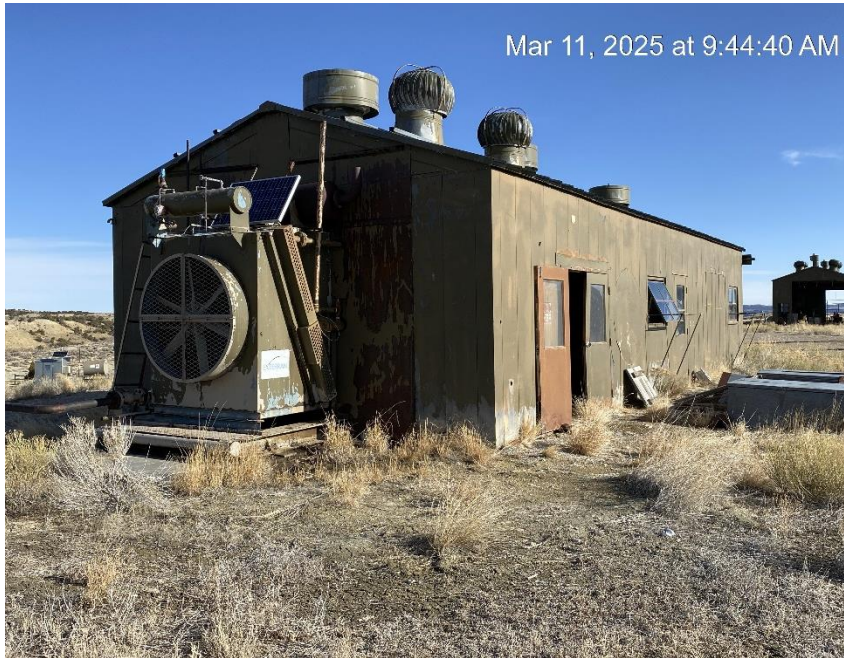
**Unused equipment**

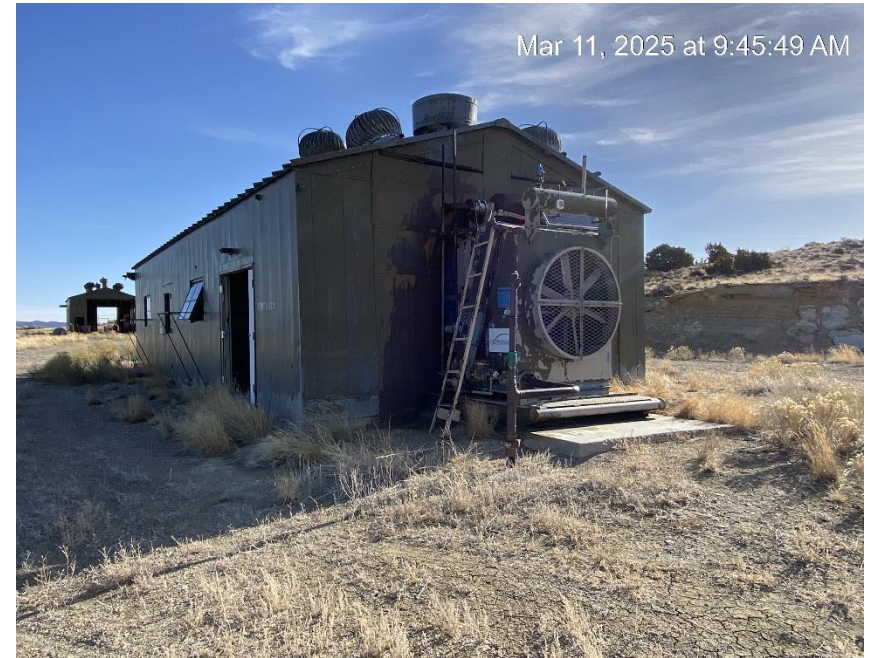
**Unused equipment**

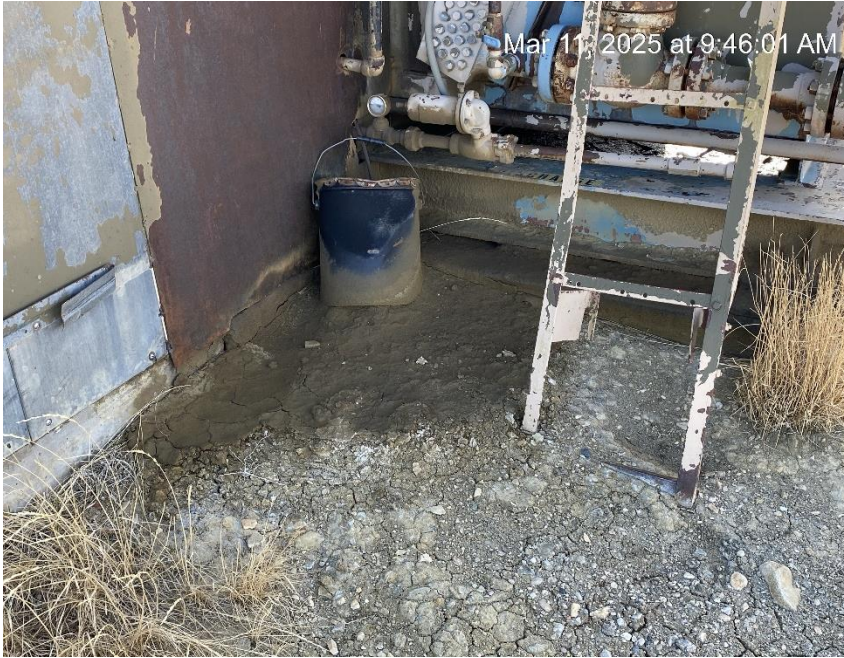
**Staining**

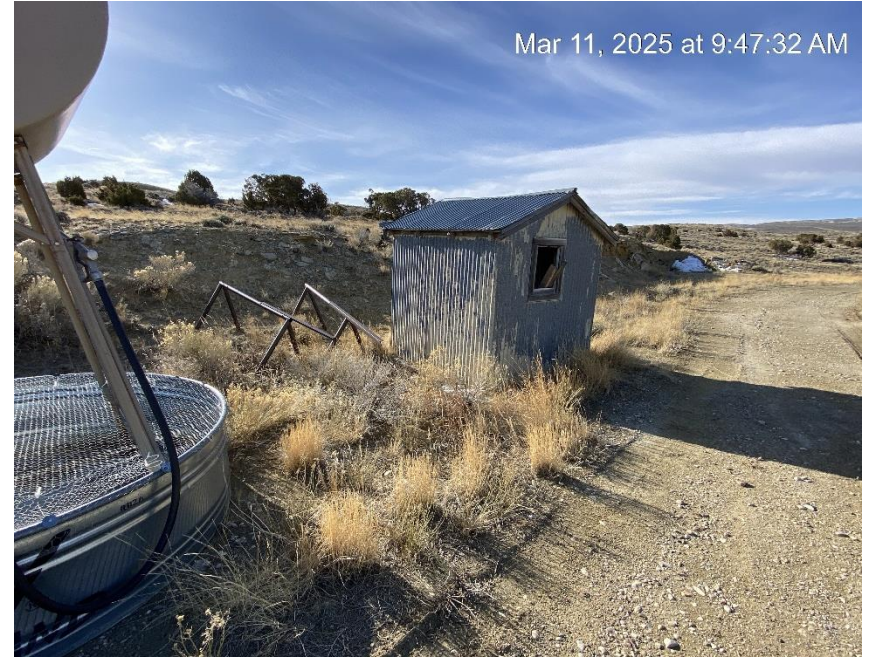
**Unused equipment**

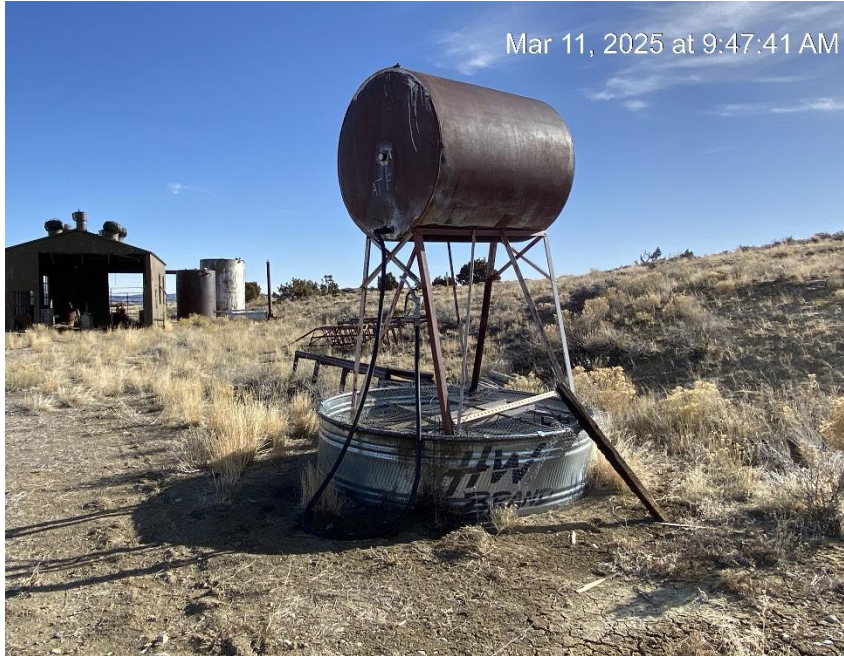
**Unlabeled and nused equipment**

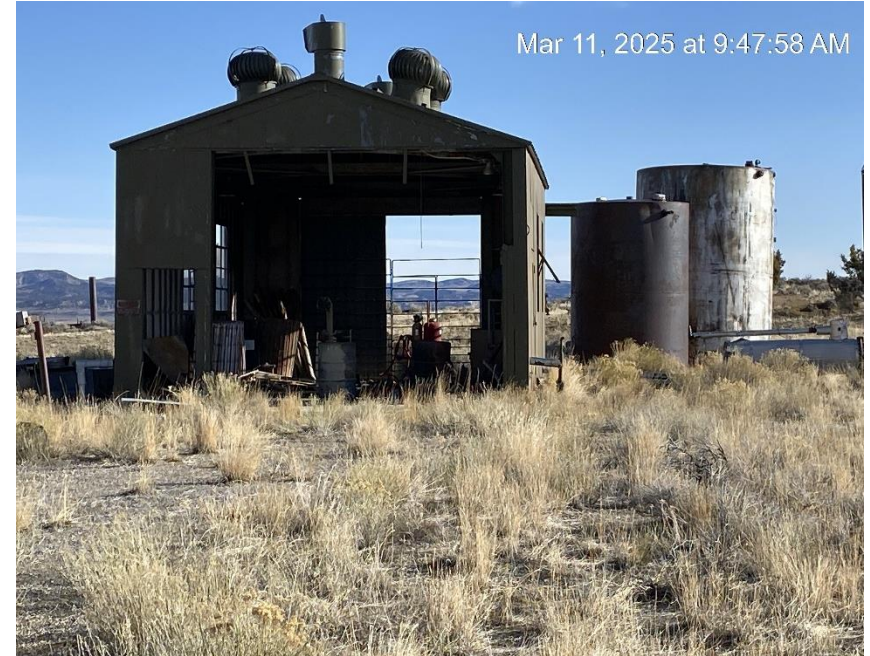
**Unused equipment**

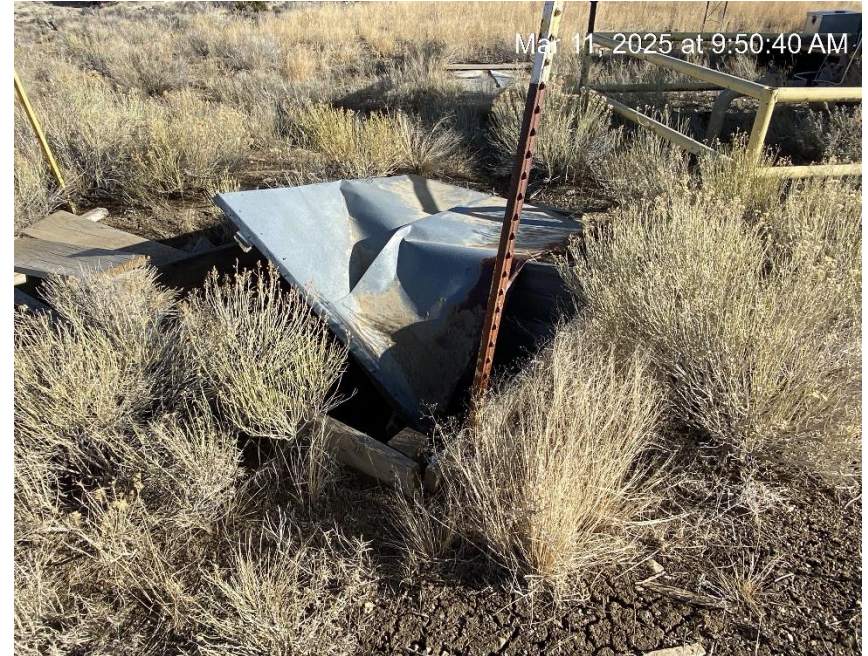
**Open to wildlife and personnel**

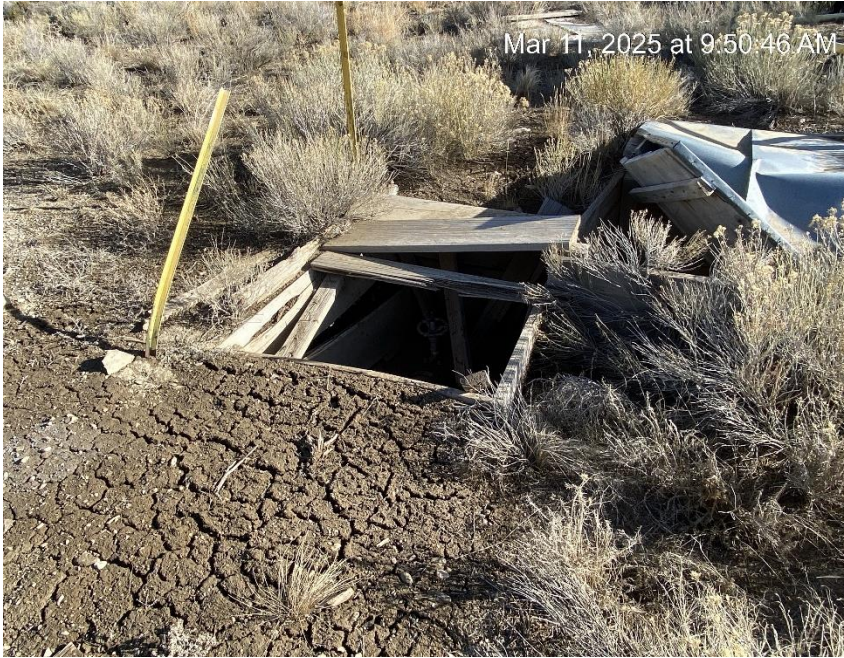
**Open to wildlife and personnel**

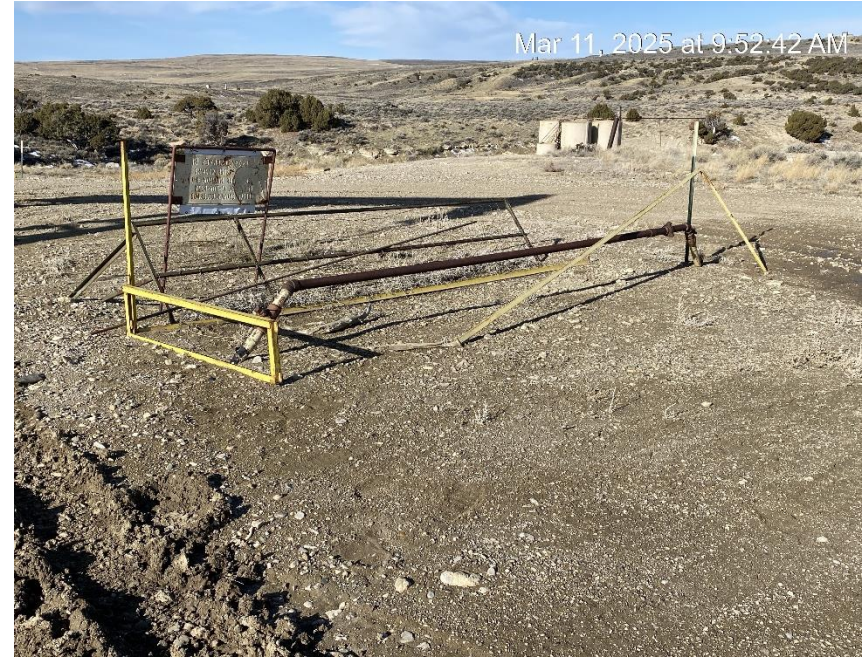
**Debris. Unprotected flowline.**

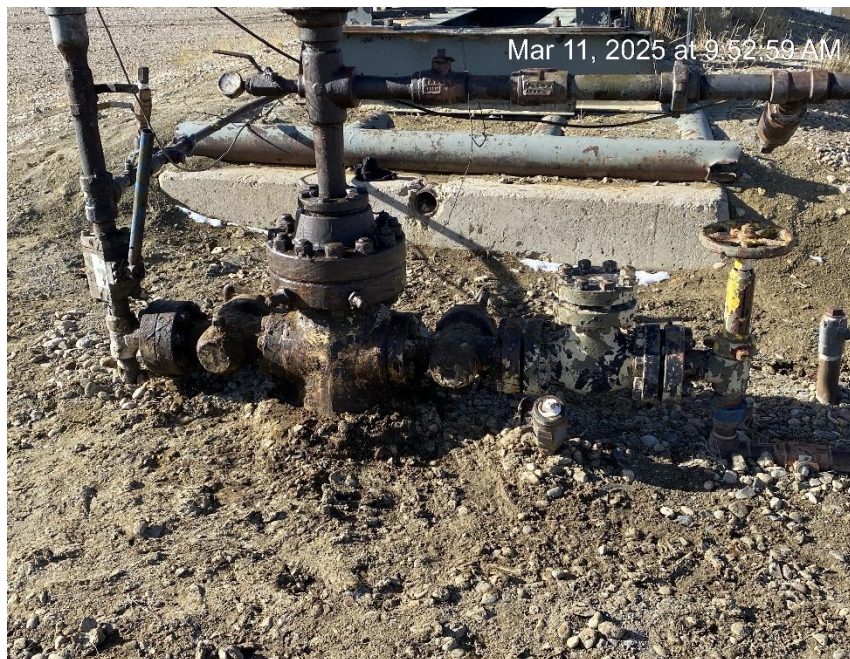
**Oily waste**

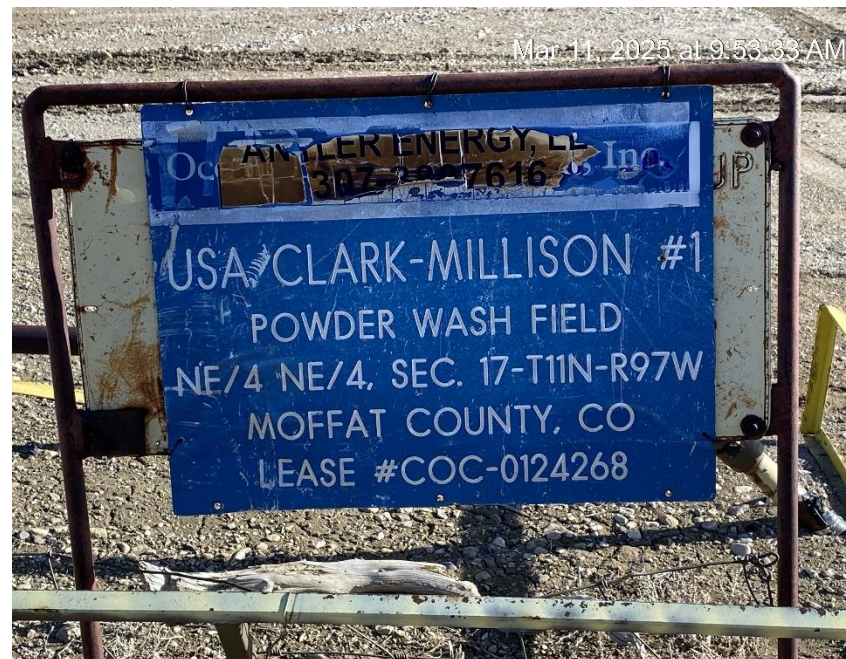
**Missing information**

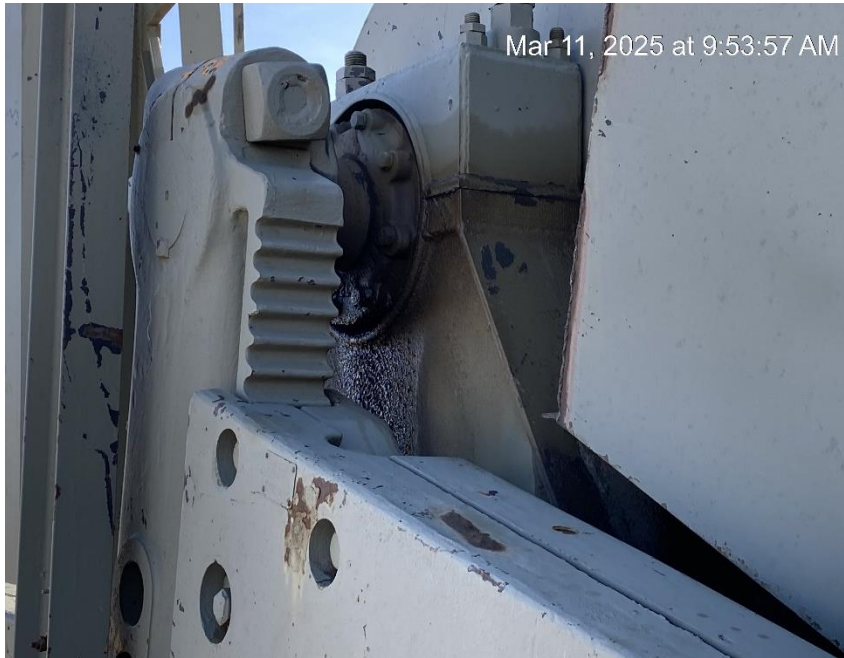
**Leaking equipment**

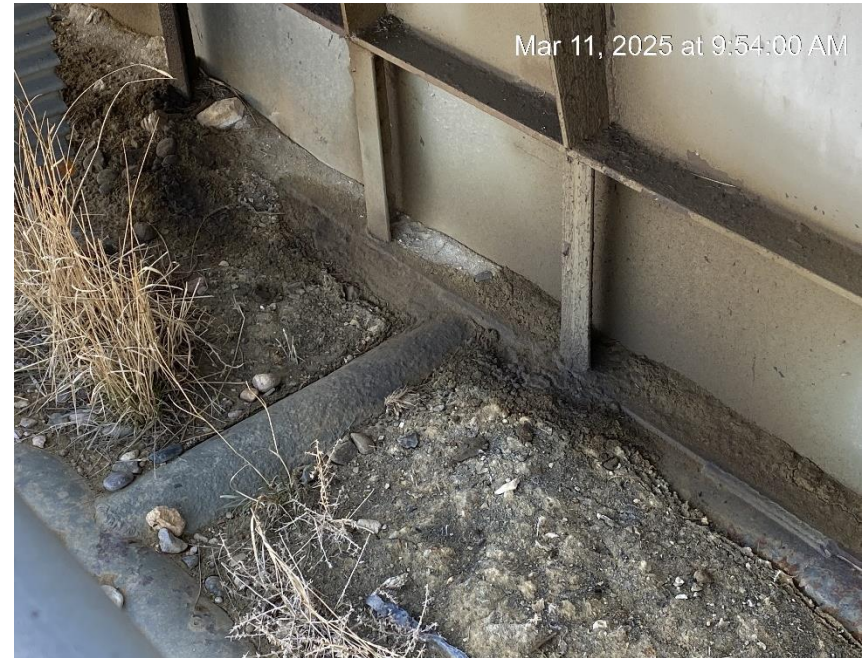
**Staining**

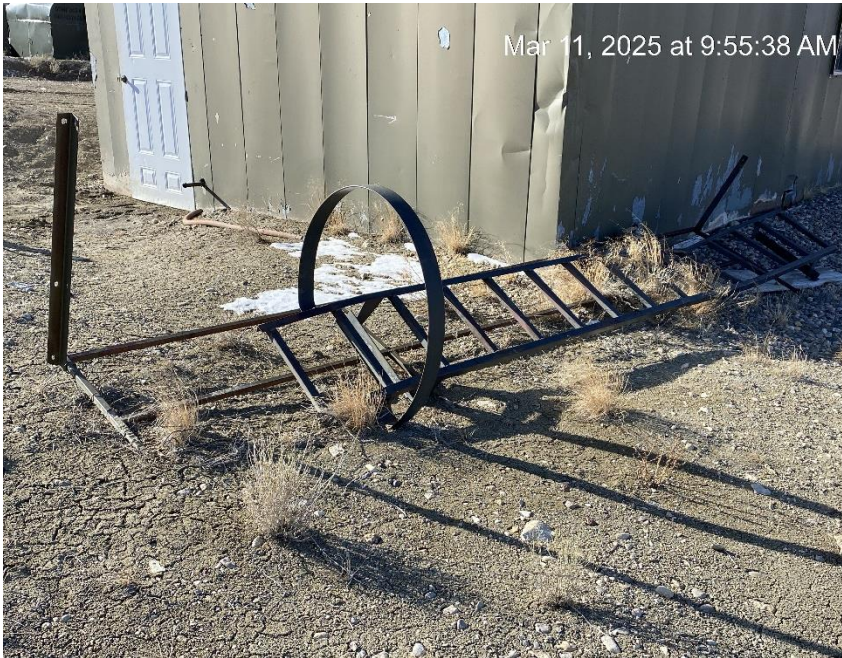
**Debris**

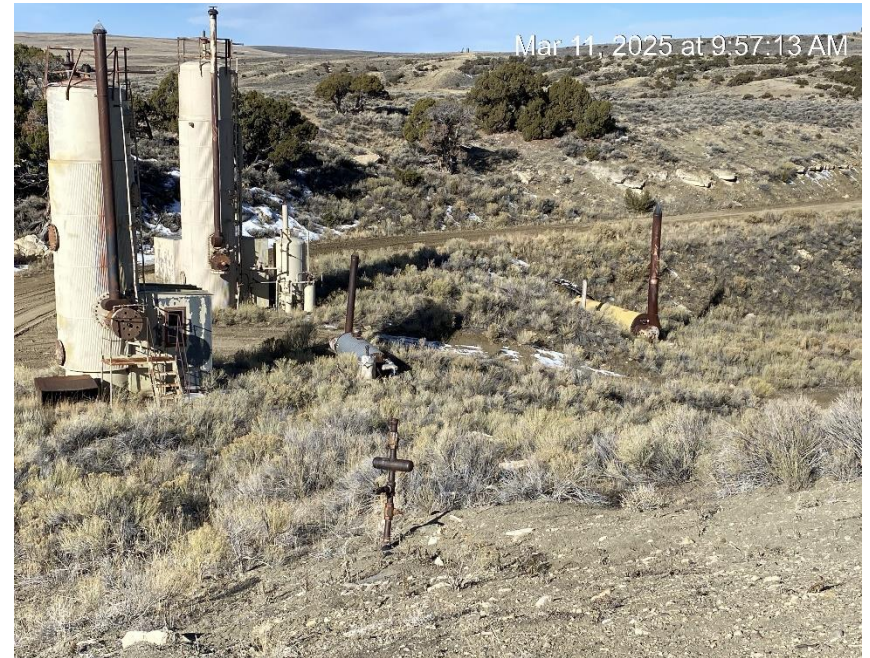
**Unused equipment**

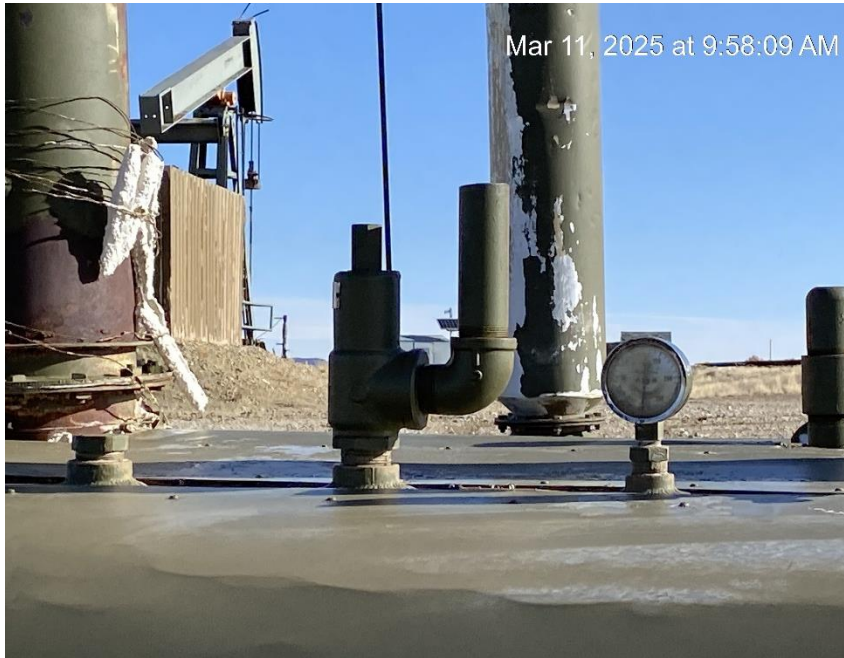
**Unprotected relief riser**

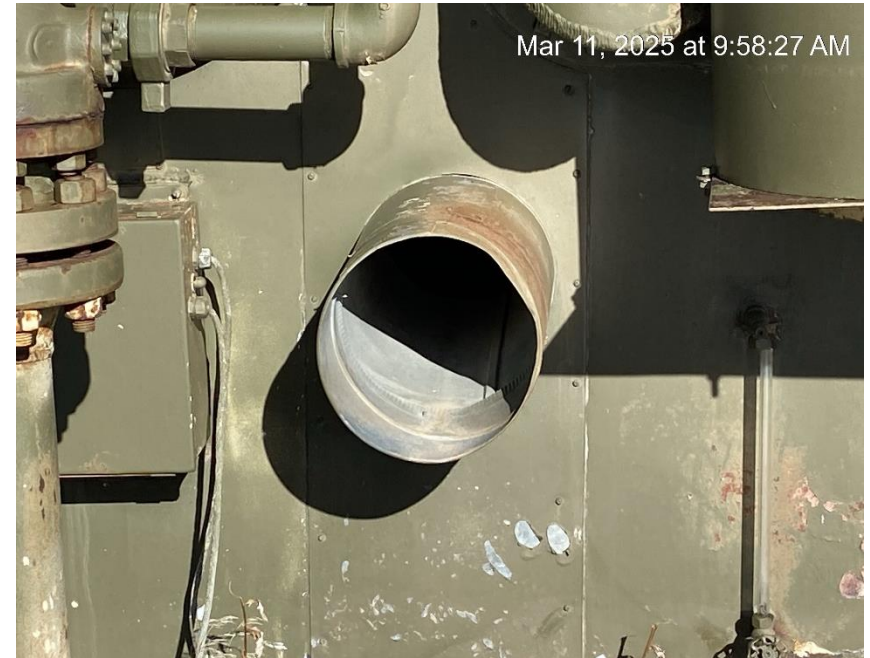
**Open to wildlife**

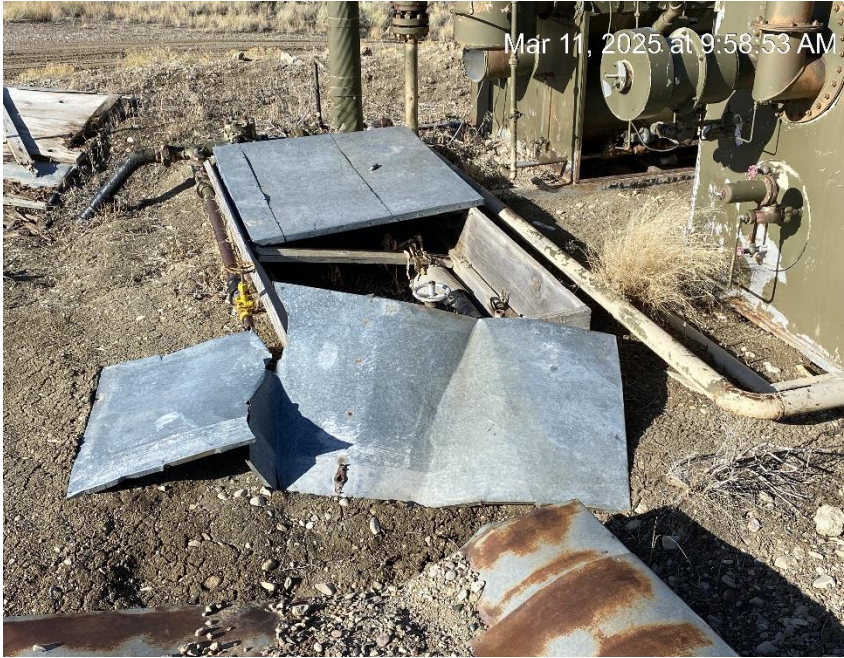
**Open to wildlife and personnel**

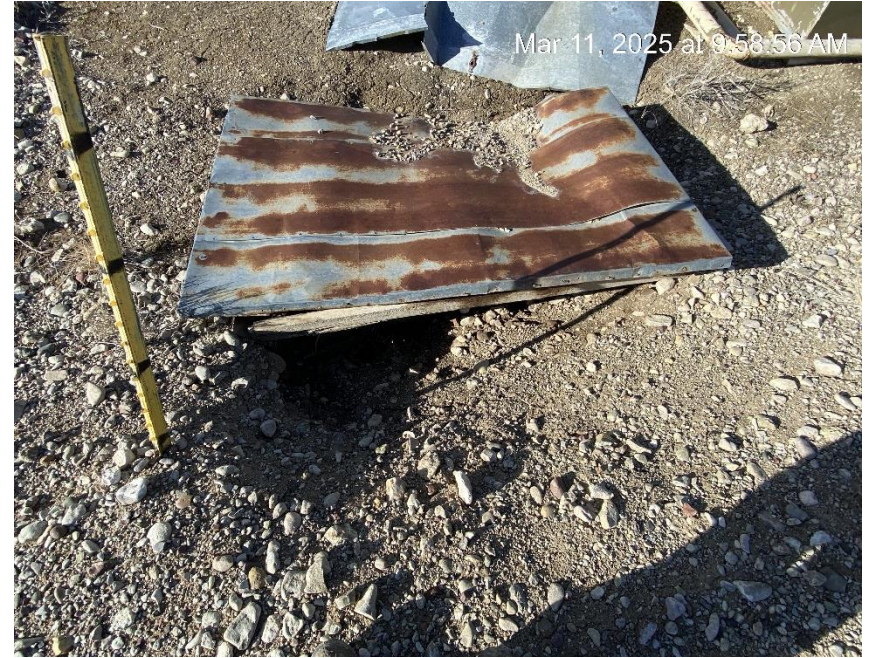
**Open to wildlife and personnel**

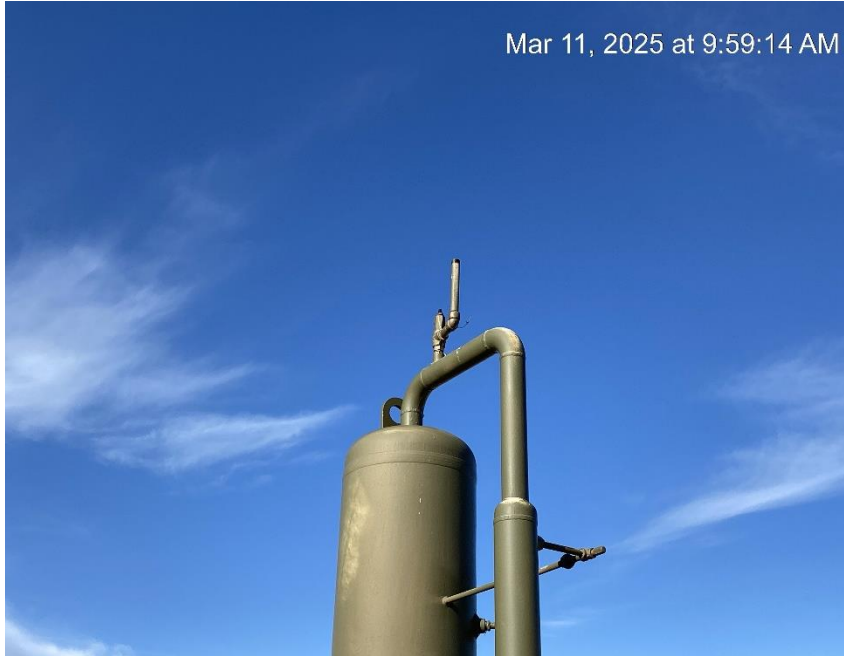
**Unprotected vent riser**

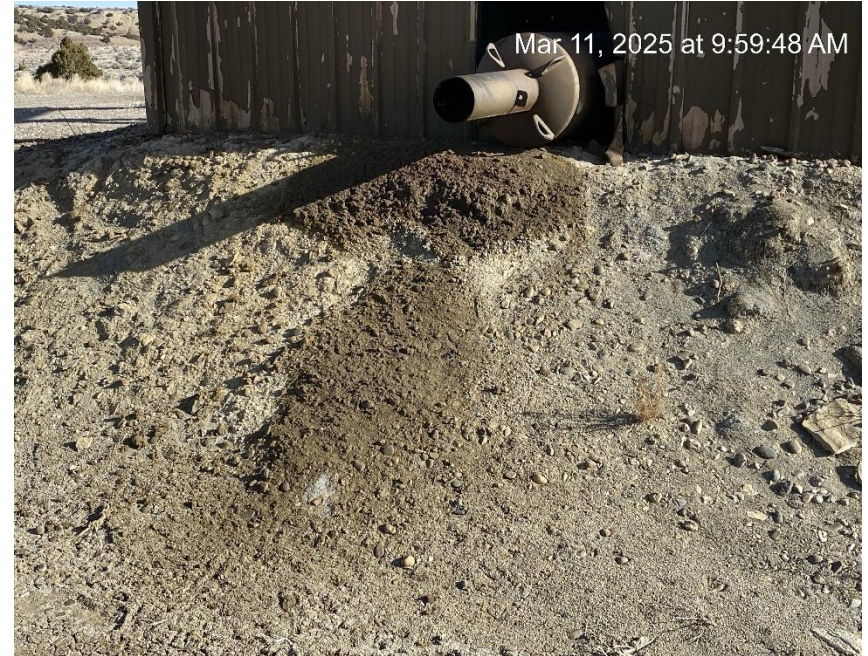
**Oily waste. Open to wildlife.**

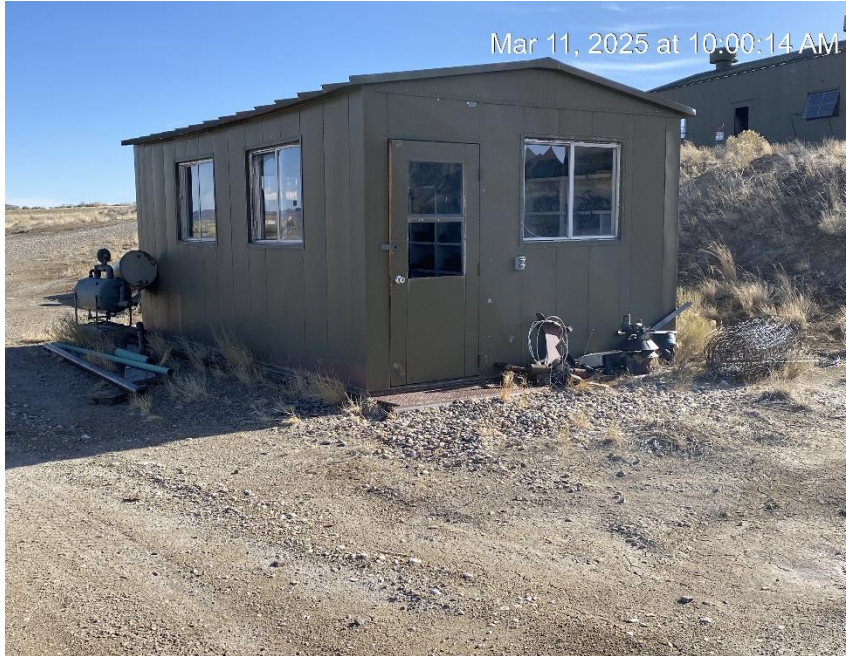
**Debris storage**

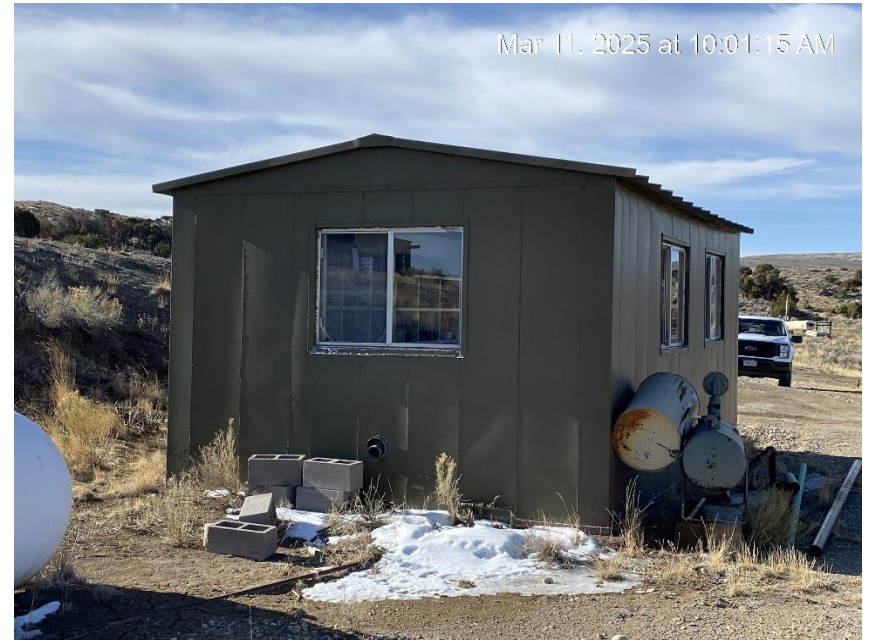
**Debris storage**

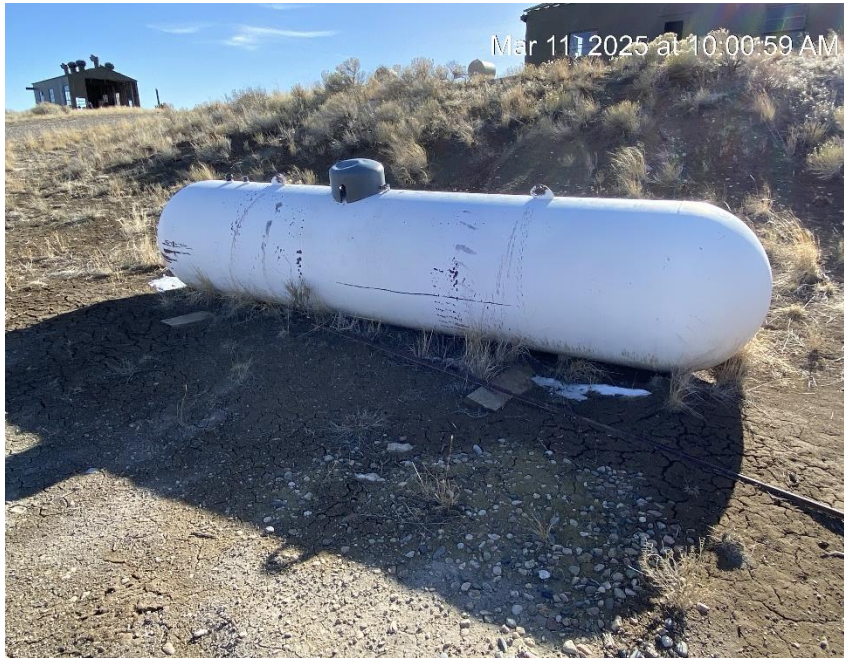
**Unused and unlabeled equipment**

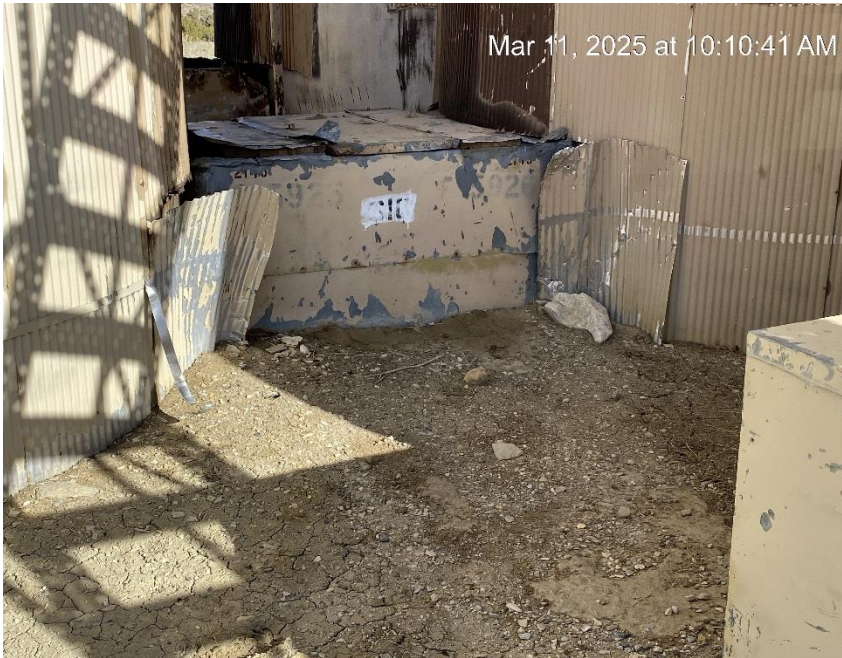
**Oily waste and staining**

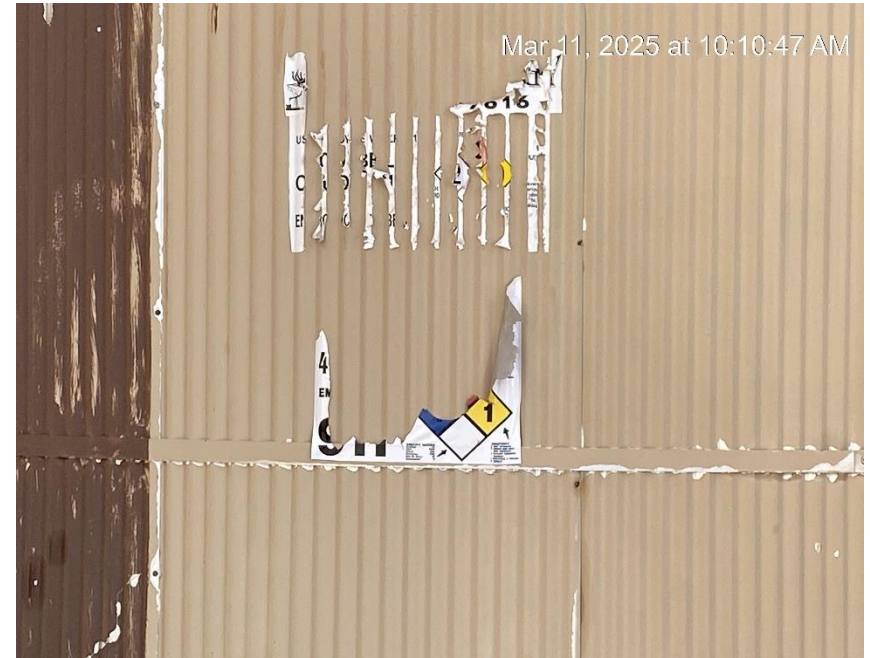
**Unlabeled tank**

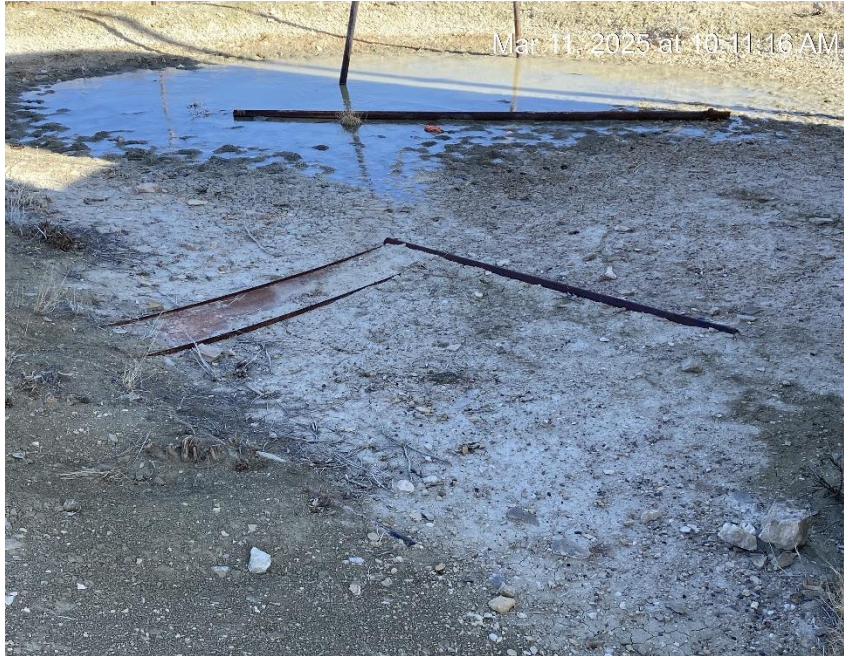
**Debris**

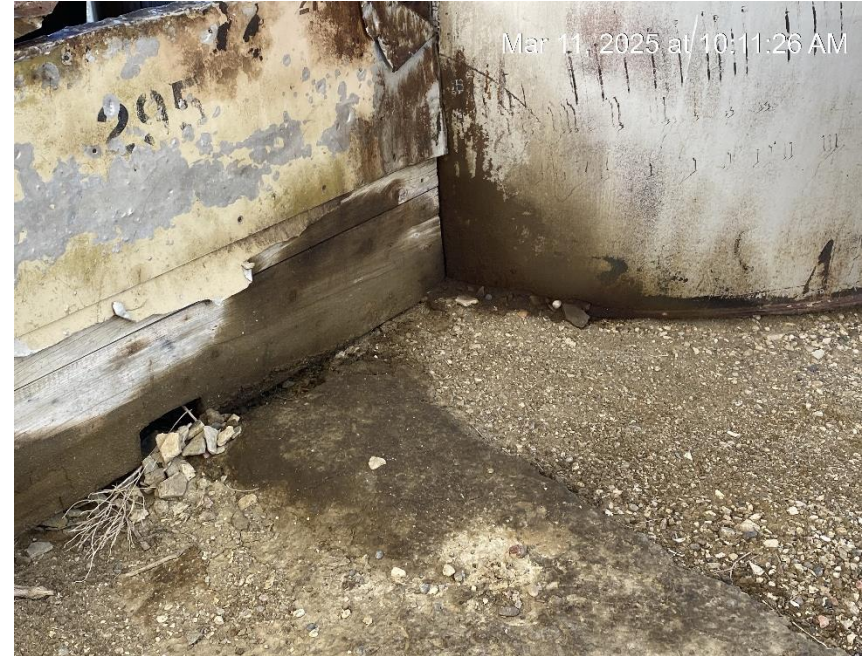
**Oily waste and staining**

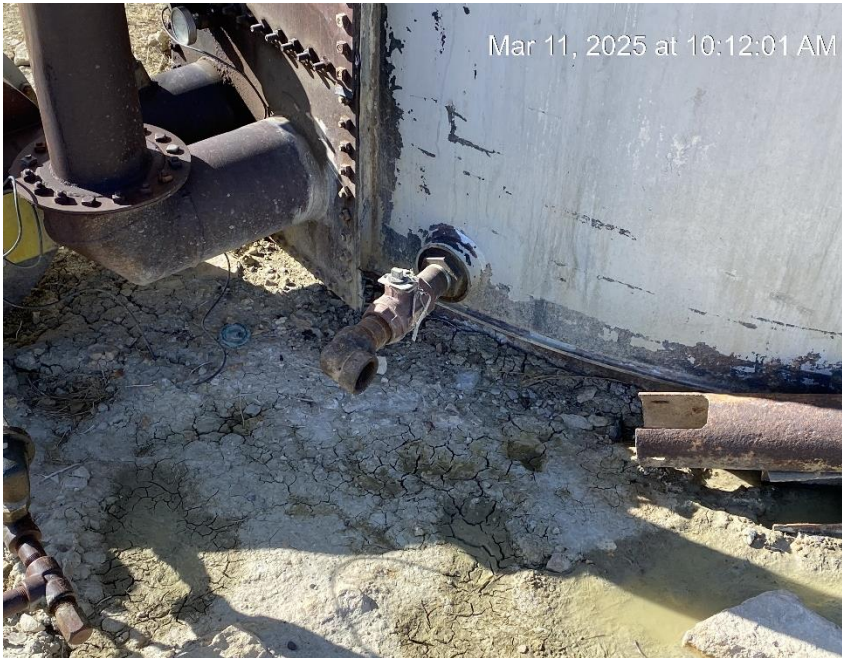
**Open end tank valve**

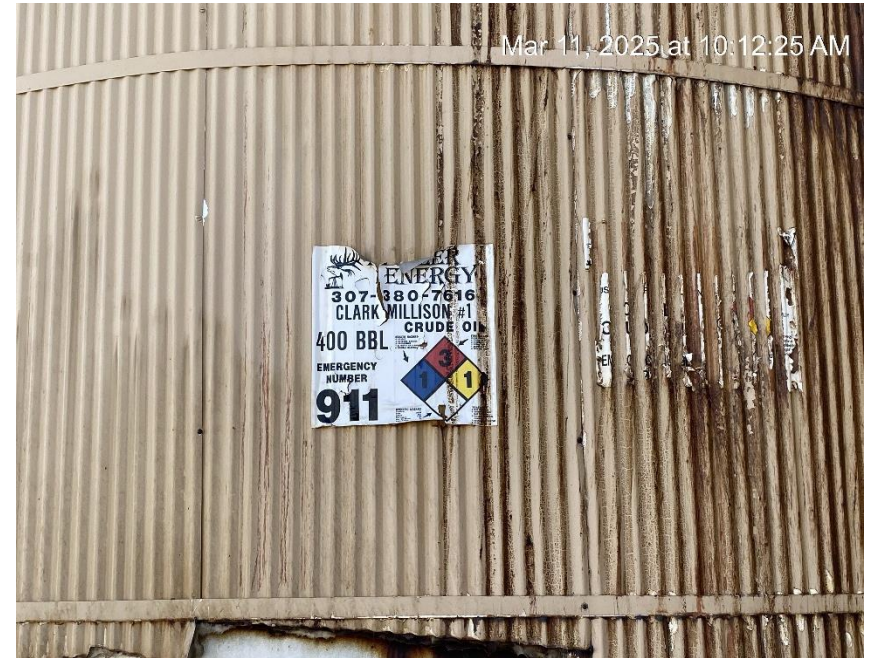
**Damaged label**

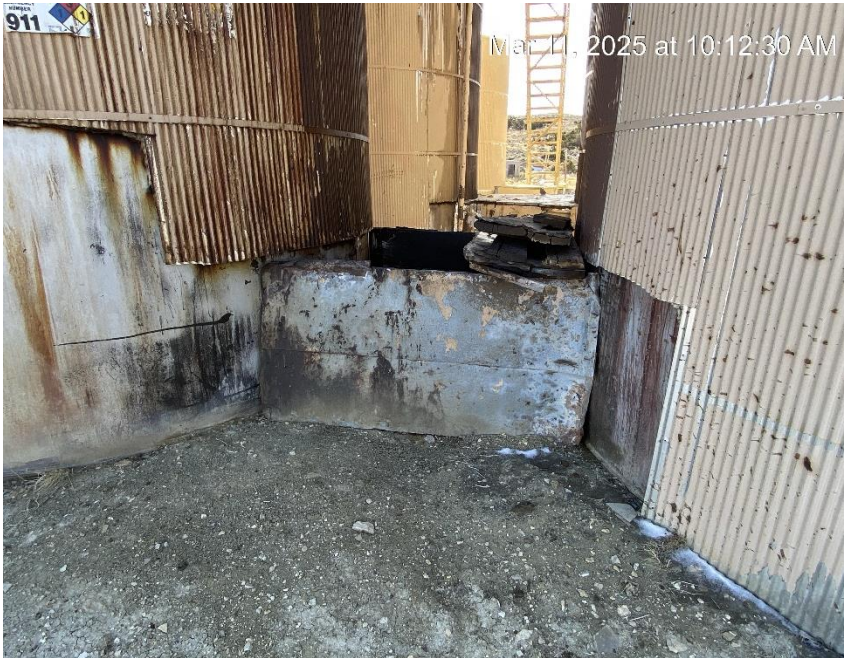
**Oily waste and staining**

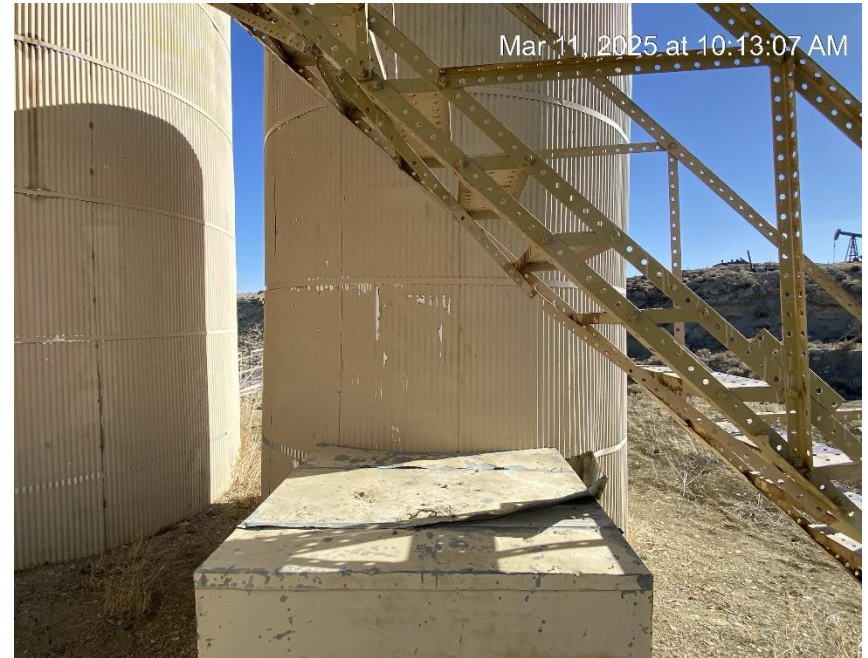
**Unlabeled tank**

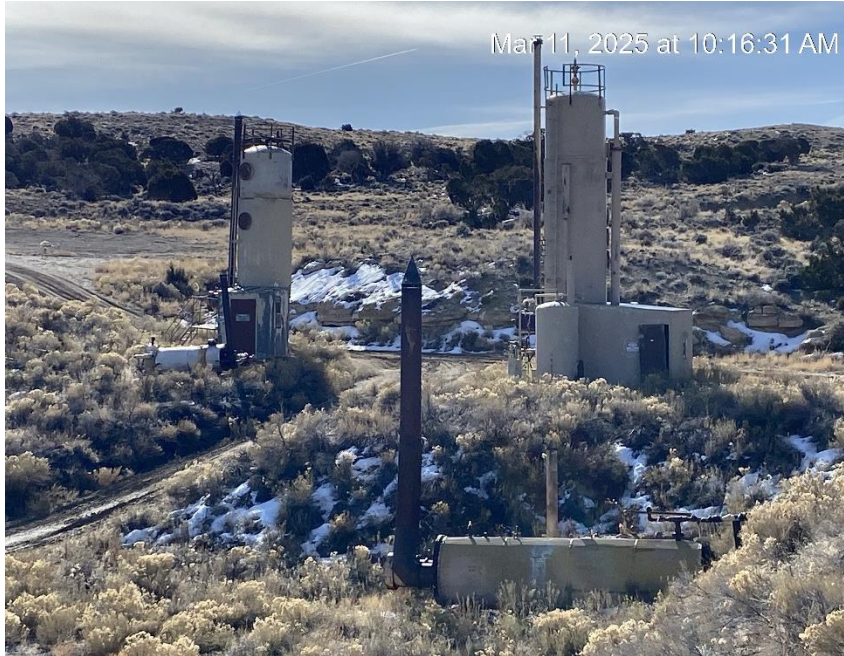
**Unused equipment**

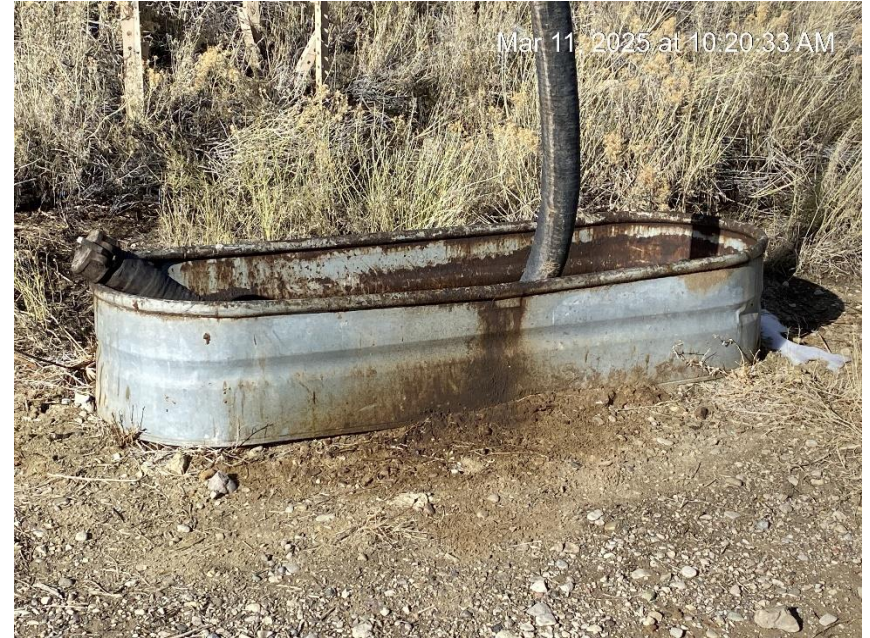
**Oily waste. Open to wildlife.**

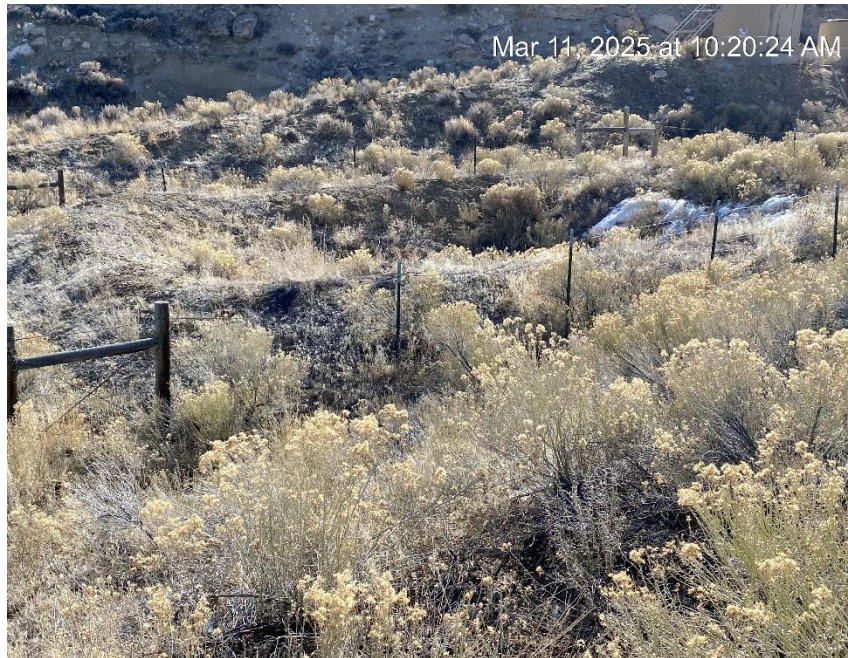
**Open pit**
