**Antler Energy LLC  
USA-Clark – Millison 1  
Location ID: 313122**

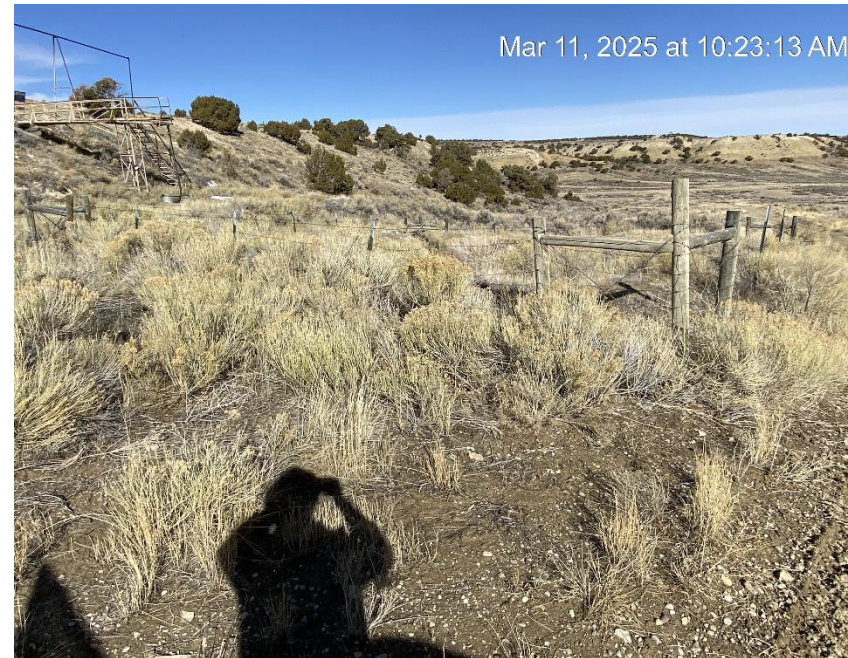
**Open pit**

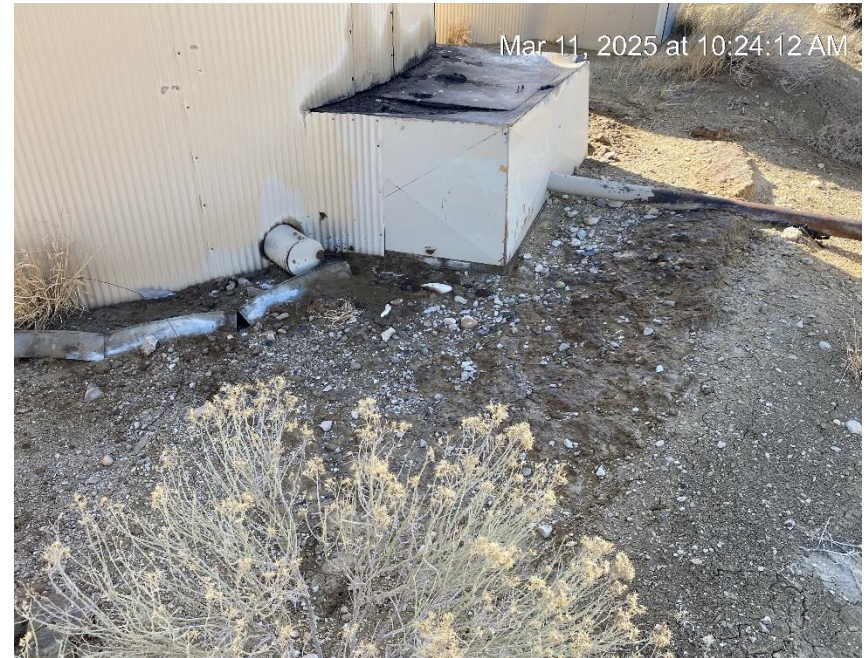
**Oily waste. Staining.**
