**Antler Energy LLC
Ptasynski 1X
Location ID: 313300**

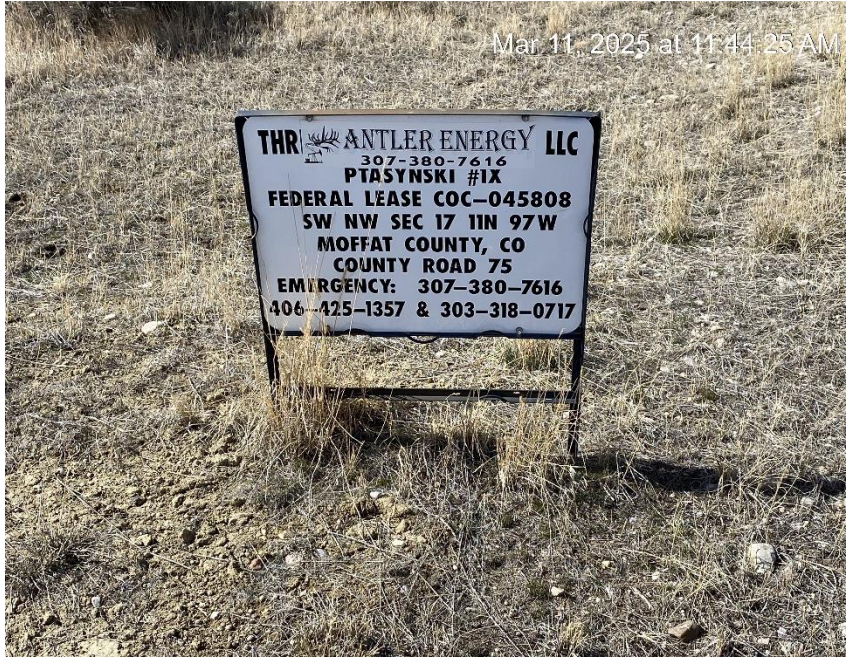
Information missing

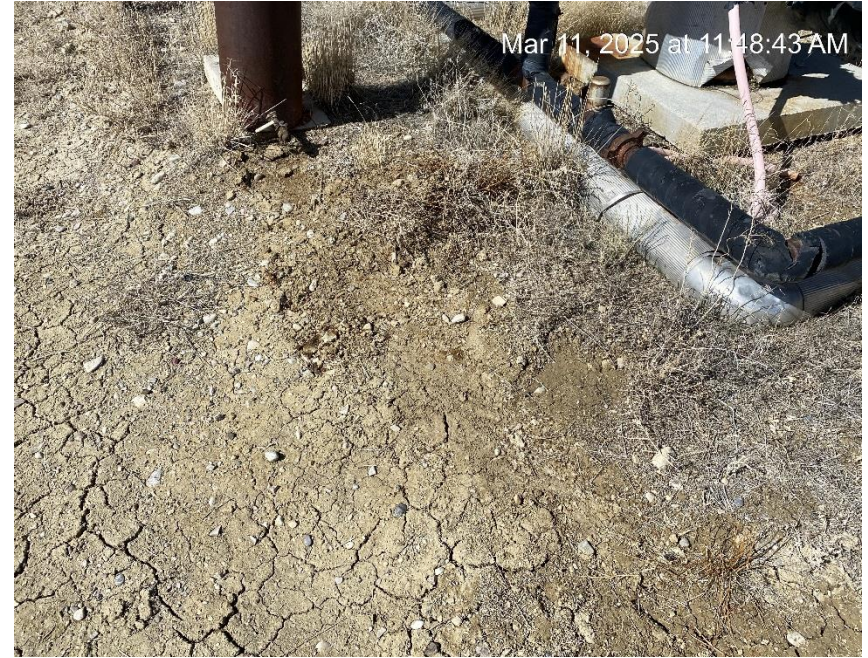
Oily waste and contaminated soil.

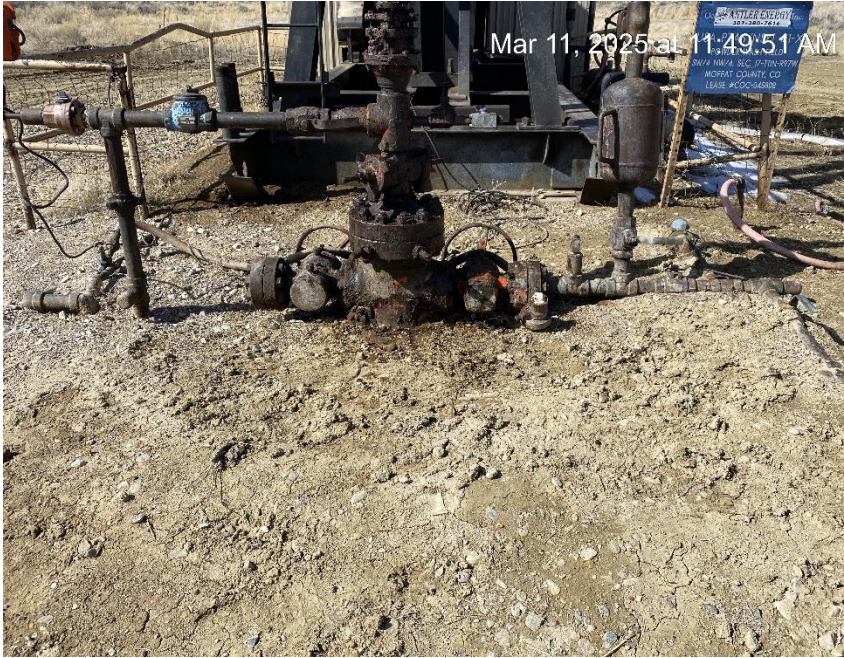
Oily waste and stained soil.

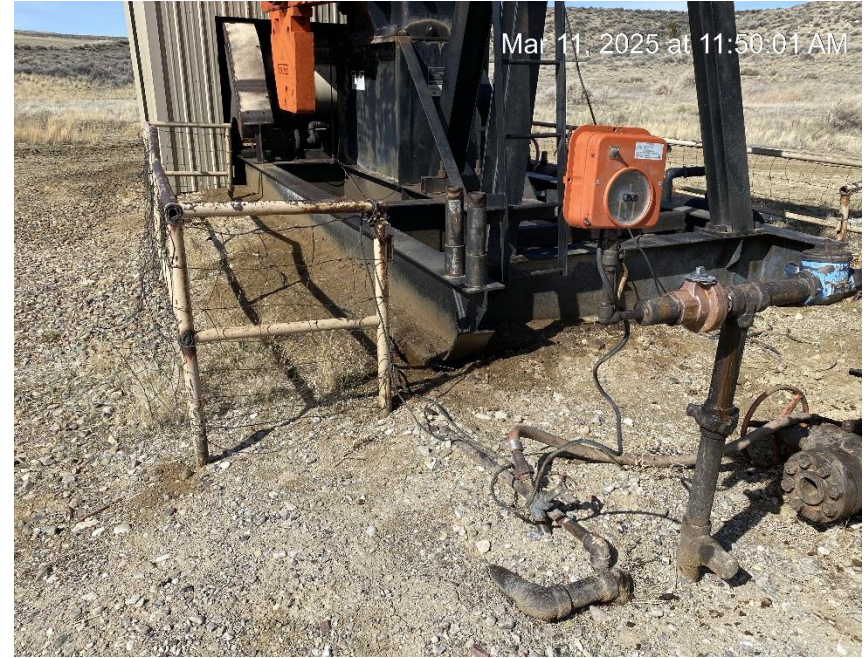
Oily waste and stained soil.

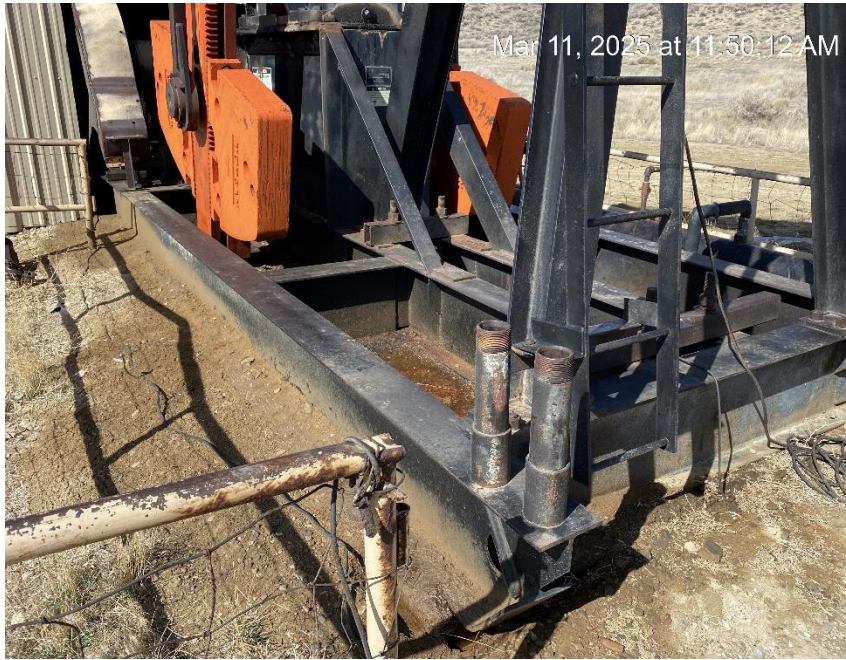
Debris. Oily waste and stained soil.

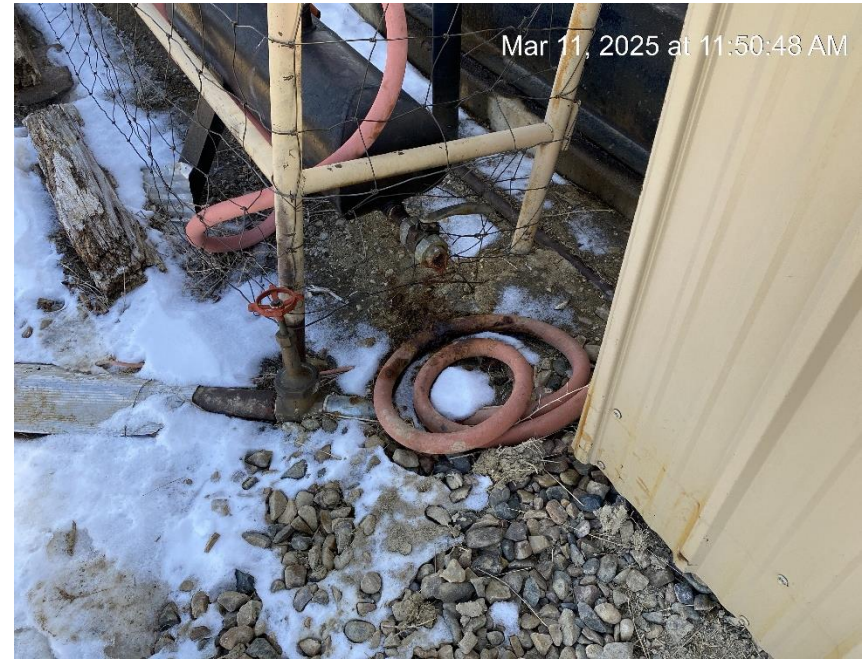
Oily waste

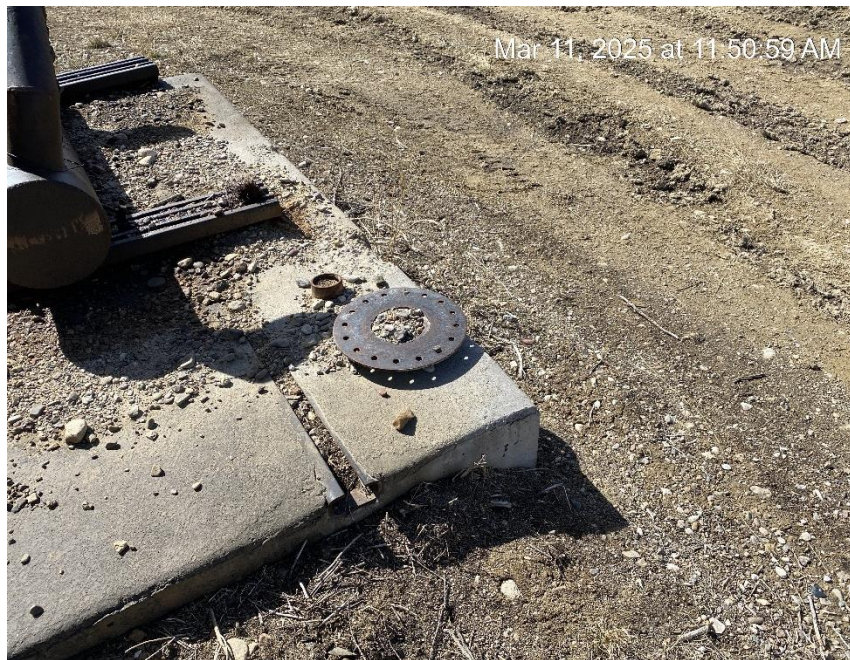
Debris

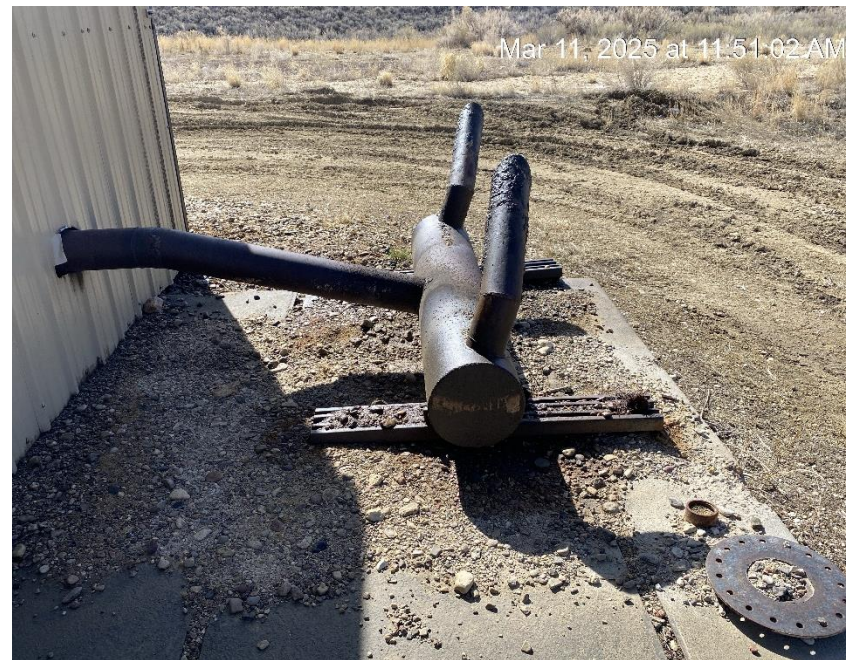
Oily waste and staining

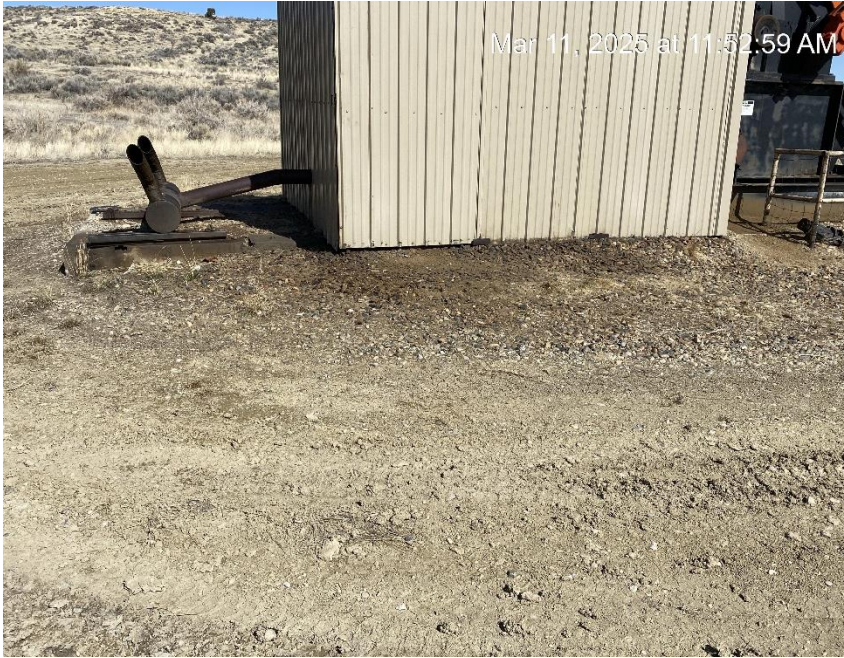
Staining

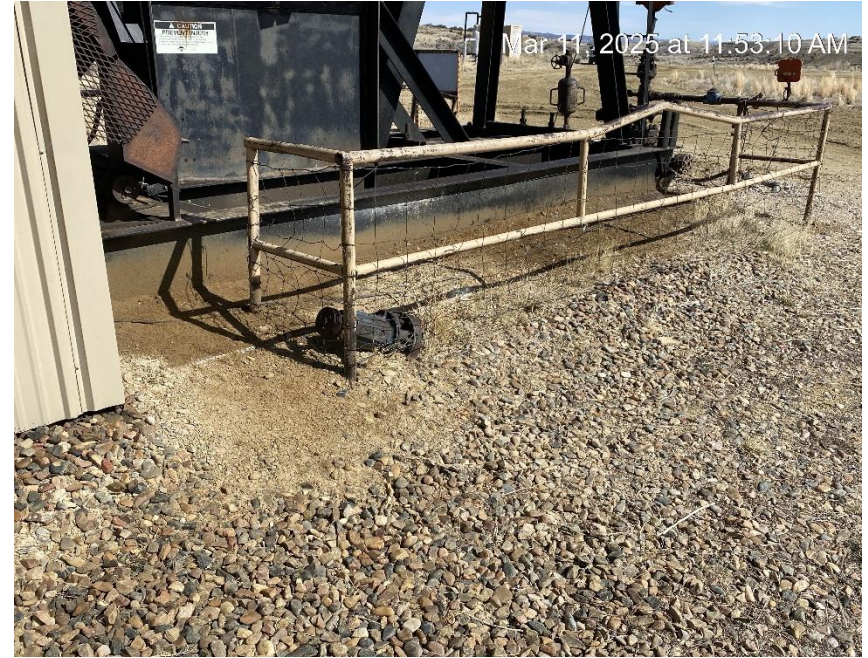
Debris. Stained soil.

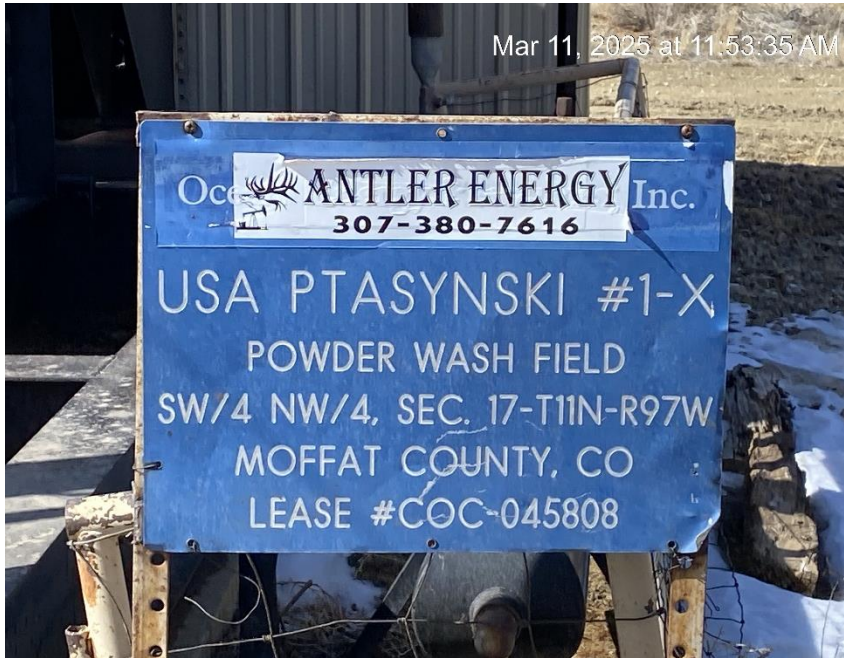
Missing required information

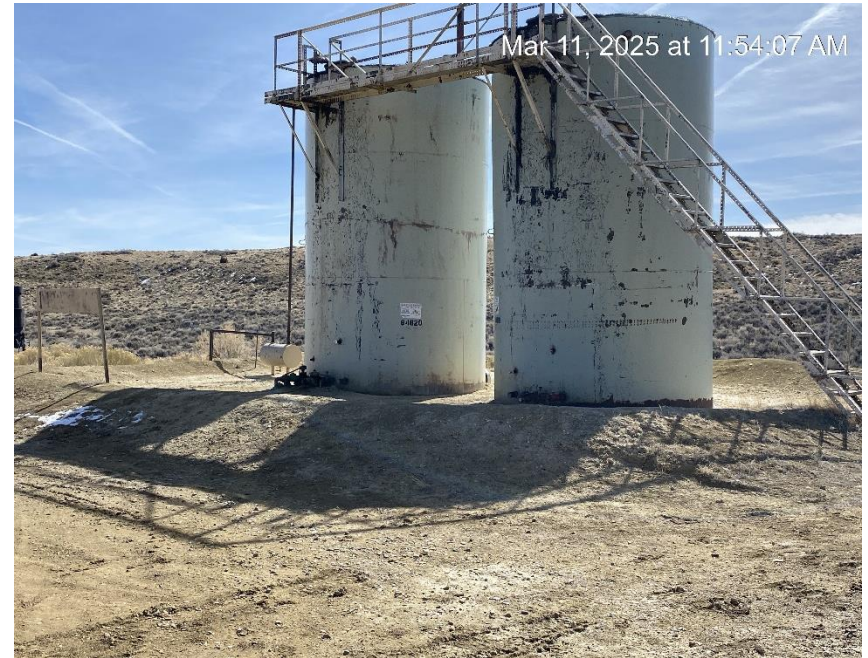
No sign at tank battery

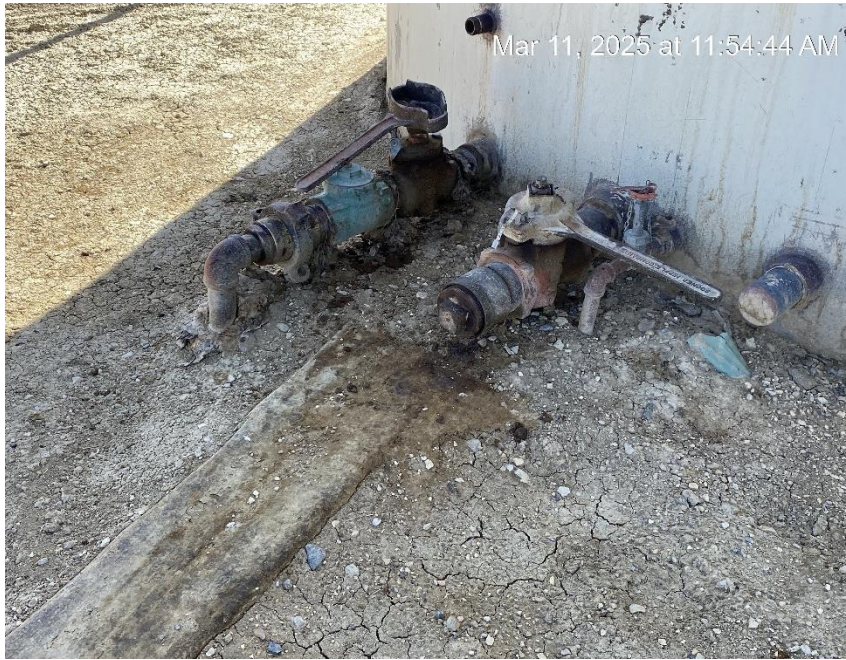
Staining

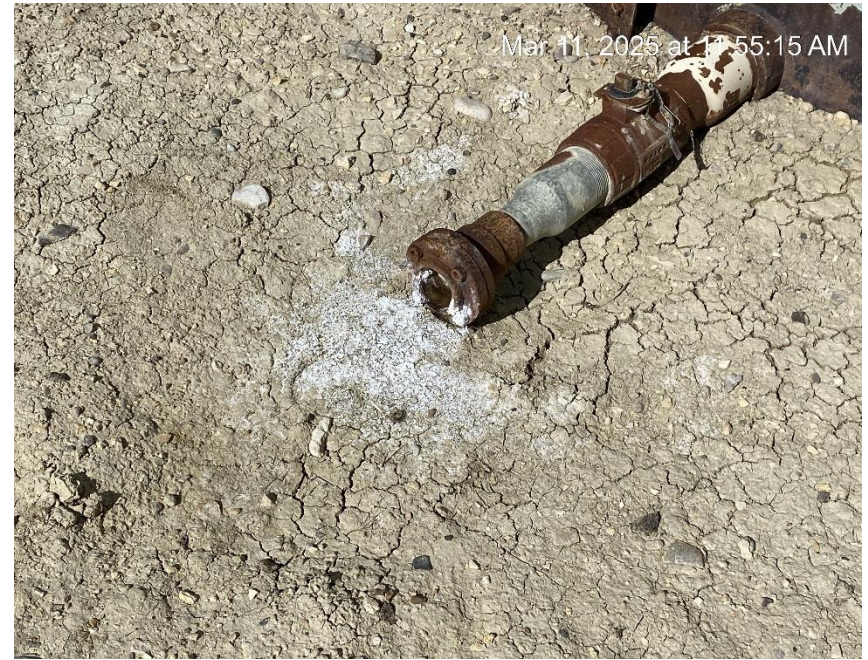
Leaking open end load line

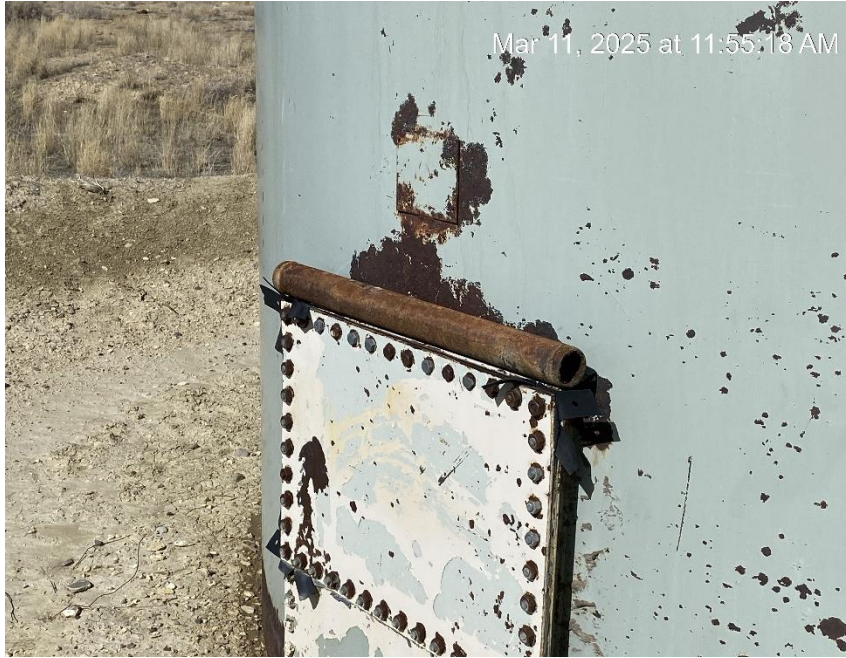
Debris

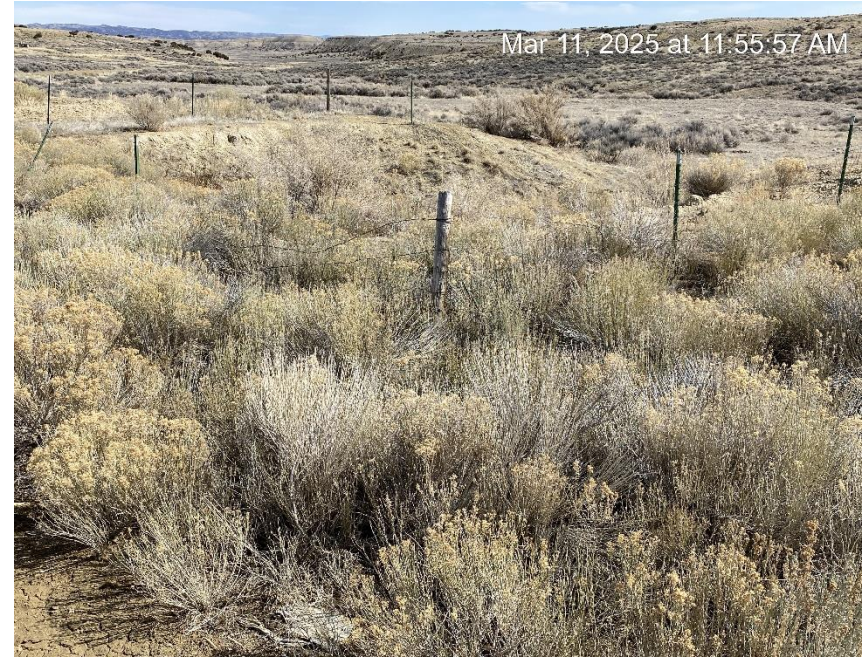
Production pit on location

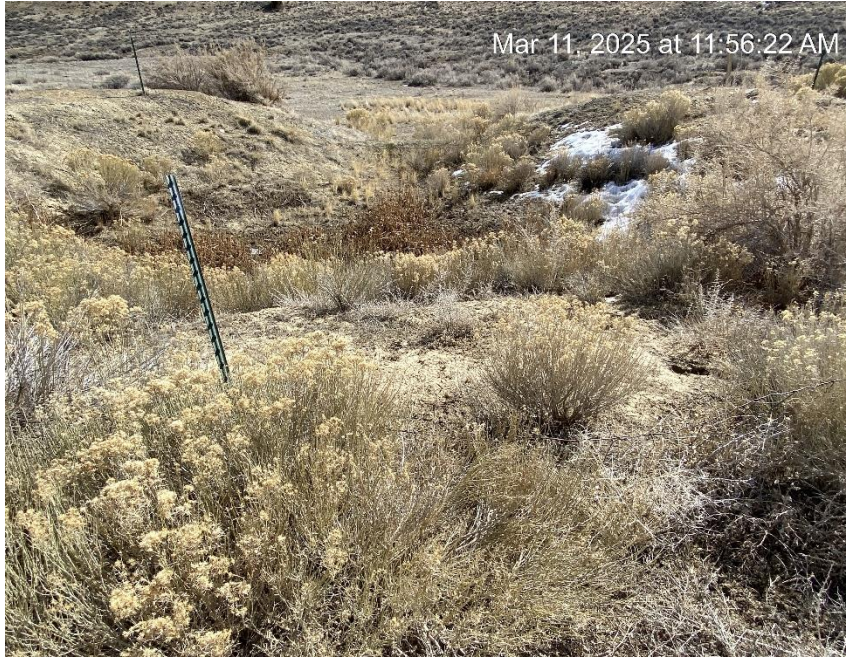
Production pit on location

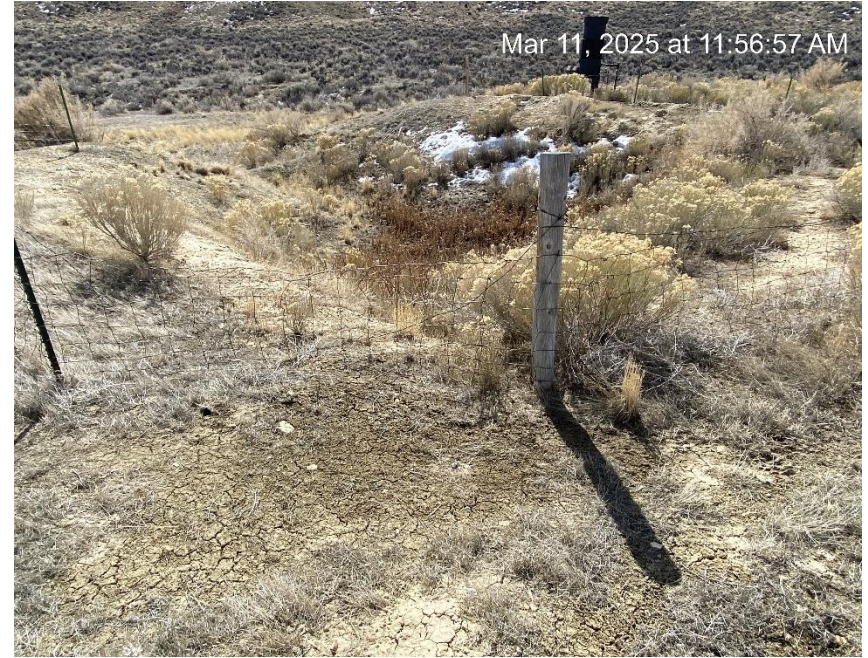
Production pit on location

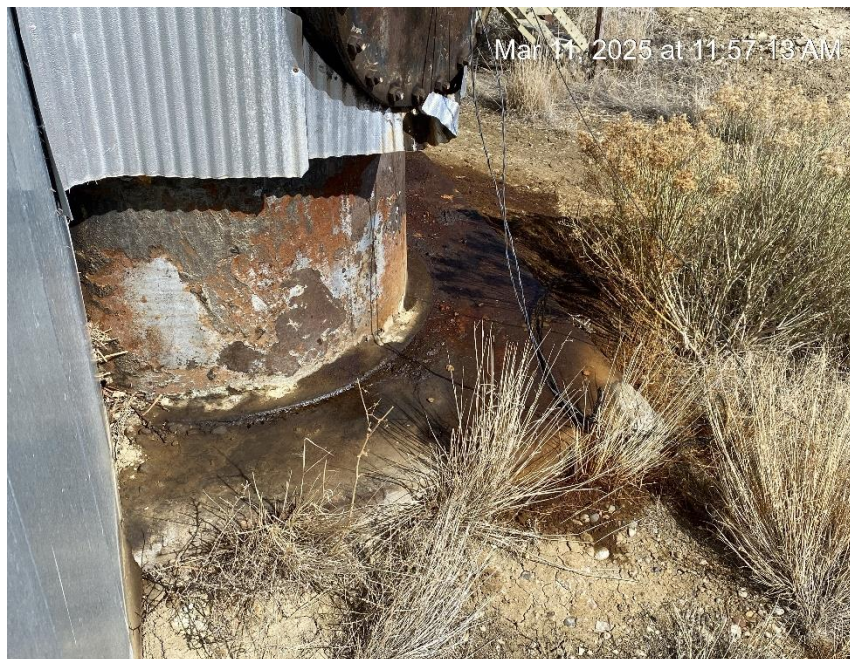
Oily waste and staining

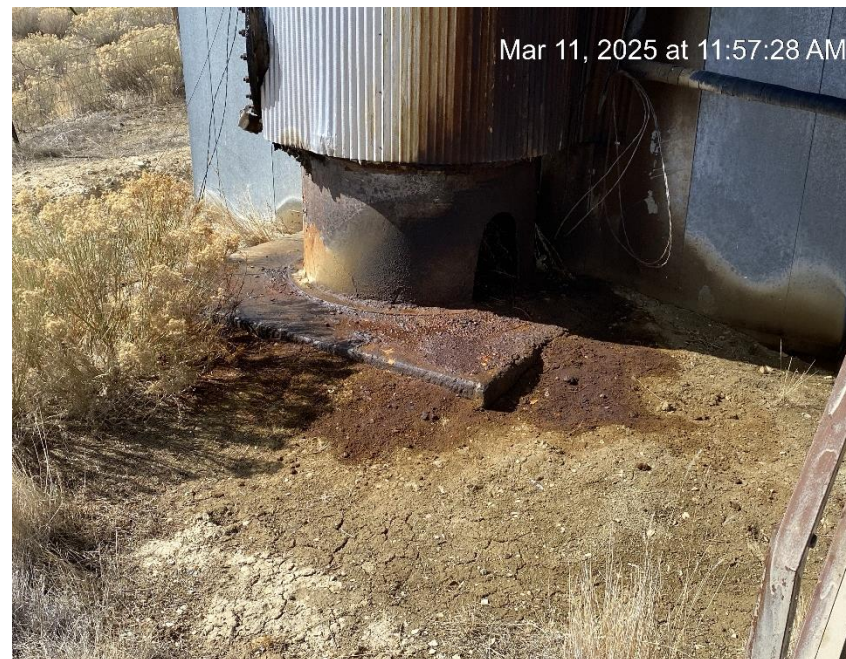
Oily waste and staining

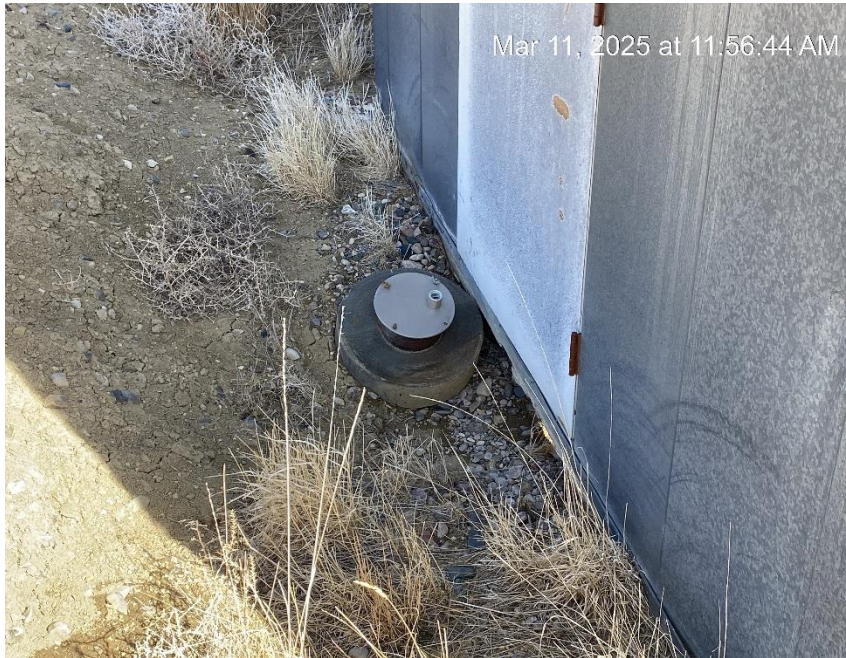
Debris
