**Antler Energy LLC
Klaenhammer 1
Location ID: 312861**

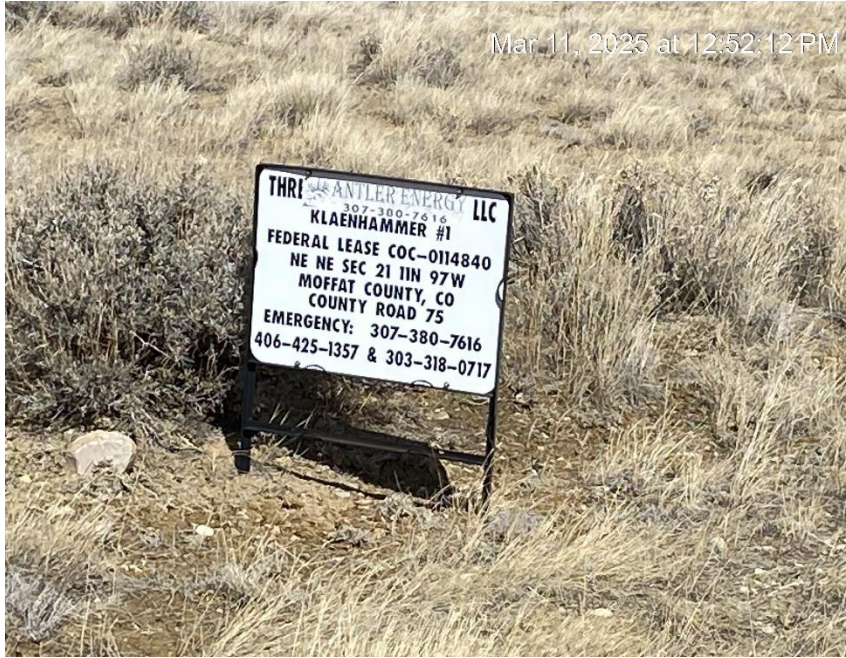
Information missing

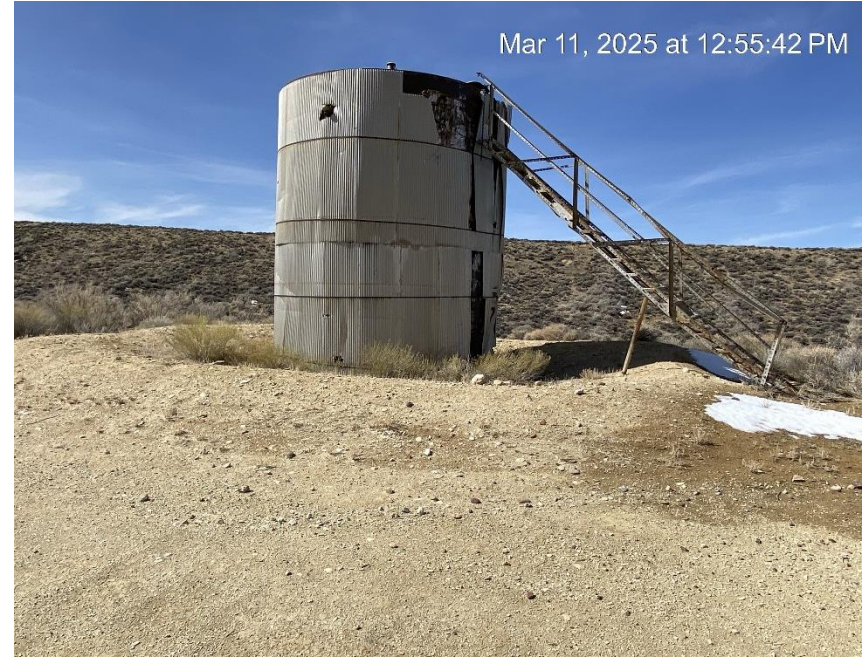
No sign at tank battery

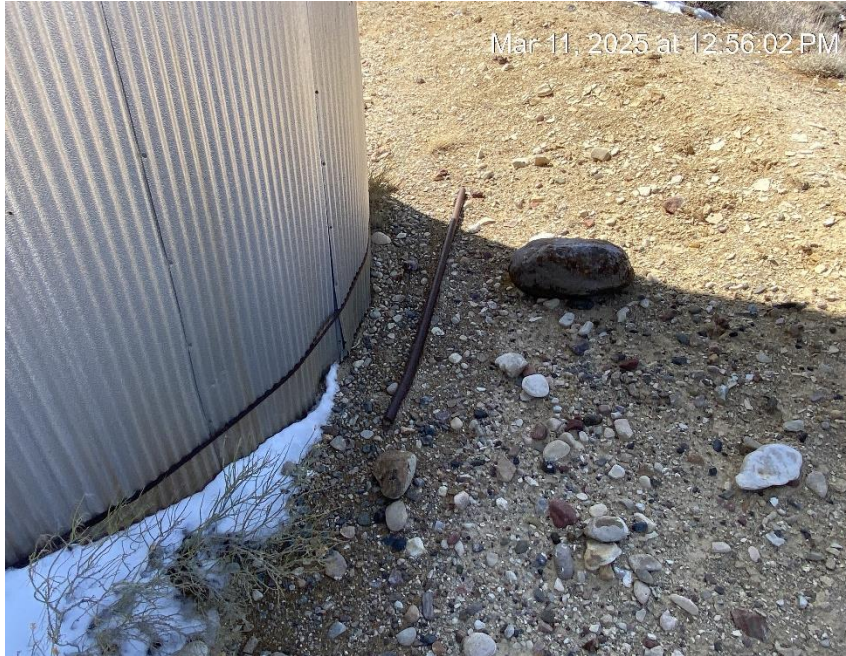
Debris

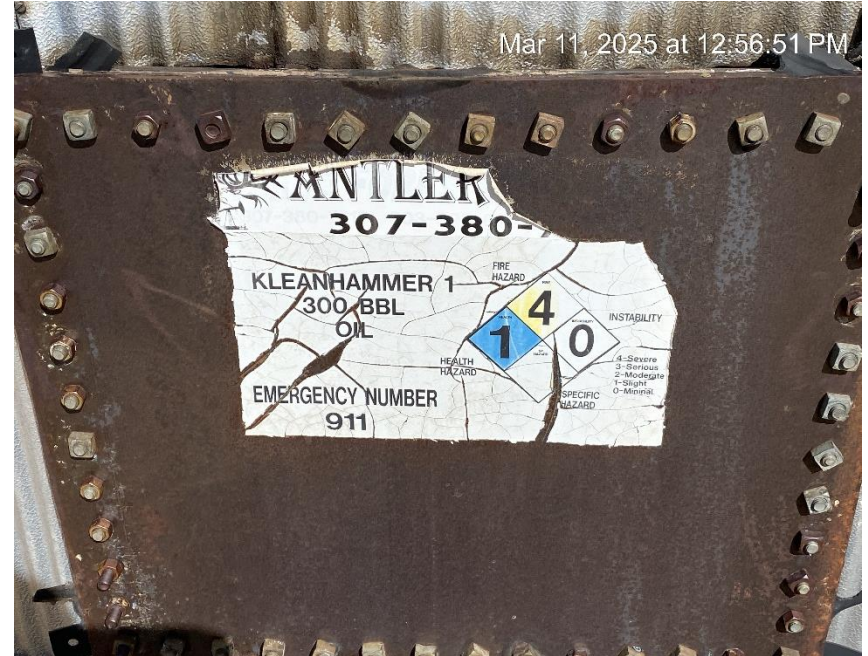
Damaged label

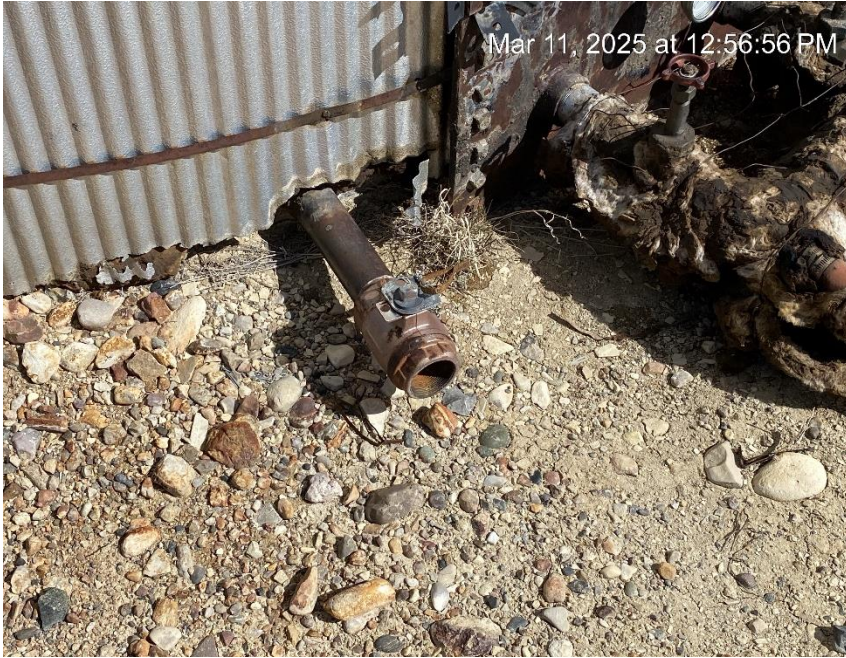
Open end tank valve

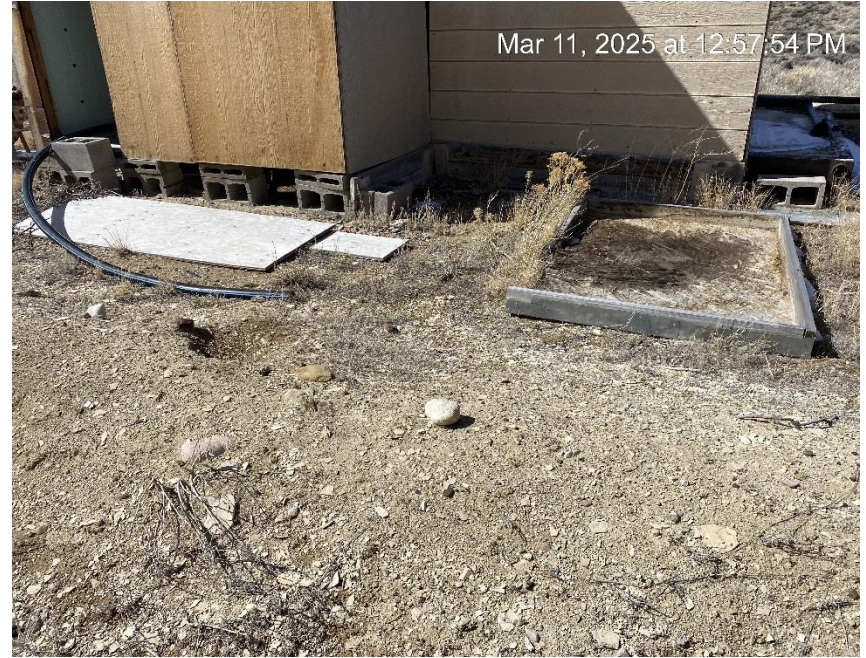
Debris

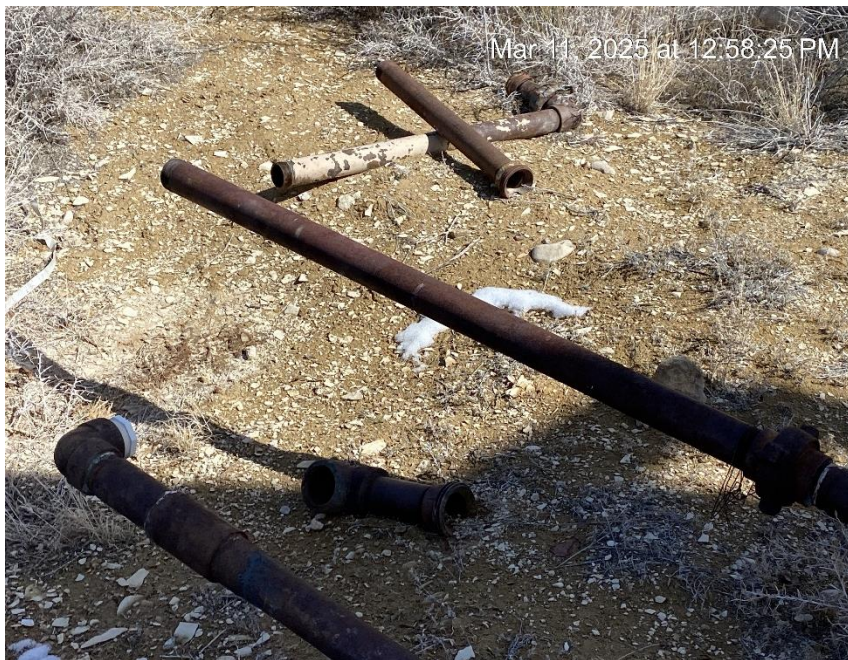
Debris

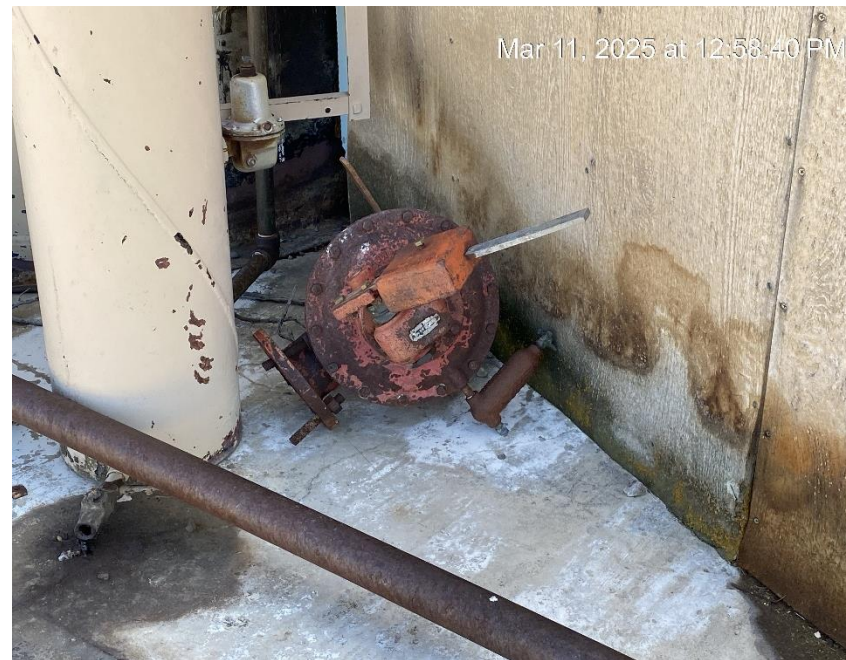
Debris

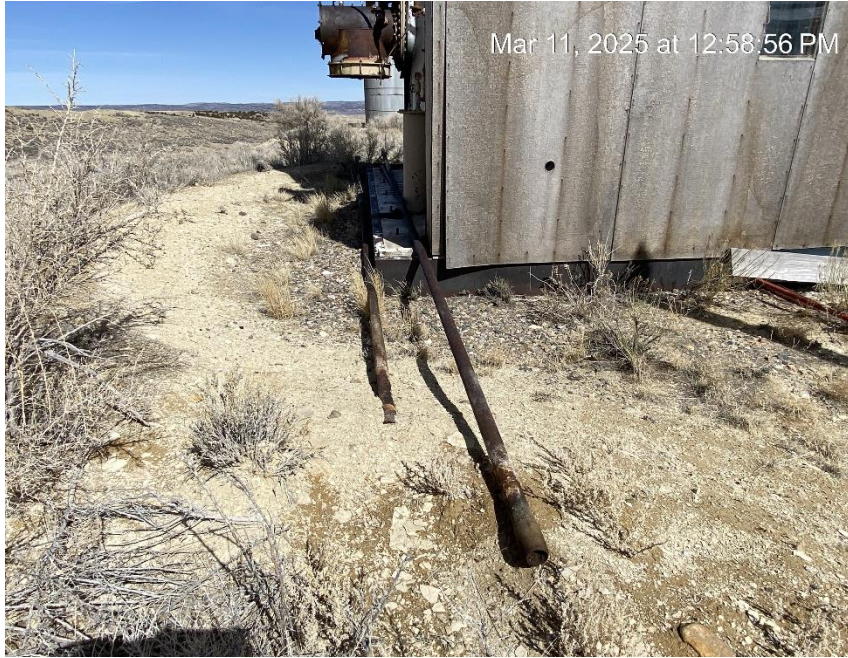
Debris

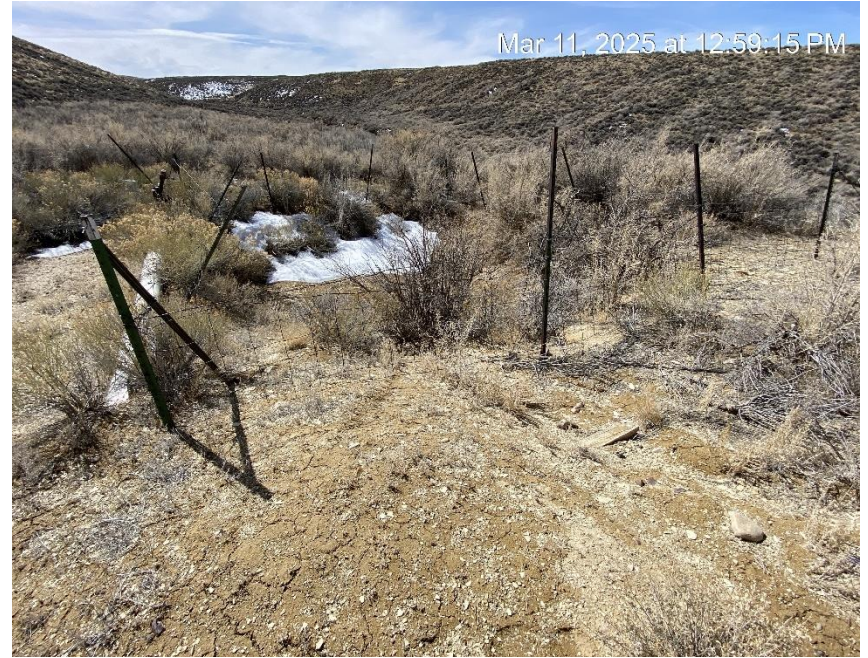
Unregistered pit?

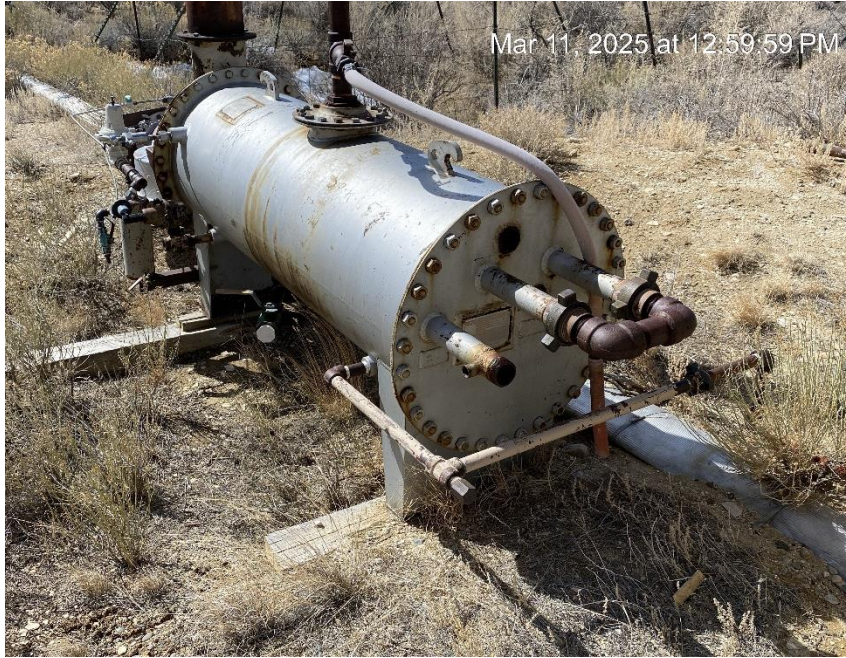
Unused equipment

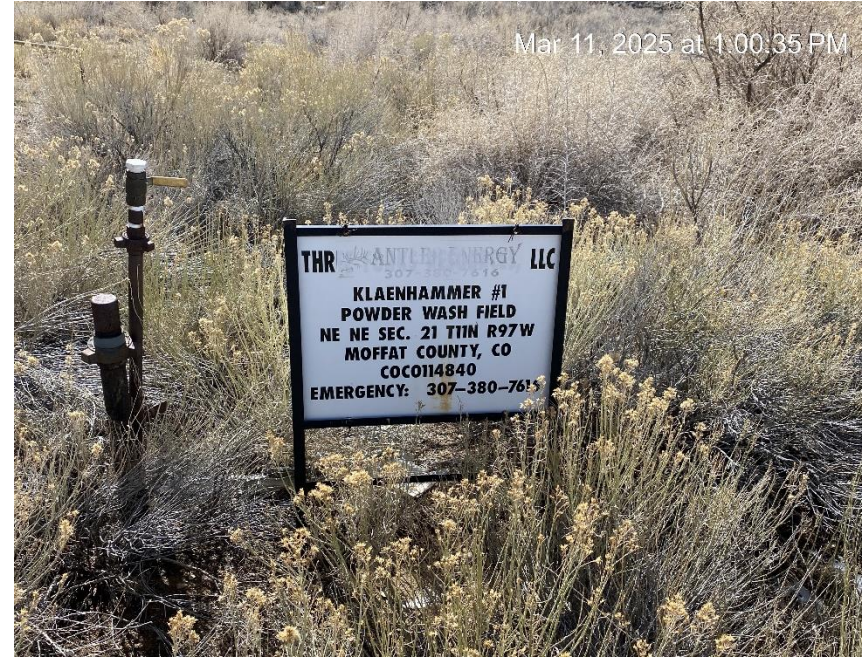
Required information missing

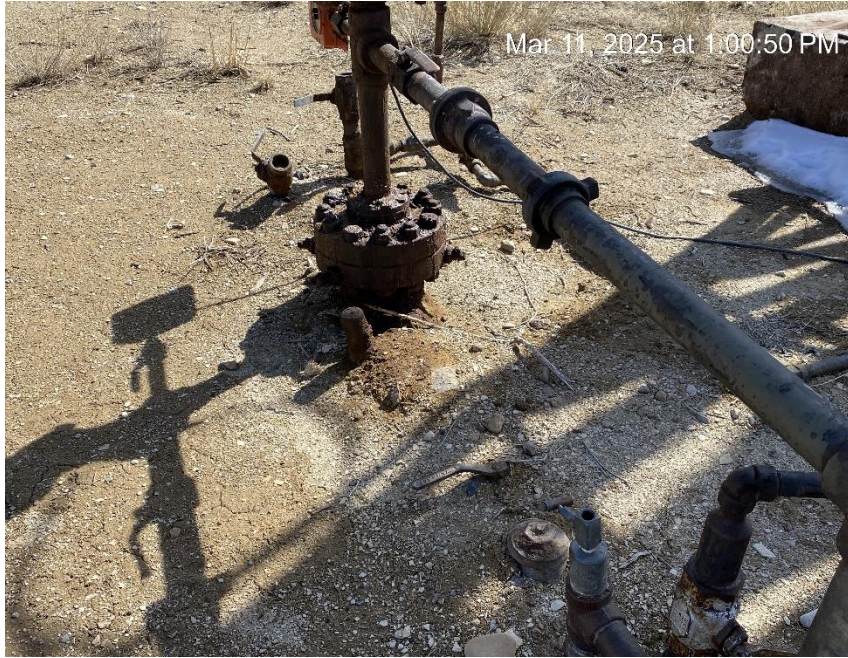
Oily waste and stained soil

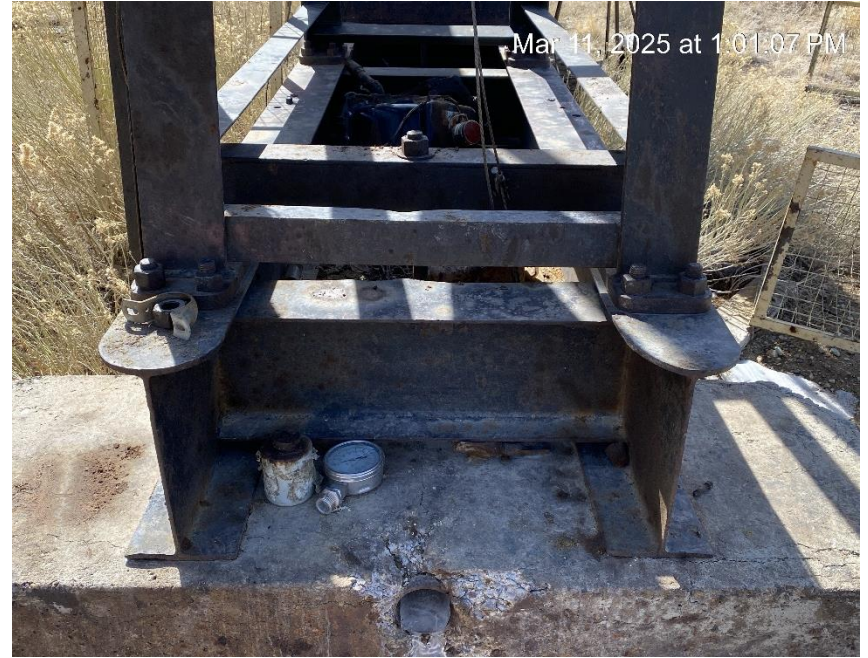
Debris

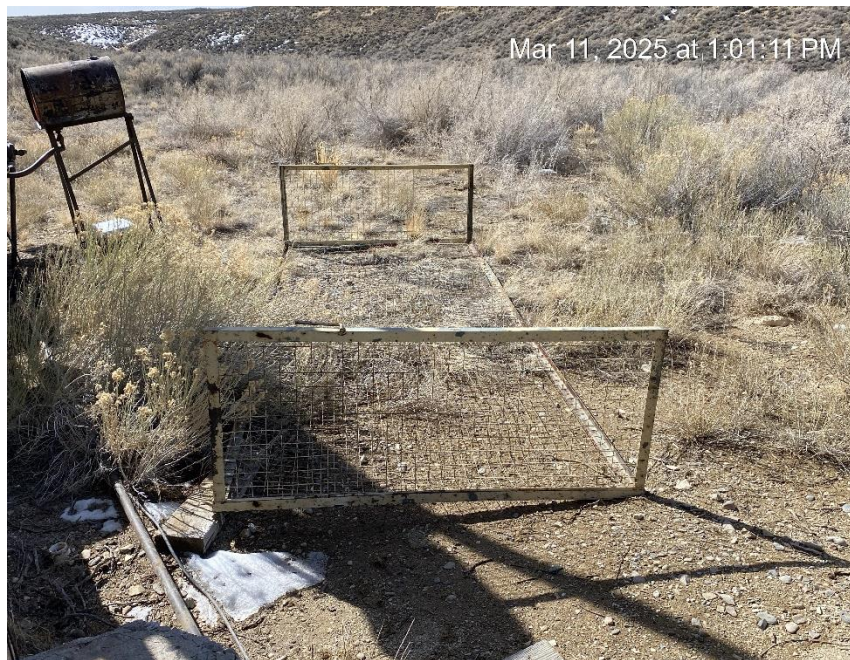
Debris

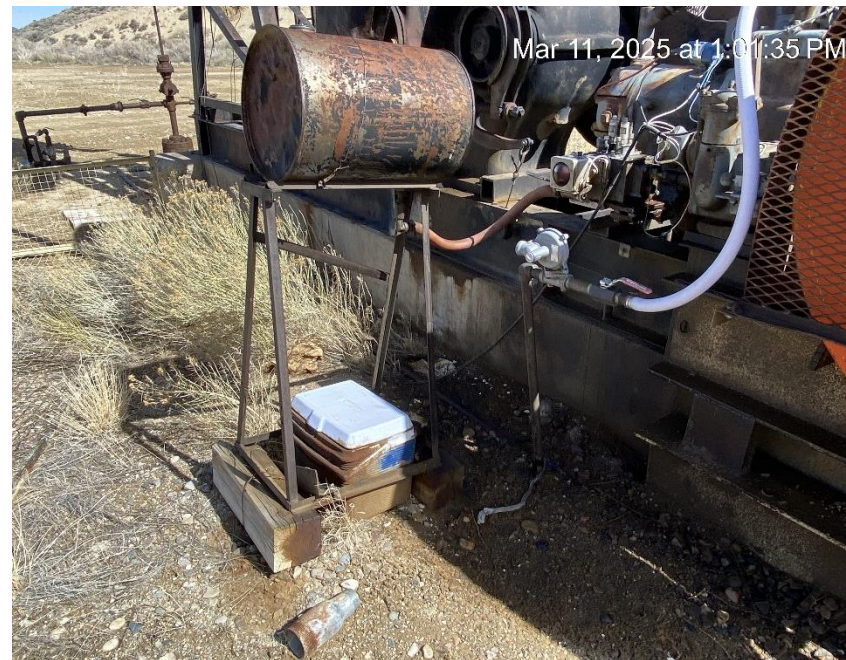
Debris. Stained soil. No containment.

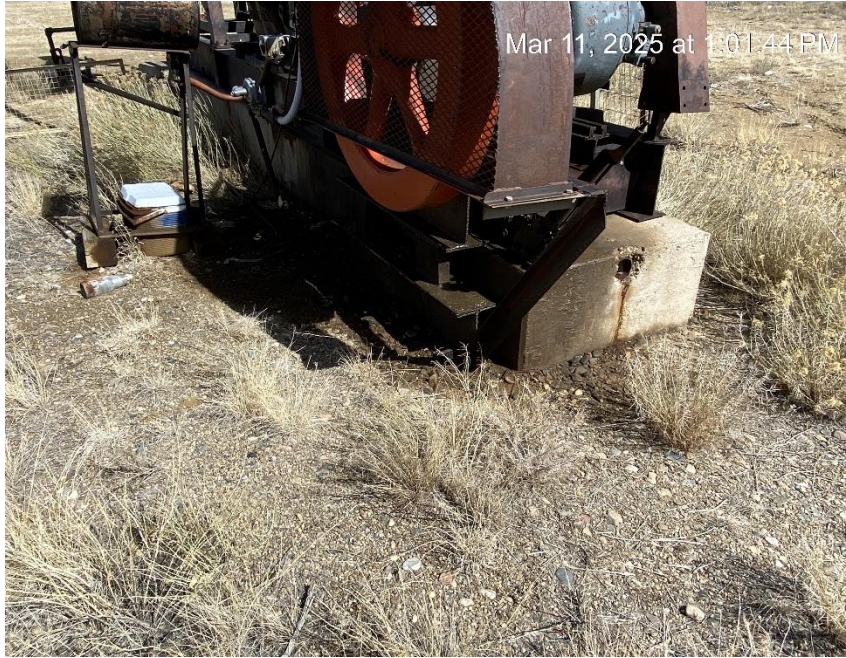
Oily waste and staining

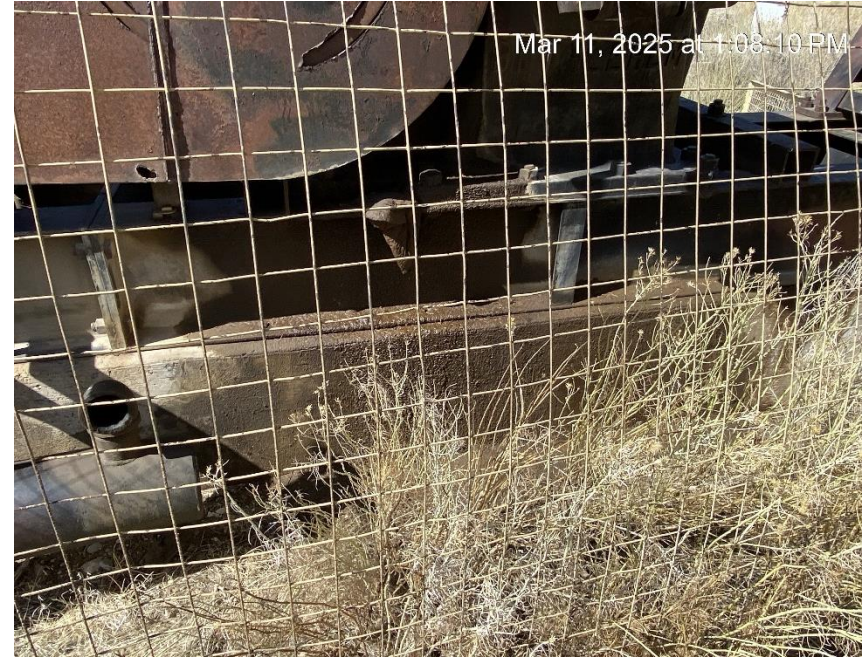
Oily waste and staining

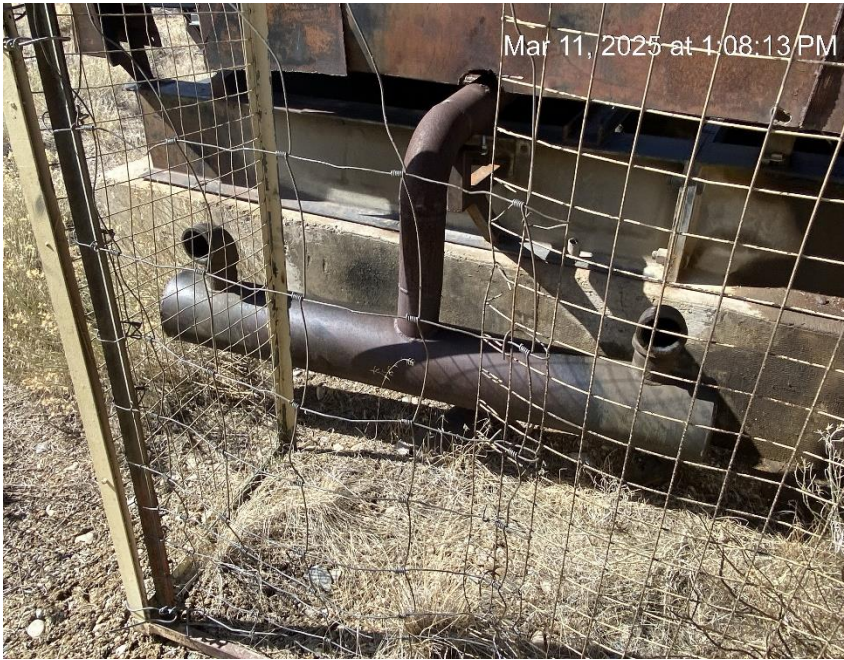
Open to wildlife
