Interim Reclamation and Stormwater Inspection

Operator: BONANZA CREEK ENERGY OPERATING
COMPANY LLC - 8960

Location ID: 422253

Inspection Photos
Location Name: Crow Valley 7-62-32-1M
Location ID: 422253

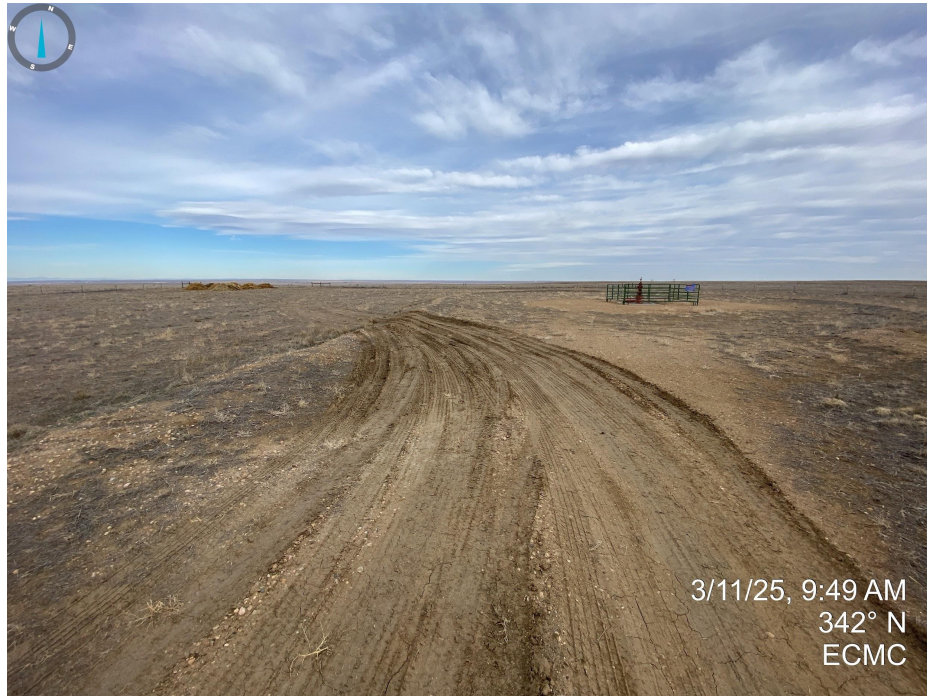
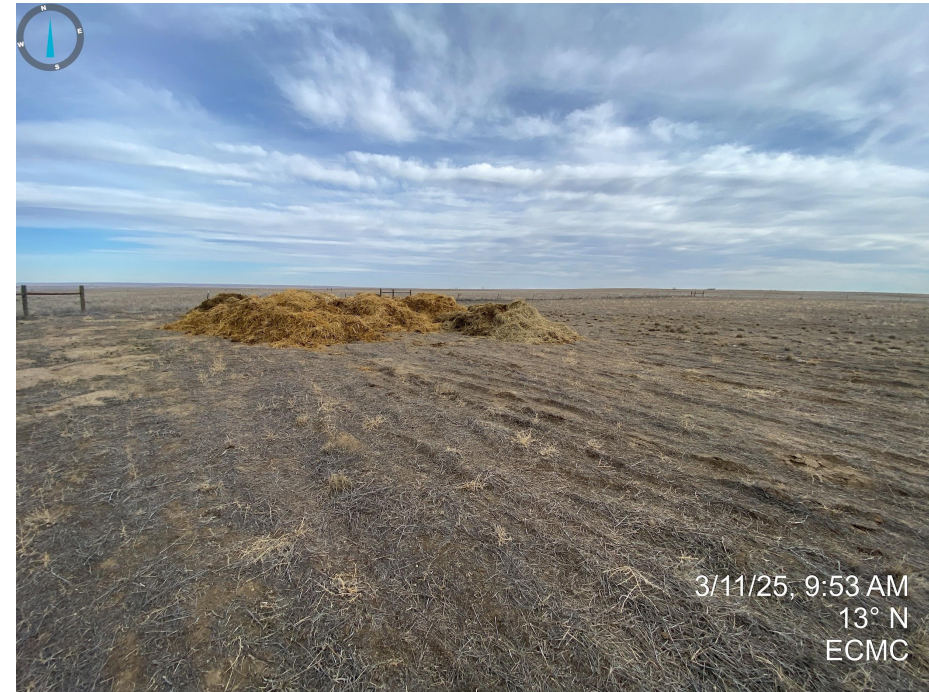
Photos 1 & 2. It appears that vehicle traffic is occurring in the interim areas with debris (hay/manure) observed in the northwest corner of the location.

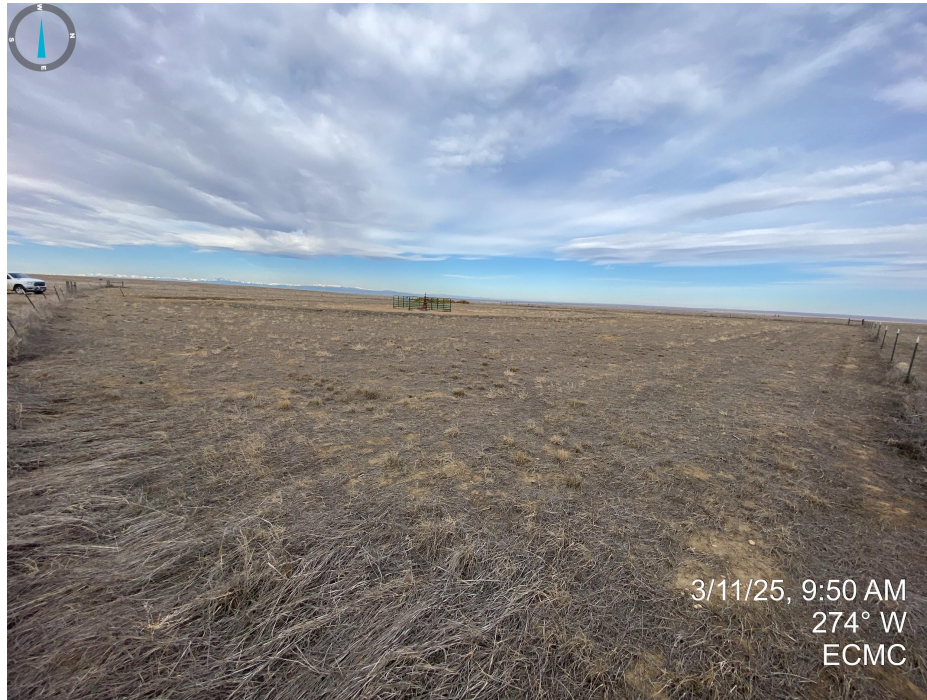
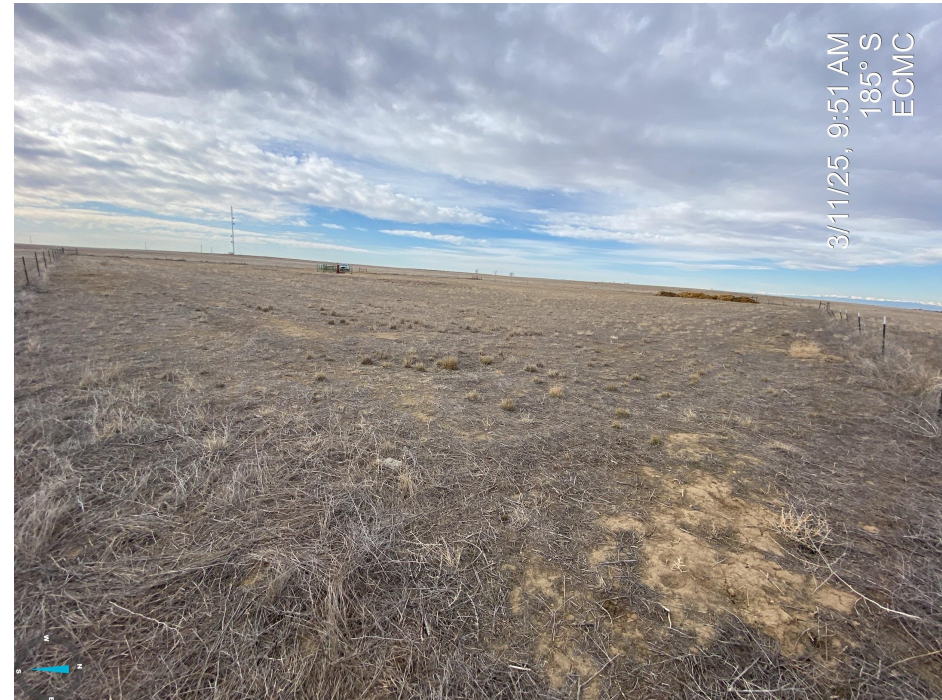
Photos 3 & 4. Taken from the southeast (left; Photo 3) and northeast (right; Photo 4) corners of the location. The location does not appear to be progressing towards reclamation standards and regulations with little evidence of desirable native vegetation observed.

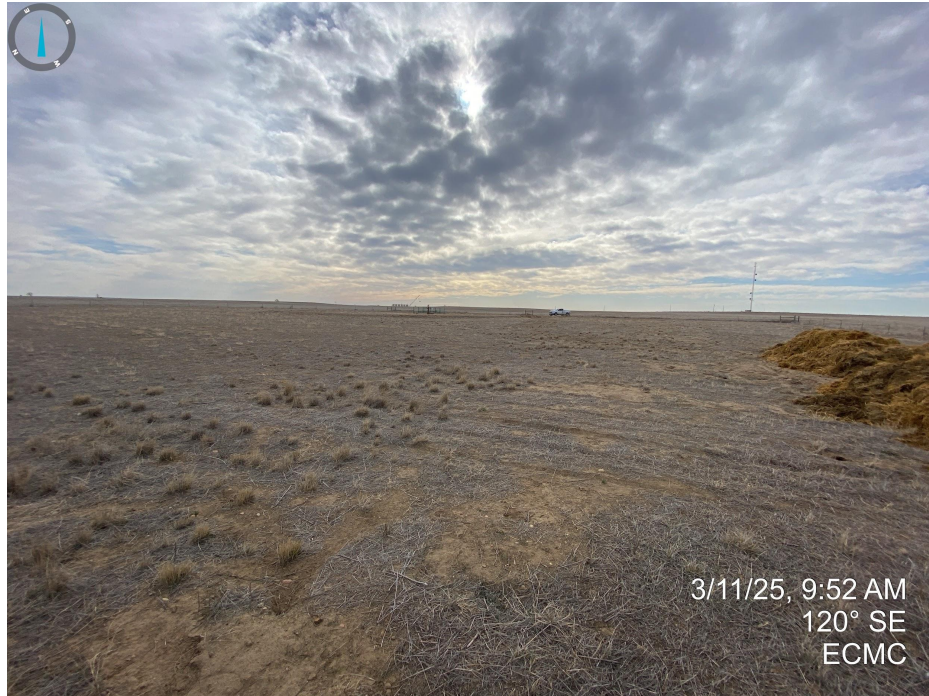
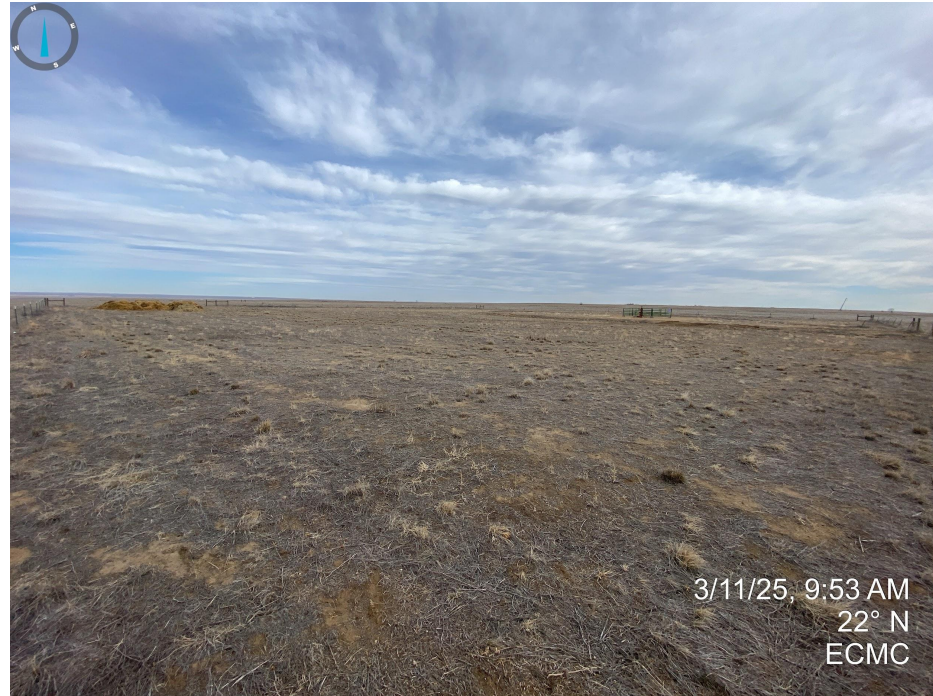
Photos 5 & 6. Taken from the northwest (left; Photo 5) and southwest (right; Photo 6) corners of the location. The location does not appear to be progressing towards reclamation standards and regulations with little evidence of desirable native vegetation observed.

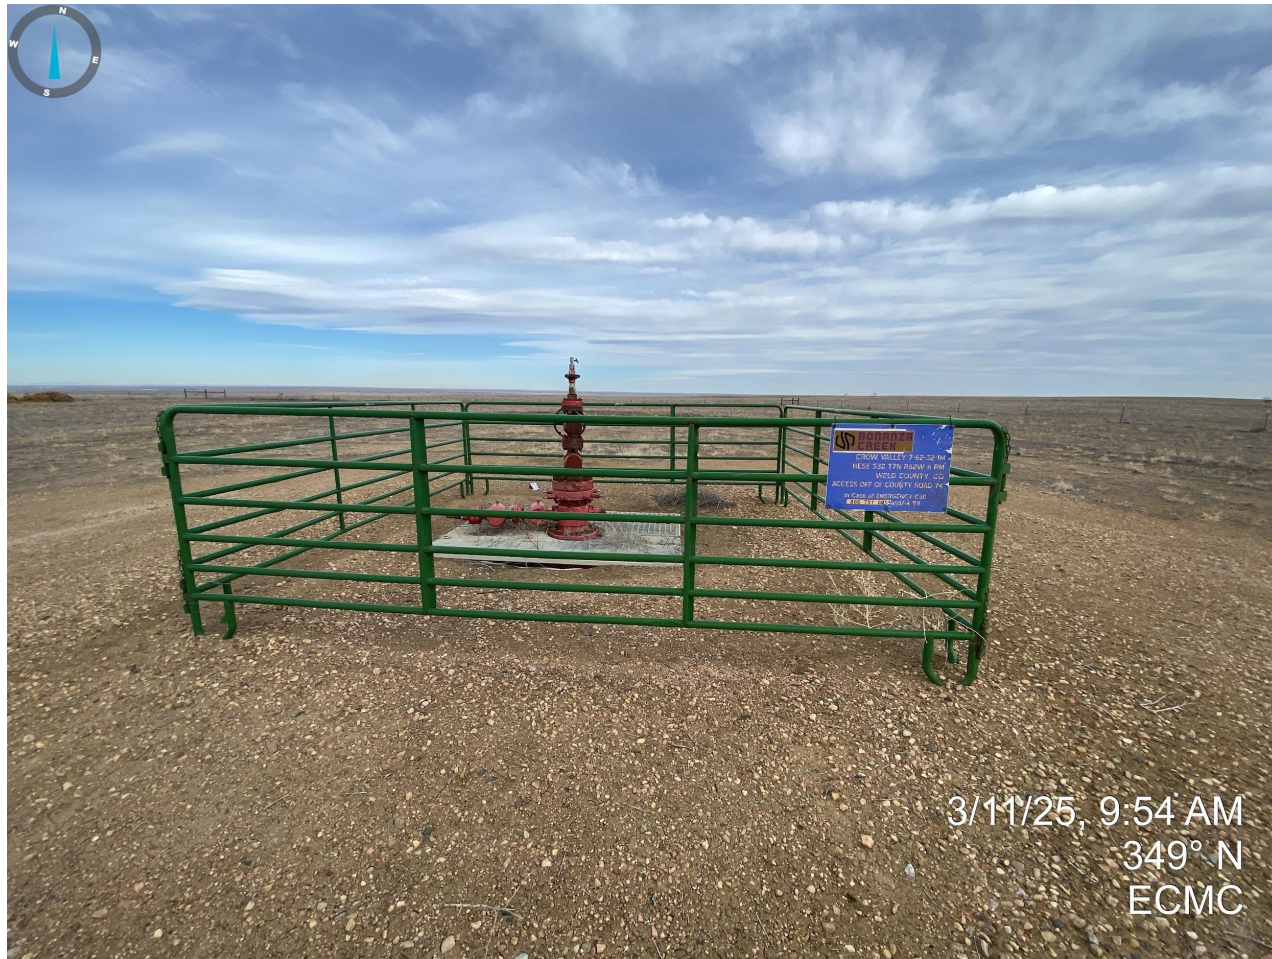
Photo 7. Well API 123-33198 has a Form 6A (doc #403226263) with a plug and abandonment date of 12/31/2027.
