# Interim Reclamation and Stormwater Inspection

Date: 03/11/2025

Operator: BISON IV OPERATING LLC - 10670

Location ID: 422674

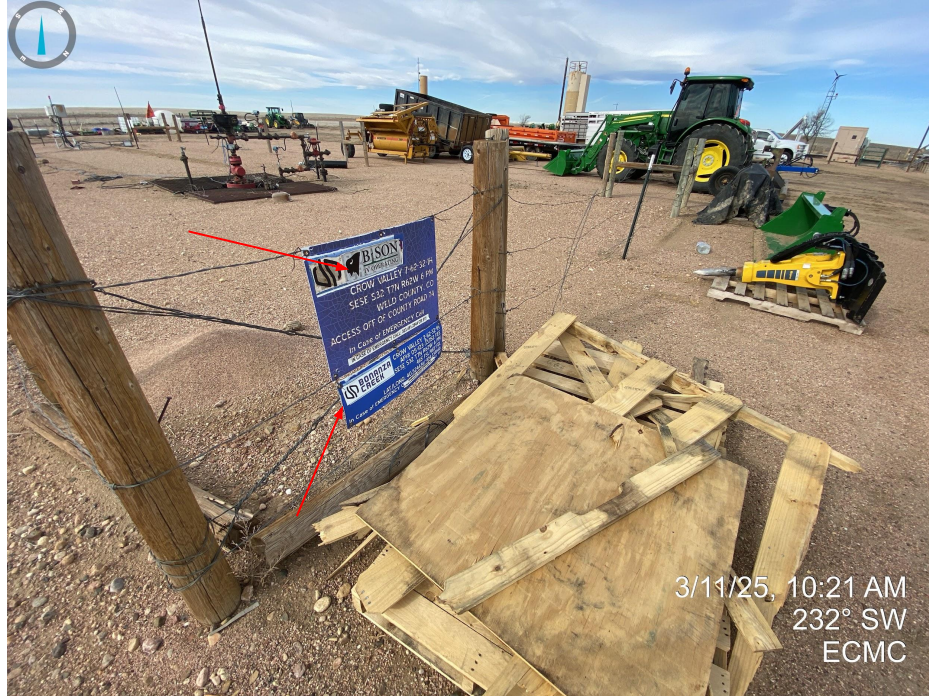
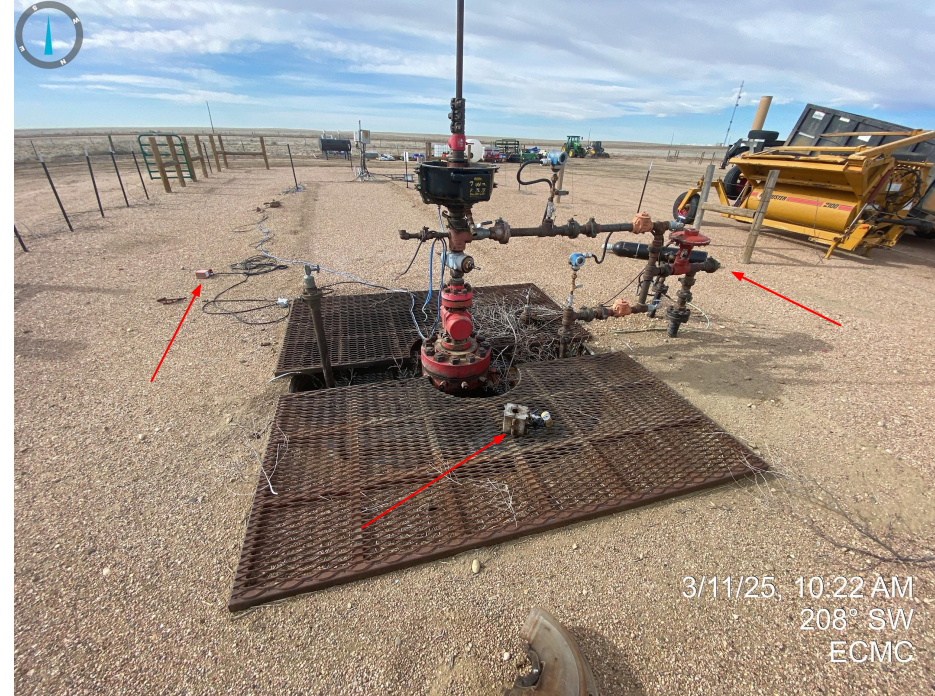
**Photos 1 & 2.** Sign at wellhead needs to be updated as there are two operators listed (Photo 1; left), and unused equipment observed around well area (Photo 2; right).

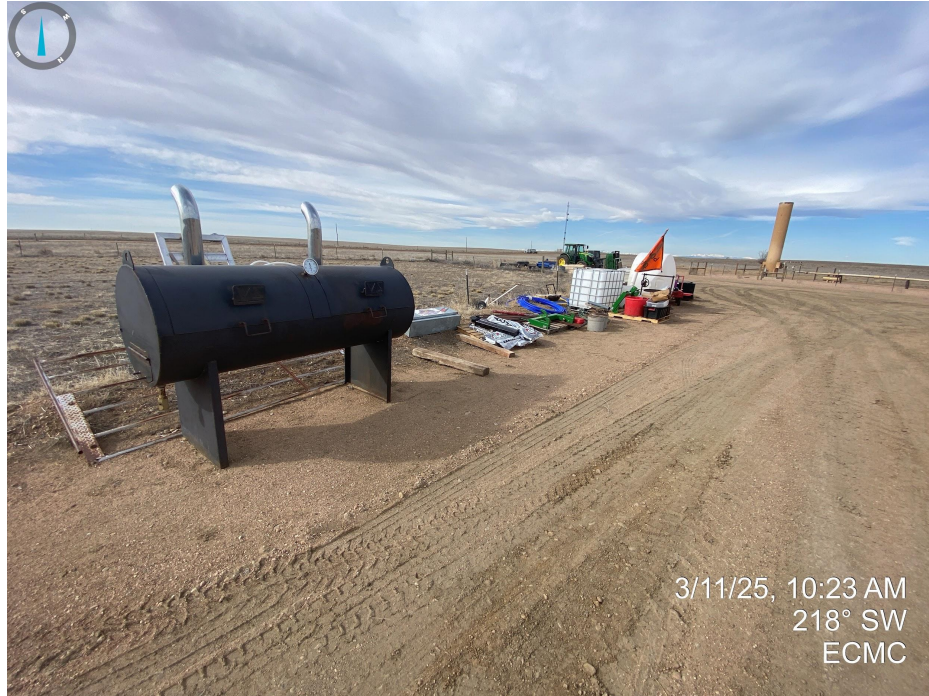
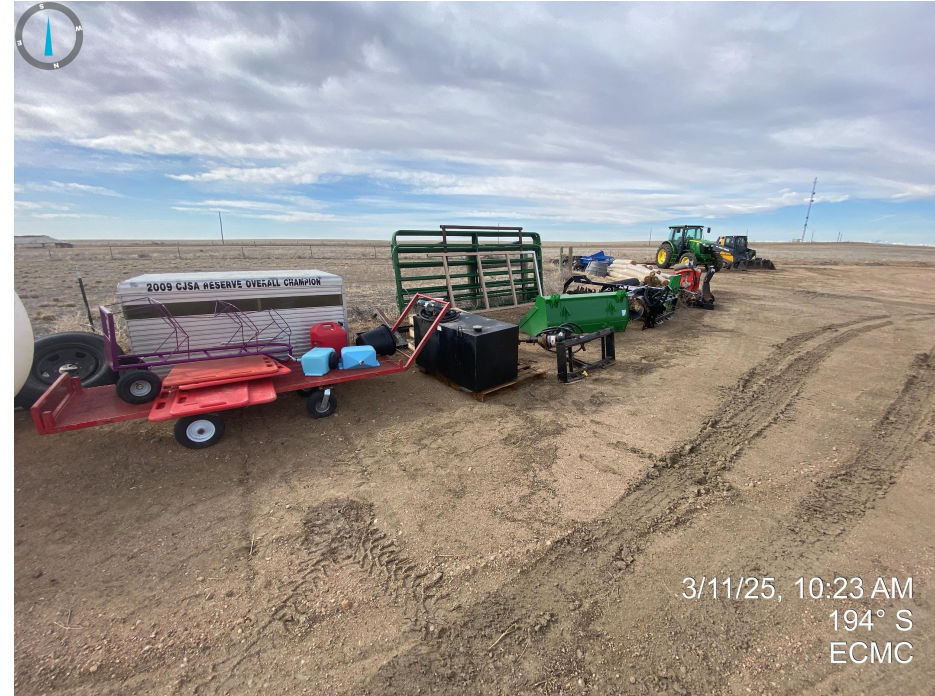
**Photos 3 & 4.** Various supplies and equipment being stored on the south side of the production facilities.

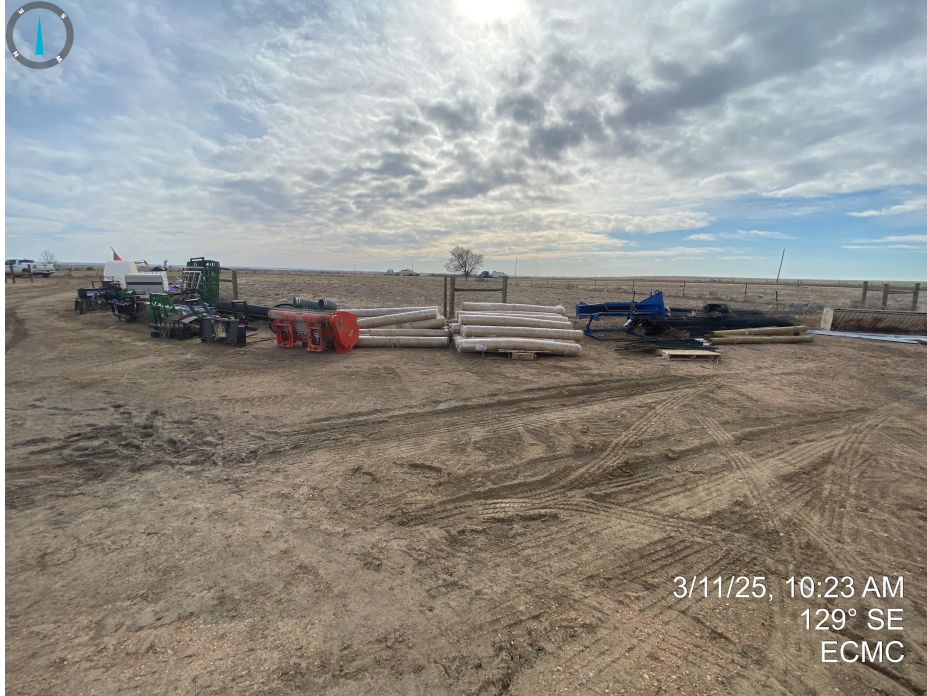
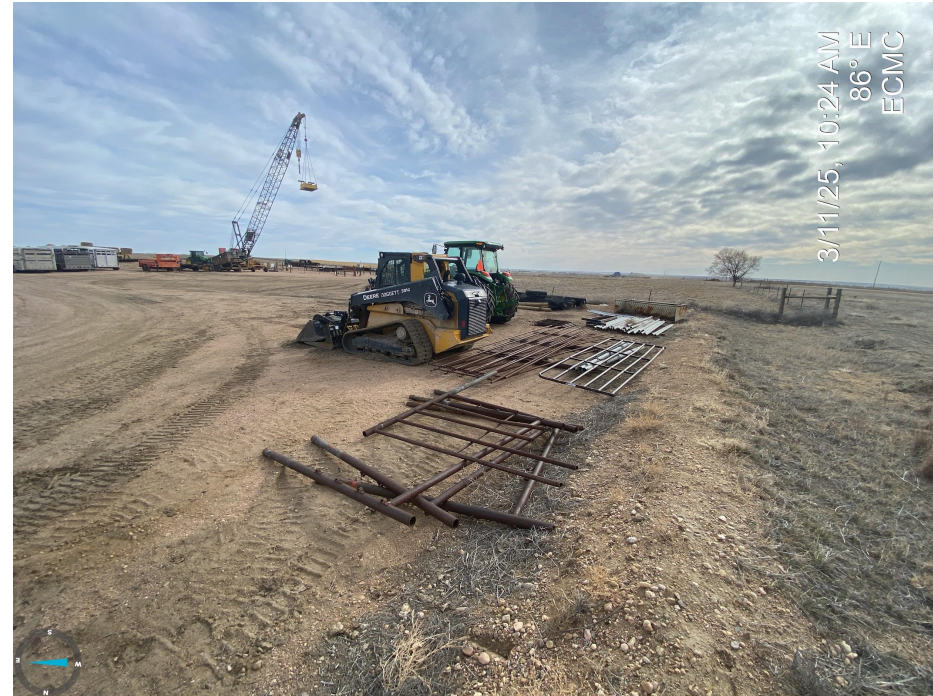
**Photos 5 & 6.** Various supplies and equipment being stored on the south side of the production facilities.

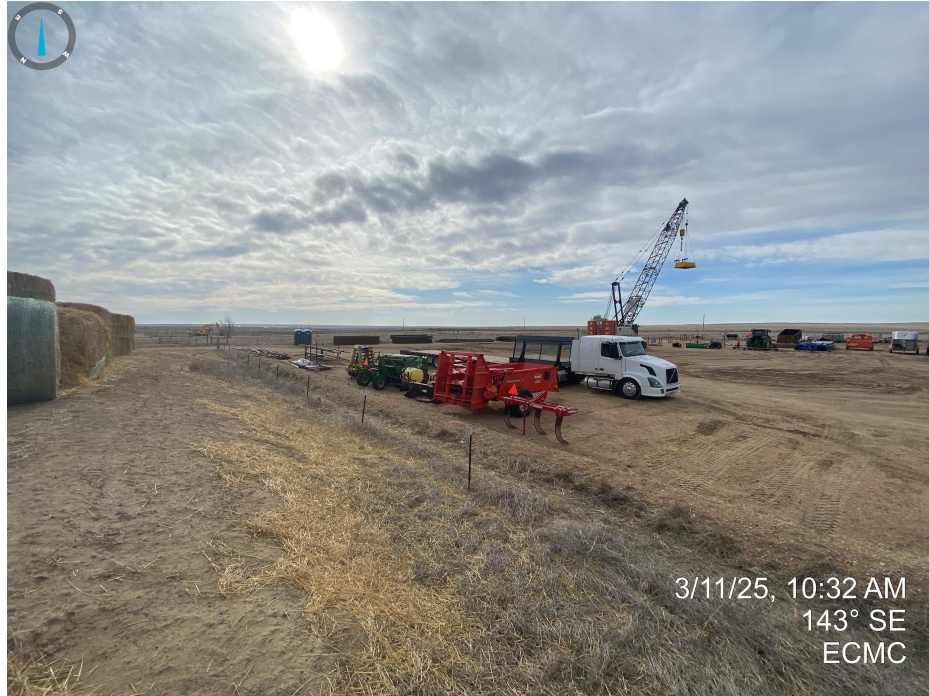
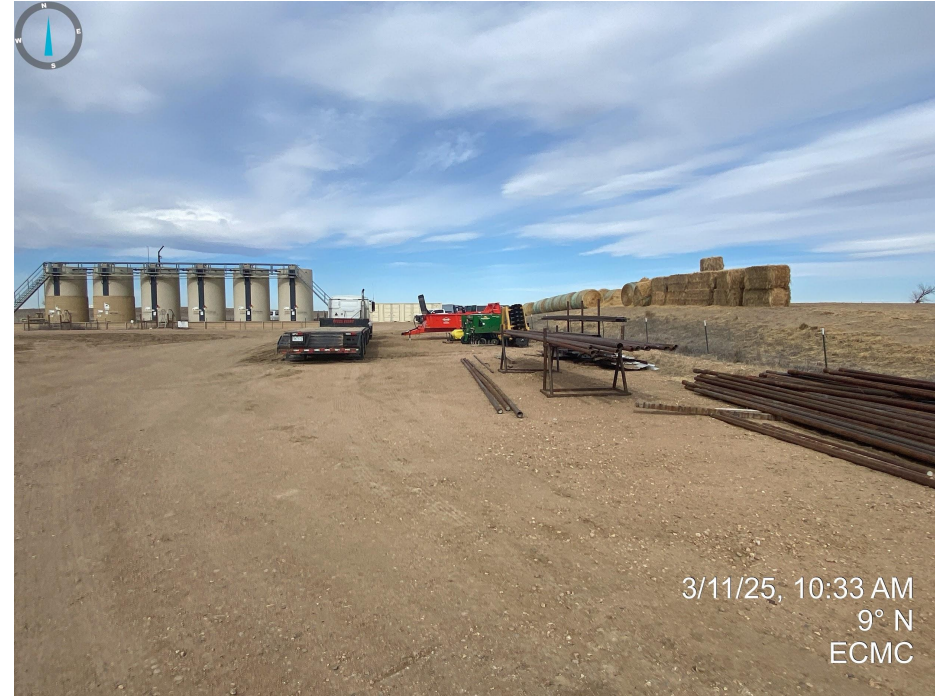
**Photos 7 & 8.** Various supplies and equipment being stored on the north side of the production facilities.

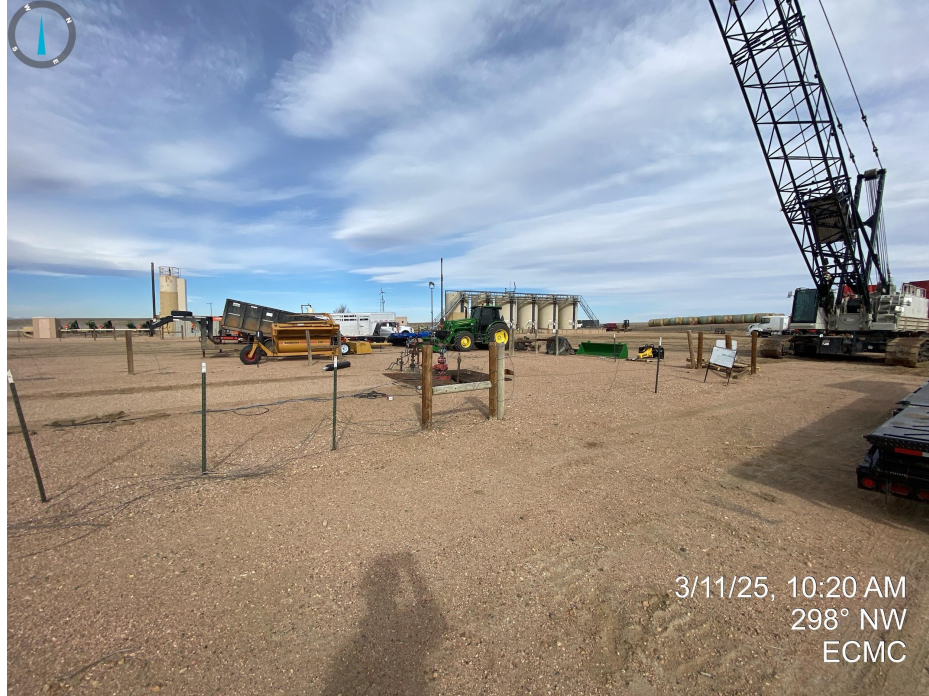
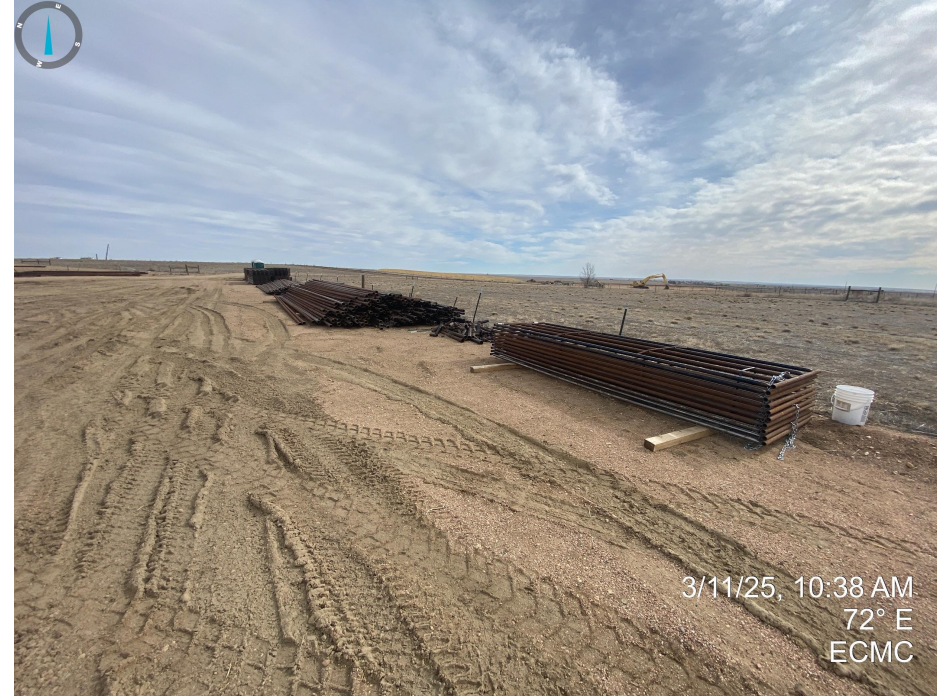
**Photos 9 & 10.** Various supplies and equipment being stored around the well location (Photo 9; left) and on the east side of the production facilities (Photo 10; right).

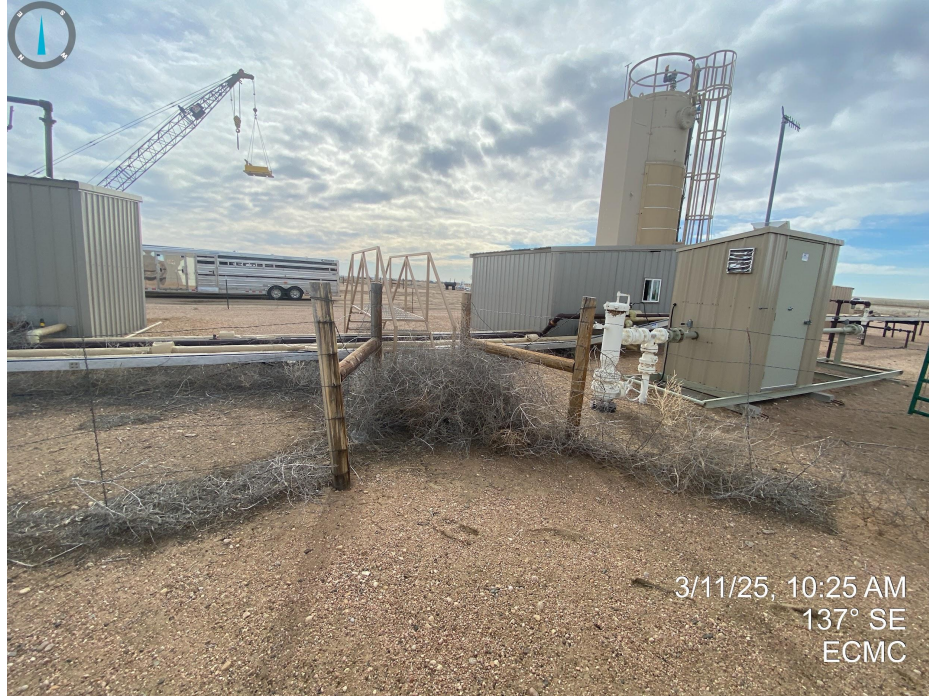
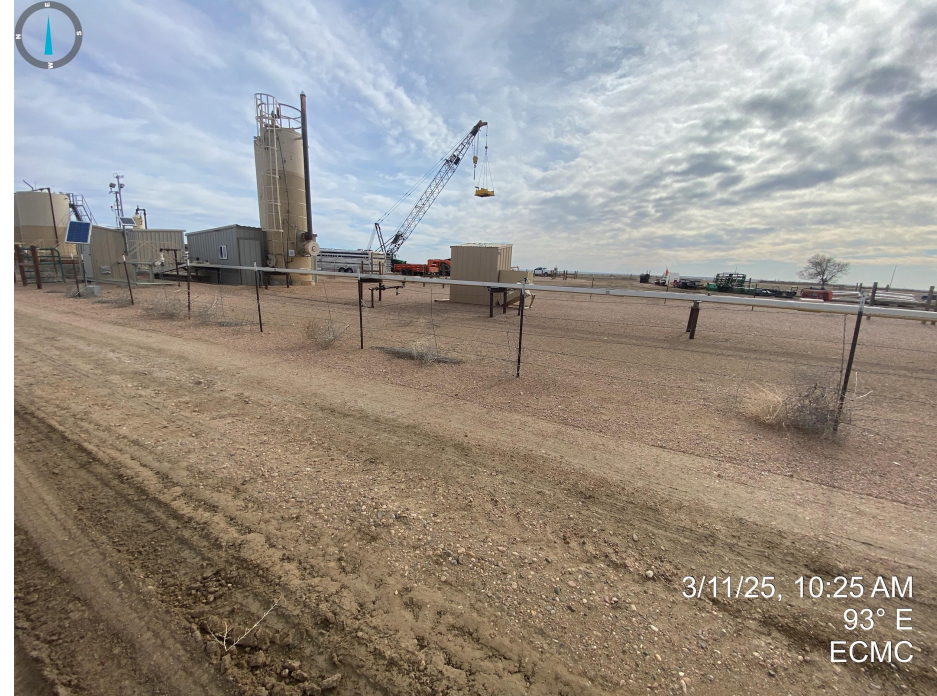
**Photos 11 & 12.** Tumbleweed debris observed throughout the location and within equipment.

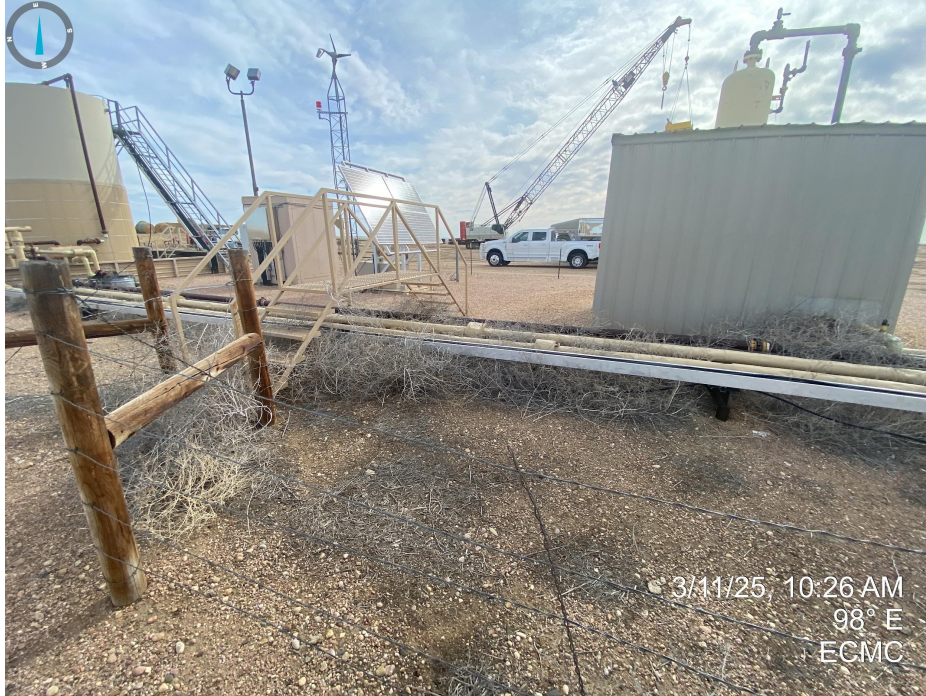
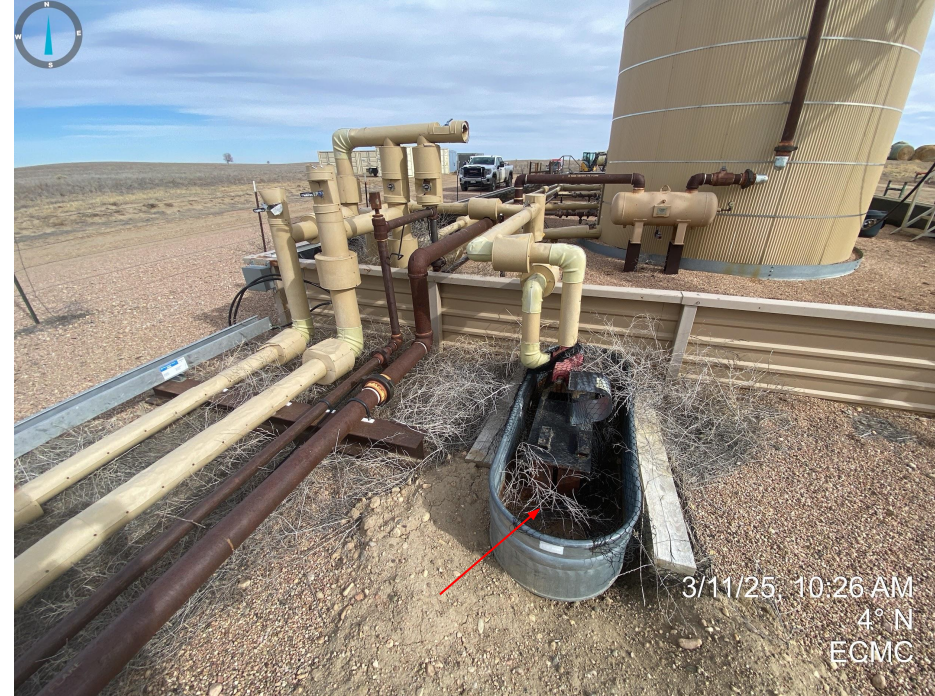
**Photos 13 & 14.** Tumbleweed debris observed throughout the location and within equipment. Also pictured in Photo 14 (right), wildlife netting does not appear adequate to exclude entry.

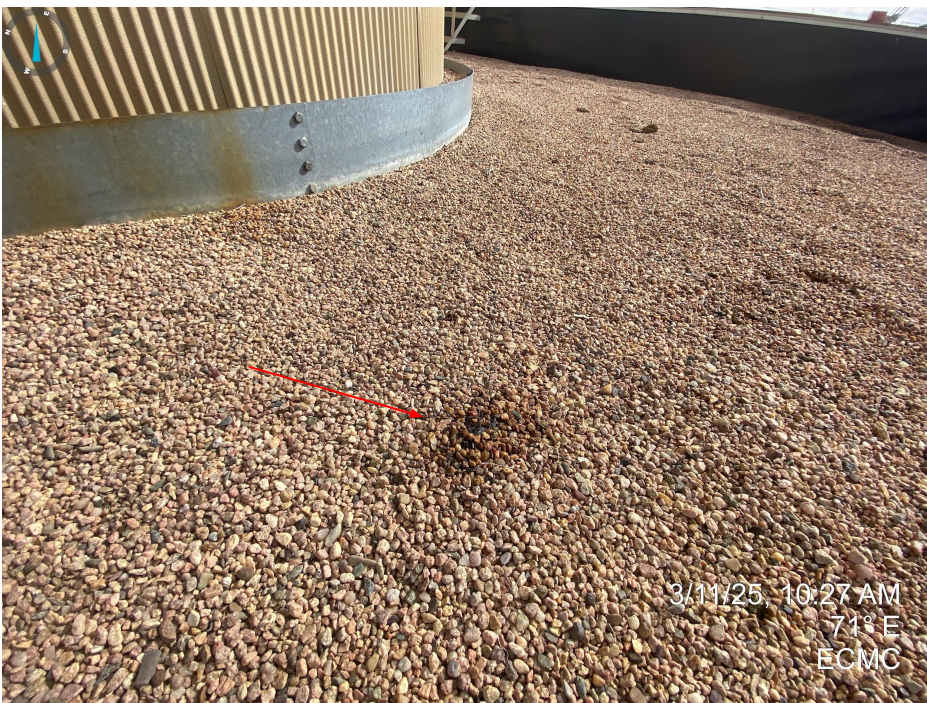
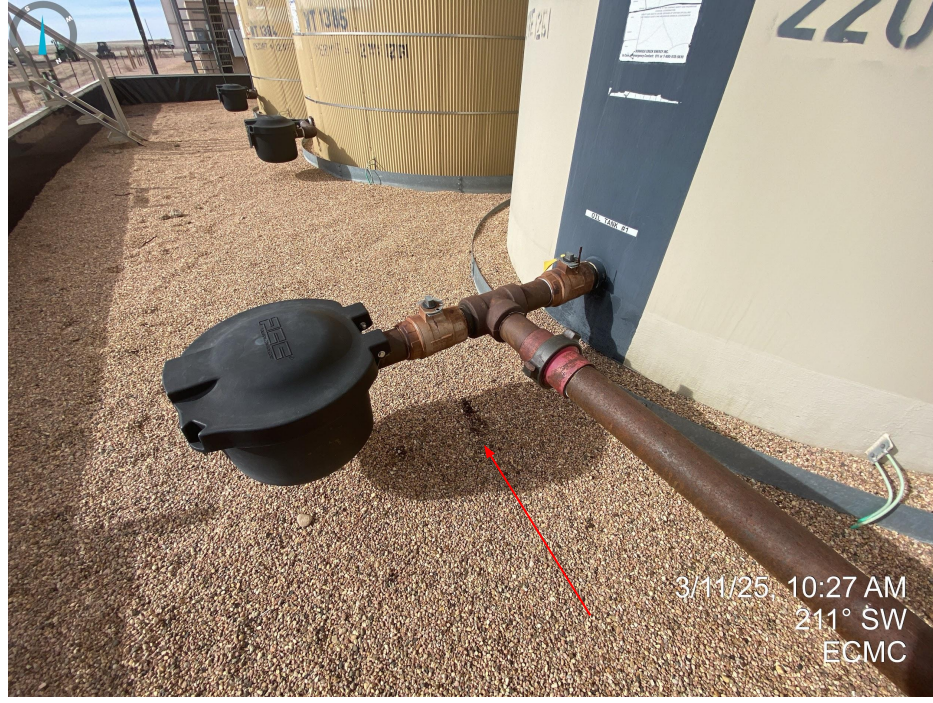
Photos 15 & 16. Hydrocarbon staining within tank battery.

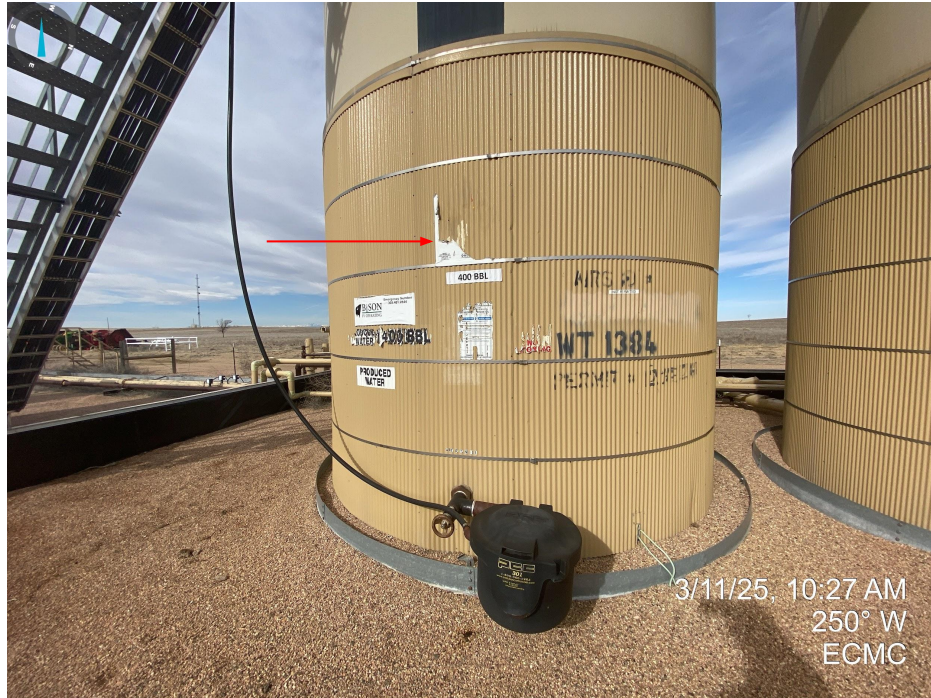
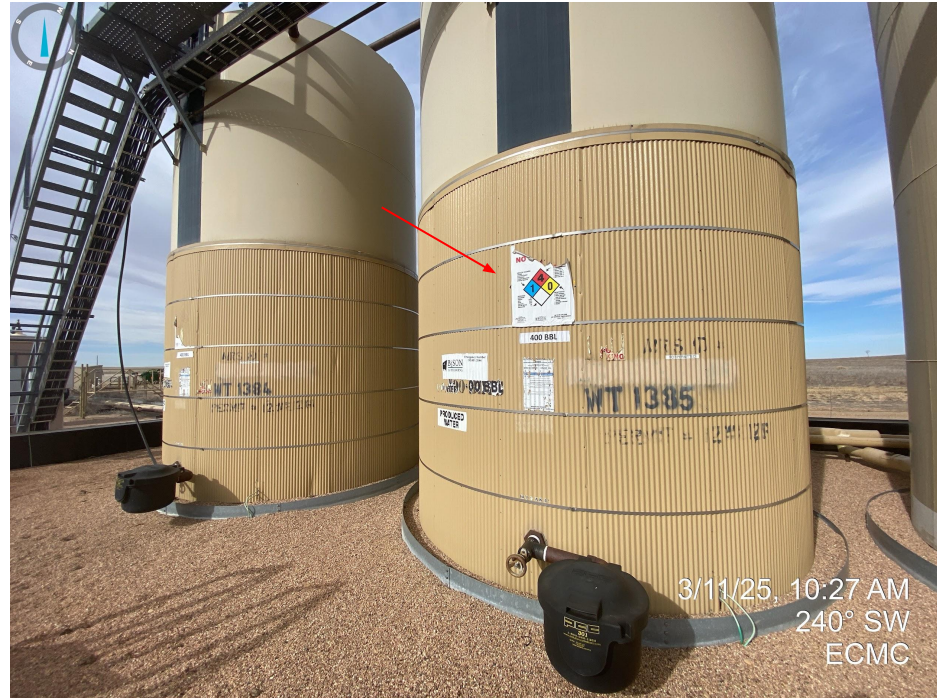
Photos 17 & 18. Tank labels/placards not legible and are peeling, faded, cracked and require replacement.

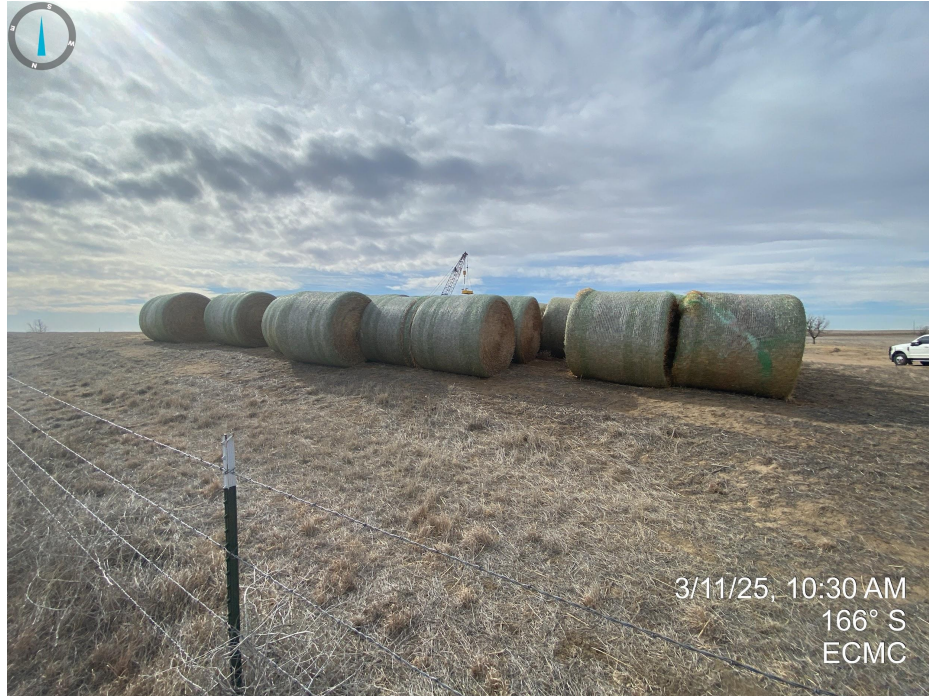
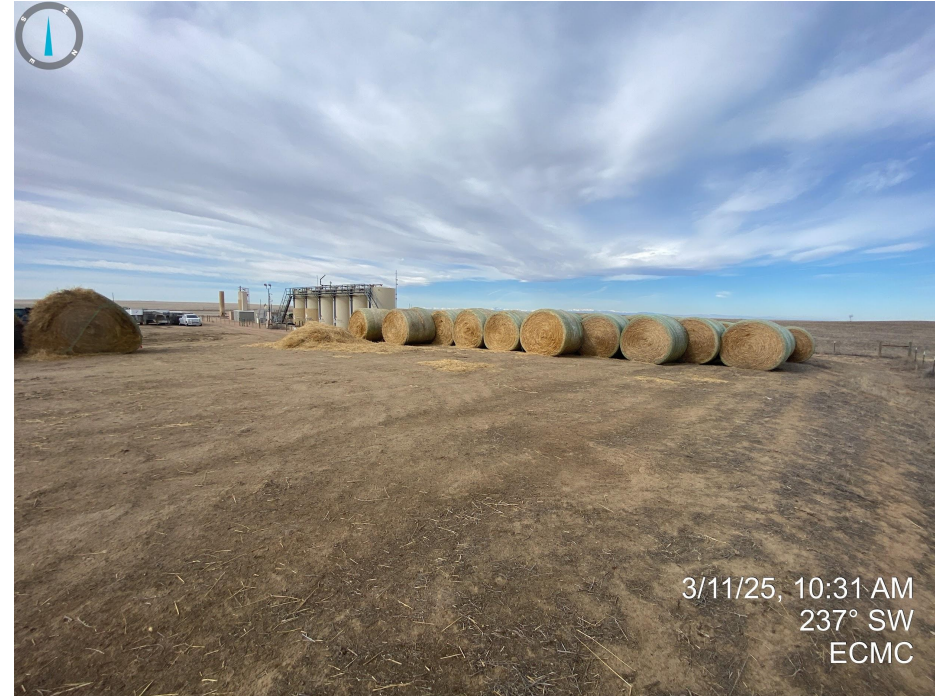
**Photos 19 & 20.** Bales of hay/straw being stored on top of the topsoil stockpile. Photo 20 (right) shows evidence of bare/unstabilized soils.

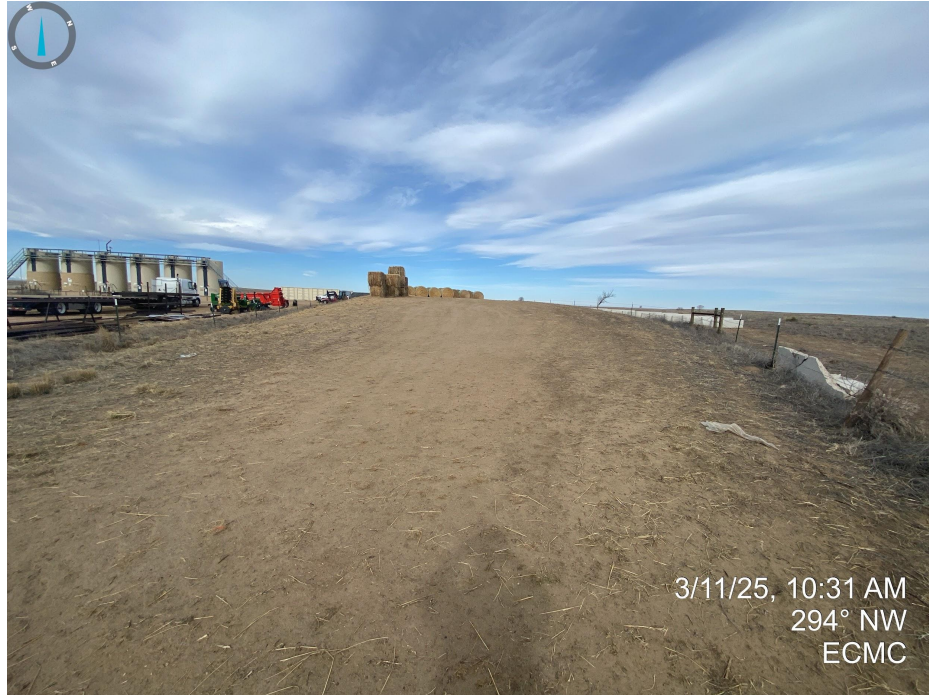
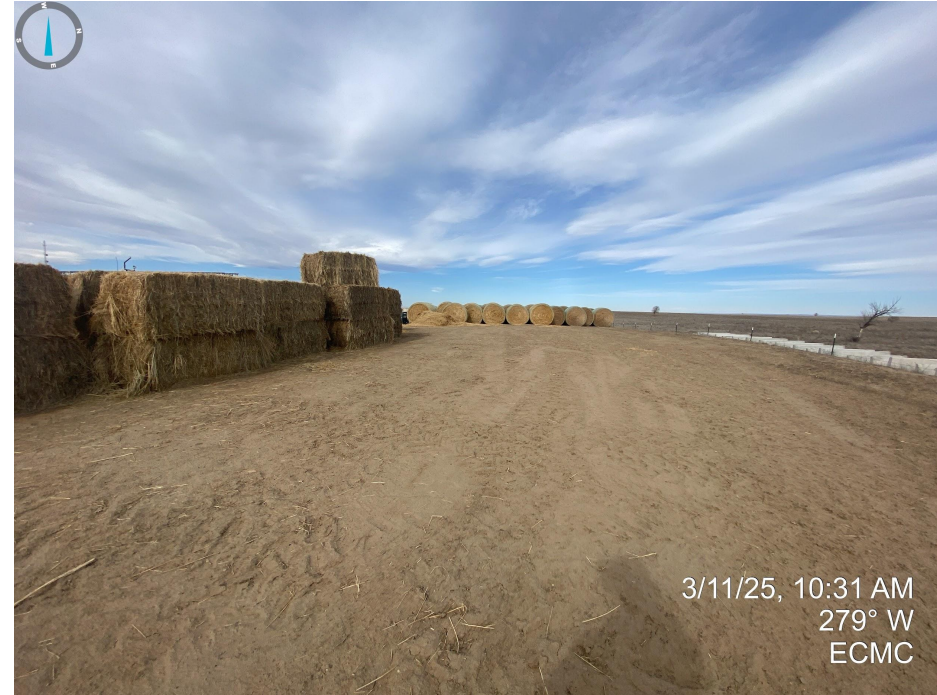
**Photos 21 & 22.** Continued from Photos 19 & 20. Evidence of bare/unstabilized soils on at the topsoil stockpile.

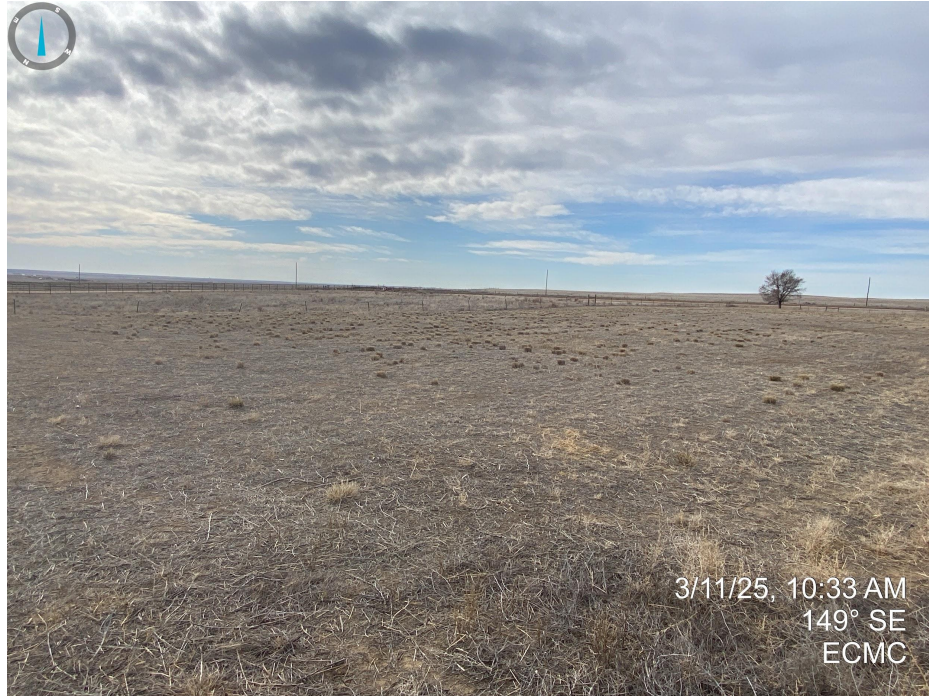
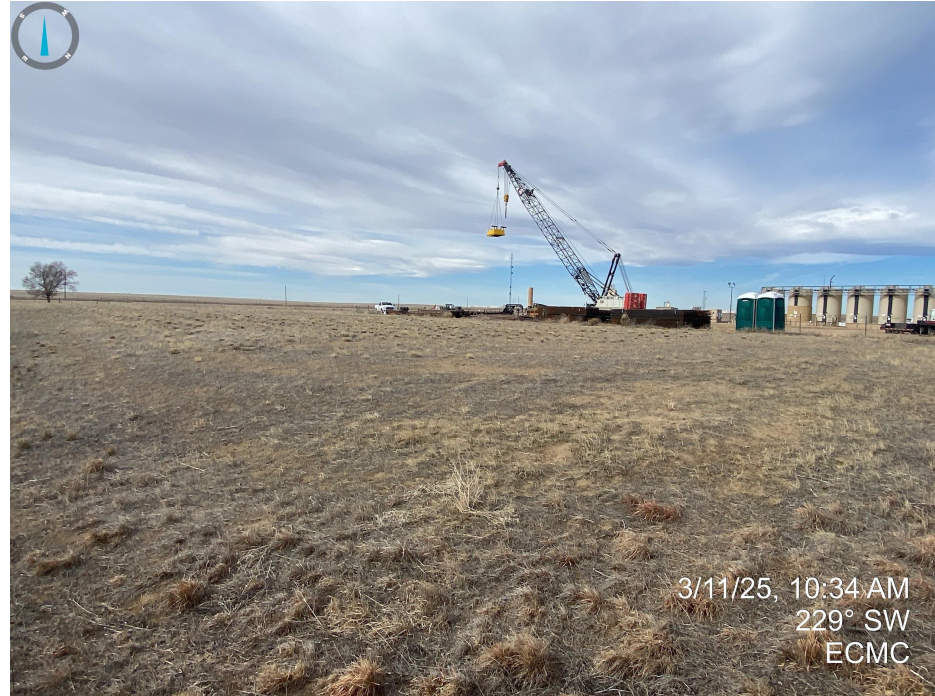
**Photos 23 & 24.** Taken from the northern portion of the interim reclamation areas. The interim reclamation areas do not appear to be progressing towards standards and regulations with little evidence of desirable vegetation observed.

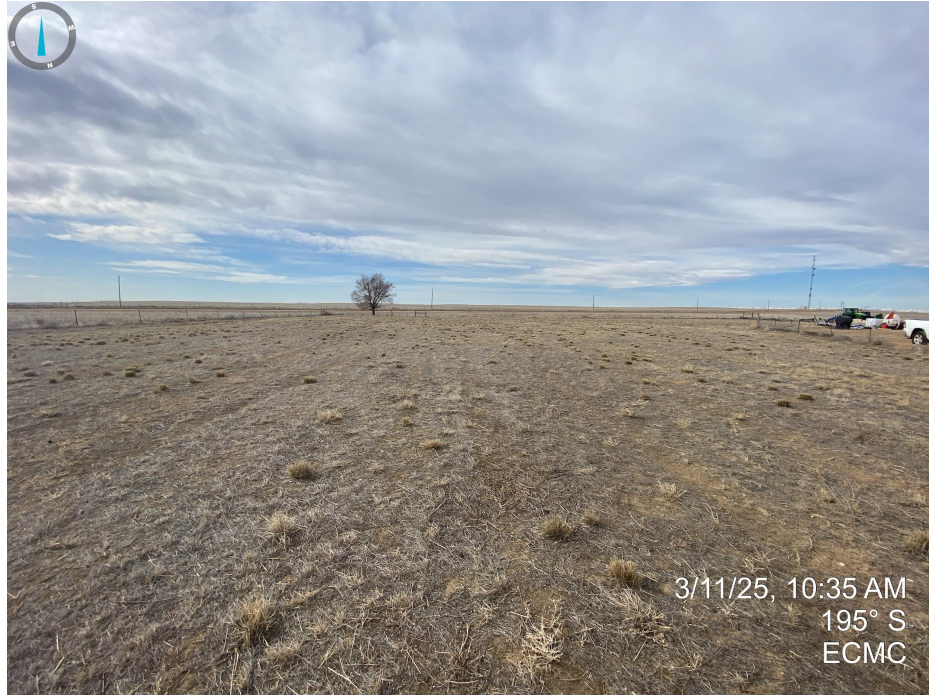
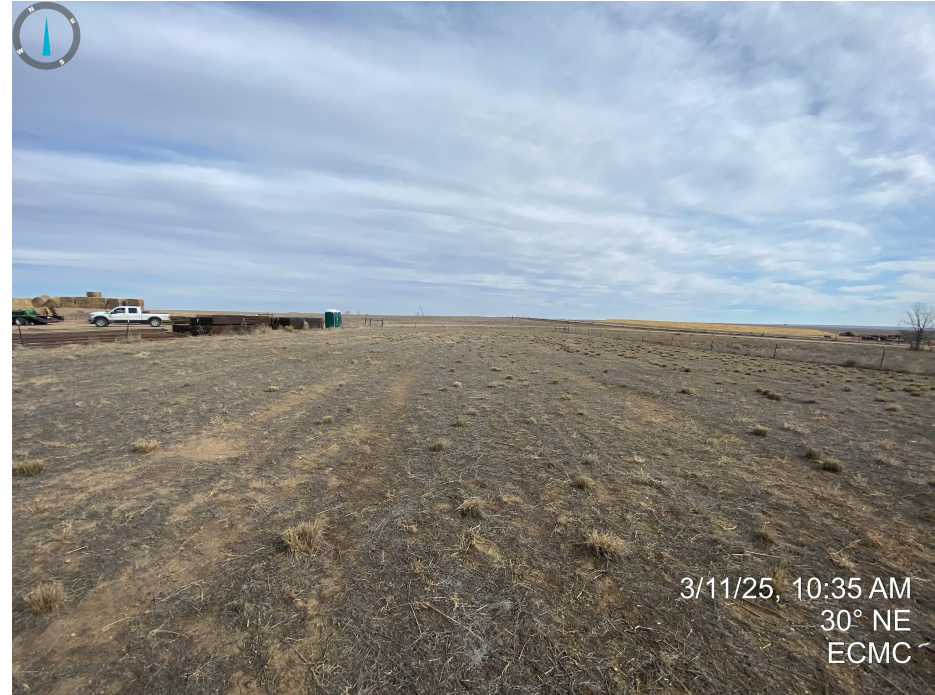
**Photos 25 & 26.** Taken from the center/middle portion of the interim reclamation areas. The interim reclamation areas do not appear to be progressing towards standards and regulations with little evidence of desirable vegetation observed.

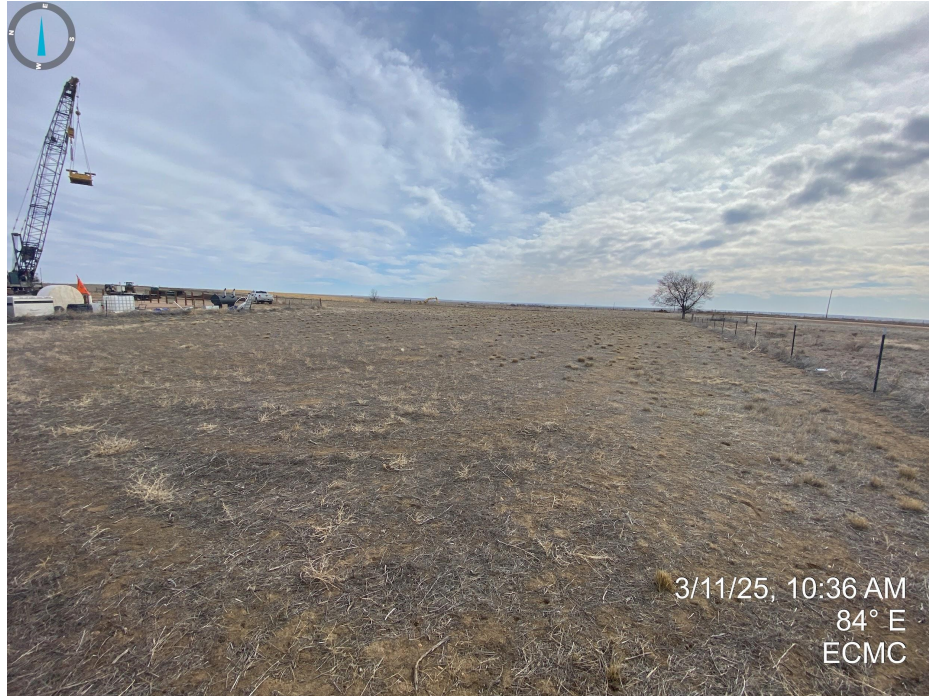
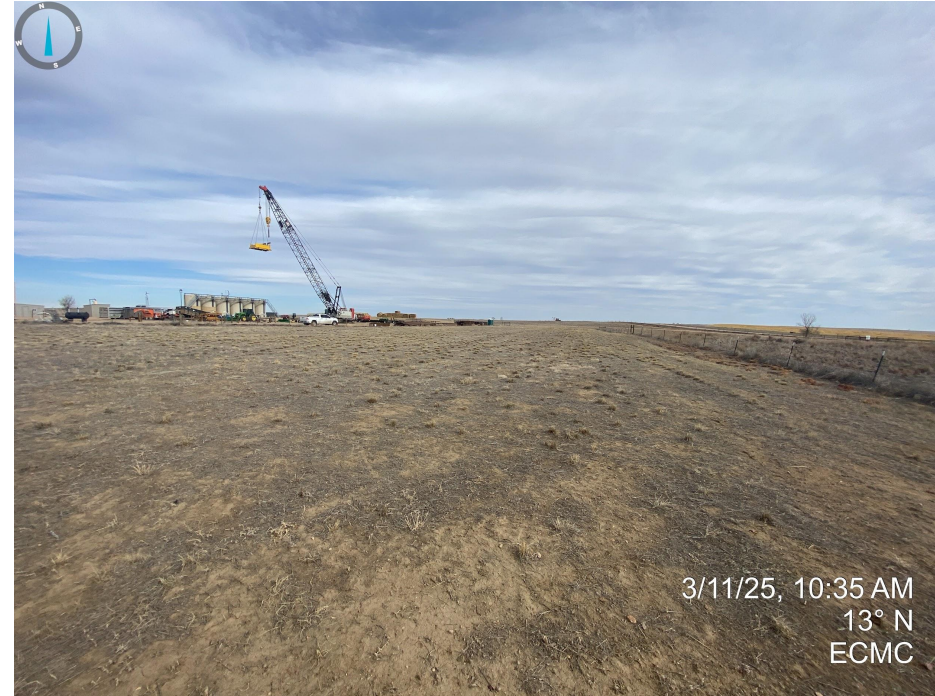
**Photos 27 & 28.** Taken from the southern portion of the interim reclamation areas. The interim reclamation areas do not appear to be progressing towards standards and regulations with little evidence of desirable vegetation observed.

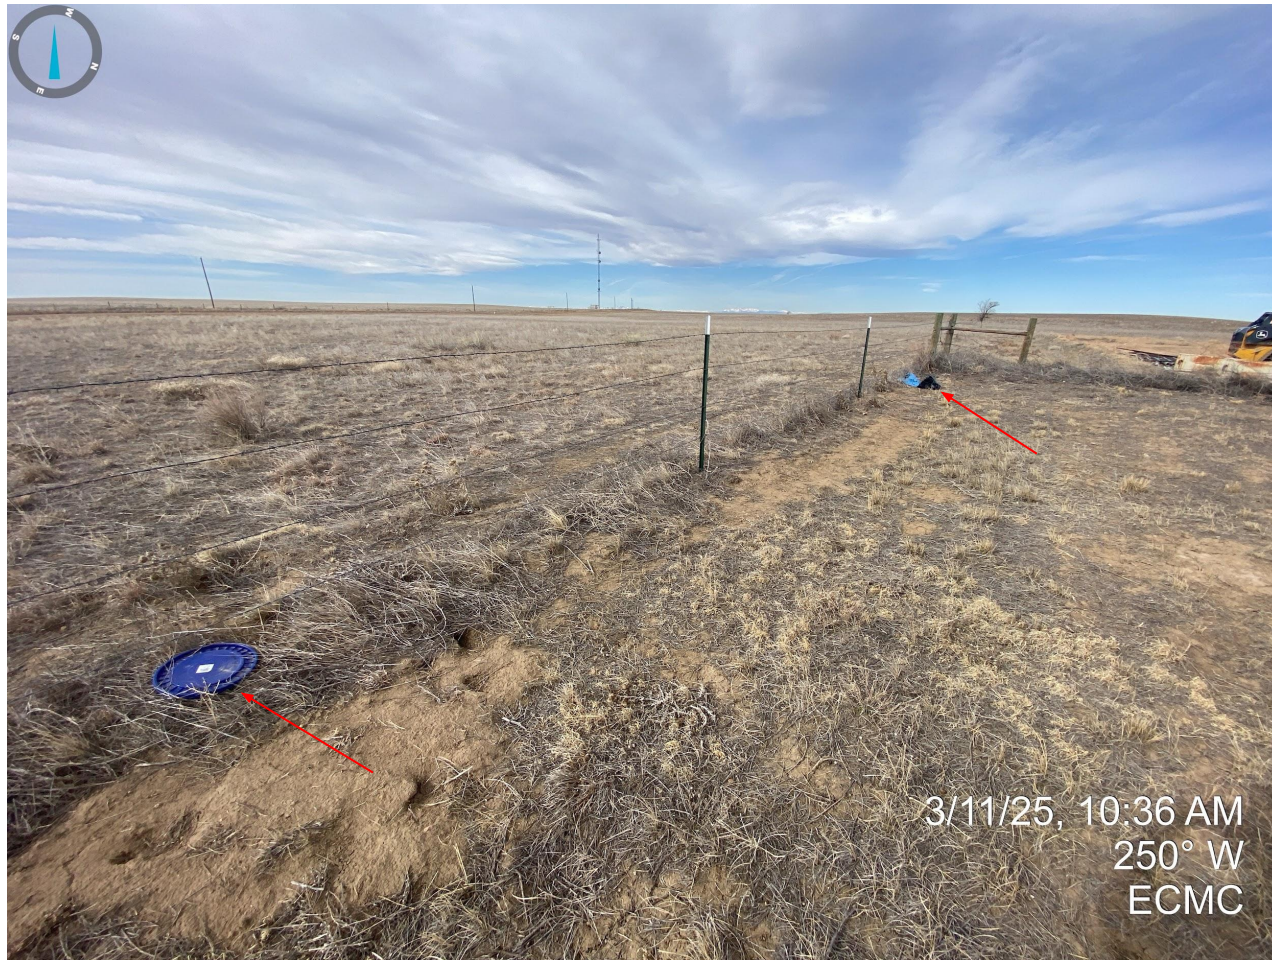
**Photo 29.** Example of trash observed on the southwest corner of the location.
