# Final Reclamation and Stormwater Inspection

Operator: BONANZA CREEK ENERGY OPERATING  
COMPANY LLC - 8960

Location ID: 421455

Inspection Document #: 718700200

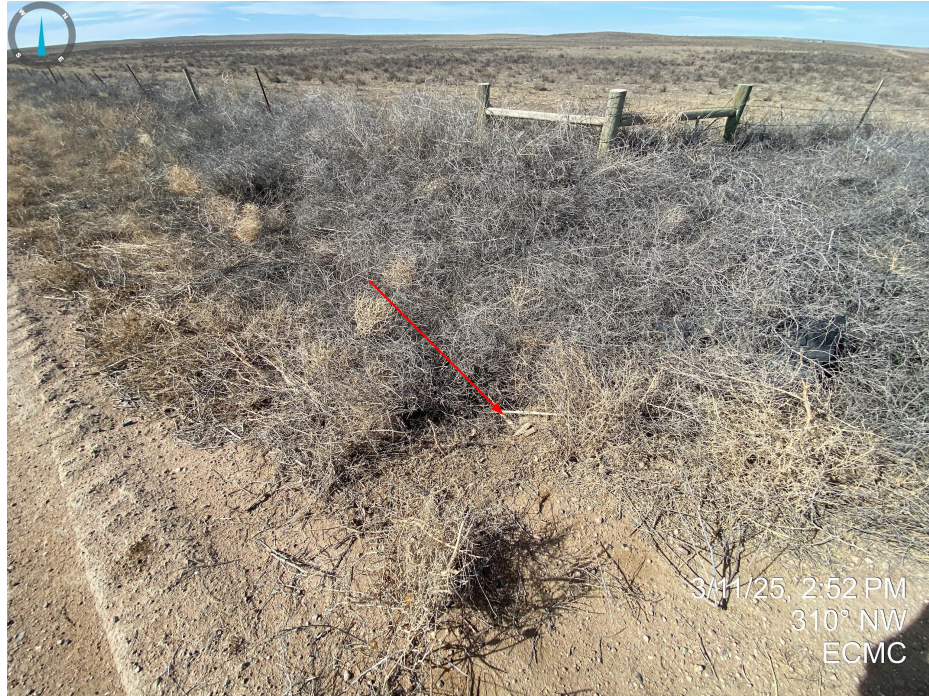
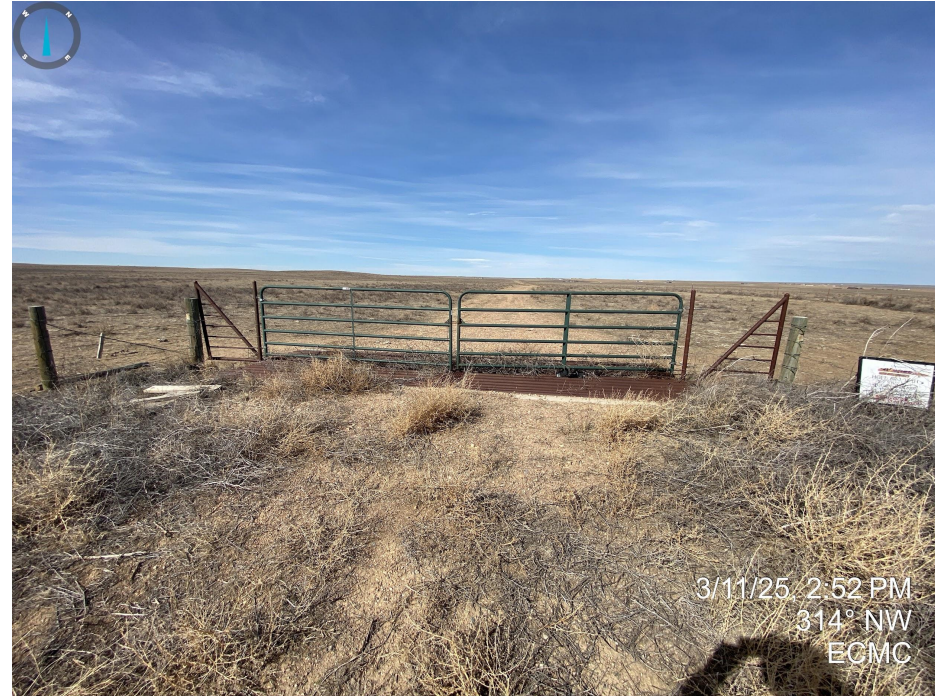
**Photos 1 & 2.** Taken from the location entrance. Culvert, cattle guard and gate remain at the former entrance.

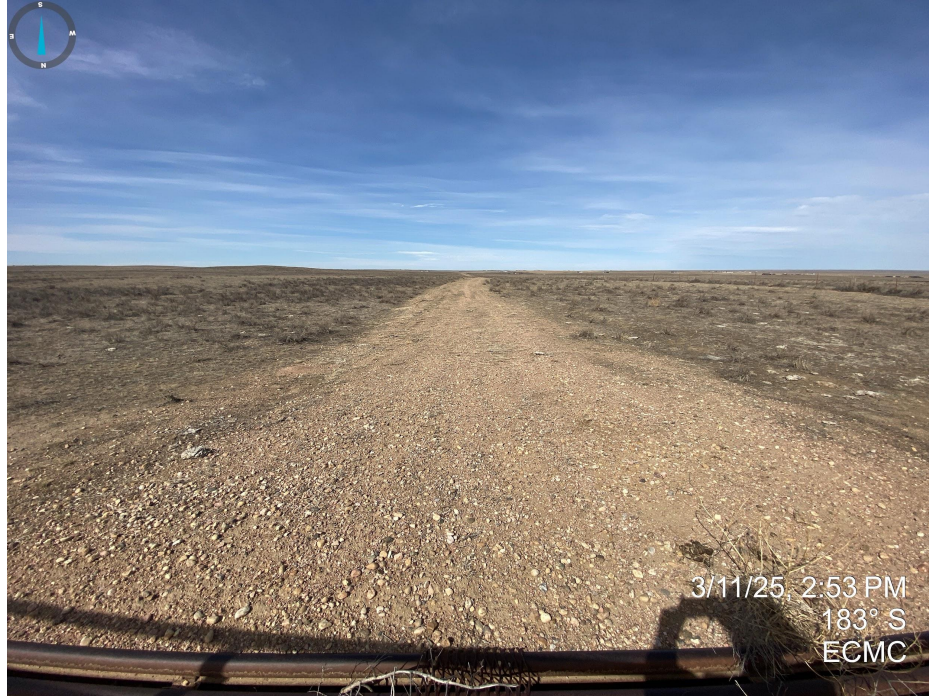
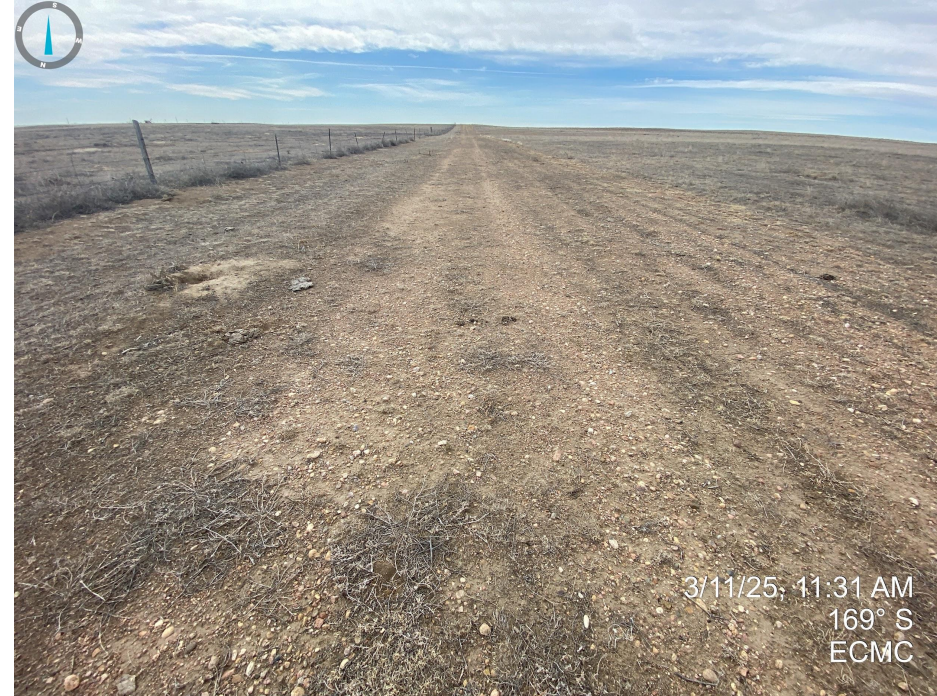
**Photos 3 & 4.** Taken from the start (Photo 3; left) and end, near location (Photo 4; right) of the access road. Evidence of road base material remains throughout.

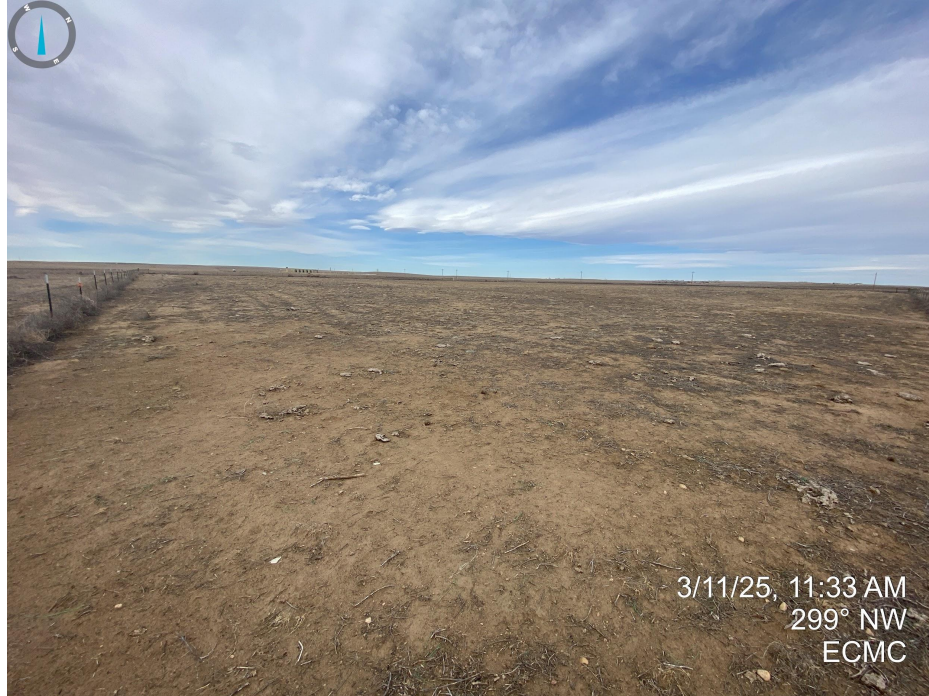
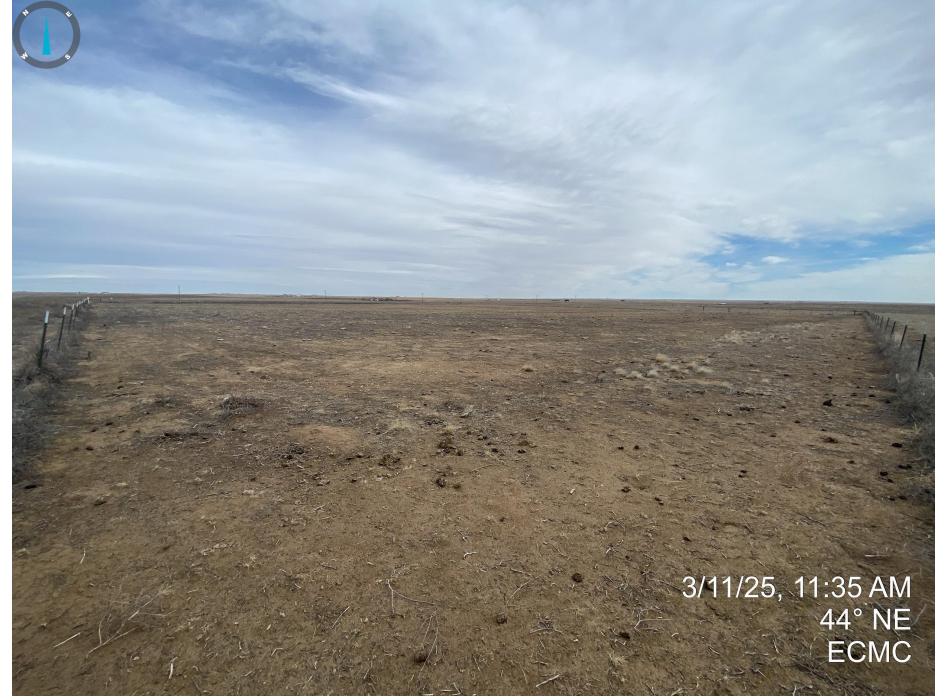
**Photos 5 & 6.** Taken from the southeast (Photo 5; left) and southwest (Photo 6; right) of the location. The former location doesn't appear to be progressing towards reclamation standards as the area is predominantly bare/unstabilized soils, with little evidence of desirable vegetation observed.

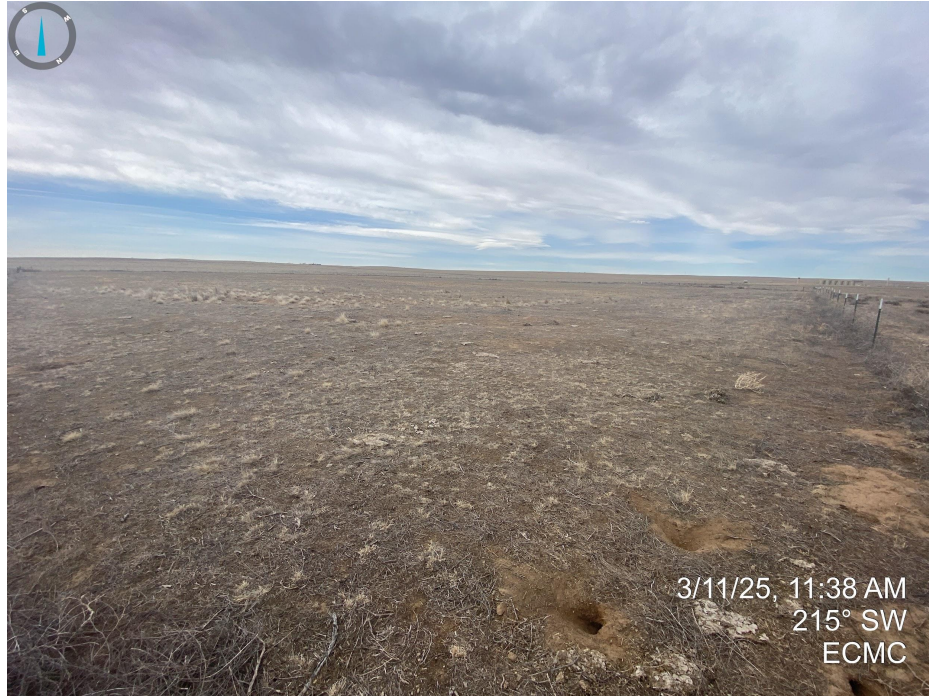
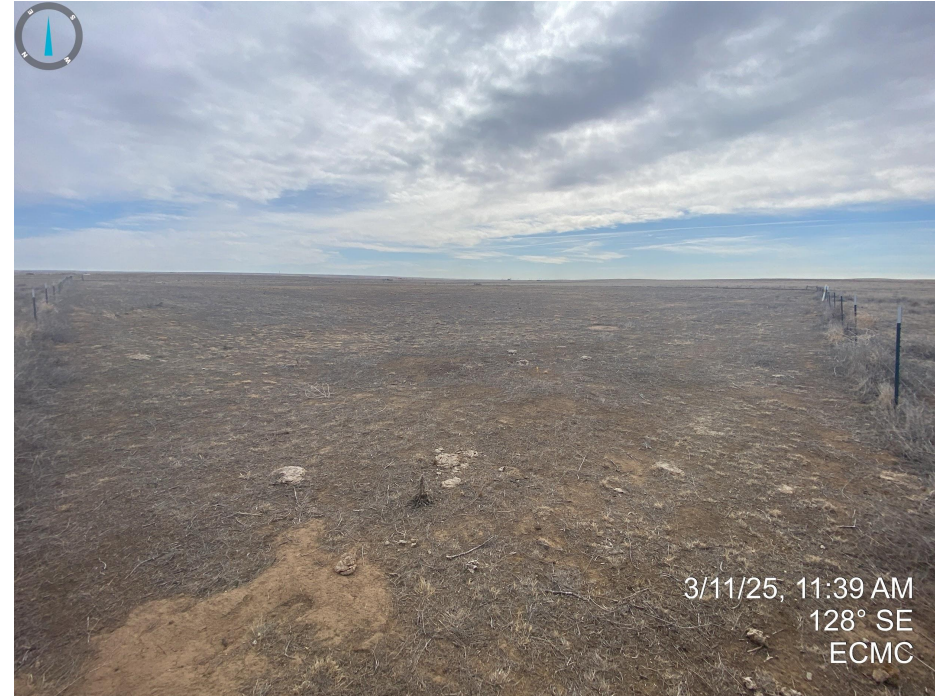
**Photos 7 & 8.** Taken from the northwest (Photo 7; left) and northeast (Photo 8; right) of the location. The former location doesn't appear to be progressing towards reclamation standards as the area is predominantly bare/unstabilized soils, with little evidence of desirable vegetation observed.

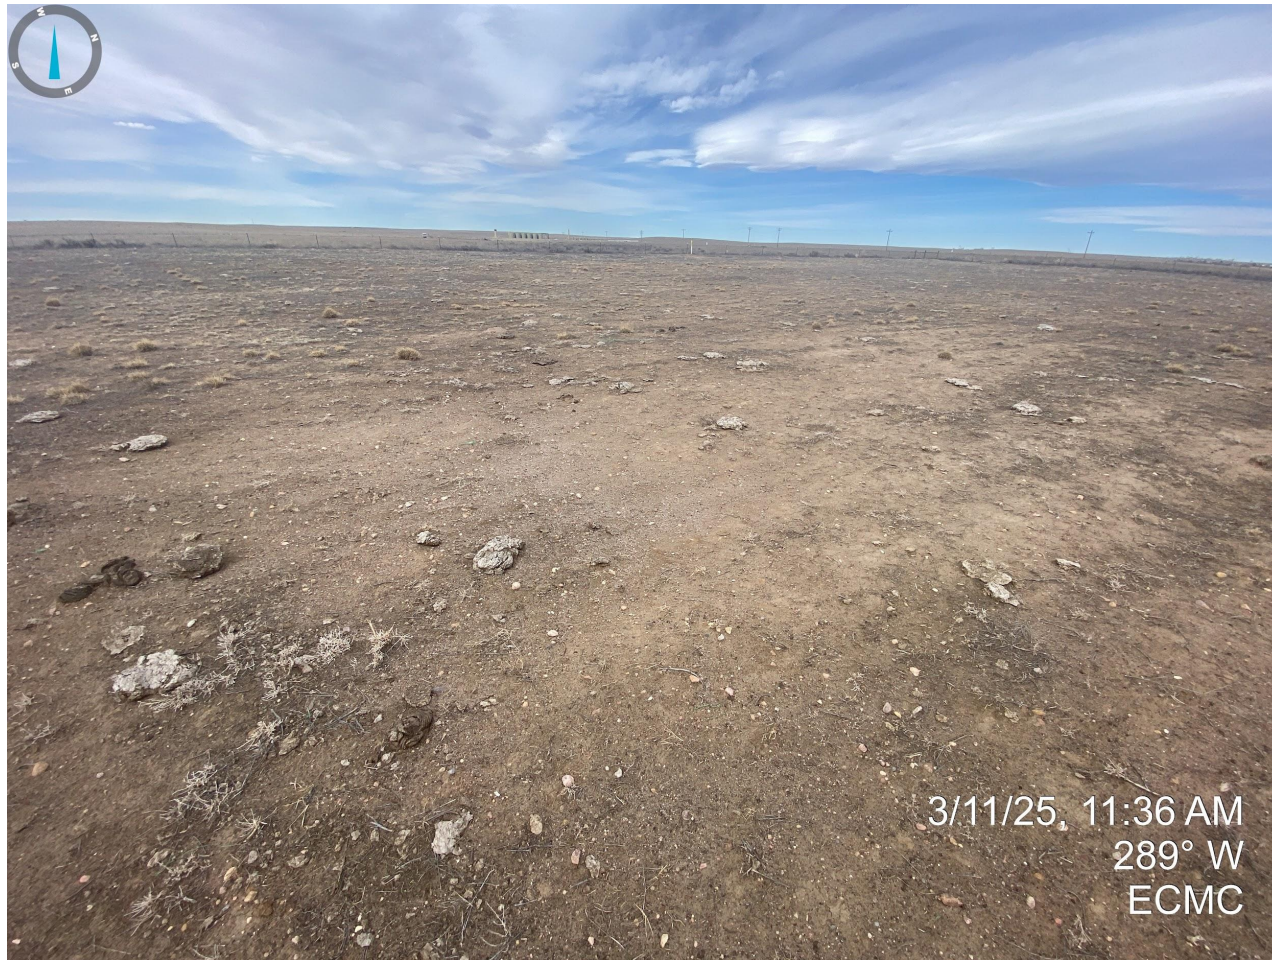
**Photo 9.** Taken near the well location. The former location doesn't appear to be progressing towards reclamation standards as the area is predominantly bare/unstabilized soils, with little evidence of desirable vegetation observed.
