Interim Reclamation and Stormwater Inspection

Operator: HIGHPOINT OPERATING CORPORATION -
10071

Location ID: 438766

Inspection Photos
Location Name: Will 6-62-15_22 NENW
Location ID: 438766

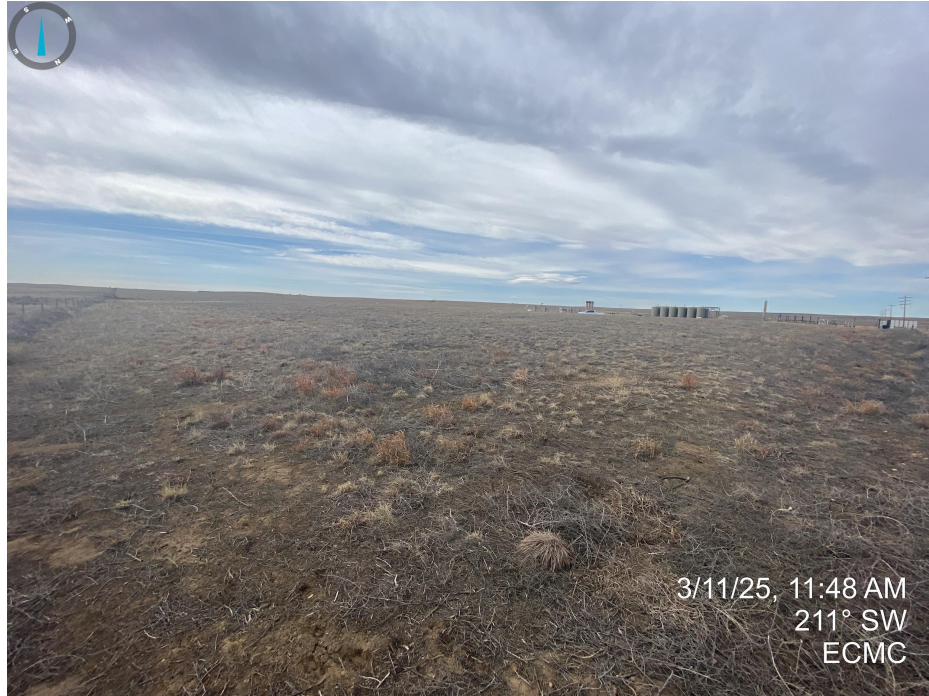
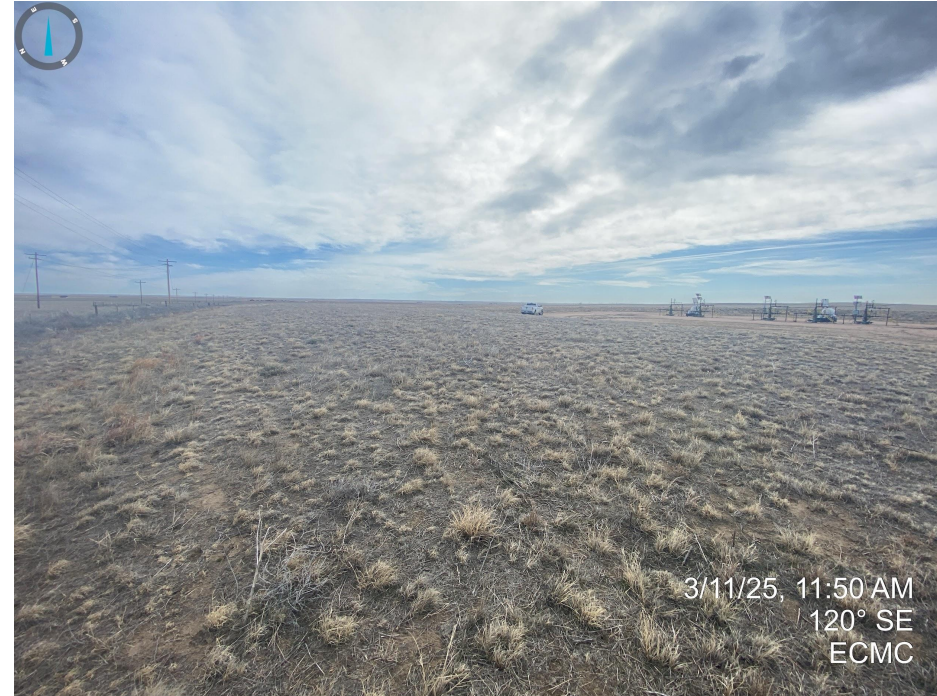
Photos 1 & 2. Taken from the northeast corner (Photo 1; left) and northern portion of the interim areas (Photo 2; right). Appears the Operator has performed interim reclamation activities to reduce disturbance areas only needed for production operations, with the evidence vegetation establishment observed in the interim areas. A follow-up inspection will be performed during the active growing season to verify vegetative compliance.

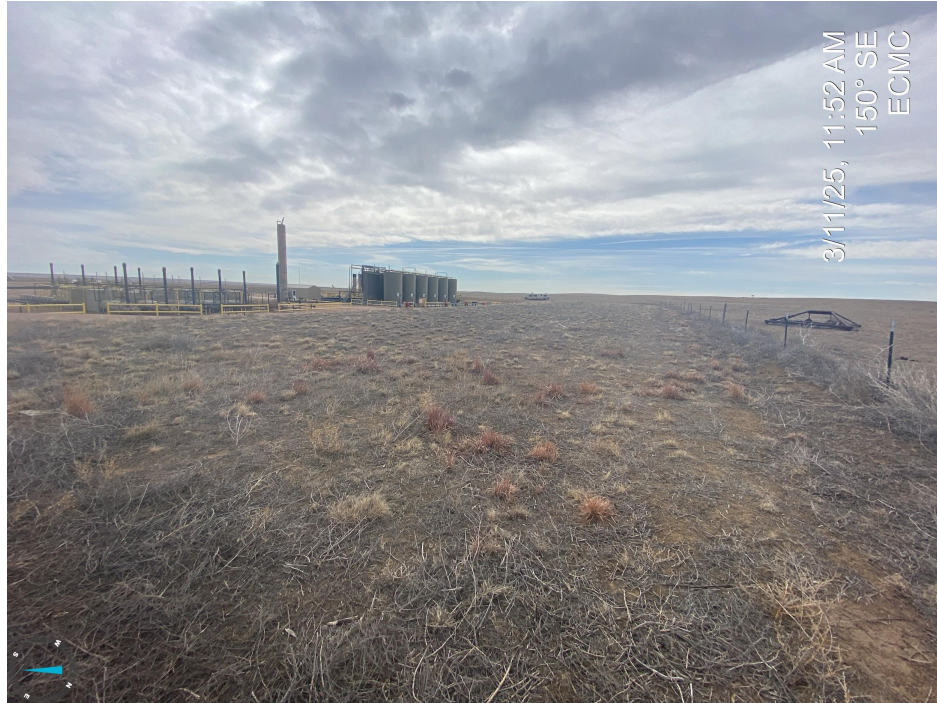
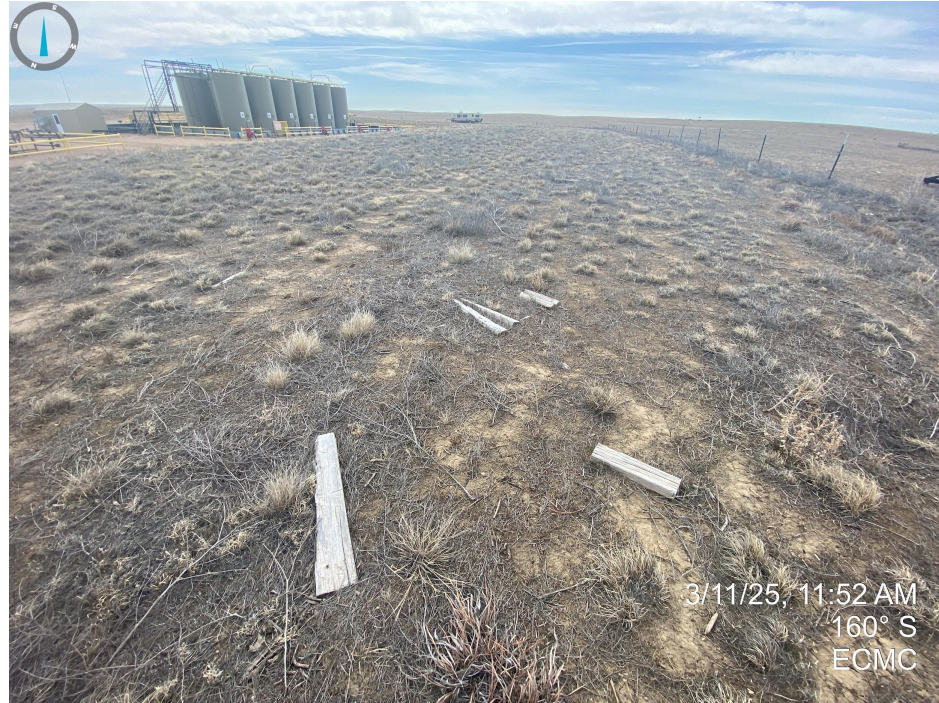
Photos 3 & 4. Taken from the northwest corner of the location (Photo 3; left), interim area pictured. Photo 4(right) illustrates example of trash/debris on the west side of the location.

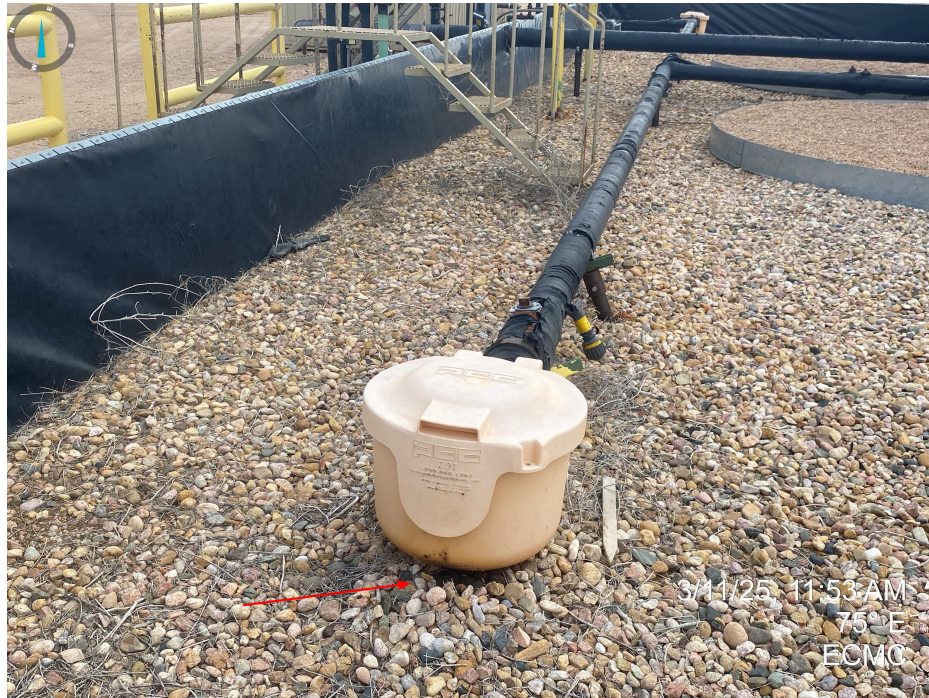
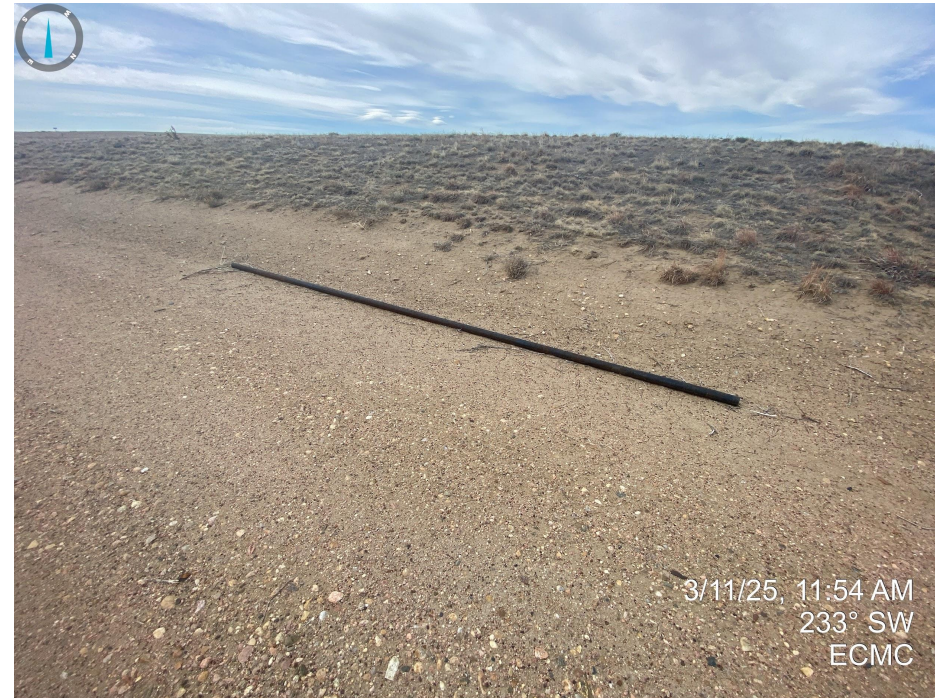
Photos 5 & 6. Hydrocarbon staining at loadout (Photo 5; left) and unused equipment on west side of tank battery (Photo 6; right).

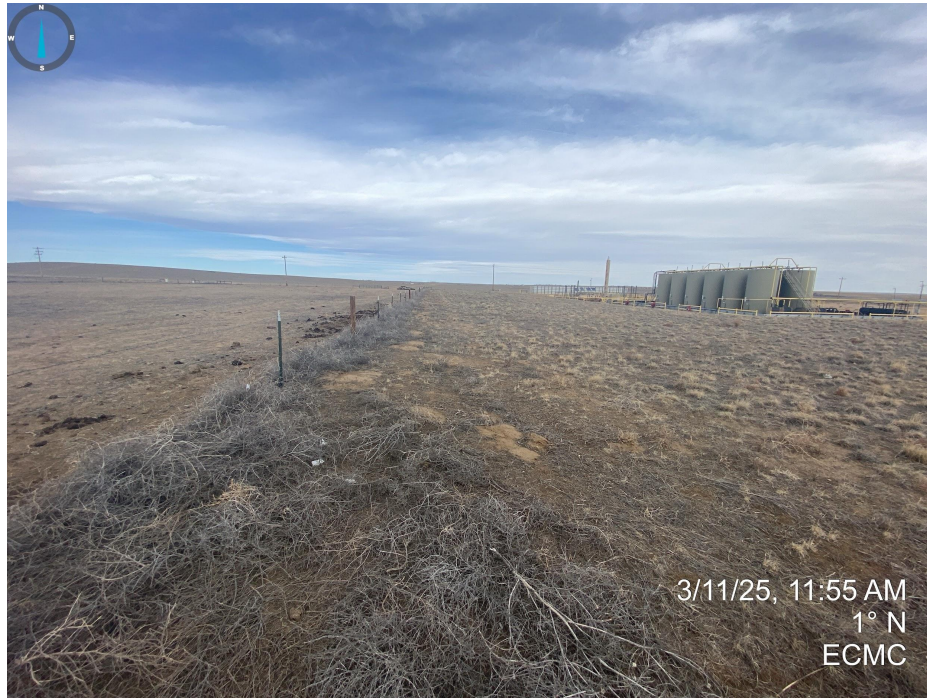
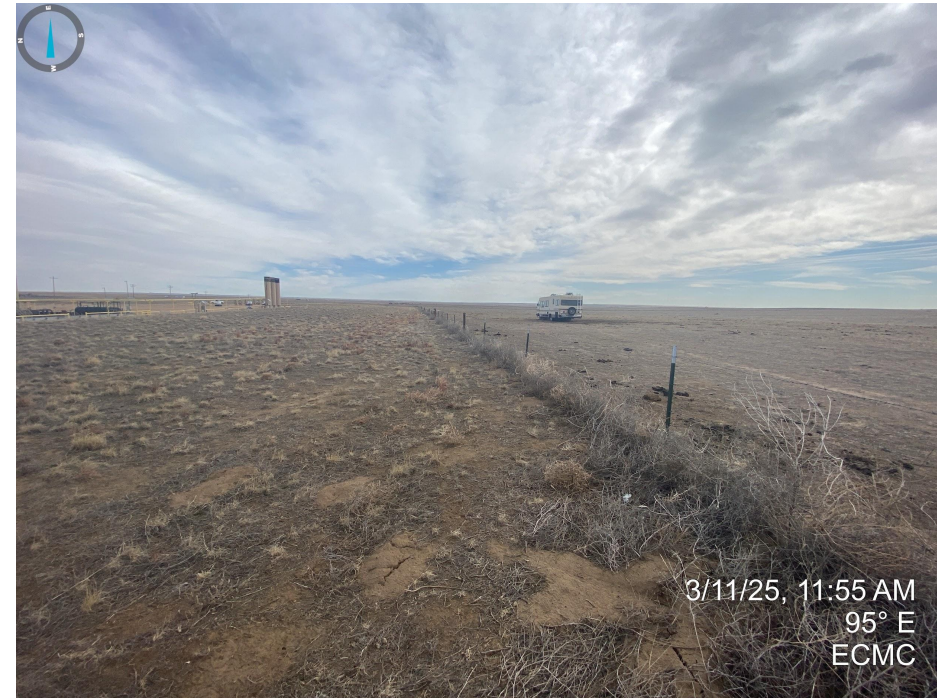
Photos 7 & 8. Taken from the southwest corner of the location. Appears the Operator has performed interim reclamation activities to reduce disturbance areas only needed for production operations, with the evidence vegetation establishment observed in the interim areas. A follow-up inspection will be performed during the active growing season to verify vegetative compliance. Also pictured, tumbleweed debris collecting along fence line.

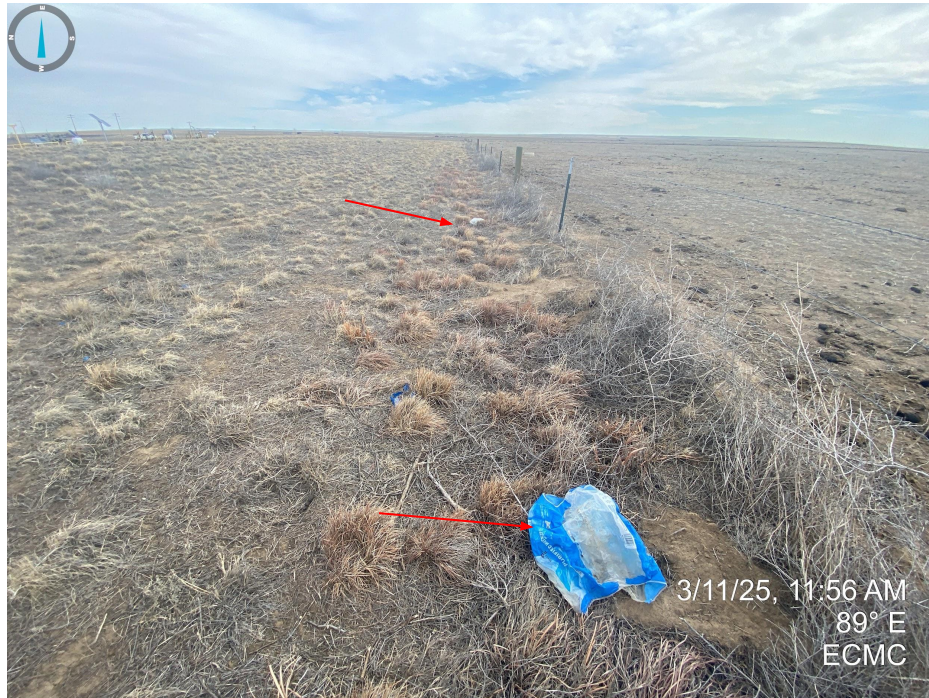
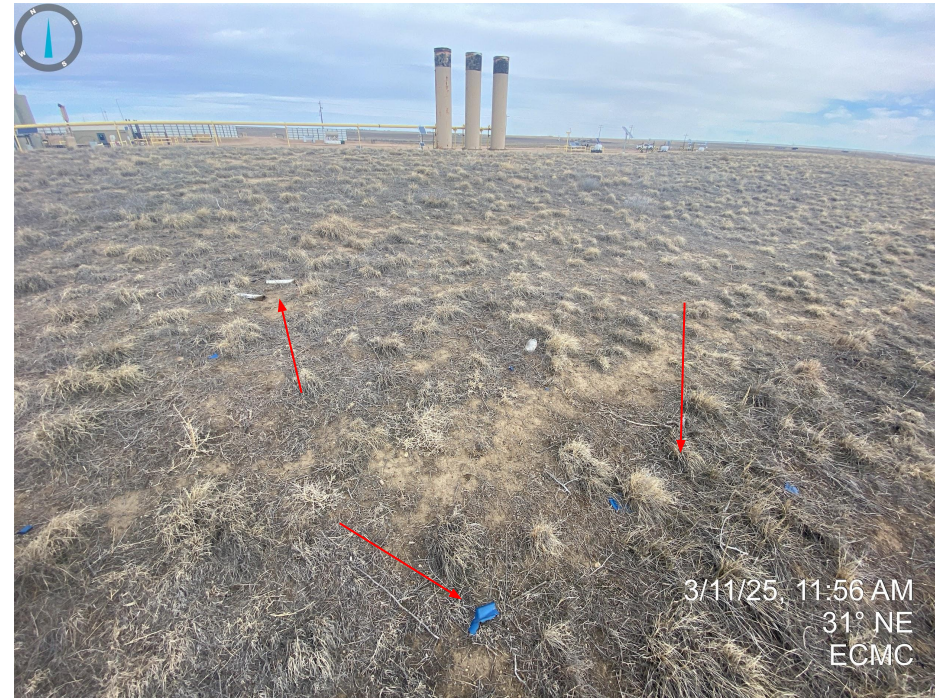
Photos 9 & 10. Examples of trash/debris observed on the southern portion of the location.

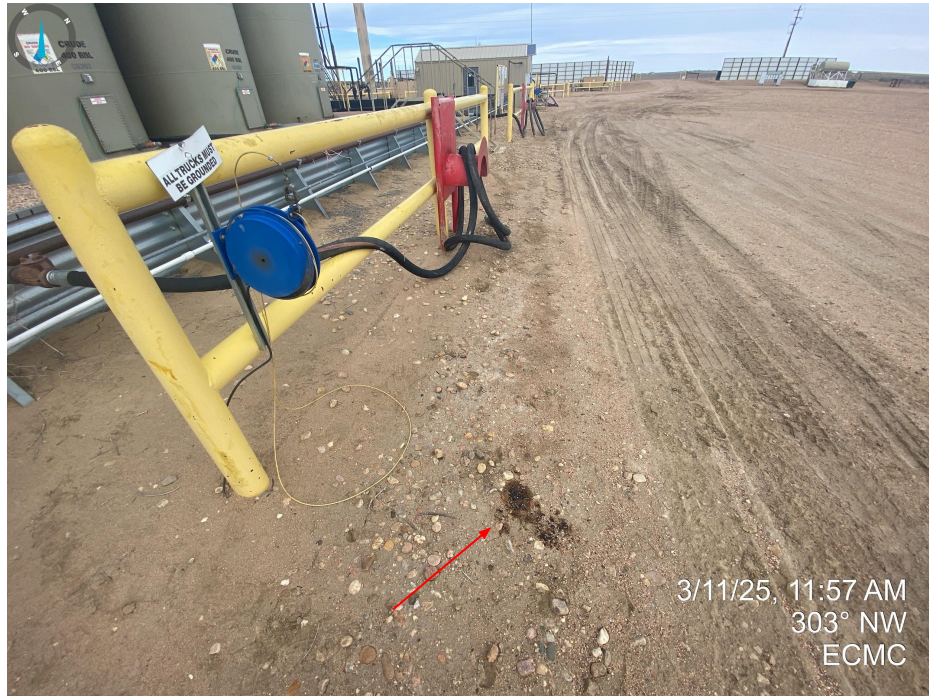
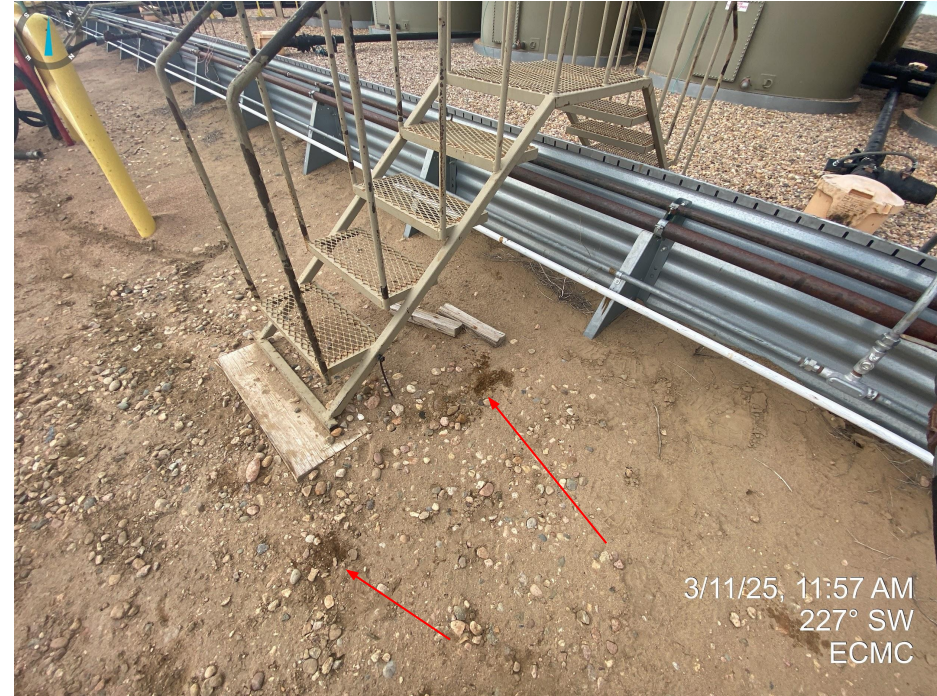
Photos 11 & 12. Hydrocarbon staining observed near tank battery.

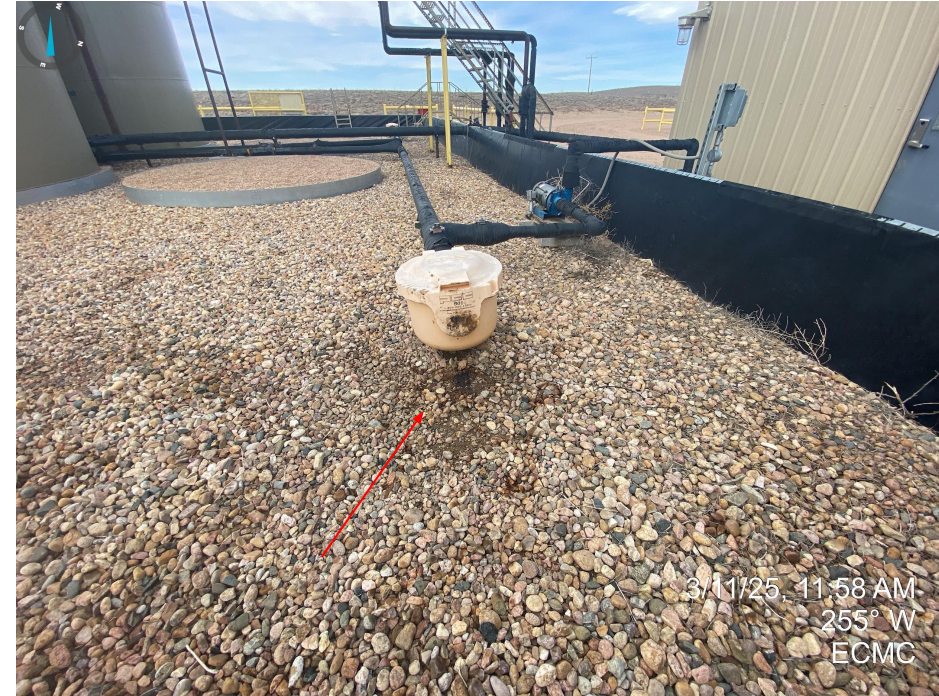
Photos 13 & 14. Hydrocarbon staining observed at loadouts within tank battery.

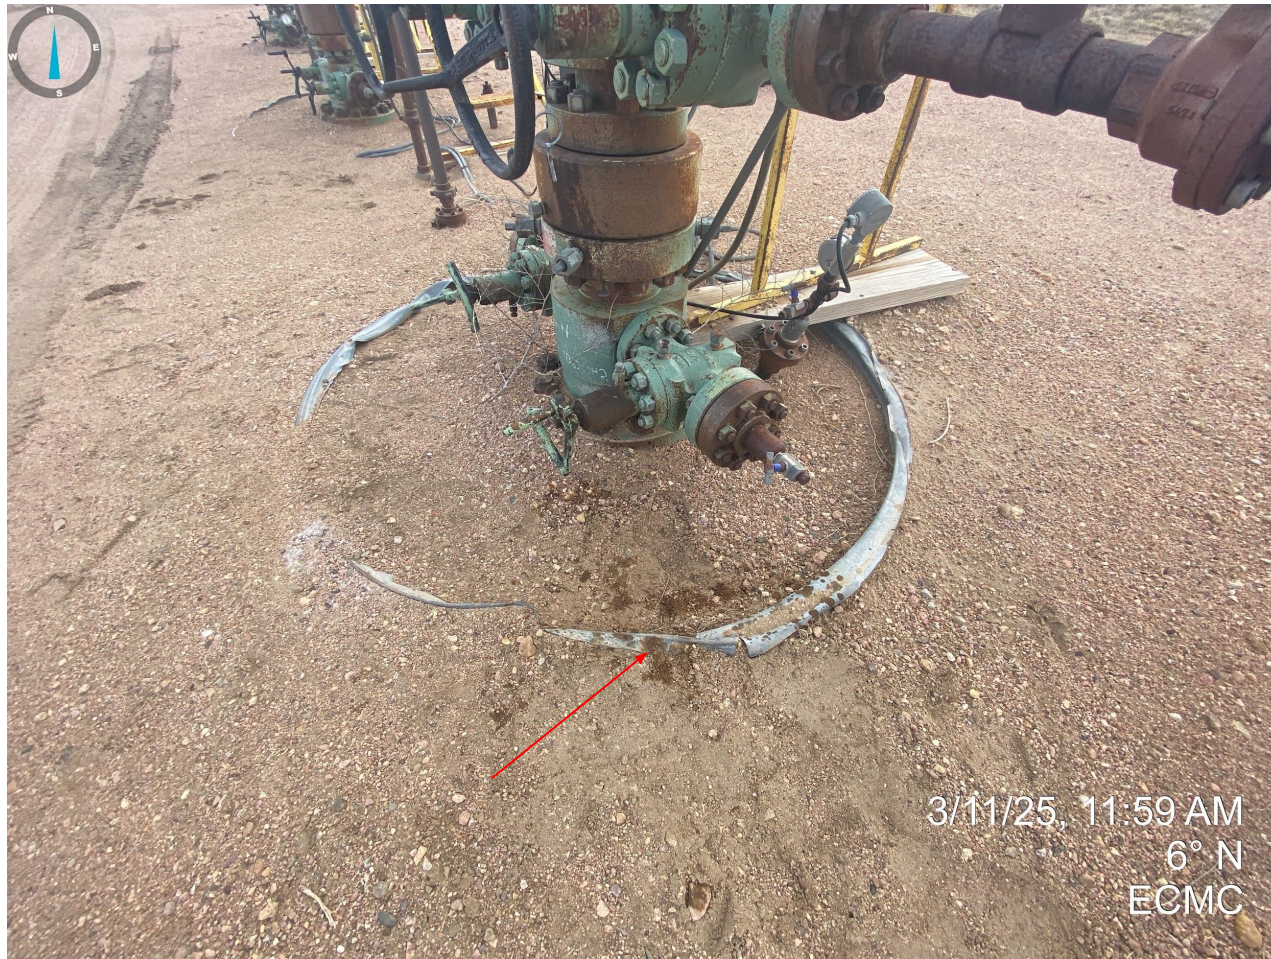
Photo 15. Hydrocarbon staining observed at wellhead.

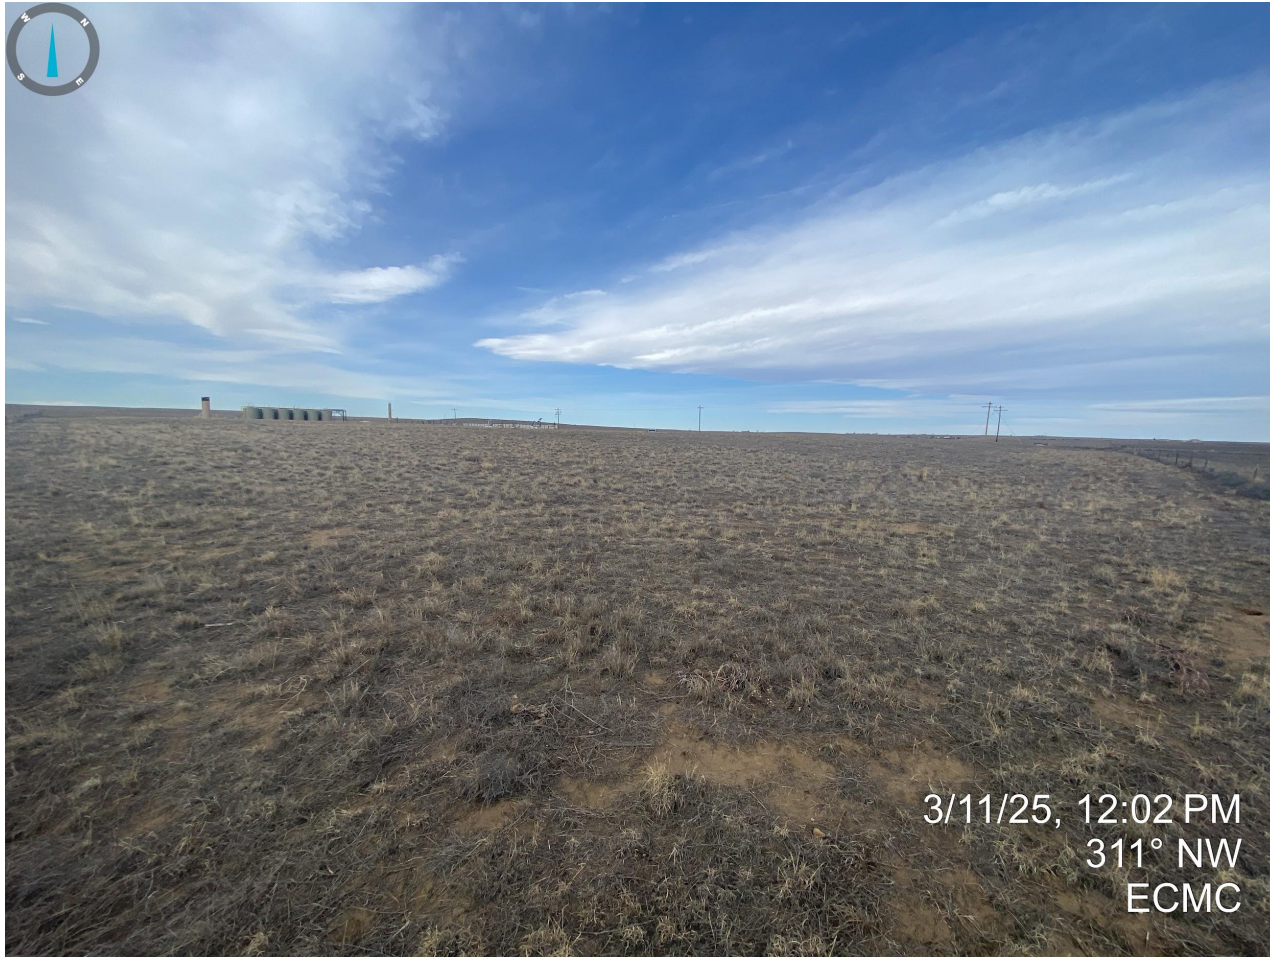
Photo 16. Taken from the southeast corner of the location. Appears the Operator has performed interim reclamation activities to reduce disturbance areas only needed for production operations, with the evidence vegetation establishment observed in the interim areas. A follow-up inspection will be performed during the active growing season to verify vegetative compliance.
