Sampling Photographic Log

Citation Arapahoe Unit 121 (23-32)

Arapahoe Unit 121 (23-32)
3/5/2025

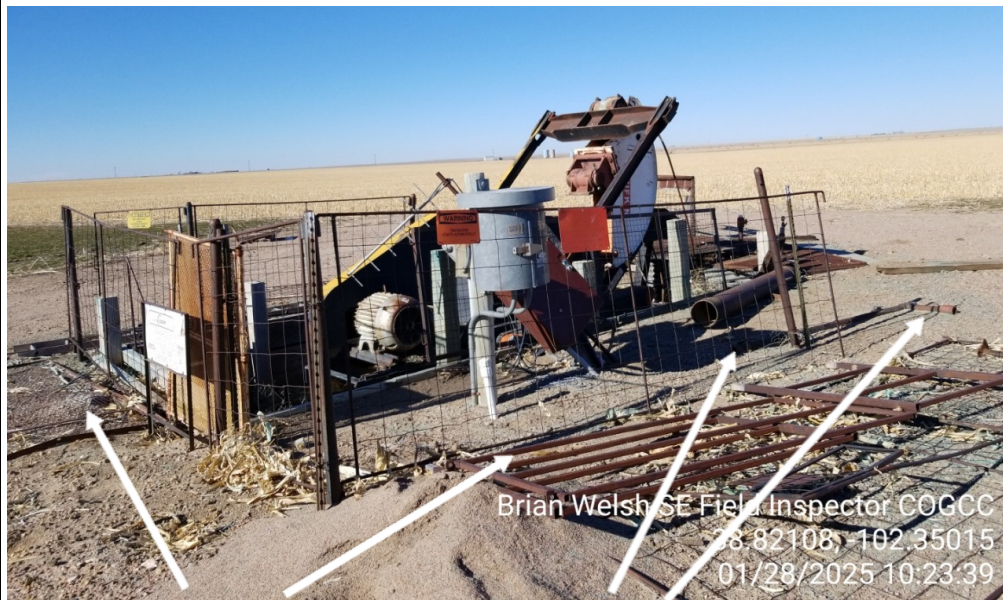
Fence down at location

Pipe laying on the ground.

1/28/2025 inspection
