**KT Resources LLC
Ant Hill Unit 21-22
Location ID: 398705**

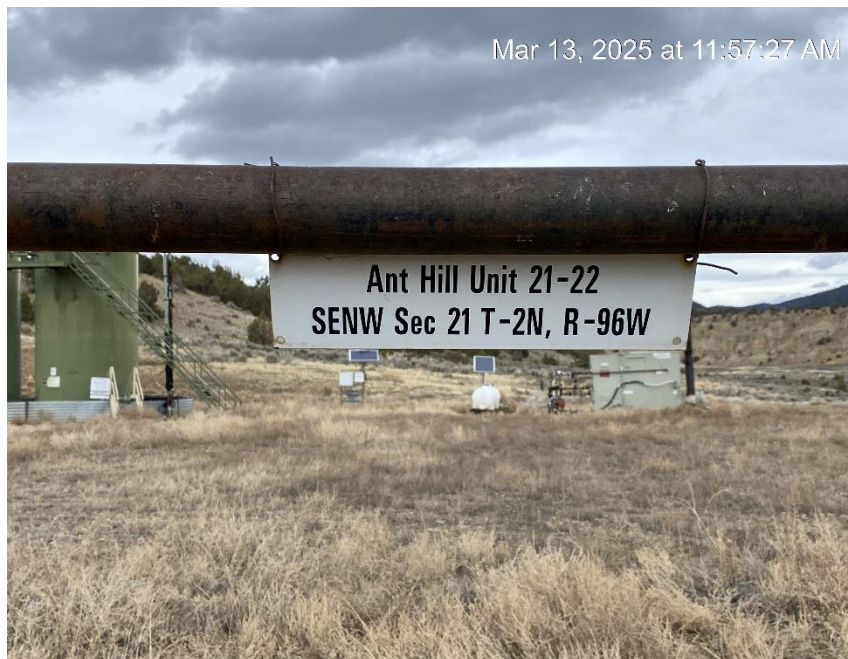
Missing required information

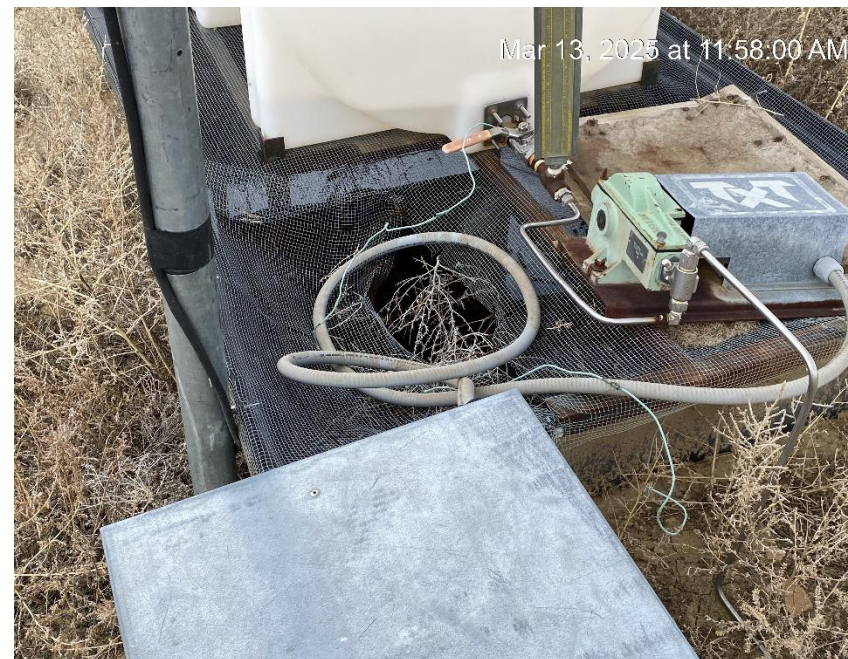
Open to wildlife

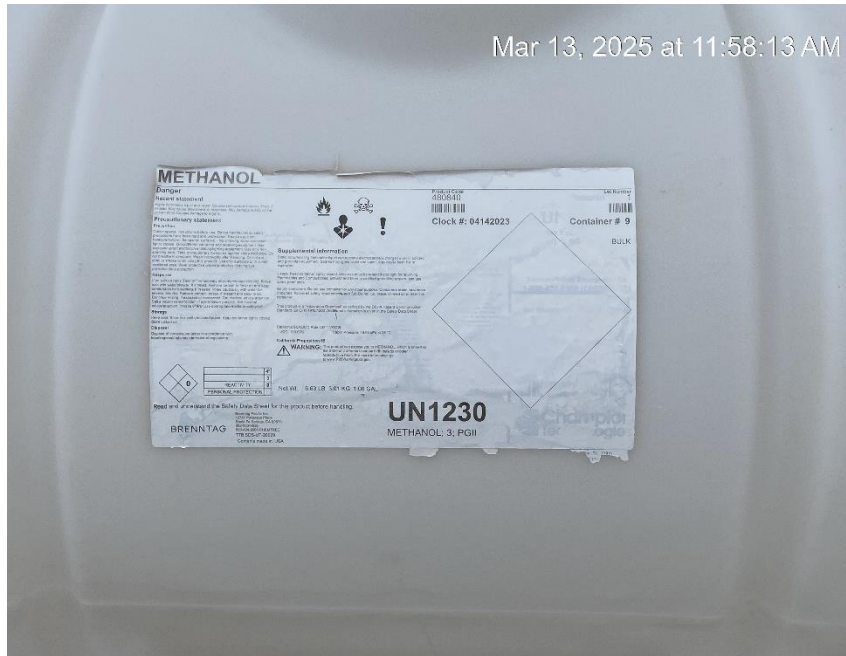
Inadequate label

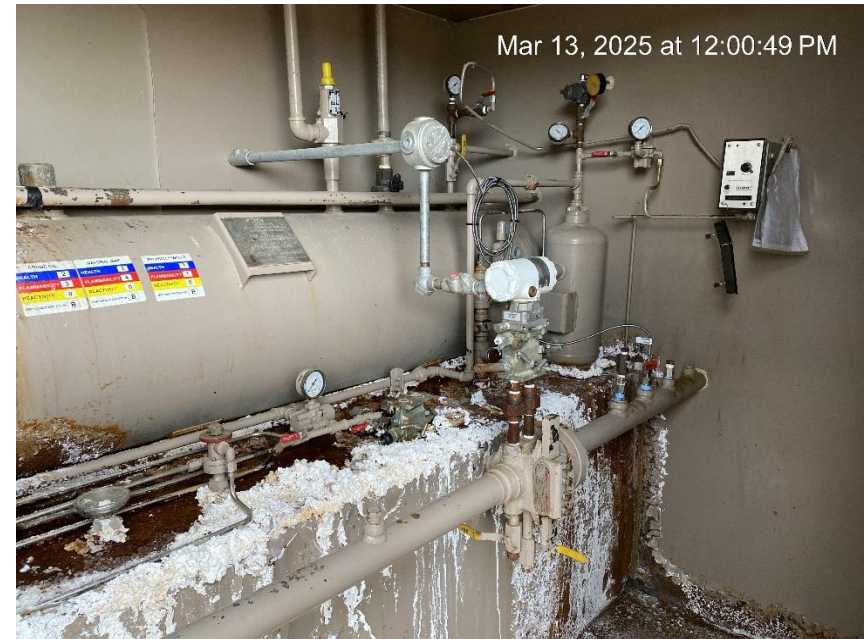
Leaking equipment. No gas calibration card displayed.

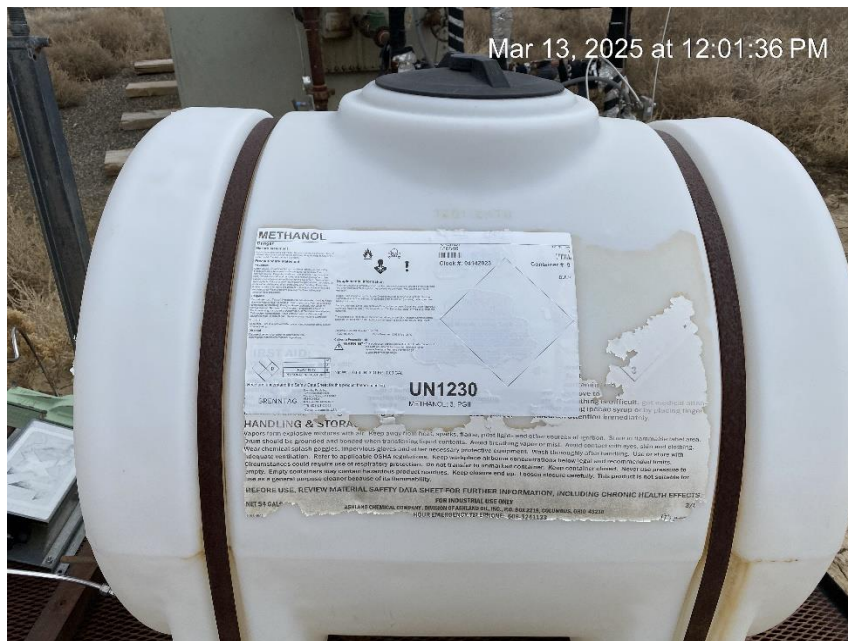
Inadequate label

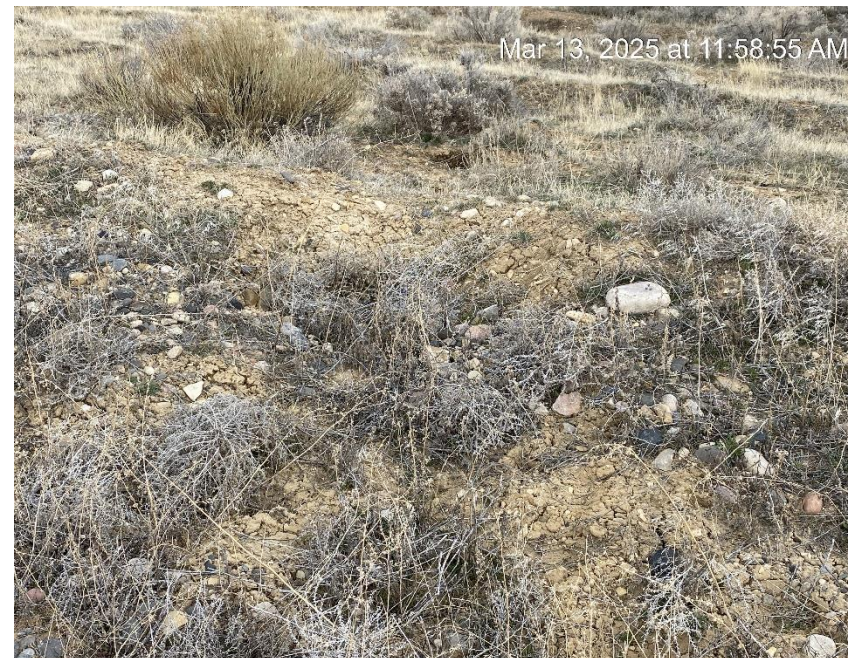
Erosion

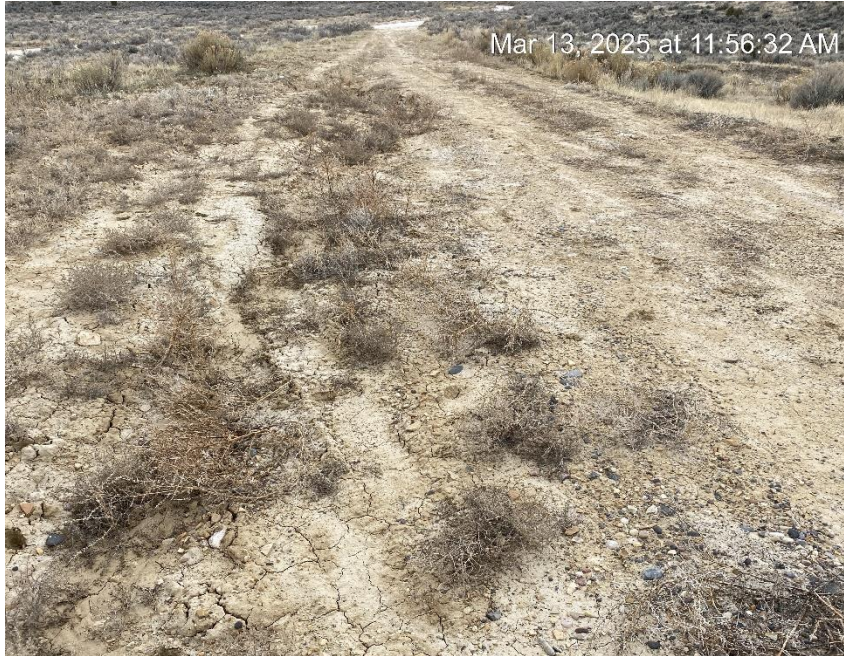
Erosion and sediment migration
