Inspection Photos

Loc: 484357

Operator: DESERT EAGLE OPERATING LLC

Inspection Date: 3/13/2025

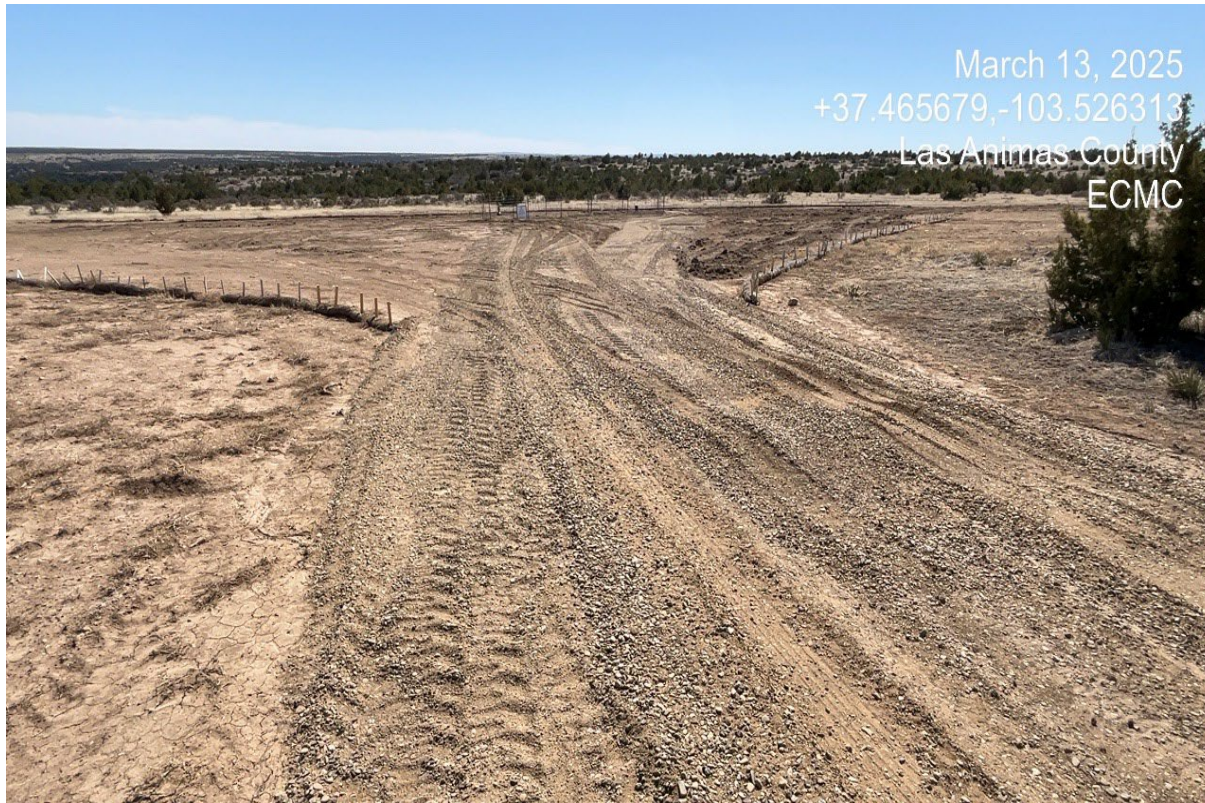
Photo 1. Facing south toward the access road and location. There has been roadbase applied along the road and wellsite.

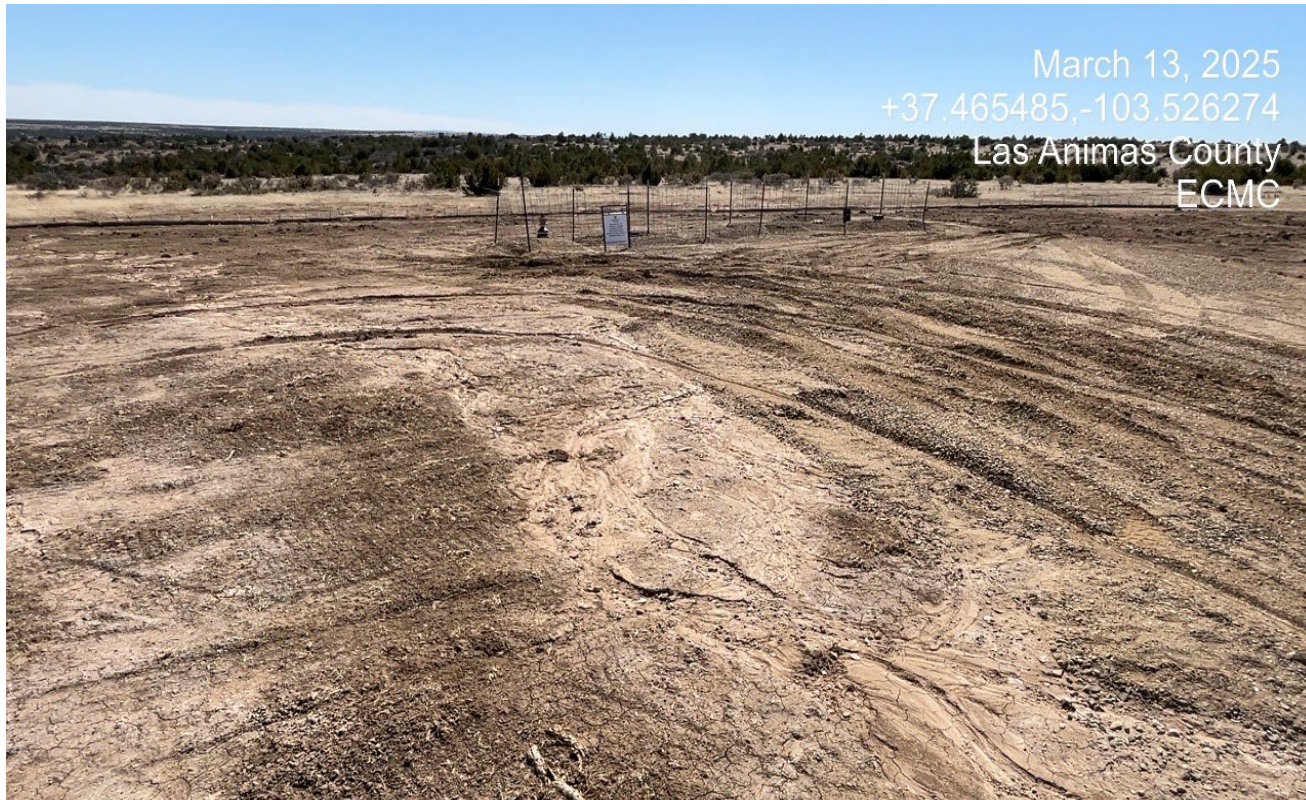
Photo 2. Facing southwest toward the wellsite. It appears clean up was performed but there still remains greyish material in this area.

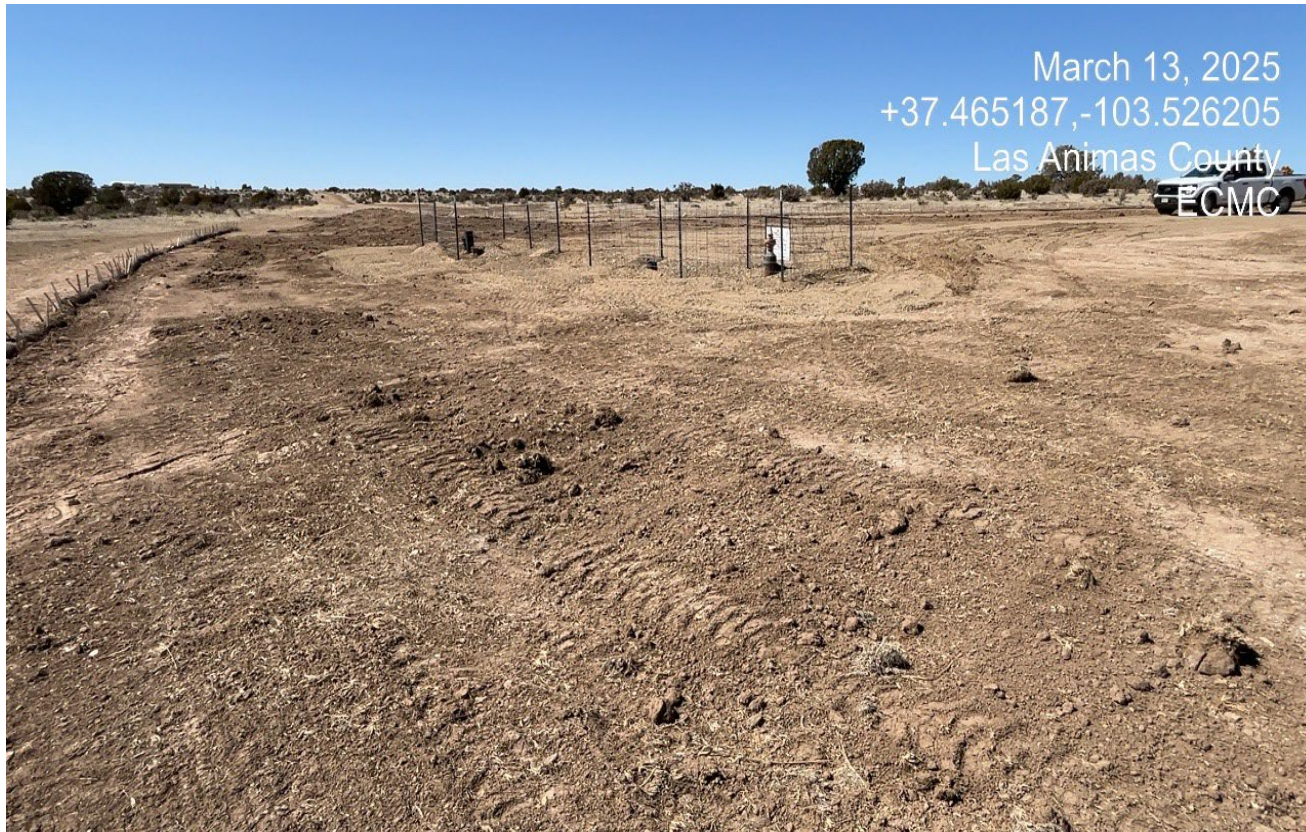
Photo 3. Facing northwest at the location. It appears the spill in this area was cleaned up but there was also fresh soil spread along this area.

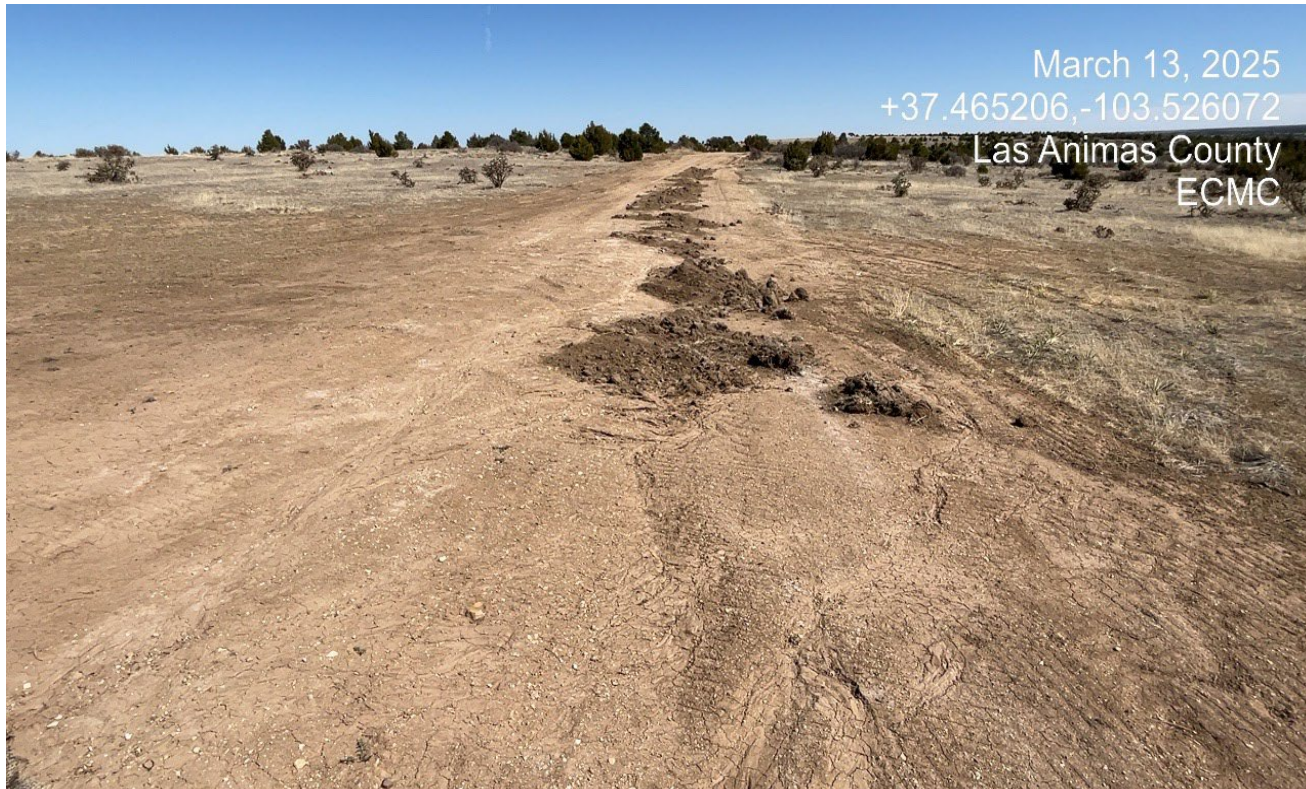
Photo 4. Facing east toward the flowline. There has been soil piles placed along the flowline in this area. This area will need to be graded and reseeded.

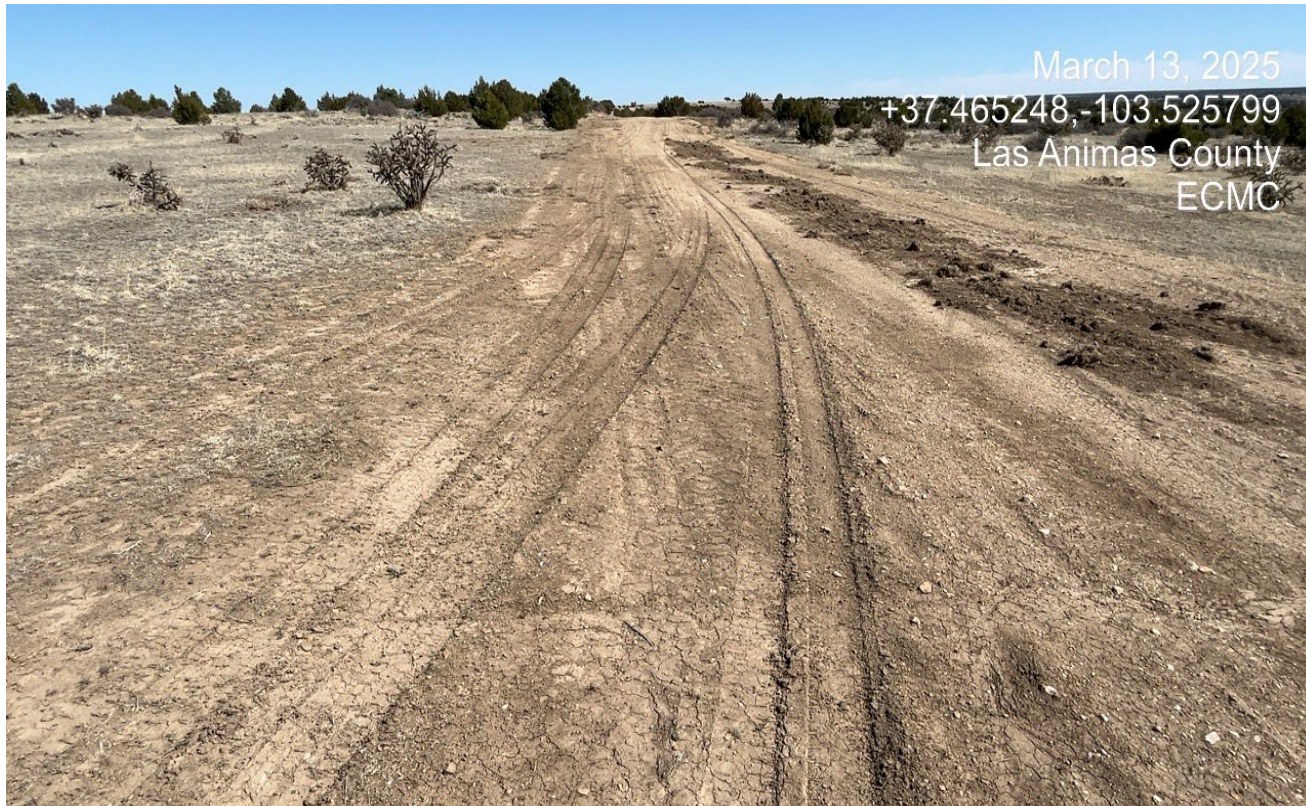
Photo 5. Facing east toward the flowline disturbance. There are fresh vehicle tracks which are causing unnecessary disturbance. This will require signage and BMP's to prevent vehicle access.

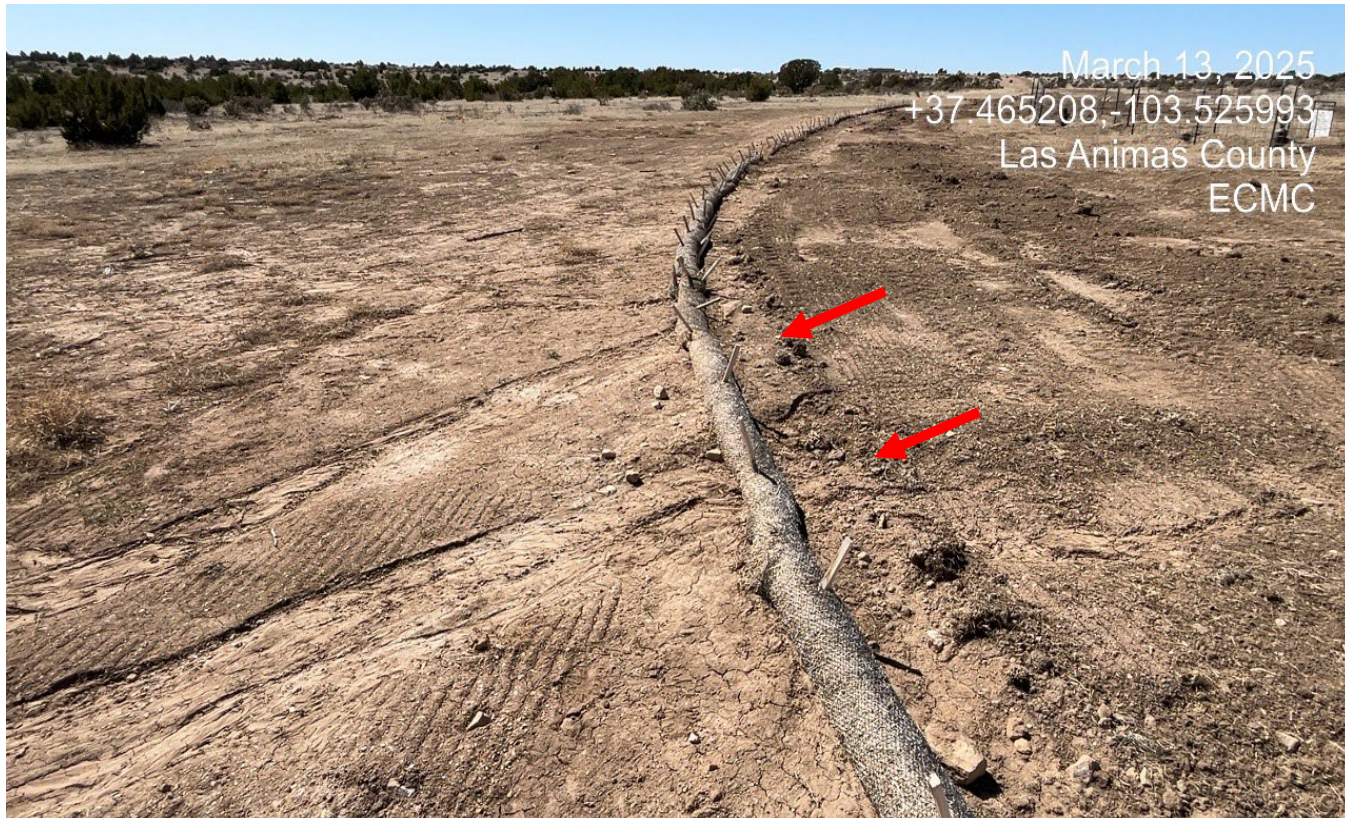
Photo 6. Facing west at south side of the location. There are signs of erosion undercutting the wattles which will require maintenance.

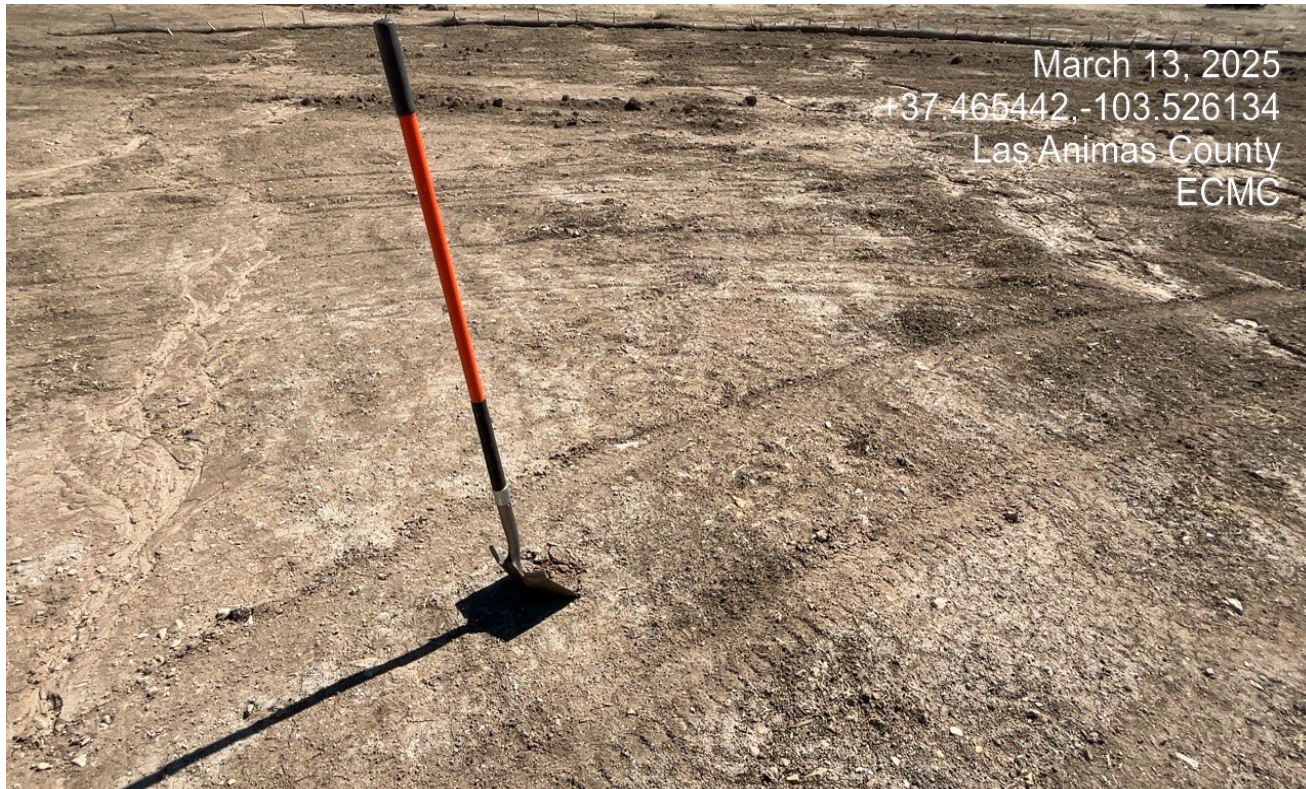
Photo 7. Using the shovel tye test for compaction, it seems area where vegetation is not establishing may have compacted soils. Decompaction must occur by cross-ripping to a depth of 18 inches per 1003 rules.
