Inspection/Audit Photos
Location Name: QB Energy BENZEL 36-3A1 (B36) Pad
Location #: 335228

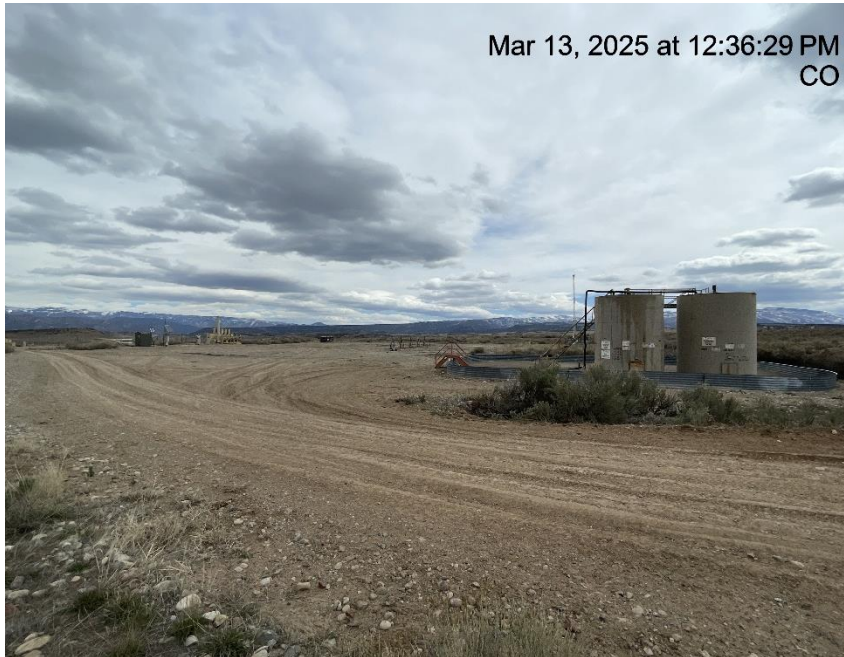
Photo # 3017 From entrance to location

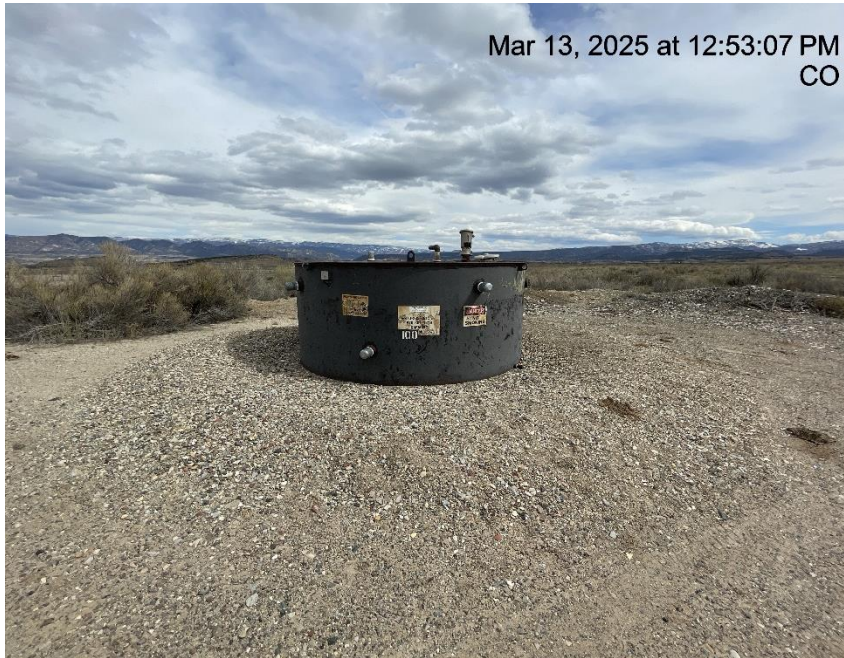
Photo # 3025 Secondary containment insufficient/does not comply with CECMC rules

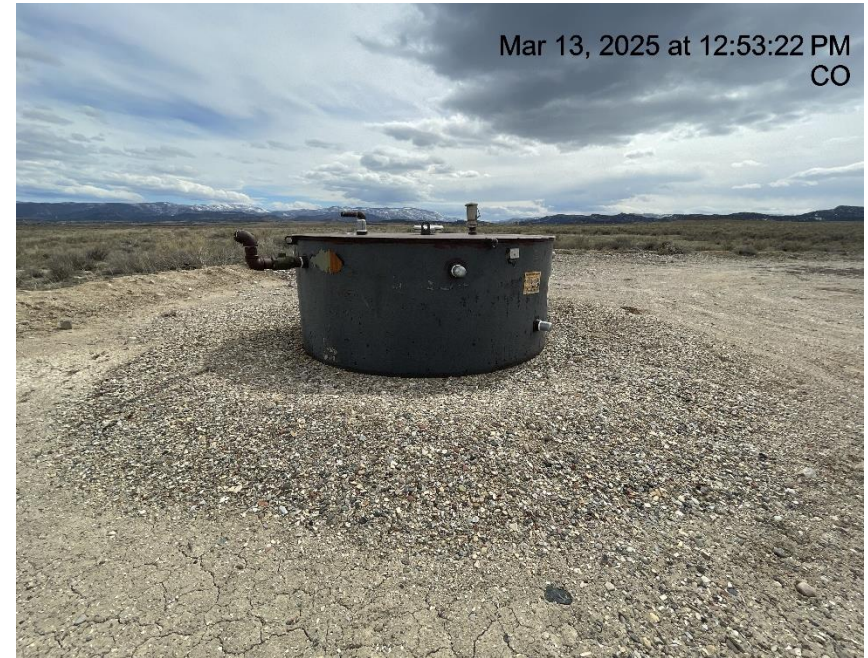
Photo # 3026 Secondary containment insufficient/does not comply with CECMC rules

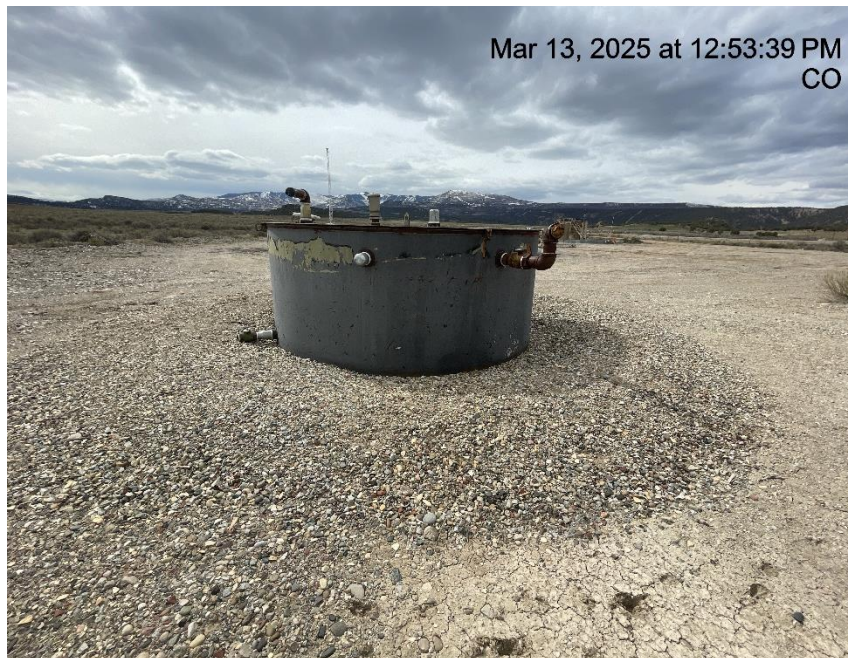
Photo # 3027 Secondary containment insufficient/does not comply with CECMC rules

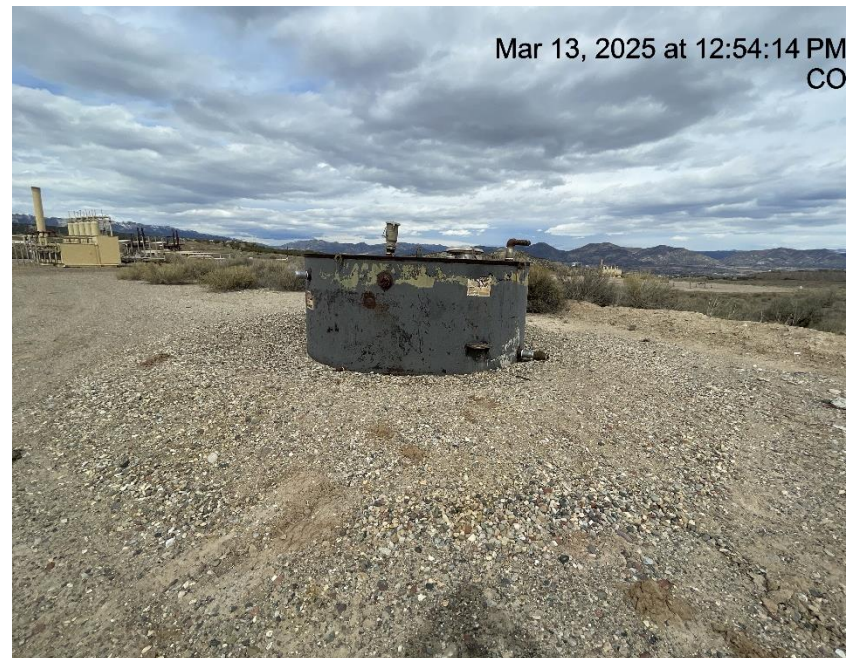
Photo # 3028 Secondary containment insufficient/does not comply with CECMC rules

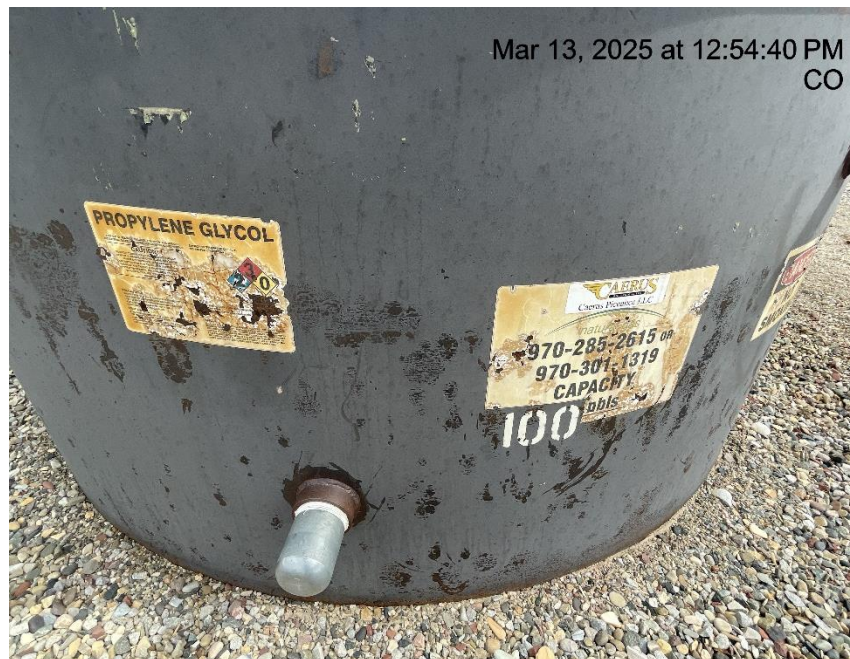
Photo # 3029 Tank labels damaged & additionally tank capacity is incorrect
