Inspection/Audit Photos

Location Name: TEP ROCKY MOUNTAIN LLC Savage RWF 23-25 Frac

Location ID: 433757

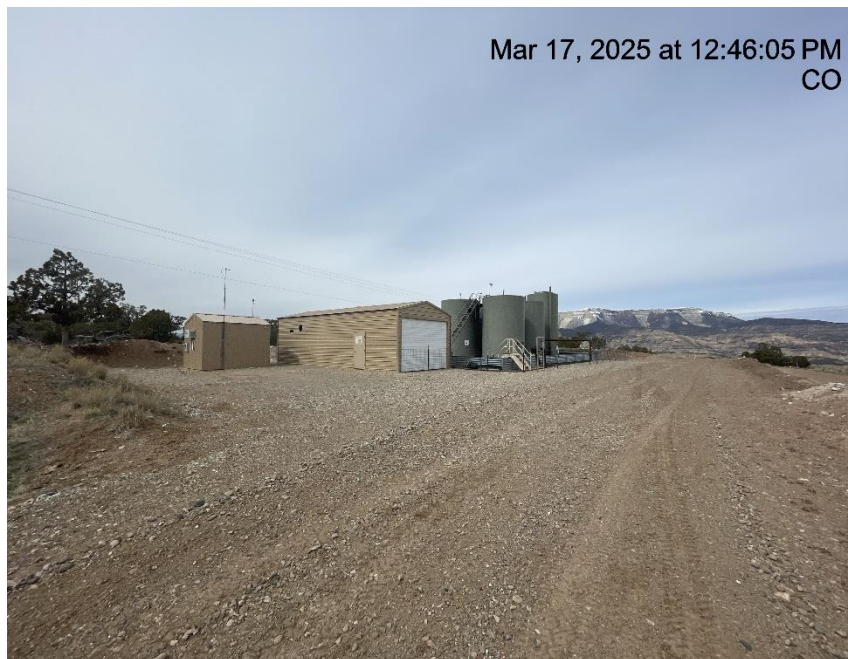
Photo # 4647 From entrance to location

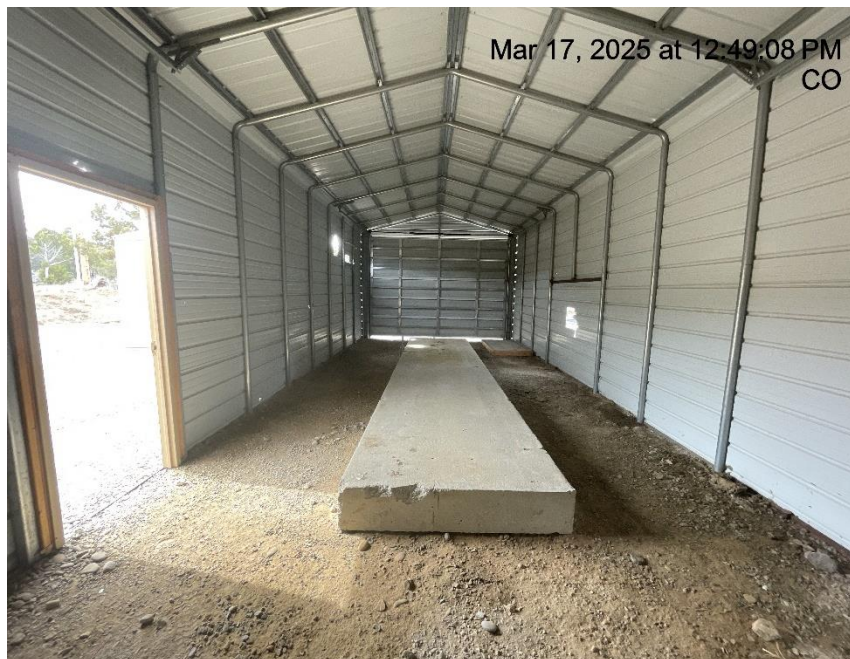
Photo # 4651 Interior of pump house

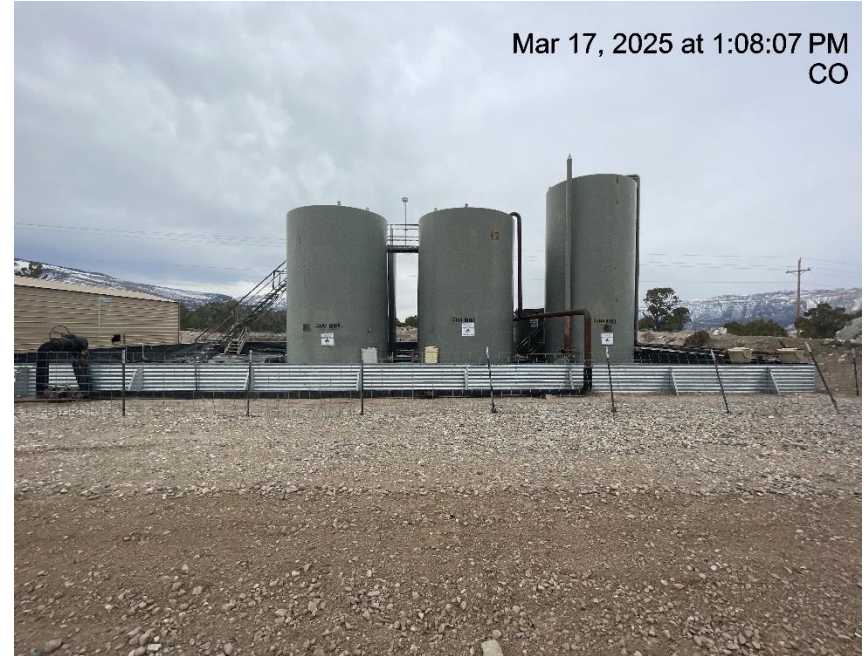
Photo # 4656 Battery lacks required signage/not in compliance with CECMC rules

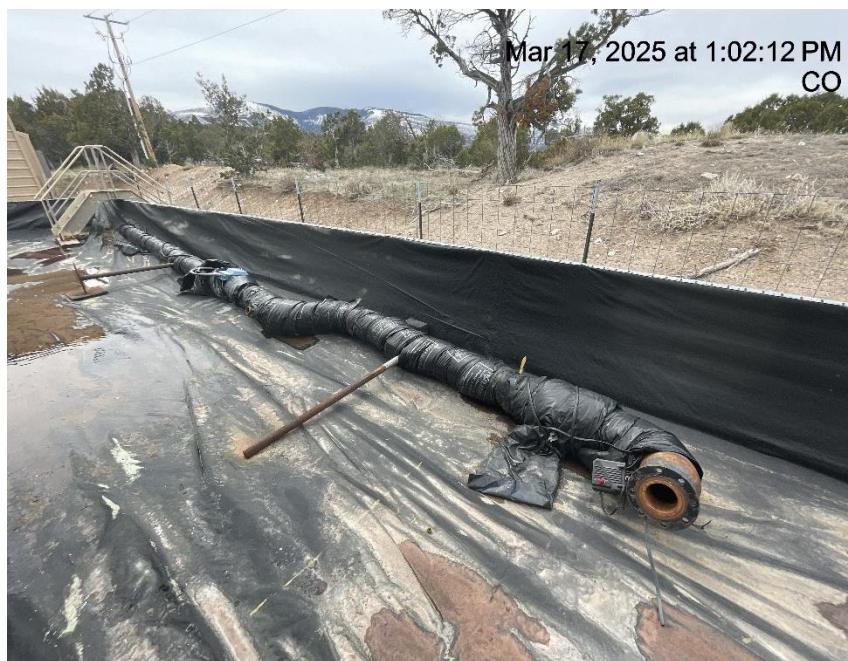
Photo # 4657 Disconnected piping

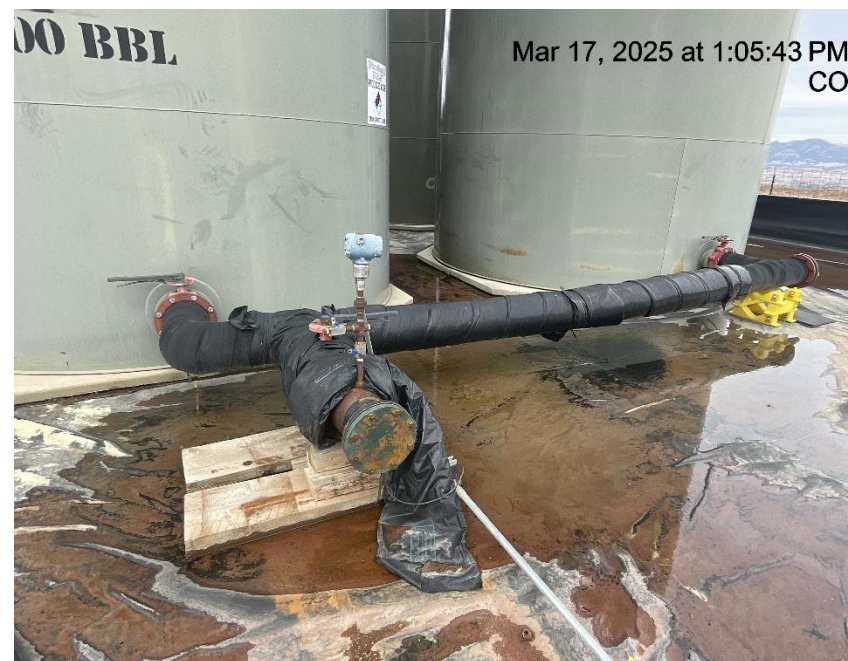
Photo # 4658 Piping disconnected & blind flanged

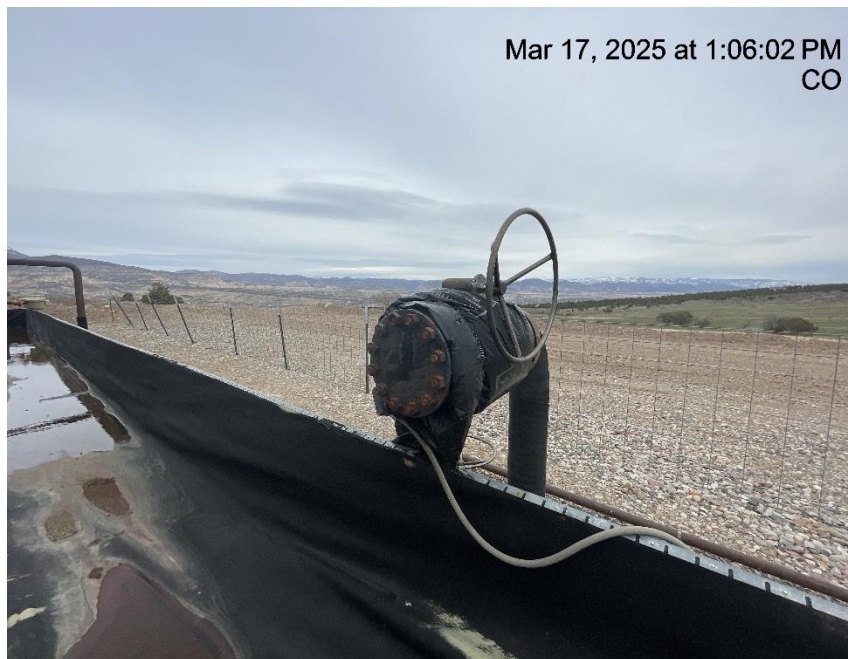
Photo # 4659 Piping disconnected & blind flanged

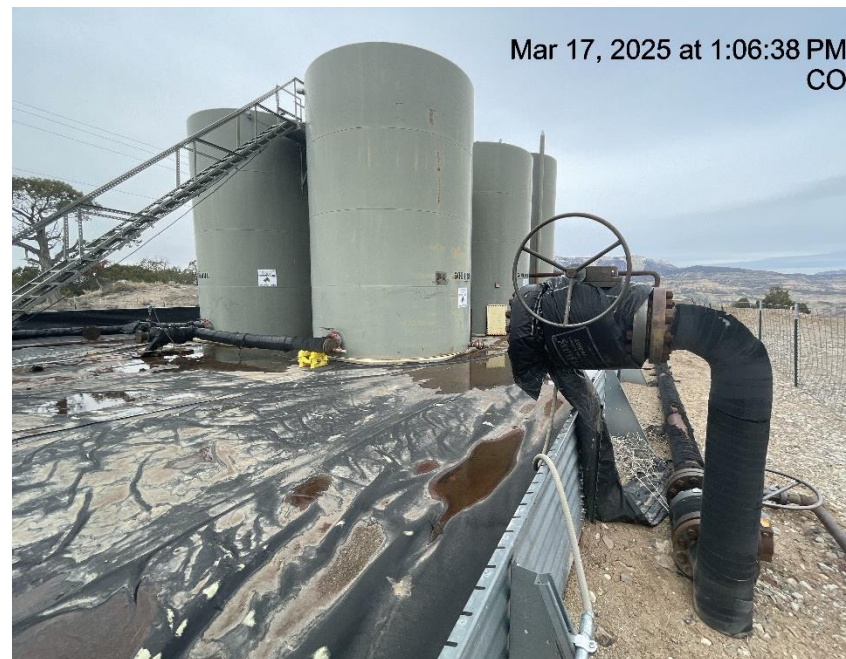
Photo # 4660 Piping disconnected & blind flanged
