# Inspection Photos

**Operator:** CAERUS PICEANCE LLC - 10456

**Location ID:** 335676

**Inspection Doc:** 718100310

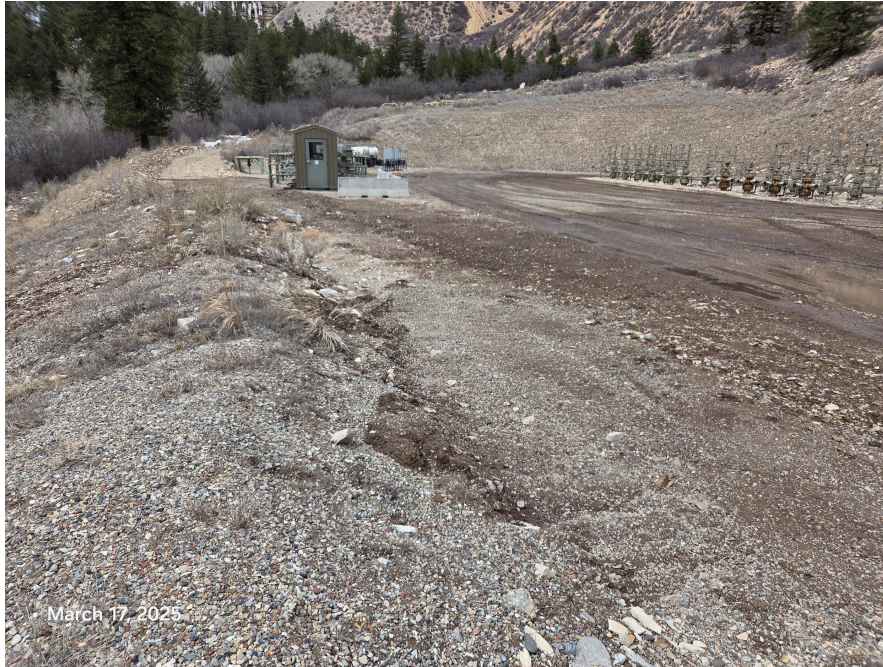
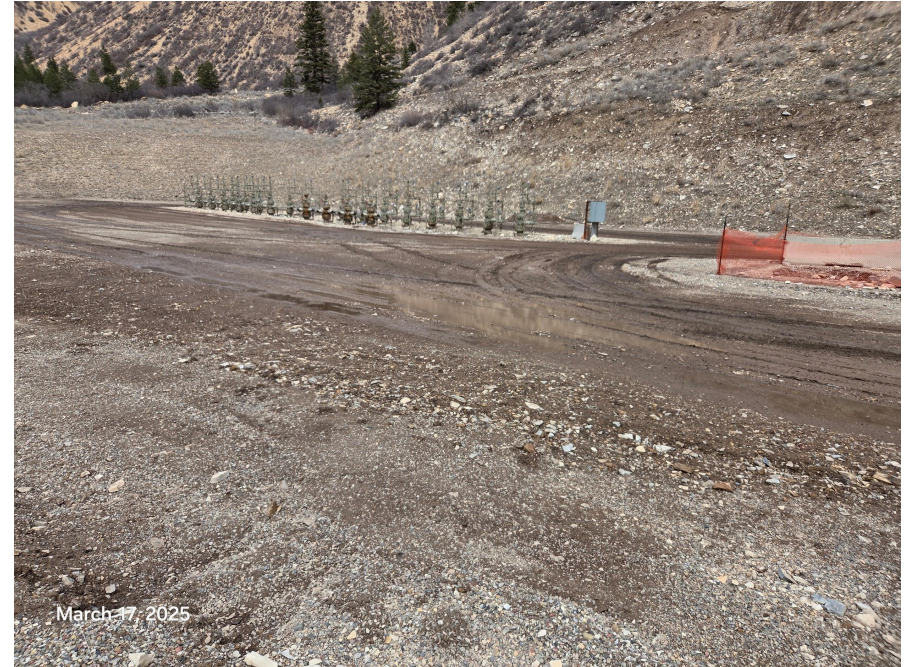
**Photo 1:** Photos 1-2 taken from the southwest end of the working pad surface. Photos provide an overview of the Location from northwest, north, northeast to southeast.

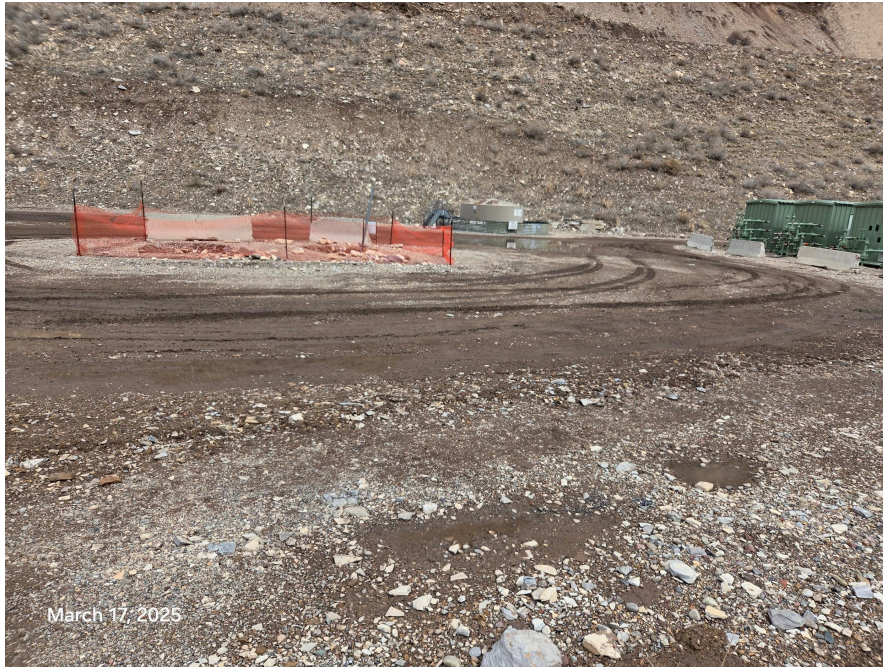
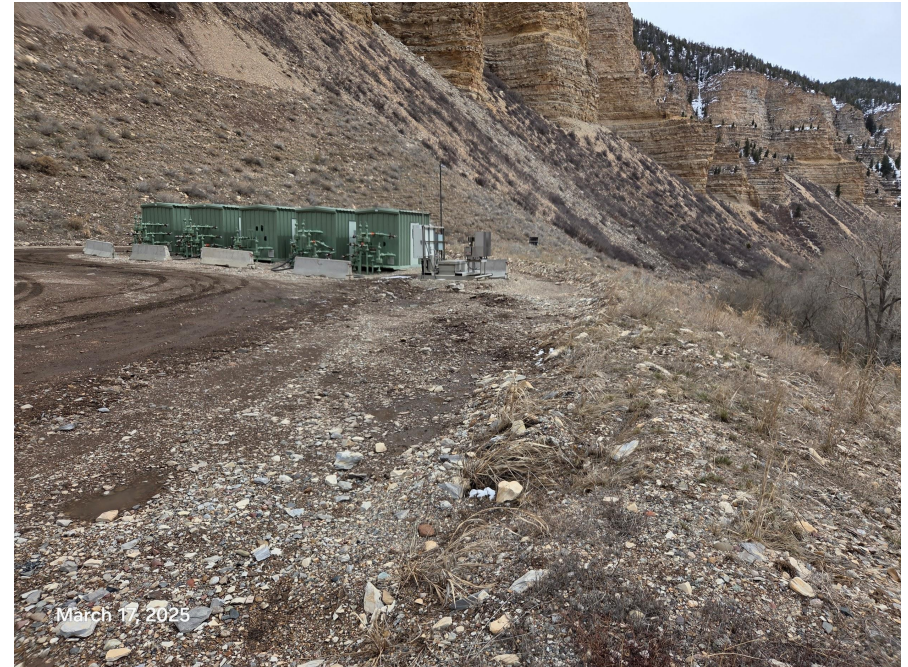
**Photo 2:** See comments under photo 1.

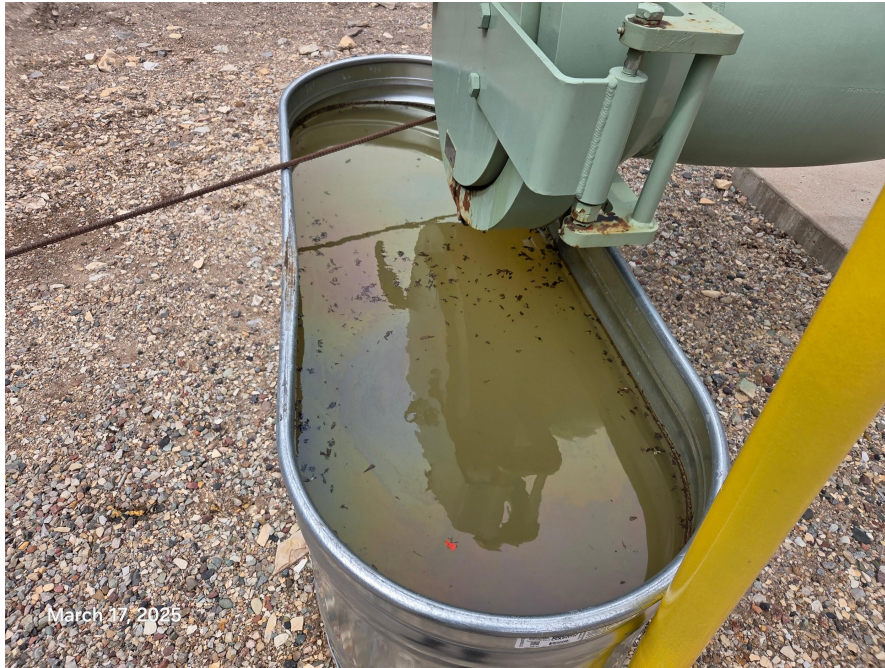
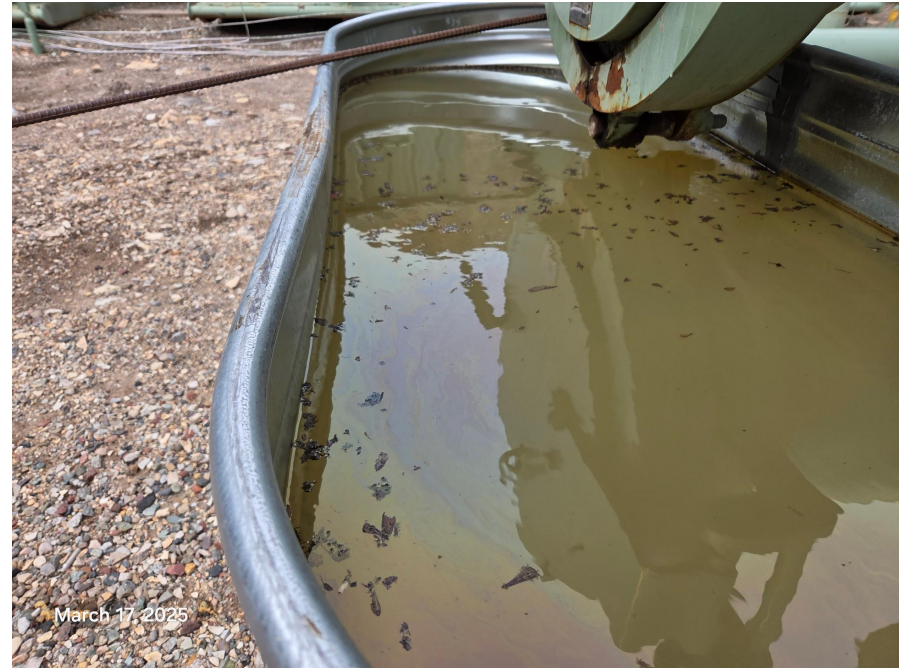
**Photo 3:** Photos taken from the pipeline equipment on the southeast end of the Location. Photo shows containment measure has filled with fluid, and a chemical sheen is apparent. Photo also shows wildlife protection measures are missing or insufficient.

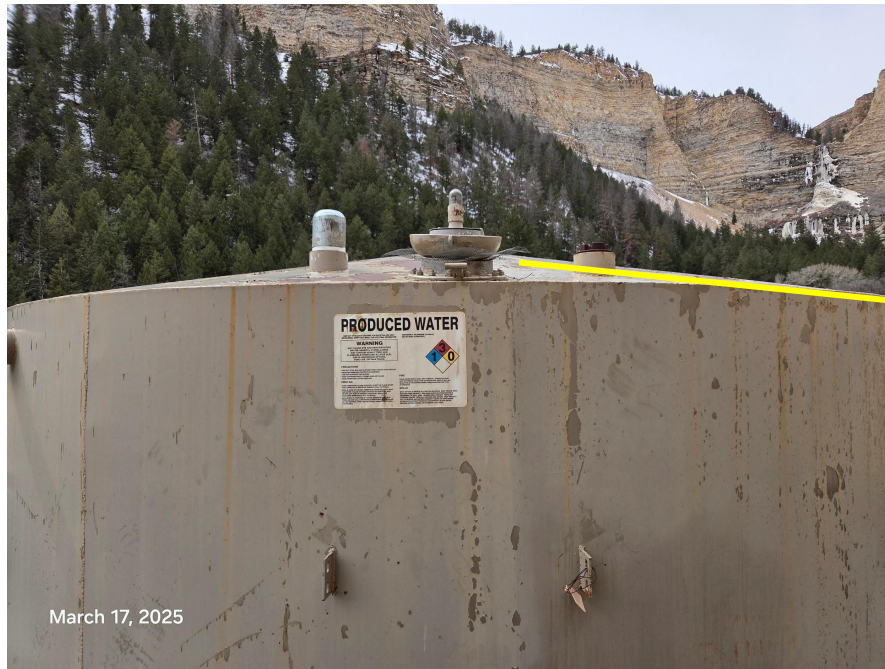
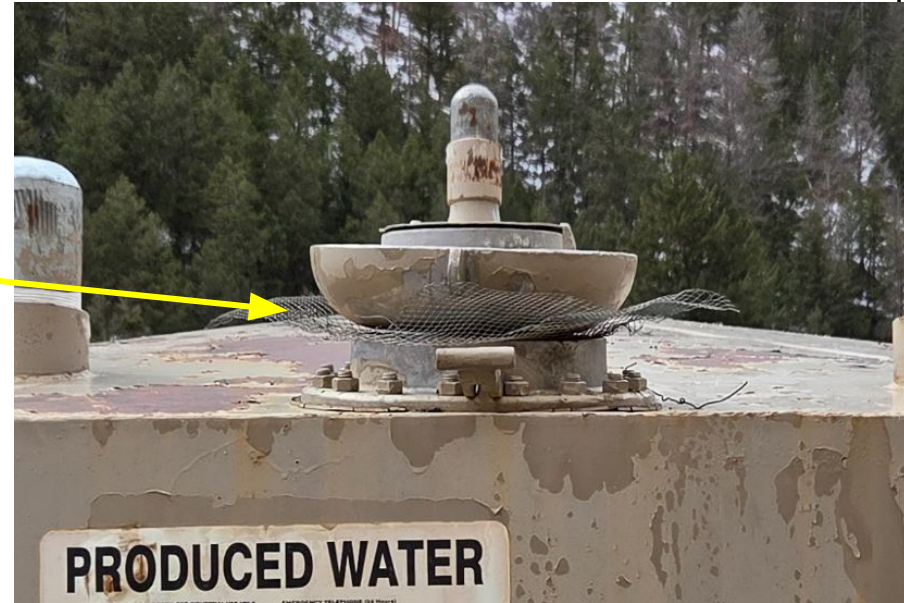
**Photo 4:** Photos taken from the produced water tank on the east end of the Location. Photo shows tank hatch is broken; Operator appears to have taken the top portion of the hatch and placed it upside down over the opening. Tank is improperly closed to prevent emissions from venting.

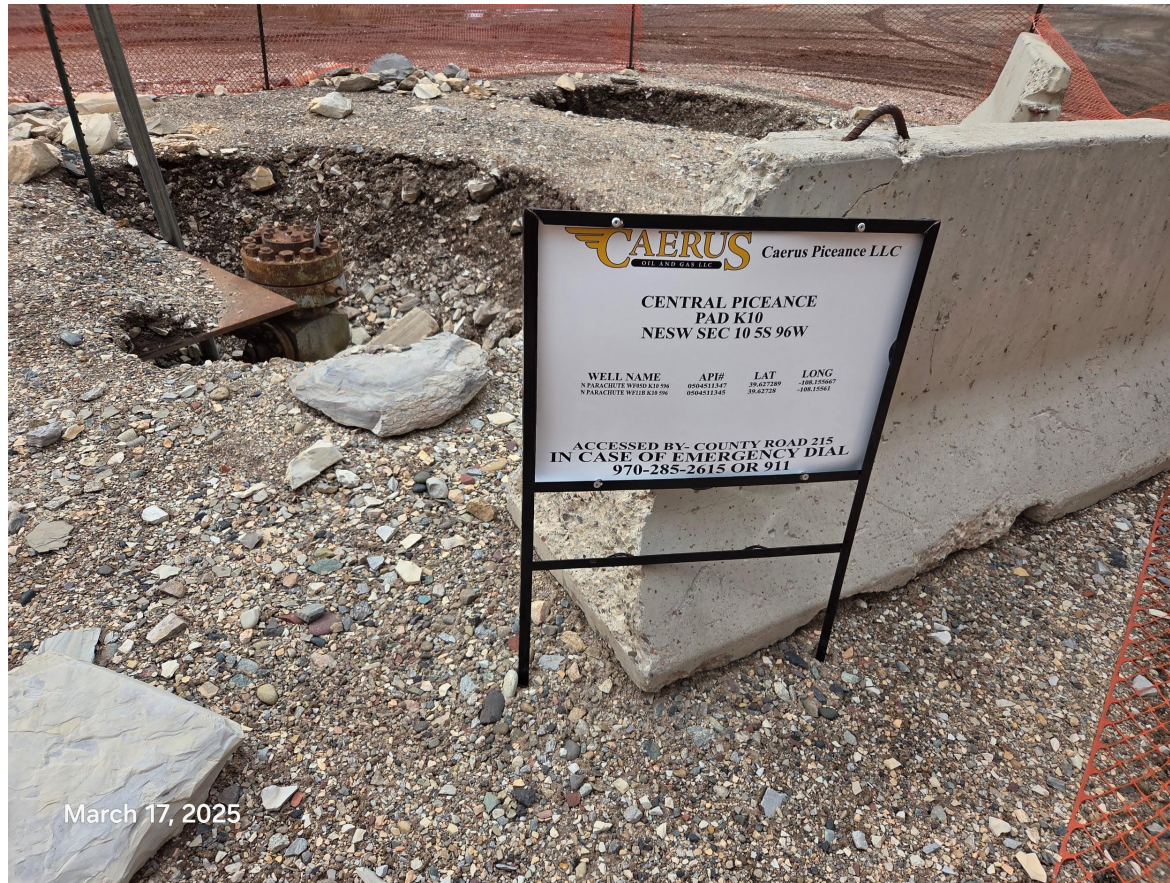
**Photo 5:** Photos 5-6 taken from the “TA” wells within the southern portion of the pad. Work appears to be in process at the wells.

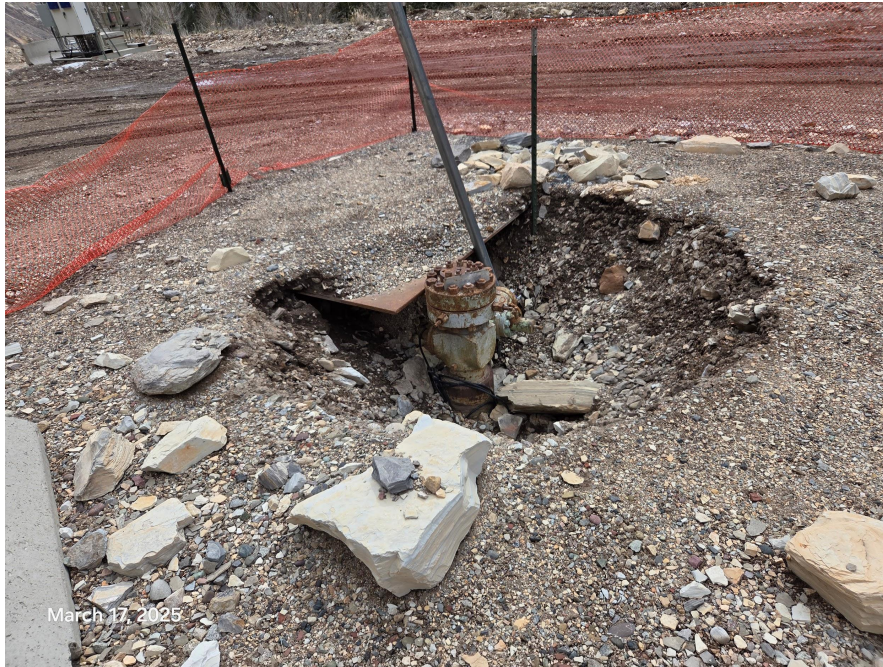
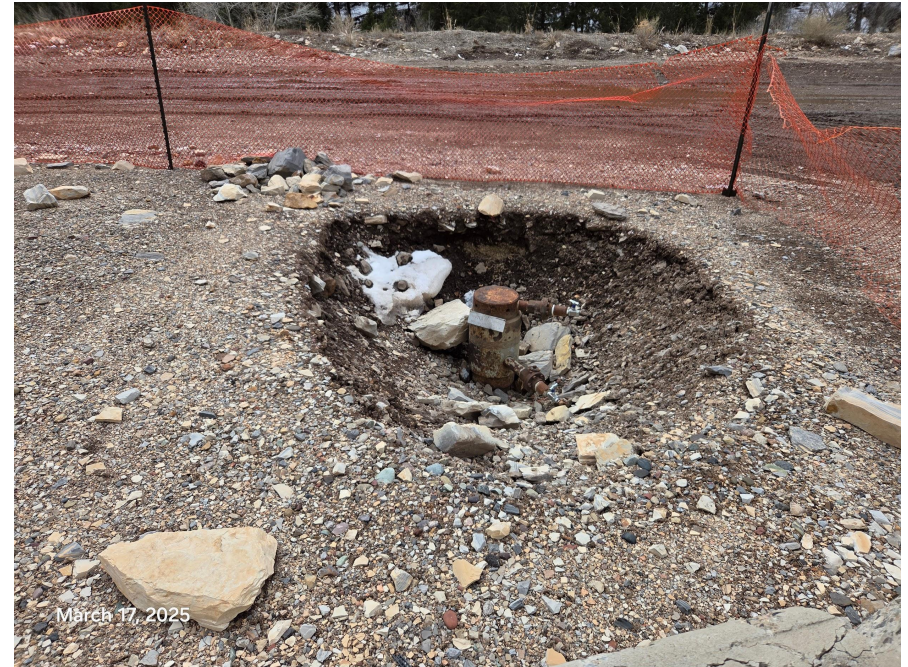
**Photo 6:** See comments under photo 5.

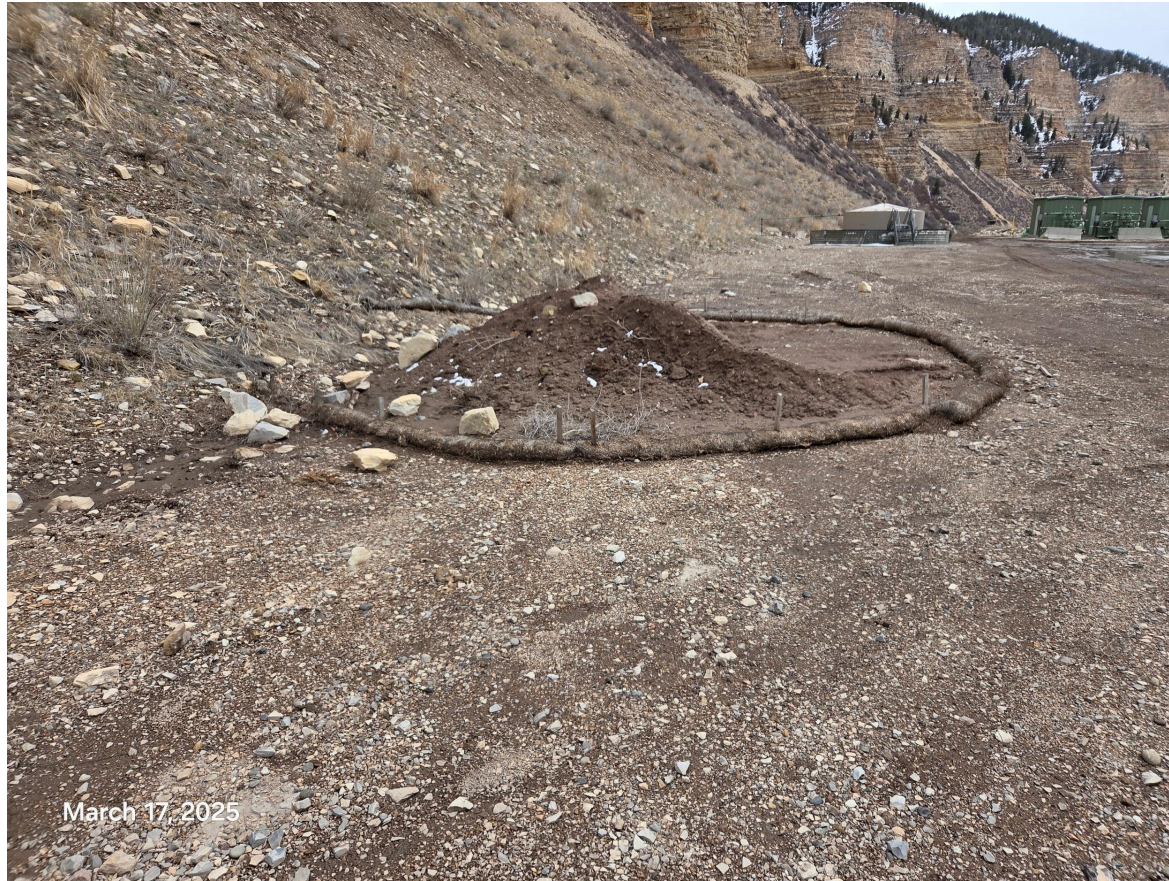
**Photo 7:** Photo taken from the northeast end of the working pad surface, facing southeast. Photo shows soil stockpile has been placed within areas of the perimeter stormwater diversion ditch- placement of stockpiles within a stormwater diversion ditch does not comport with stockpile protection requirements, and places the soils at risk to commingling with stormwater runoff, and sediment transport.

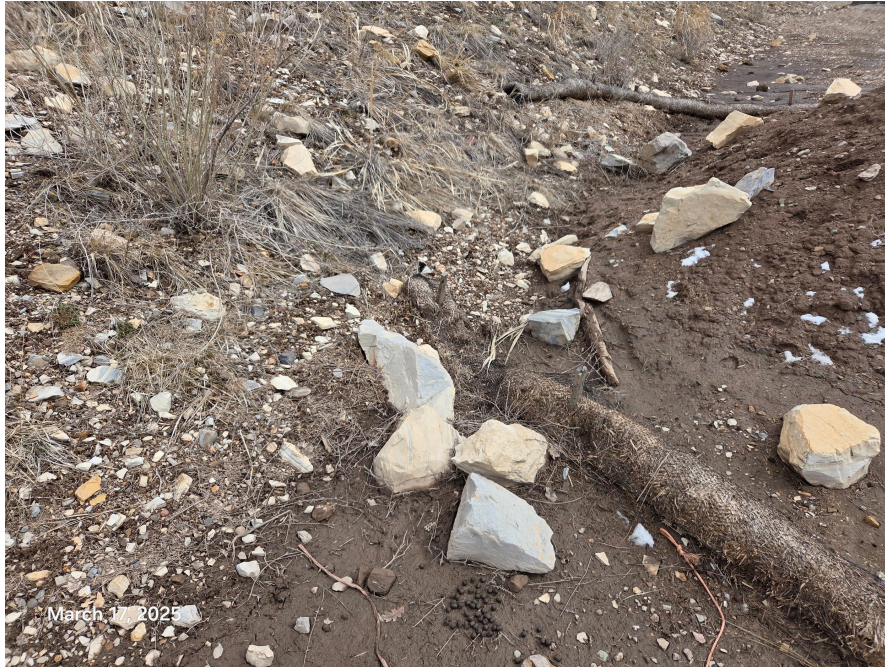
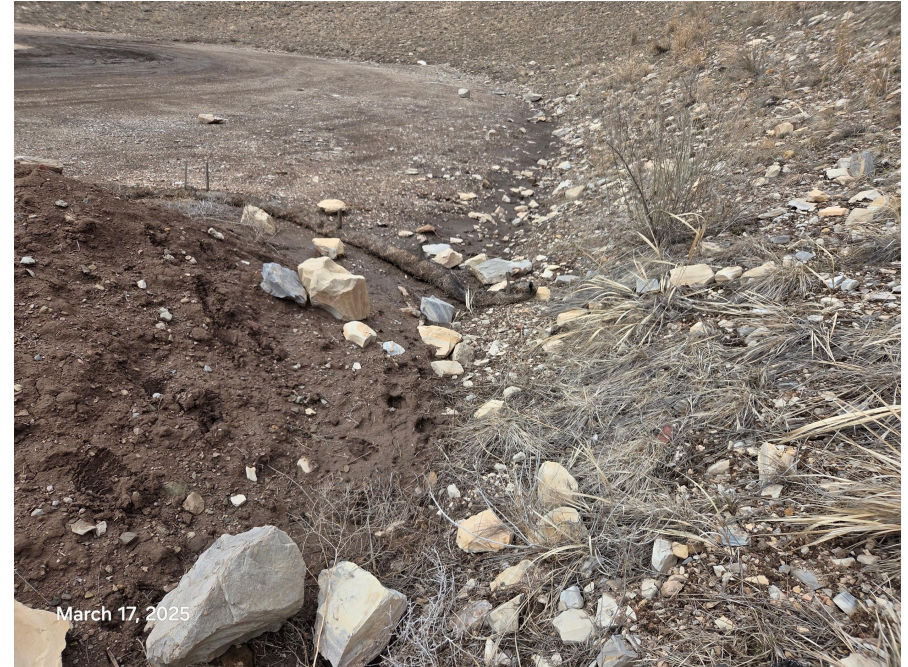
**Photo 8:** Continued from photo 7. Photo shows erosion log placed at the soil stockpile has been crushed, and is no longer in proper functioning condition to minimize sediment migration for the stockpile. Photo also shows soil stockpile has been placed within areas of the perimeter stormwater diversion ditch.

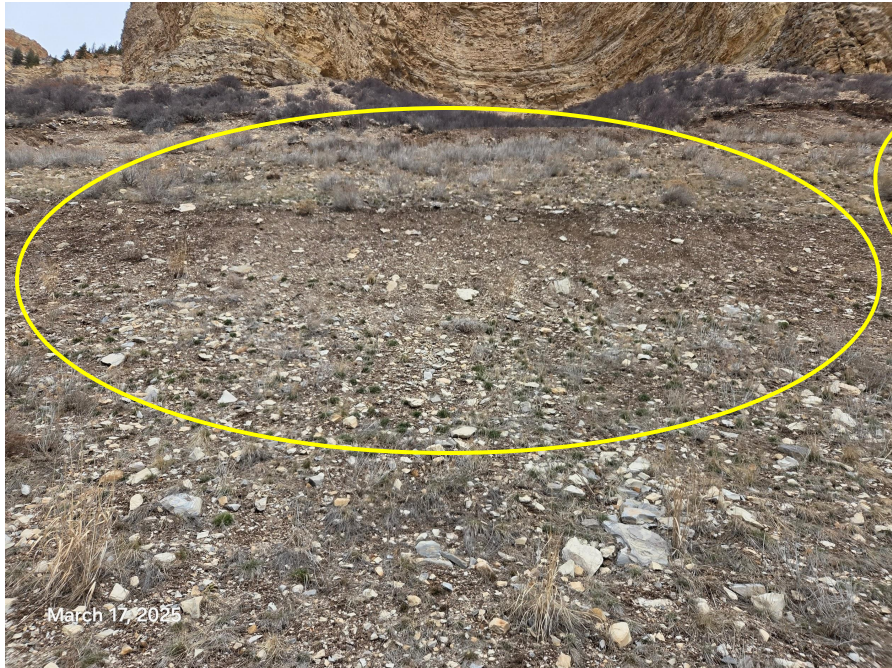
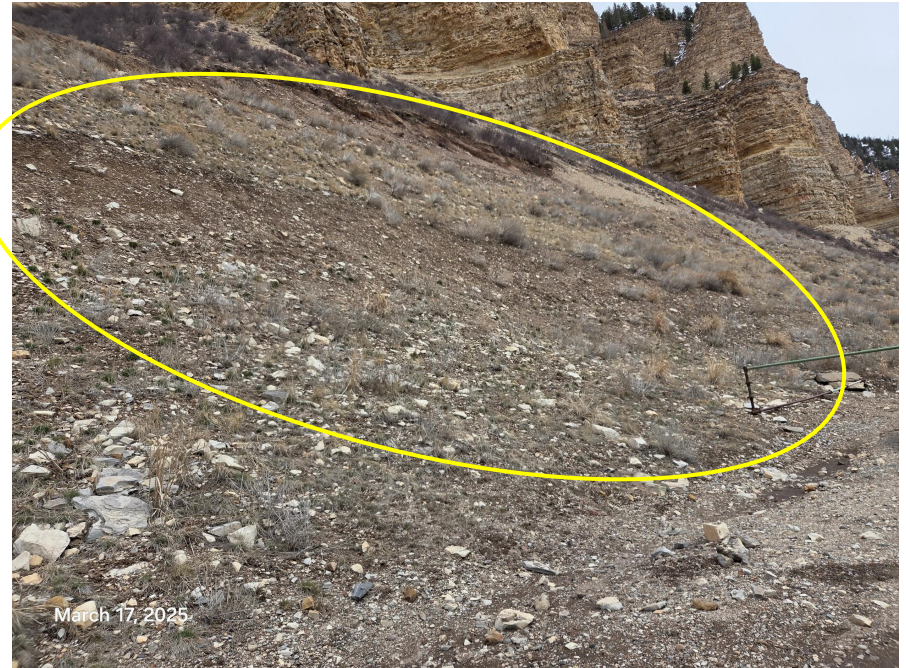
**Photo 9:** Photos taken from the interim areas on the east end of the Location. Photos examples showing areas where desirable perennial vegetative establishment does not appear to be uniform.
