Inspection Photos
Location Name: Werning 1-2B
API #123-26399

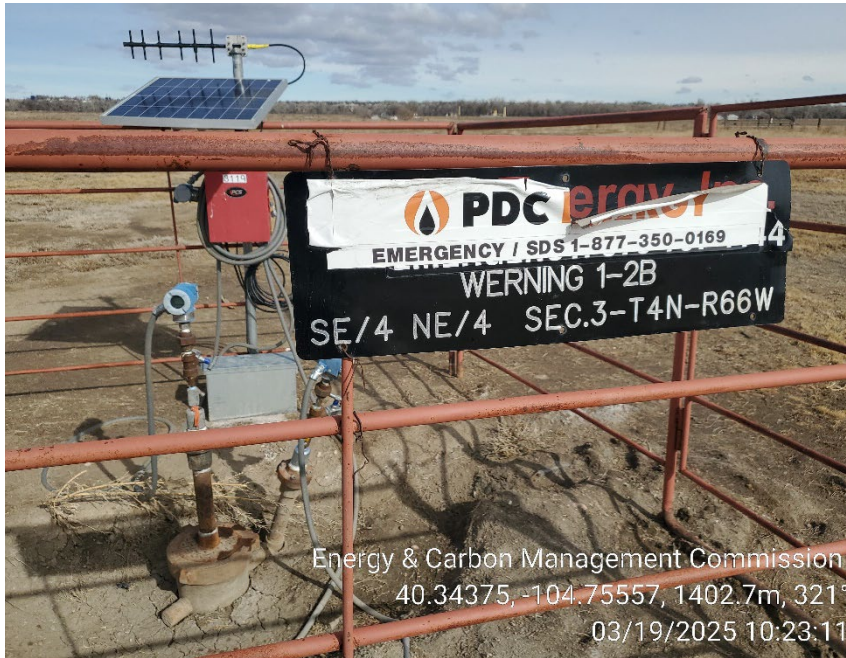
Wellhead and sign

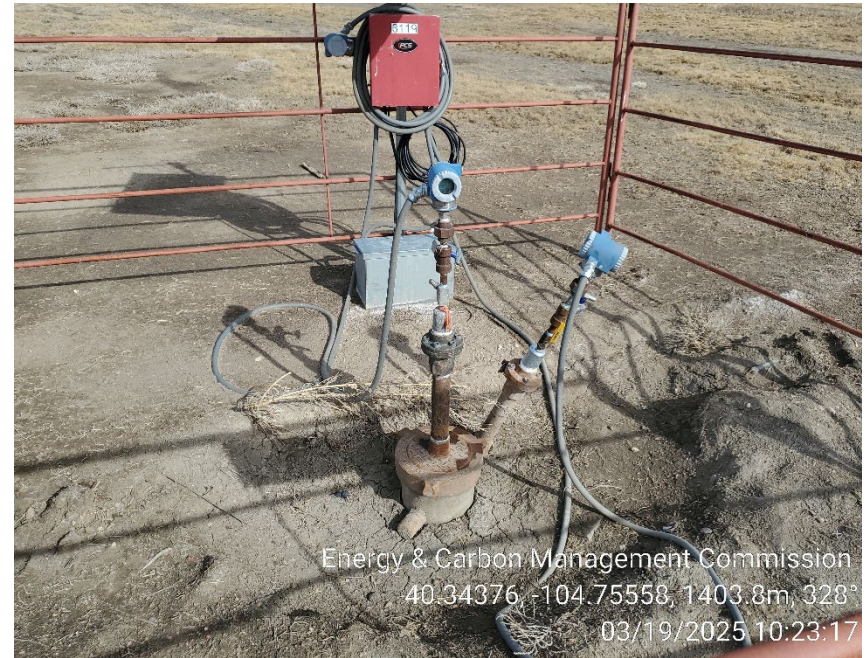
Wellhead

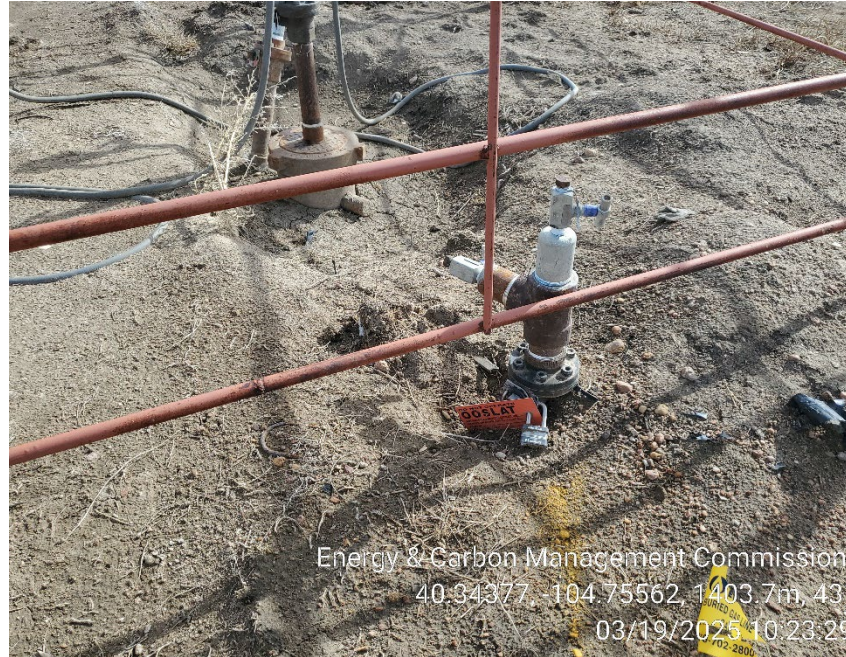
Flowline OOSLAT tag
