Inspection Photos

Operator: Hilcorp Energy Company - 10133

Location ID: 325510

Inspection Photos
Location Name: Davis Gas Unit 1
Location ID: 325510

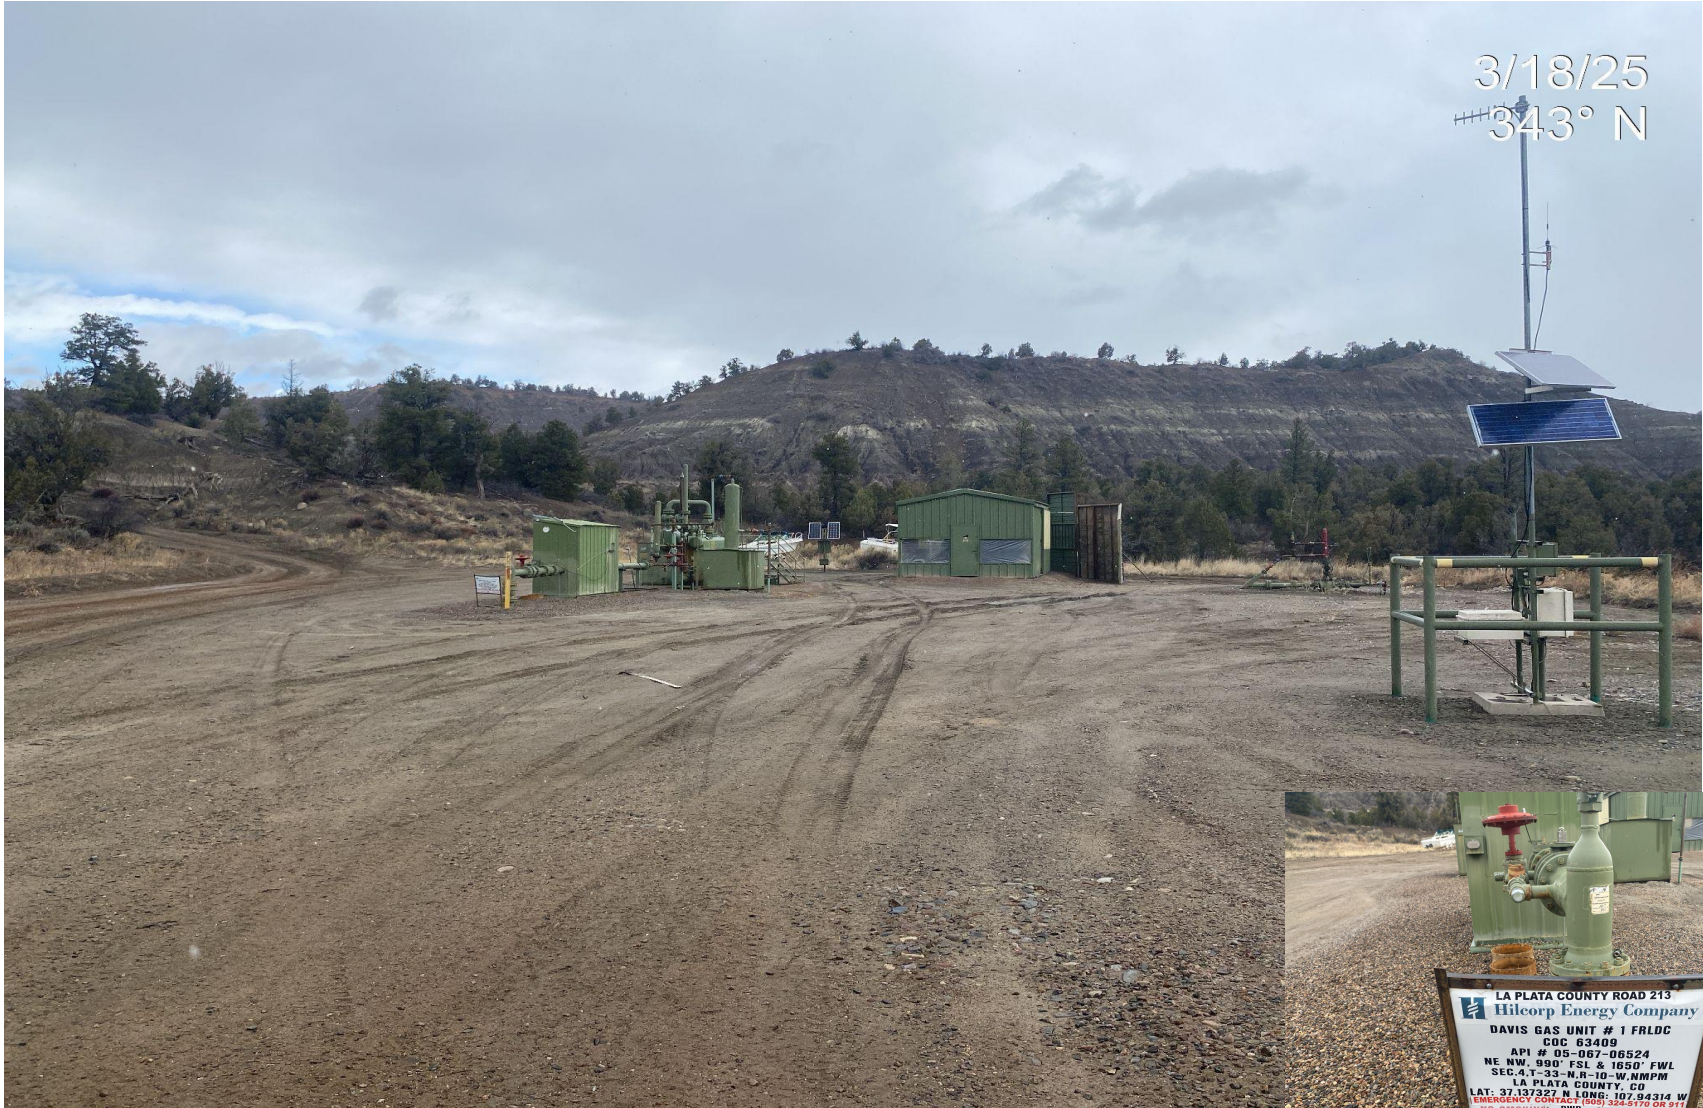
Photo 1. View of well pad taken from the access point facing center.

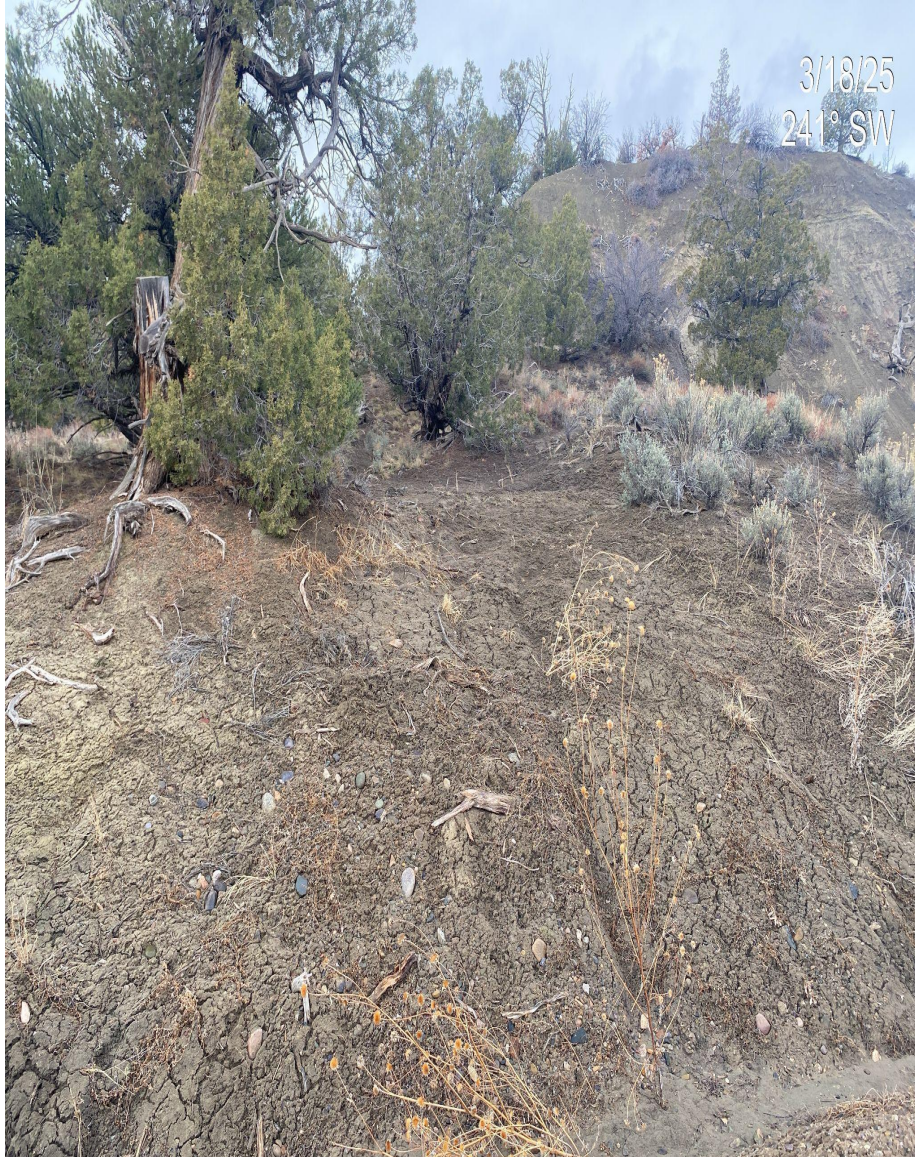
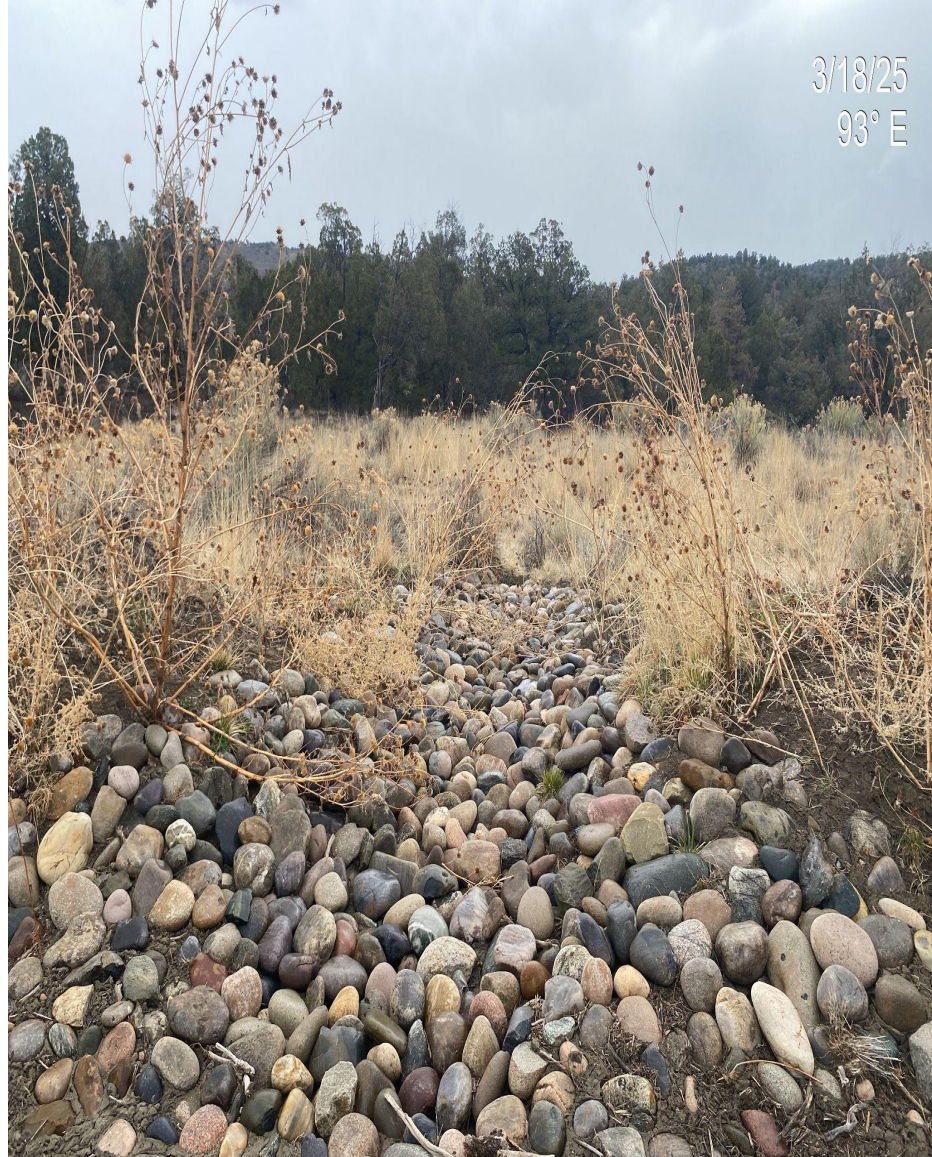
Photo 2. No active erosion and adequate stormwater BMPs observed at the access point and in the eastern interim reclamation areas.

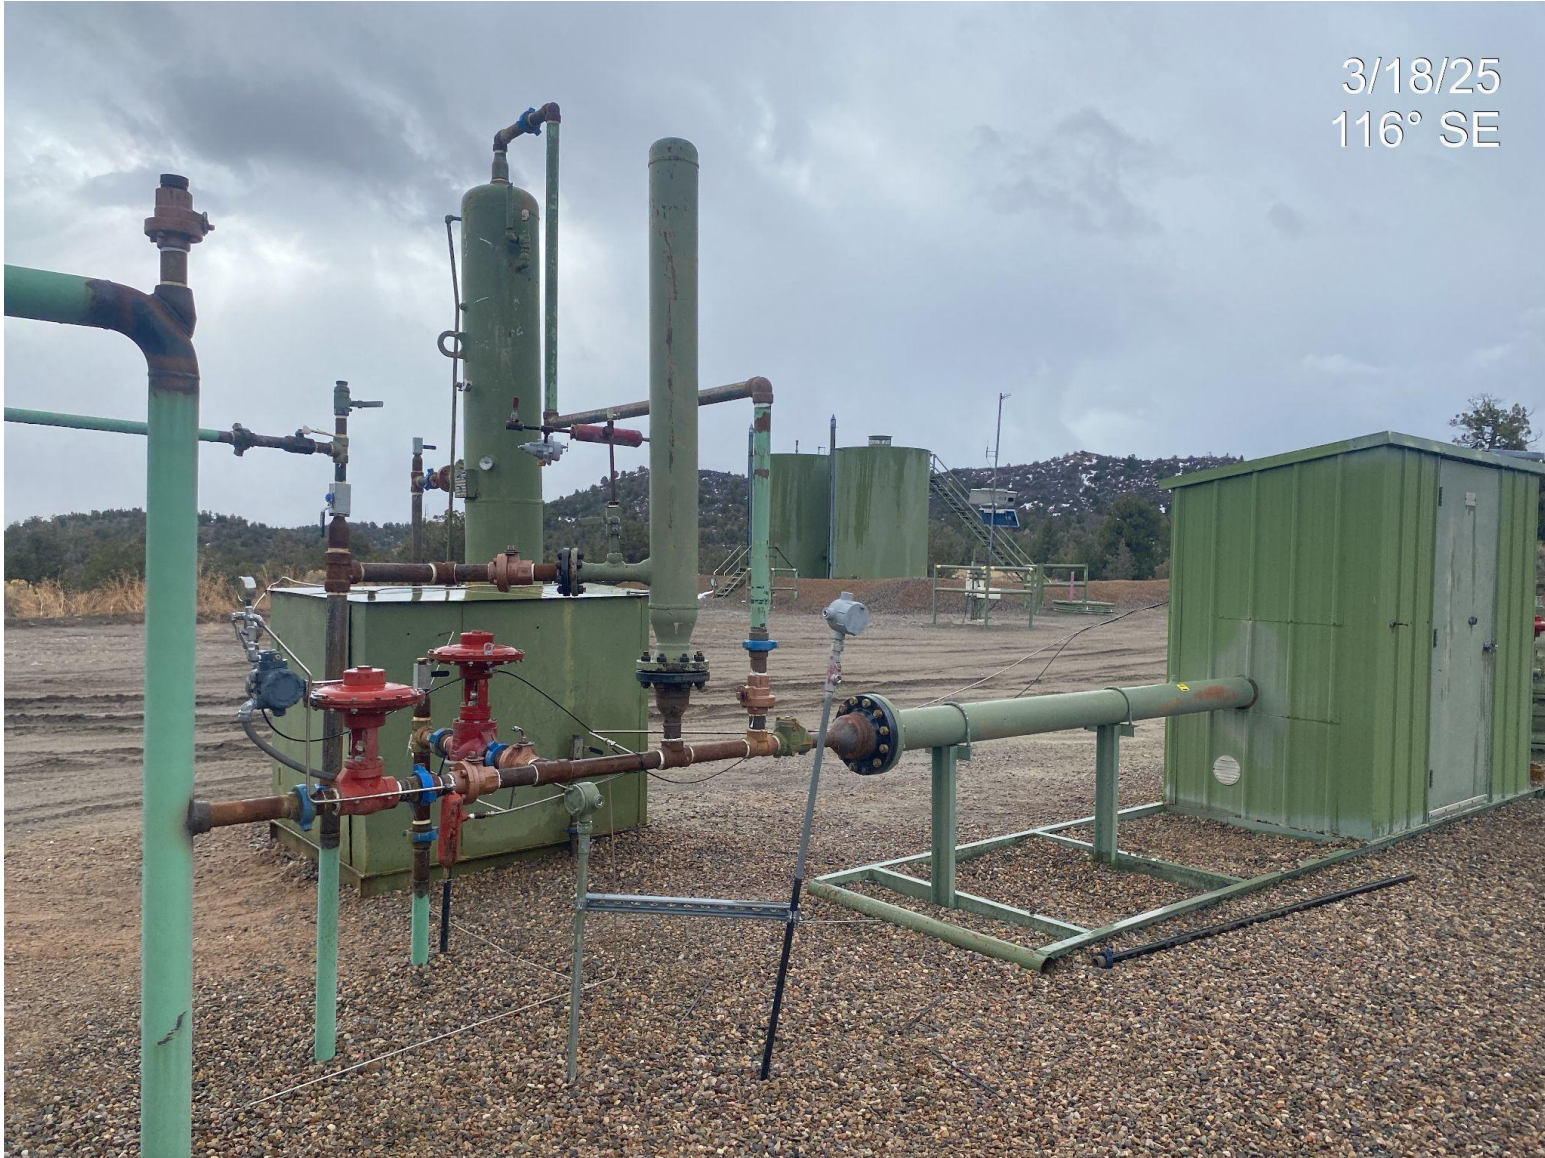
Photo 3. Unused equipment at separator equipment has been removed from location.

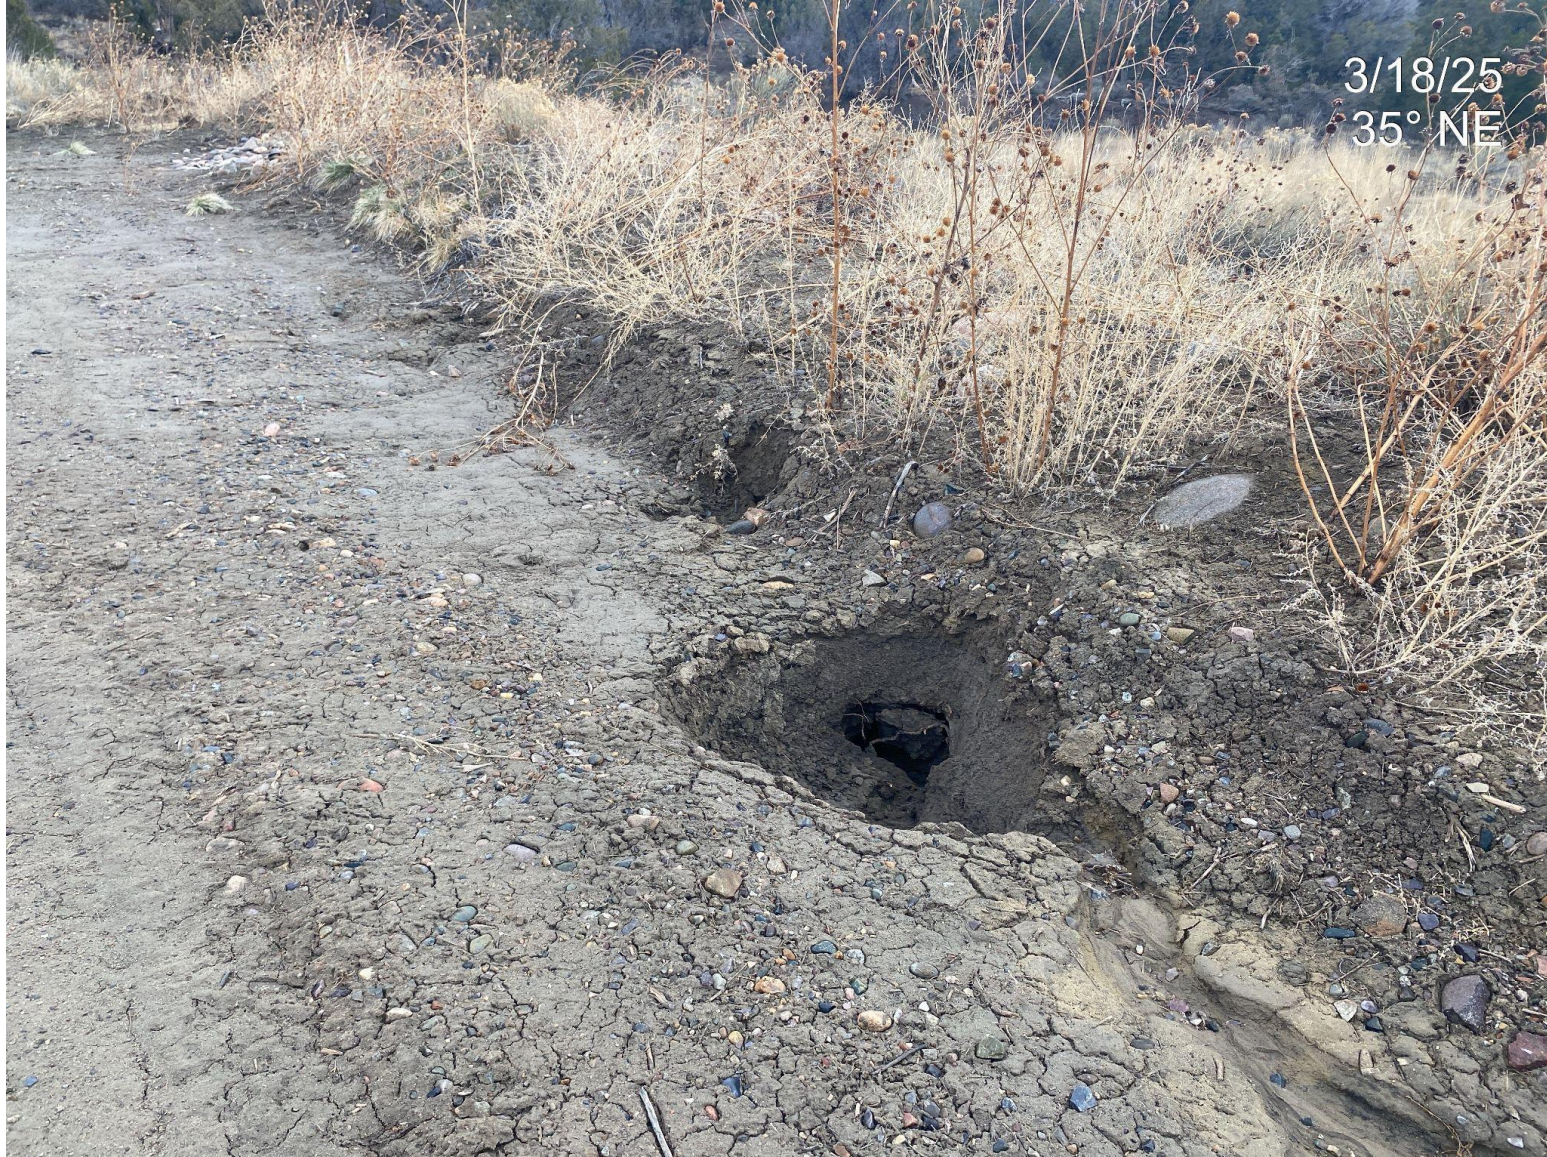
Photo 4. Hole/erosion tunnel forming along the eastern perimeter berm.
