# Inspection Photos

**Operator:** CAERUS PICEANCE LLC - 10456

**Location ID:** 487650

**Inspection Doc:** 718100314

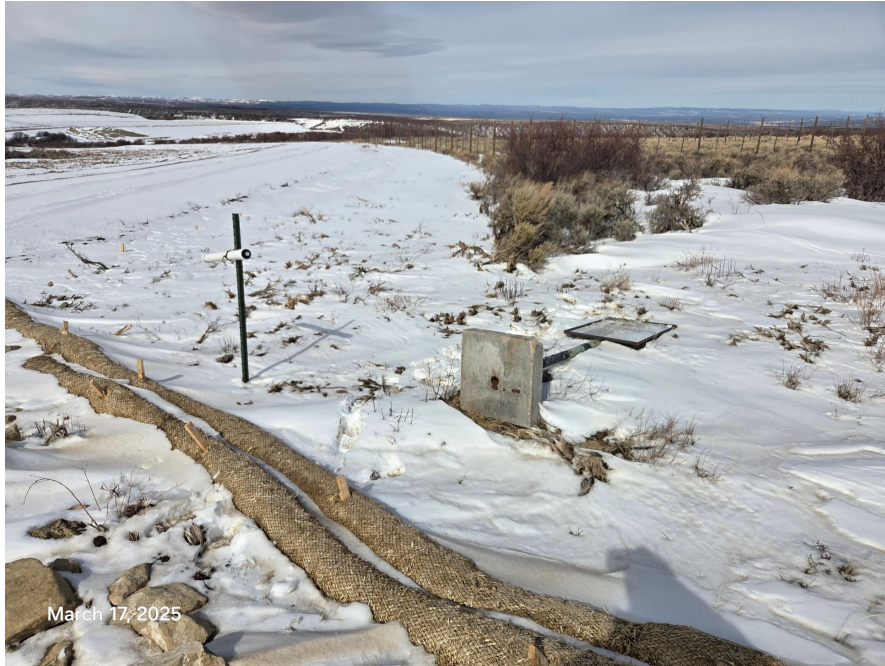
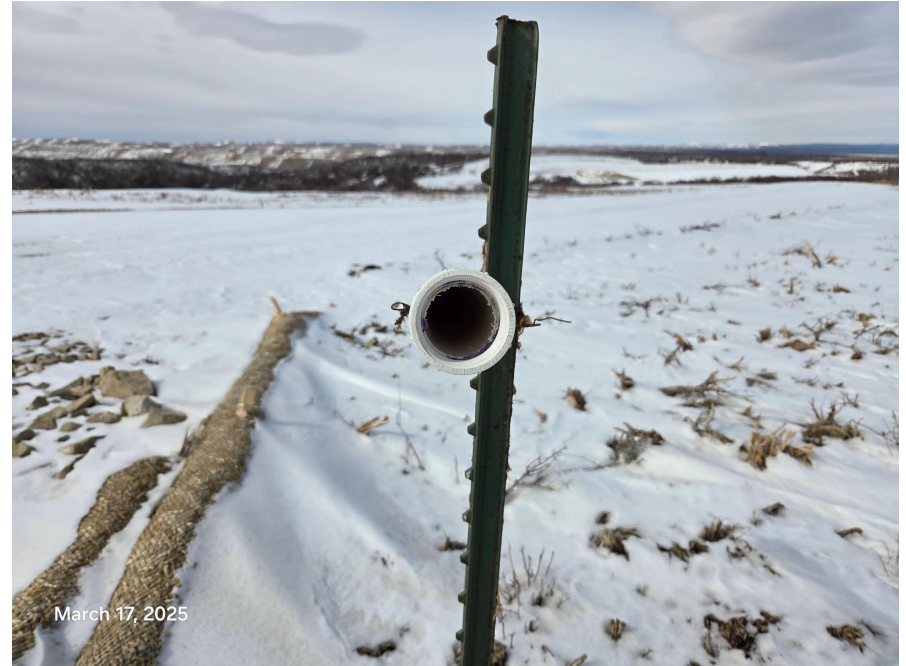
**Photo 1:** Photos taken from the access road intersection, east of the Location. Photos show only sign associated with the Location. Photo also shows empty tube that appears to have been intended for the Form 2A permit and associated Form 4s. Permit/Form 4s have not been posted on the Location.

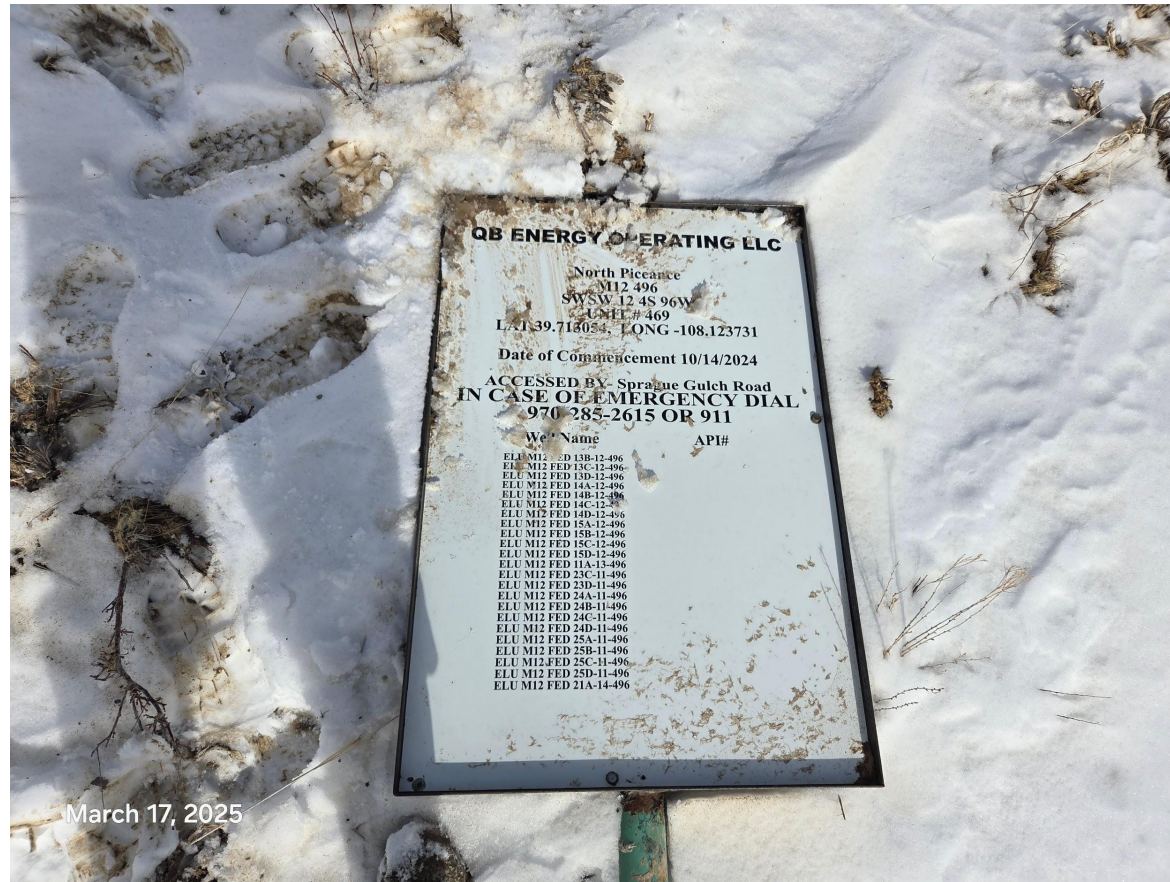
**Photo 2:** Continued from photo 1. Photo shows sign.

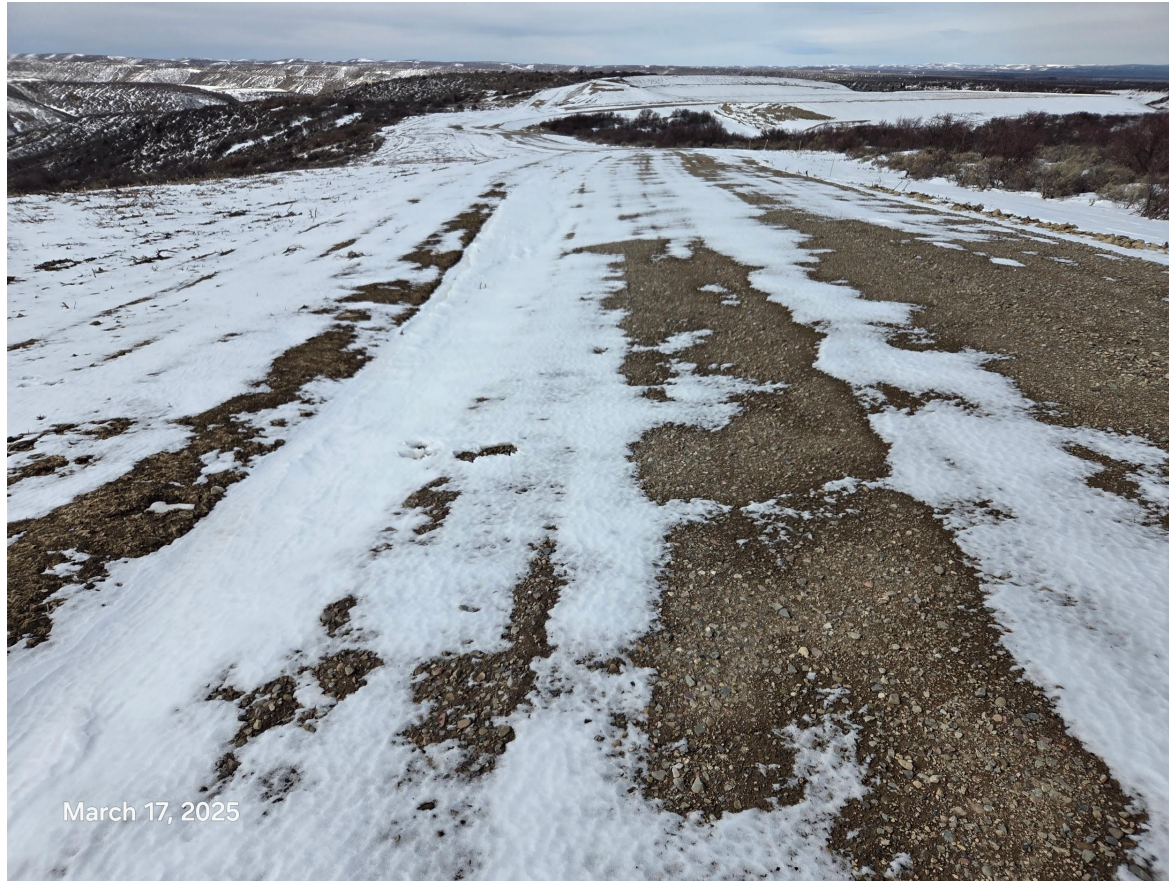
**Photo 3:** Photo taken from the access road, east of the Location, facing west. Road appears to have been stabilized with use of gravel / road base material.

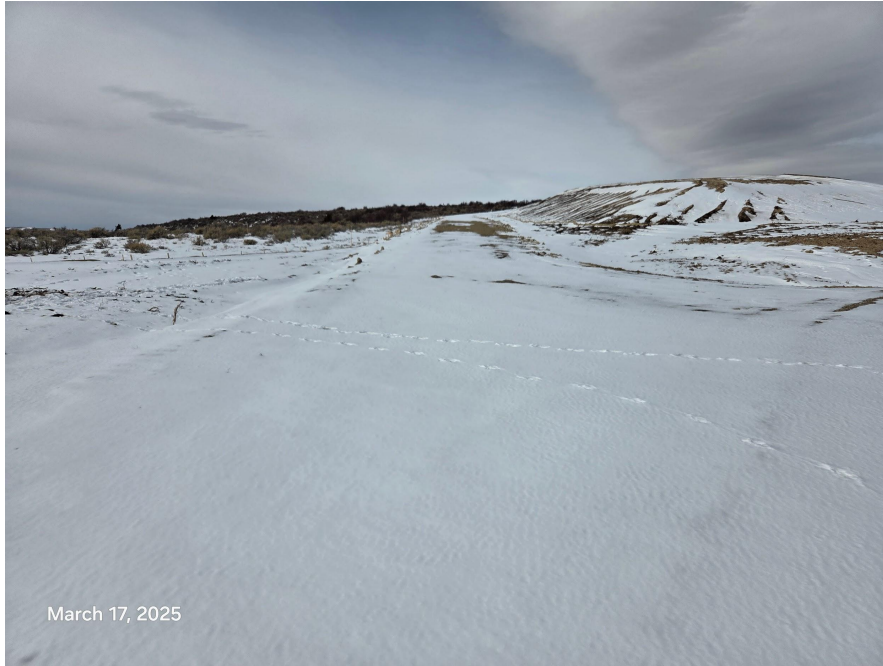
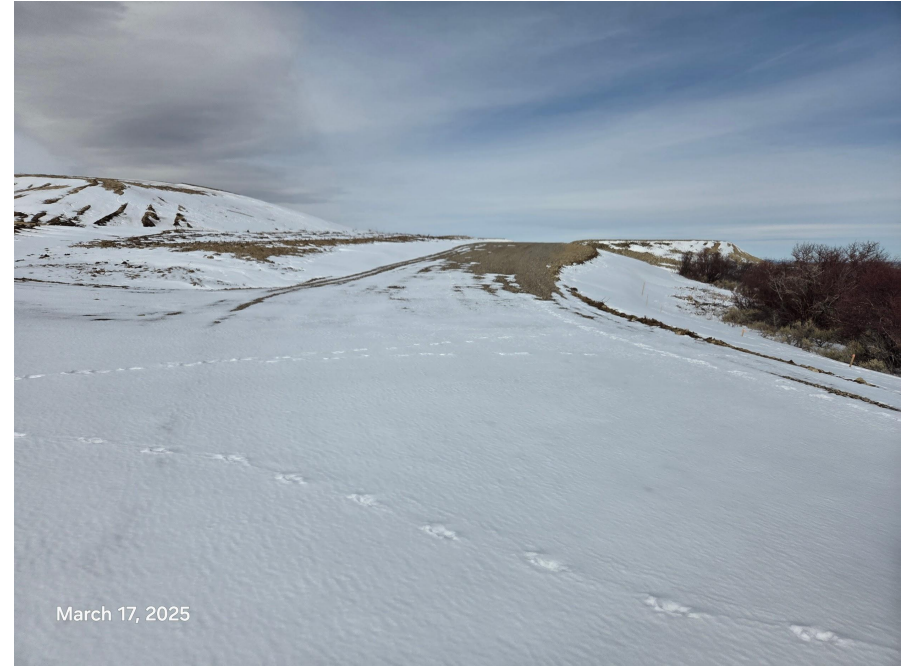
**Photo 4:** Photos taken from the southeast end of the Location, facing west and north. Photo left shows the Secondary Road leading along the west end of the Location; photo right shows the Primary Road leading to the location entrance on the south end of the Location.

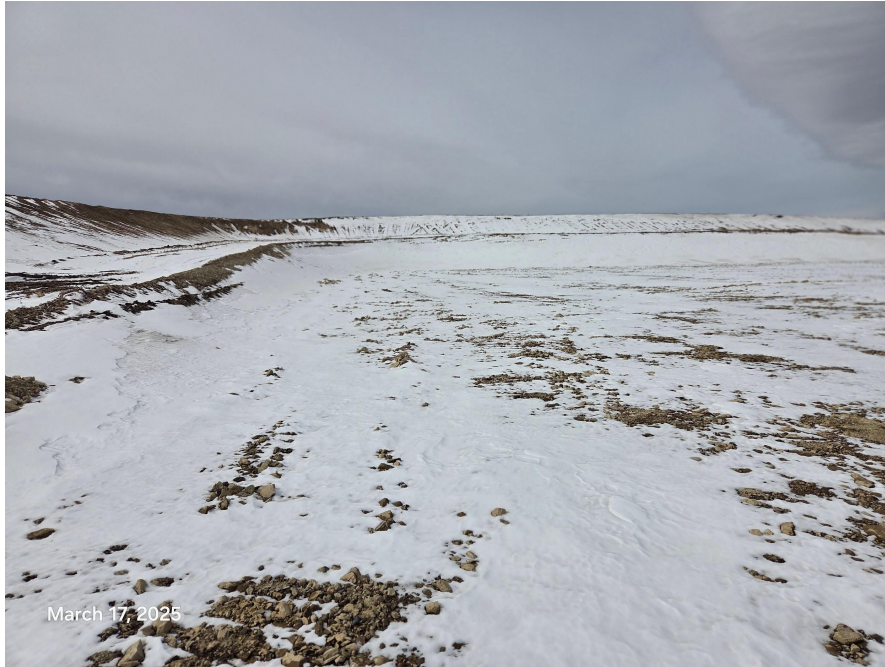
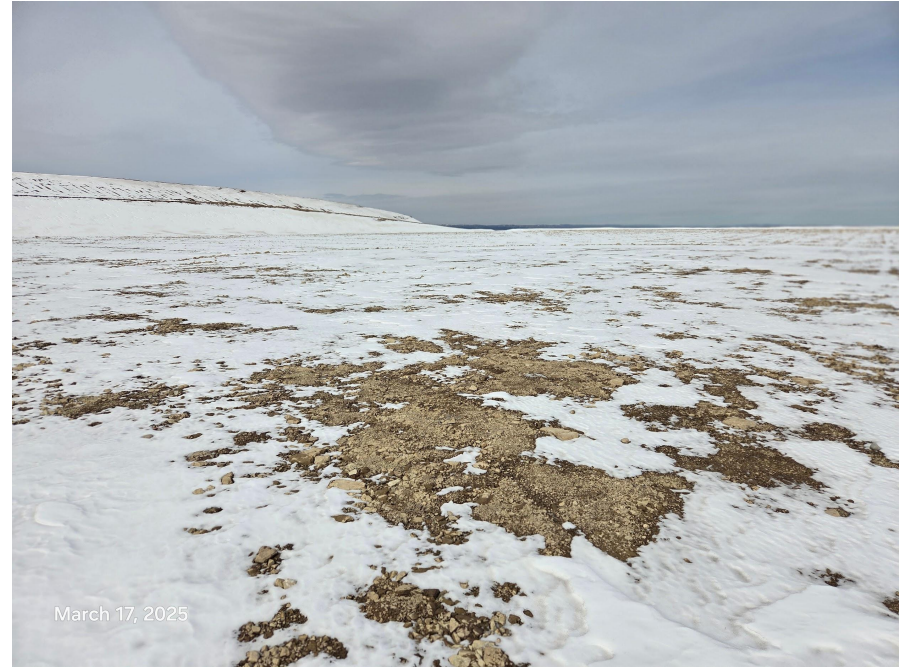
**Photo 5:** Photos taken 5-6 taken from the south end of the Location. Photos provide an overview of the Location from west, northwest, northeast to east.

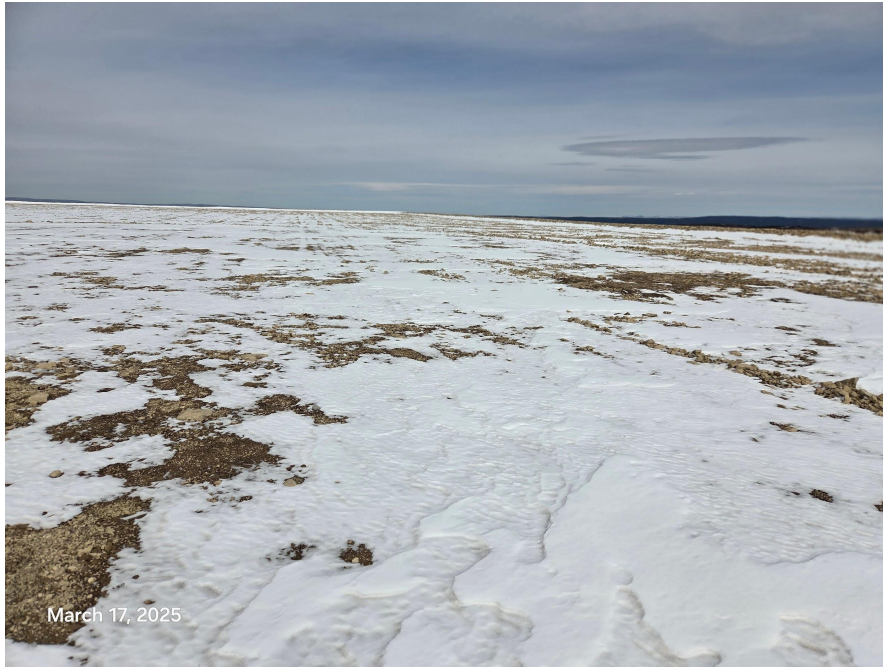
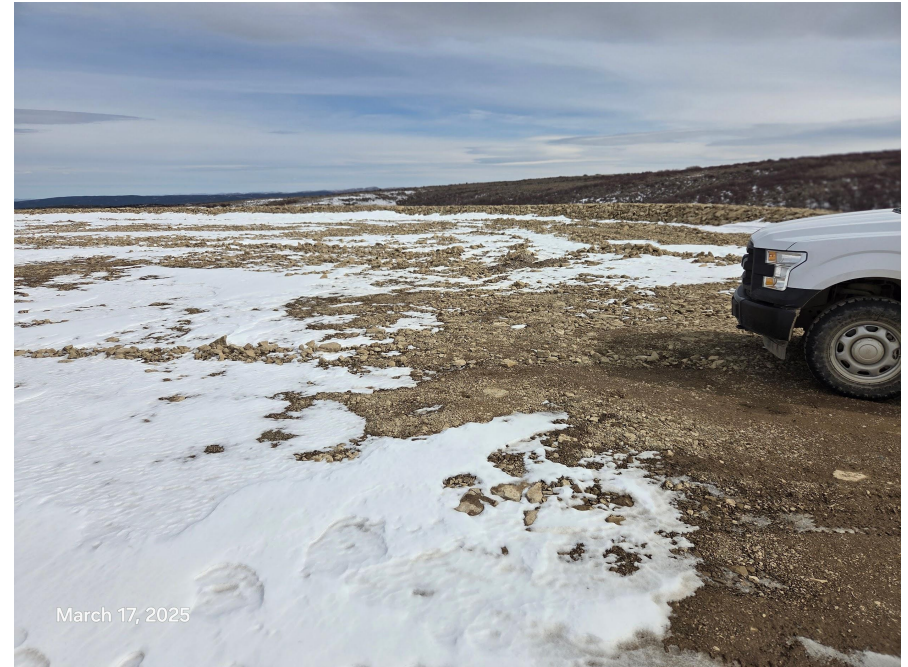
**Photo 6:** See comments under photo 5.

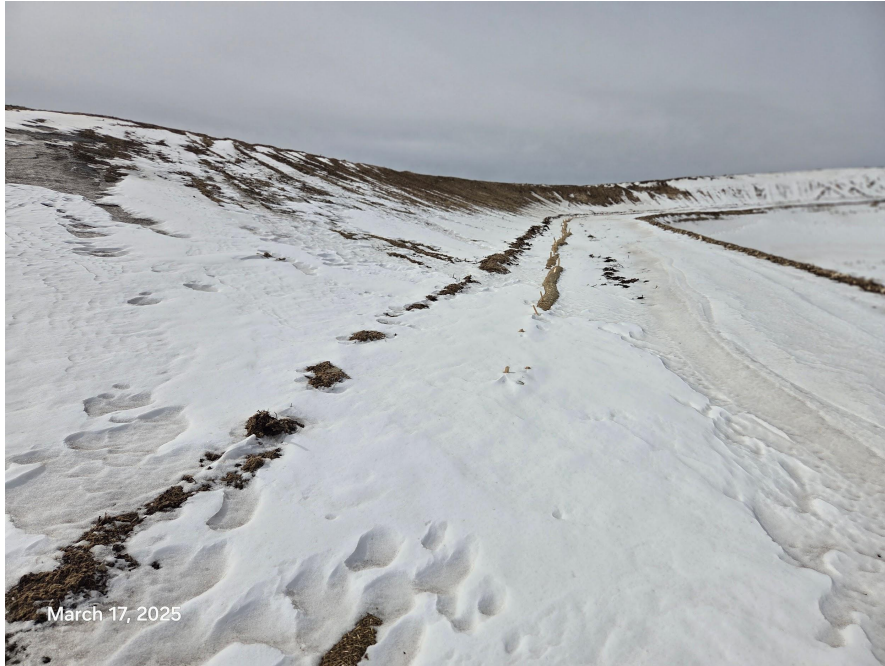
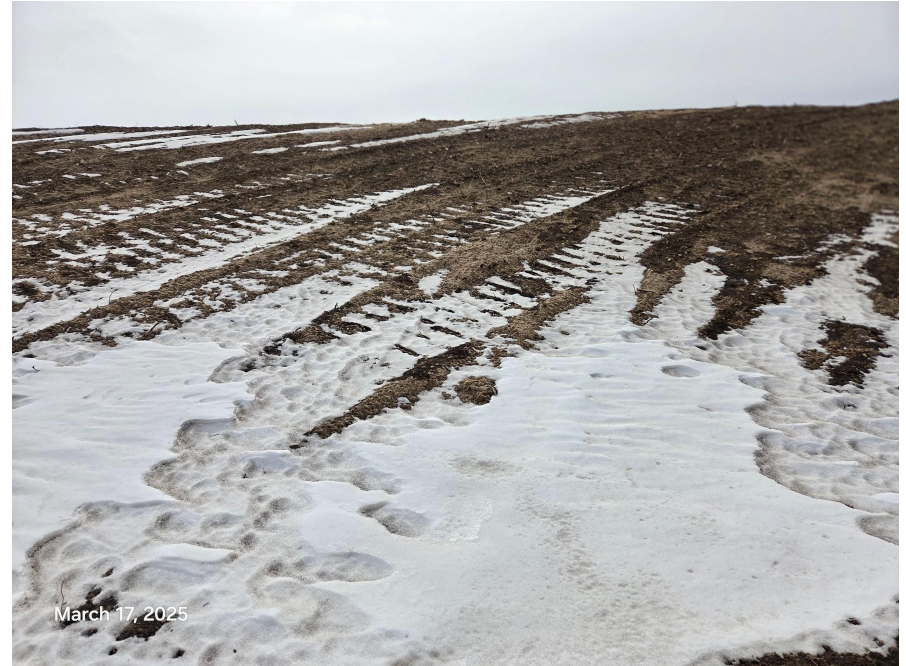
**Photo 7:** Photos taken from the south end of the Location; photo left facing west. Photos show topsoil stockpile stored on the south and west ends of the Location. Hydromulch has been sprayed on the soils, and erosion logs have been installed along the toe/perimeter of the stockpile.

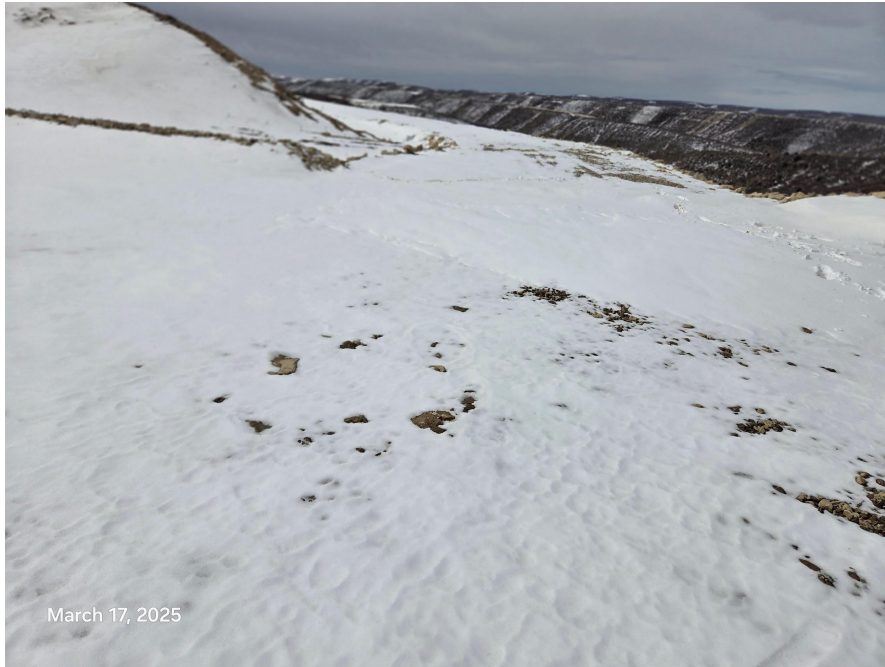
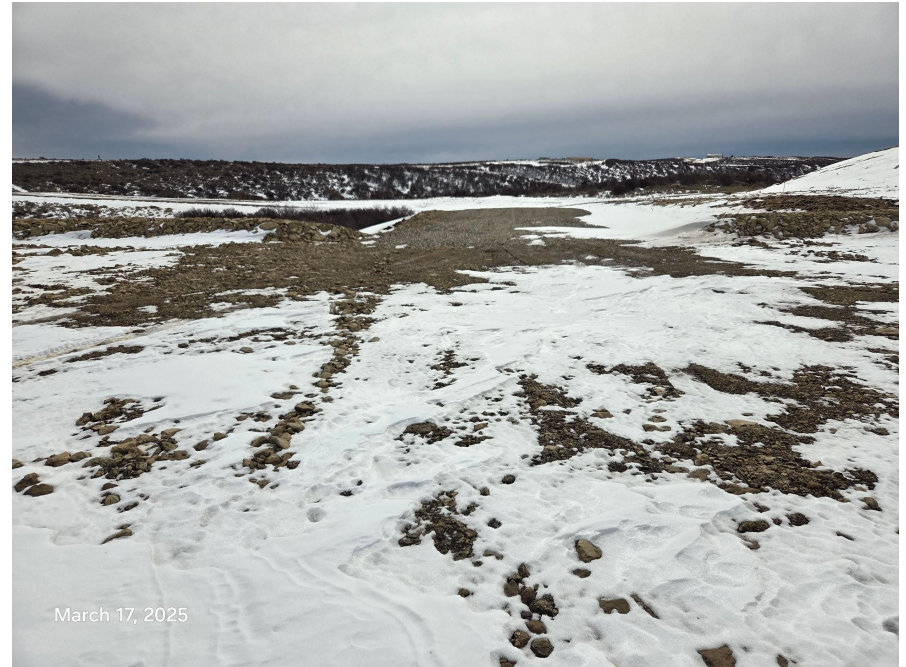
**Photo 8:** Photos left taken from the “Secondary Access Point on the west end of the Location, facing west; photo right taken from the “Primary Access Point” on the south end of the Location, facing south. Photos show that either a “Tracking Control Pad”, or a “Rumble Strip” VTC, has not been installed at either access point in accordance with good engineering practice. Operator appears to have only placed gravel within these areas.

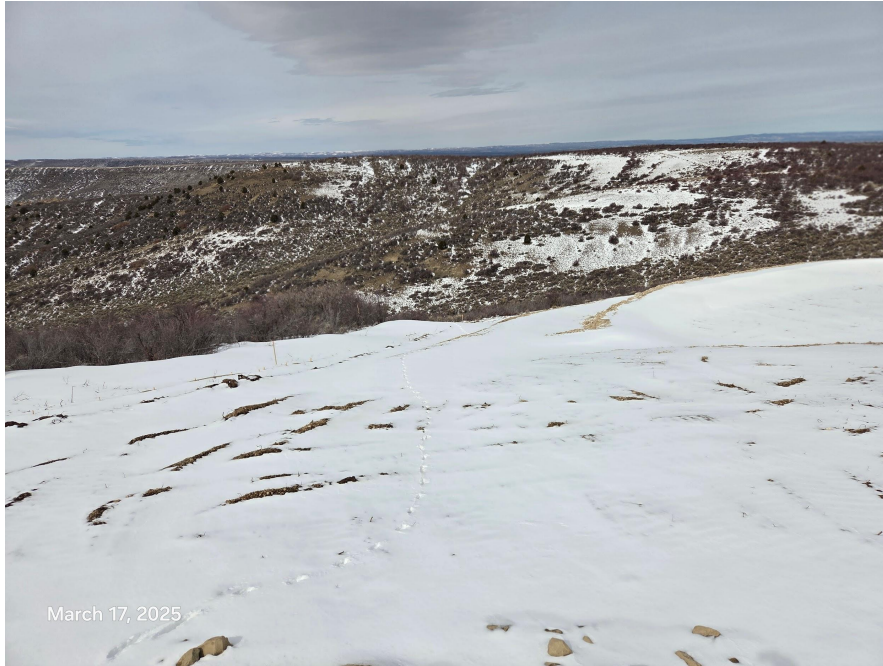
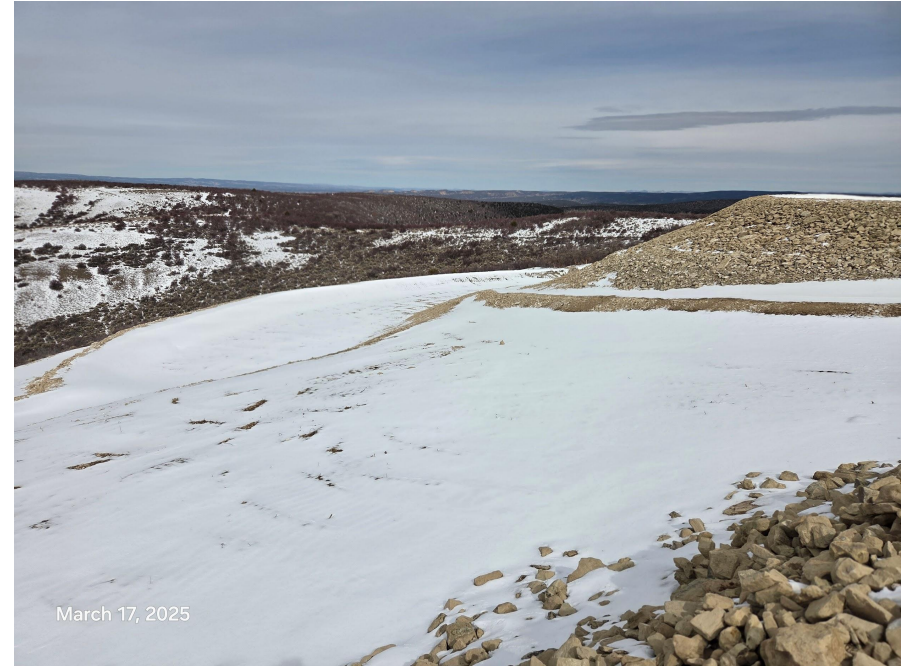
**Photo 9:** Photos taken from the northwest end of the Location, facing northwest and north. Photo shows stormwater basin on the western perimeter of the Location.

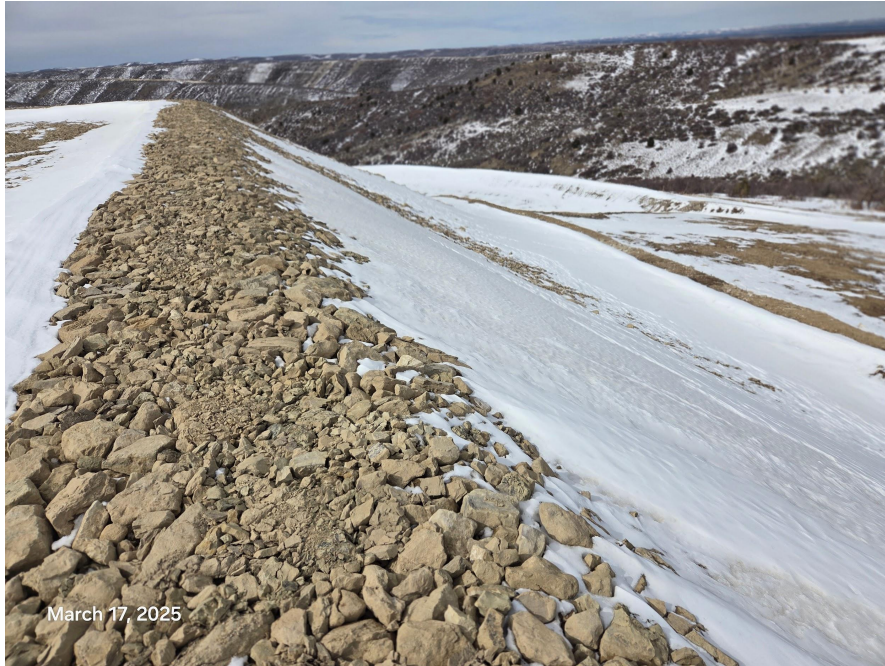
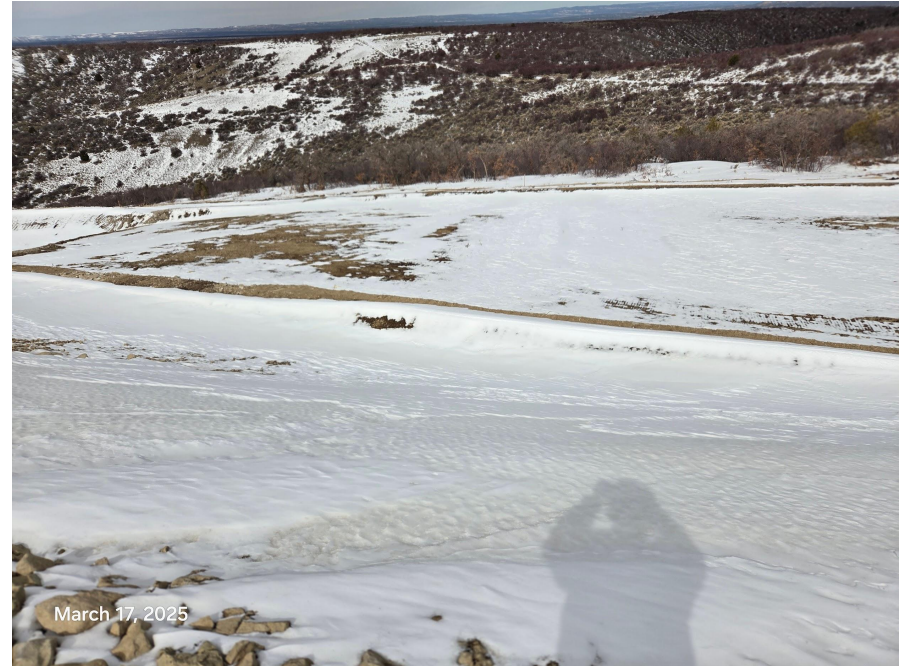
**Photo 10:** Photos 10-11 taken from the north end of the Location, facing west, northeast, northeast and east. Photo shows perimeter controls including berm at the toe of the fill slopes, stormwater basins on the west and north end of the Location, and a berm along the perimeter of the Location's disturbance.

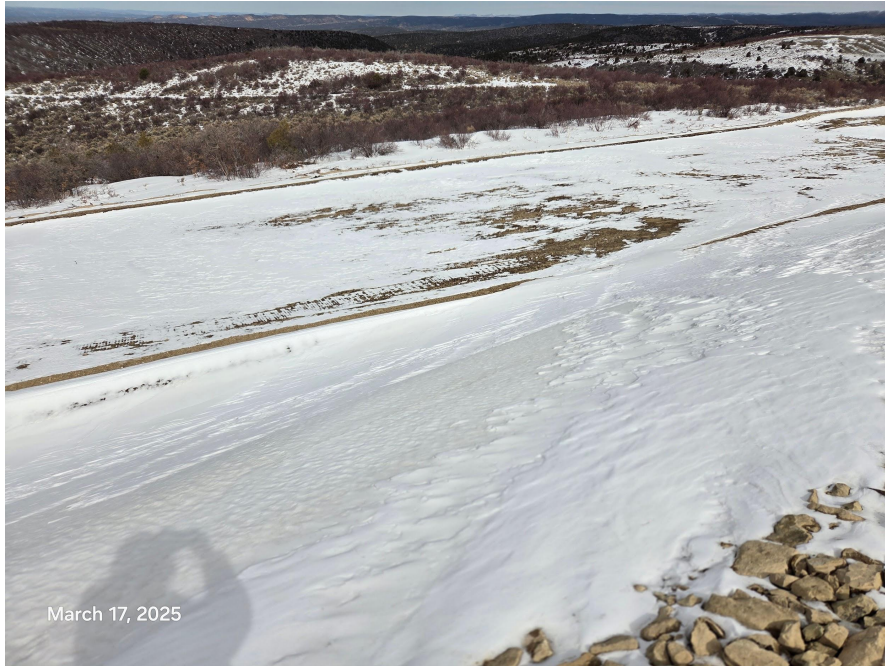
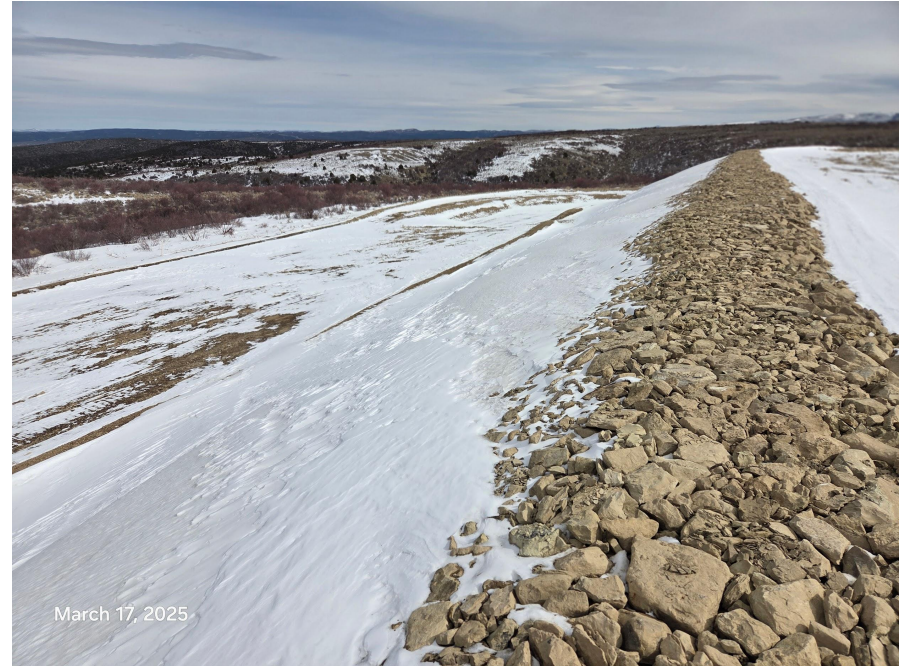
**Photo 11:** See comments under photo 10.

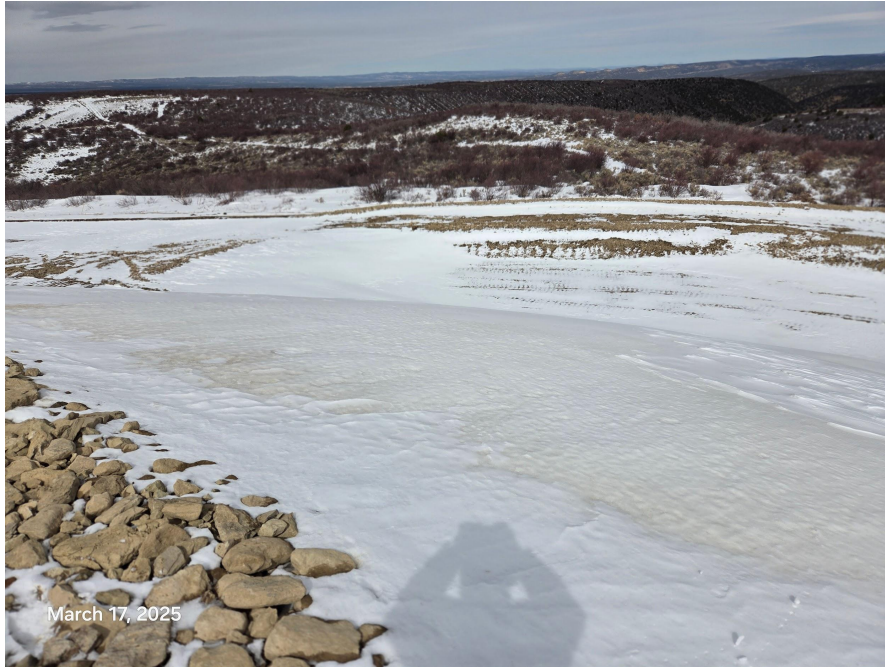
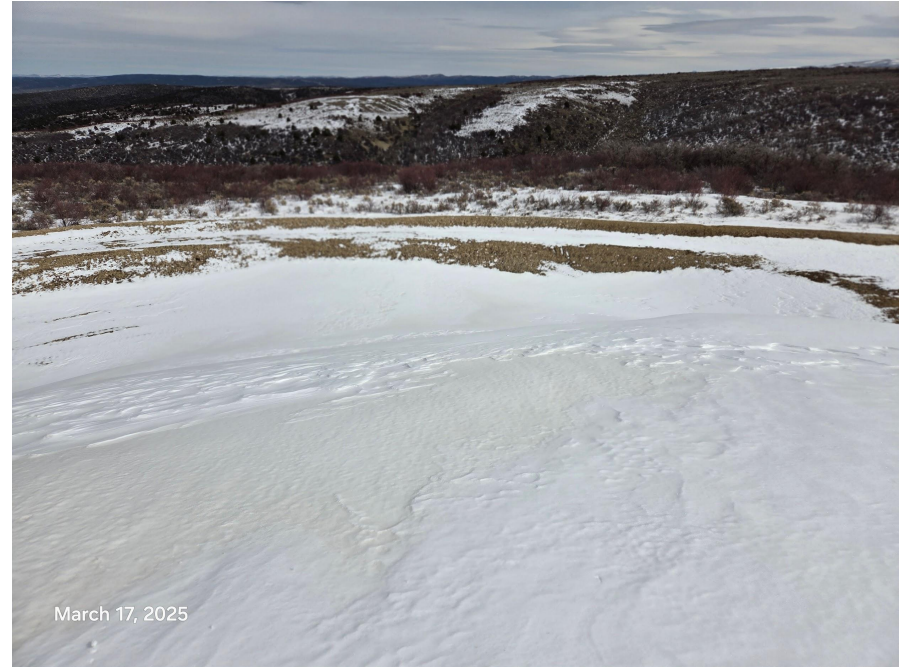
**Photo 12:** Photos taken from the north end of the Location, facing north and northeast. Photo shows stormwater basin.

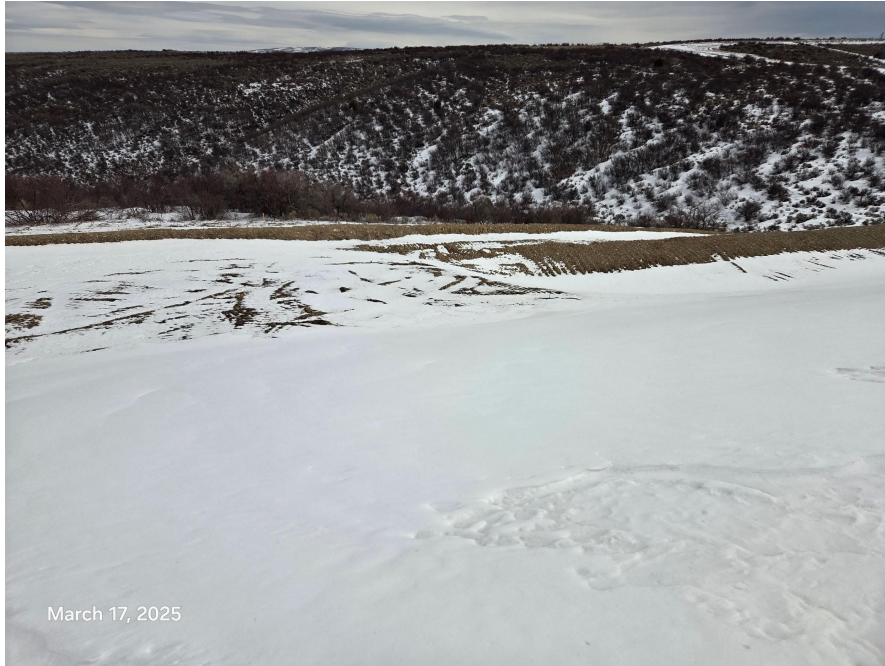
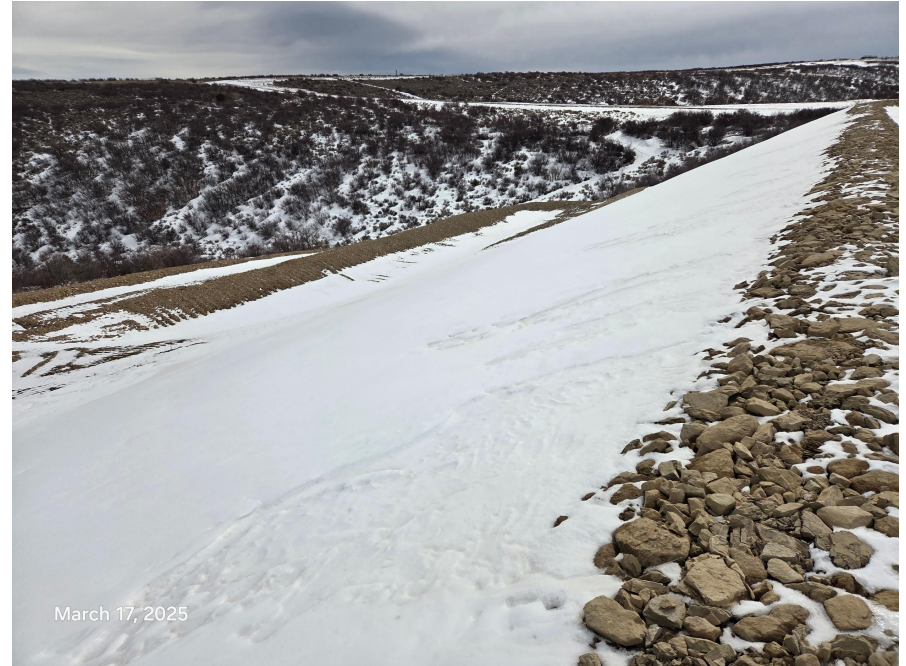
**Photo 13:** Photos taken from the east end of the Location, facing east and southeast. Photo shows stormwater basin, and berms at the toe of the fill slope and perimeter of the Location.
