Inspection/Audit Photos
Location Name: TEP Rocky Mountain LLC CSF T Pad
Location # 335052

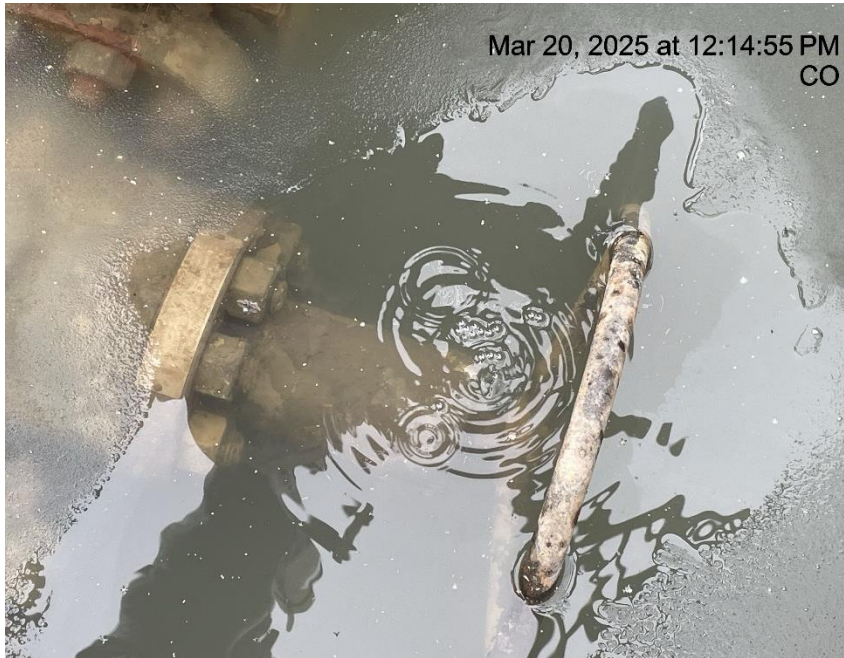
**Photo # 5665 Mechanical Condition - Possible leak on CSF
42B-07-07-91 wellhead casing valve**

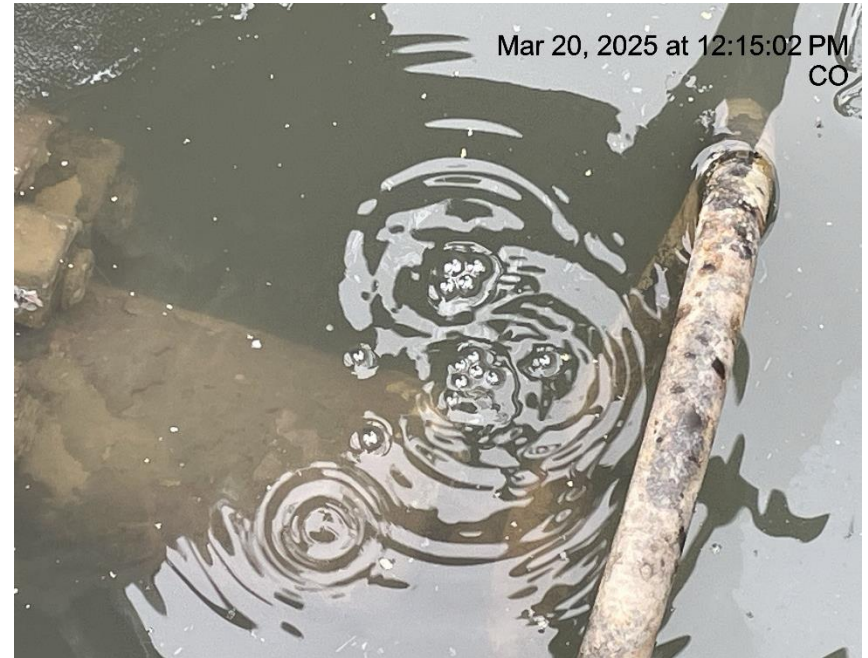
**Photo # 5666 Mechanical Condition - Possible leak on CSF
42B-07-07-91 wellhead casing valve**

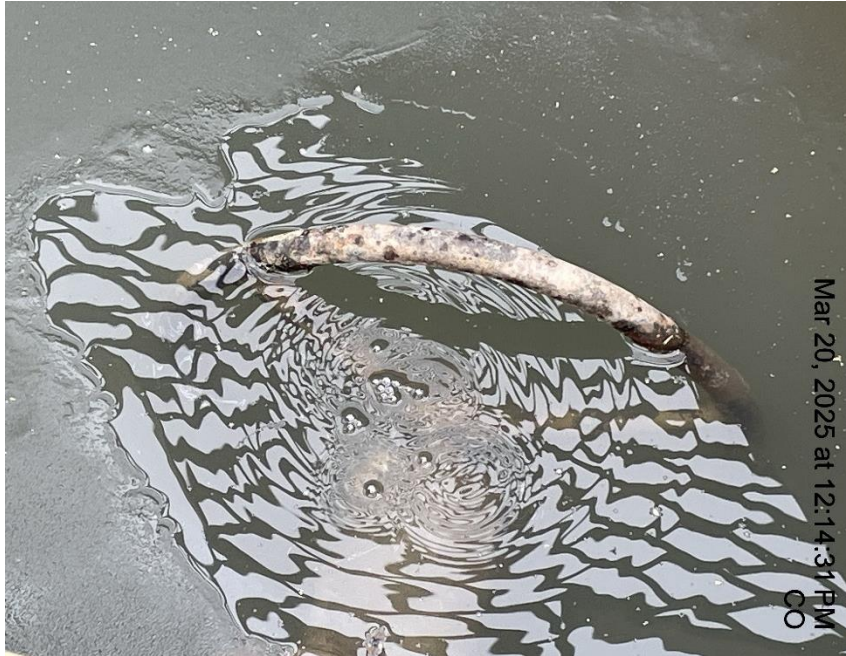
Photo # 5667 Mechanical Condition - Possible leak on CSF
42B-07-07-91 wellhead casing valve

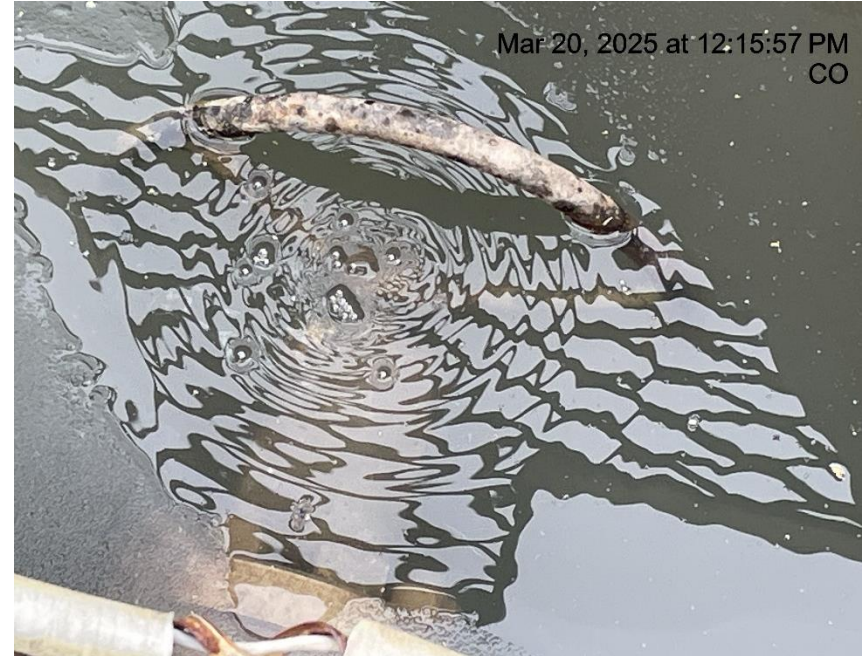
Photo # 5668 Mechanical Condition - Possible leak on CSF
42B-07-07-91 wellhead casing valve

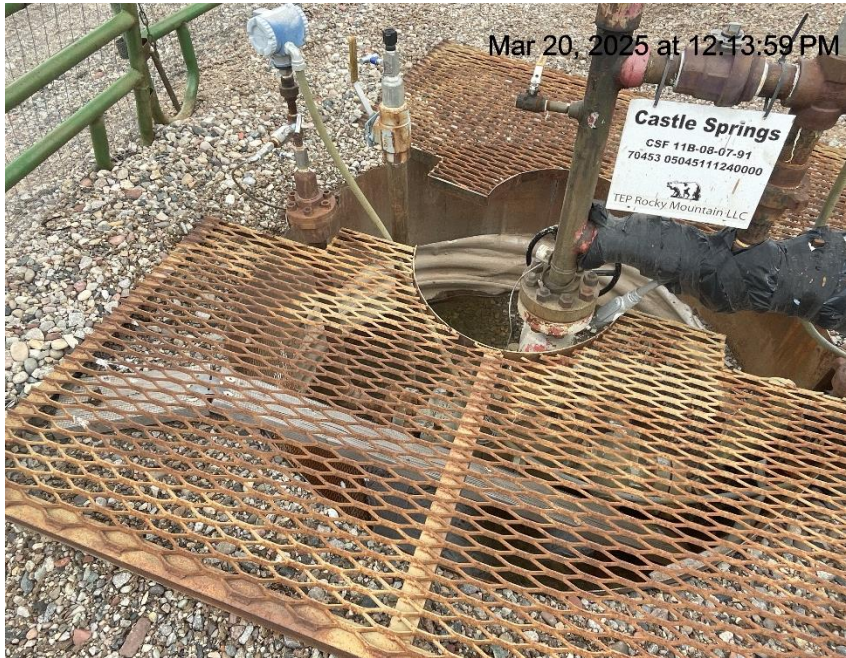
Photo # 5669 Wildlife egress board improperly placed/cellar cover has rendered egress board unusable
