Inspection/Audit Photos

Location Name: QB Energy SAVAGE 2-31 (RL2) Pad

Location #: 324005

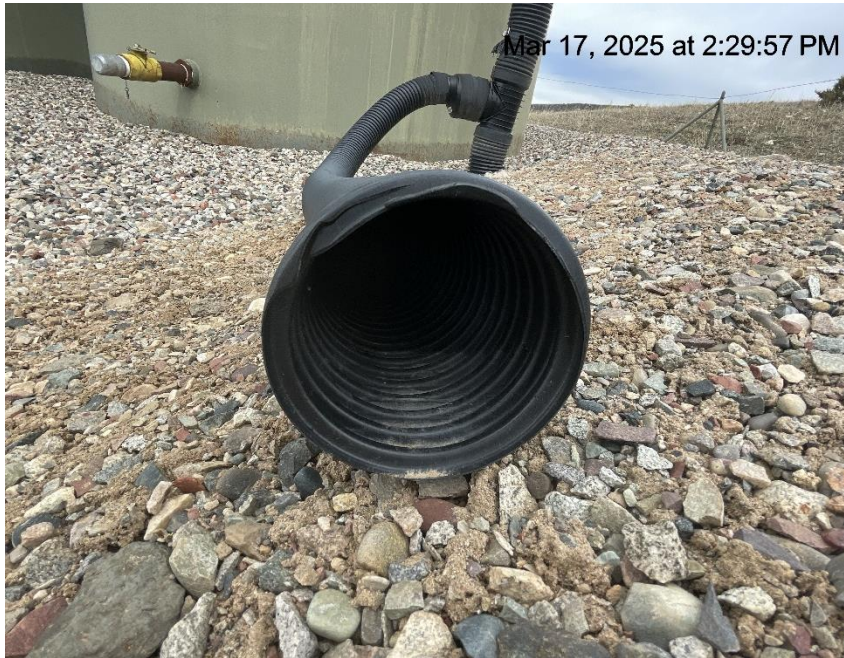
**Photo # 4760 Flowline heating insulation open ended
/wildlife hazard/available for entry by wildlife**

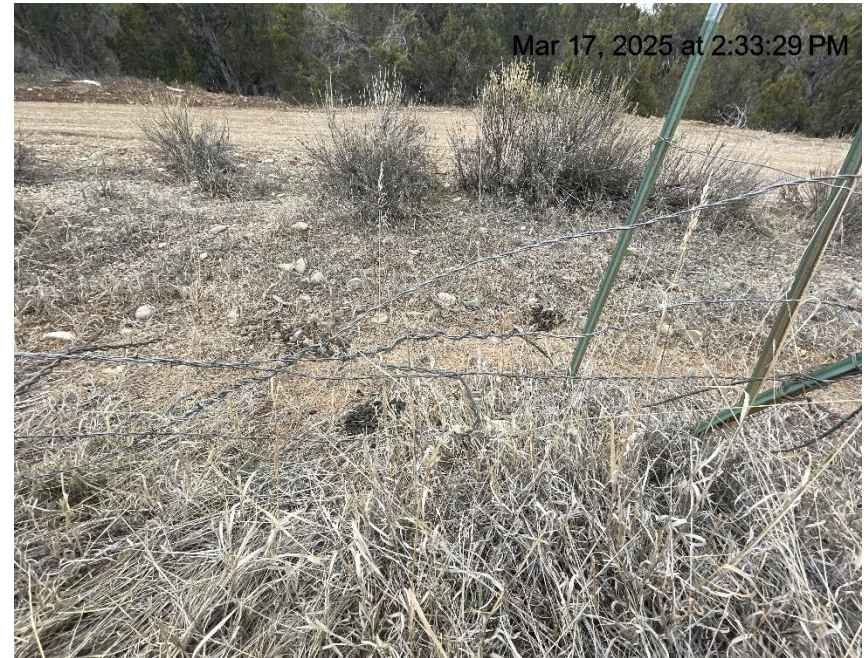
**Photo # 4761 Barbed wire fence needs maintenance/wildlife
hazard**

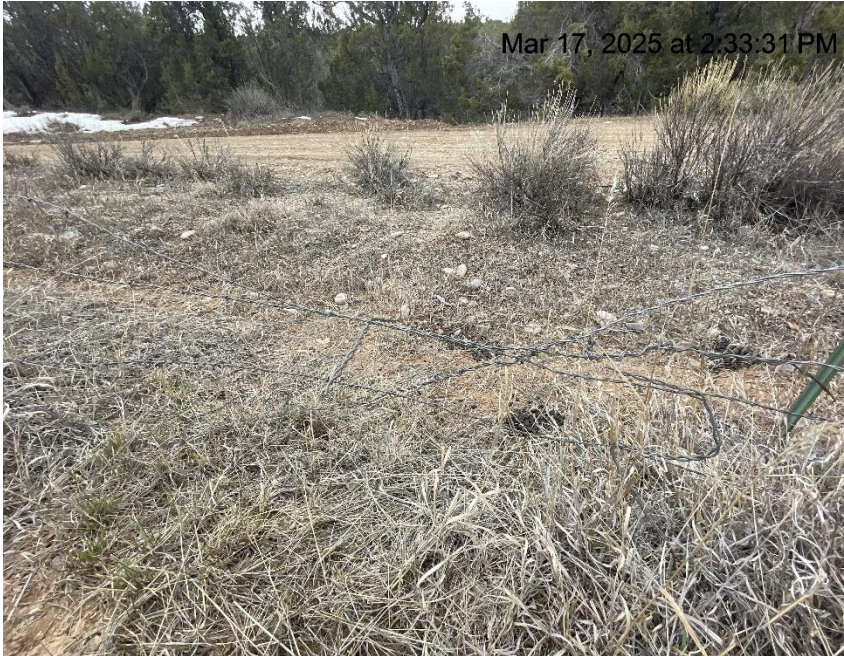
Photo # 4762 Barbed wire fence needs maintenance/wildlife hazard

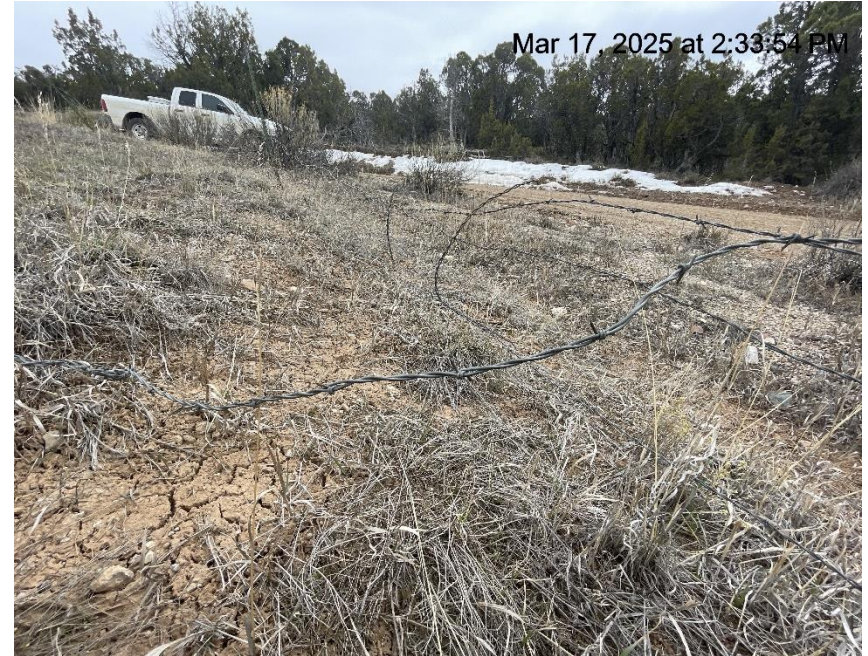
Photo # 4763 Barbed wire fence needs maintenance/wildlife hazard

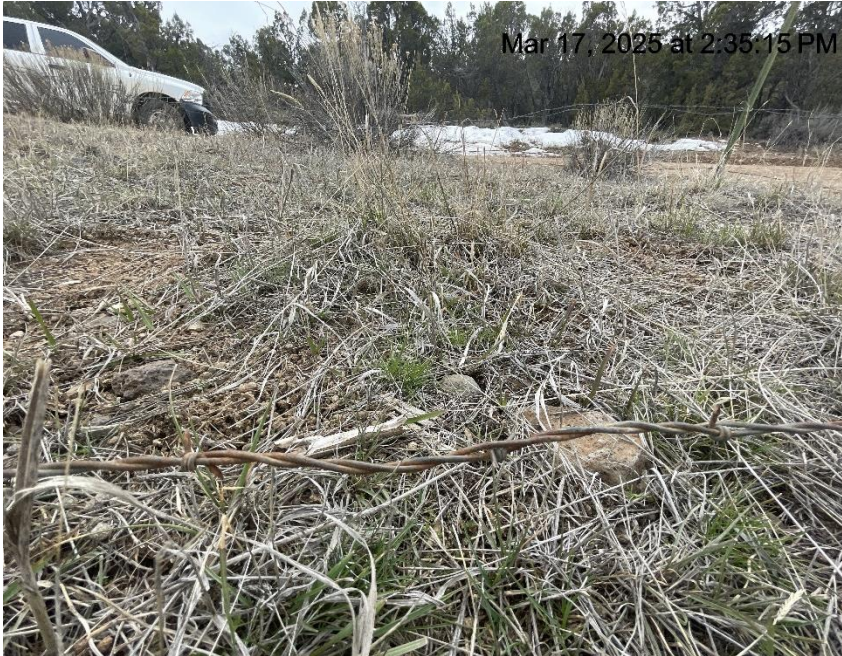
Photo # 4764 Barbed wire fence needs maintenance/wildlife hazard

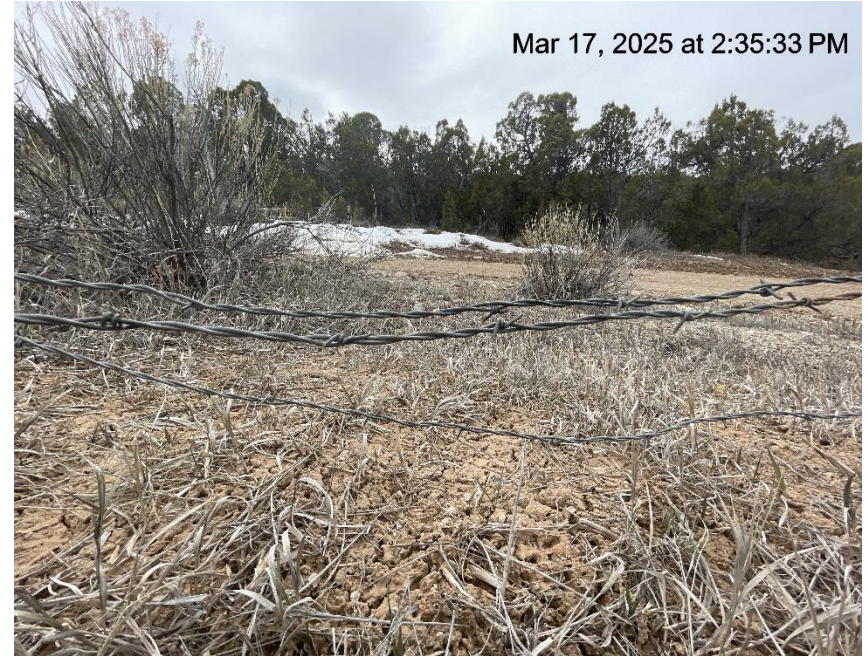
Photo # 4765 Barbed wire fence needs maintenance/wildlife hazard

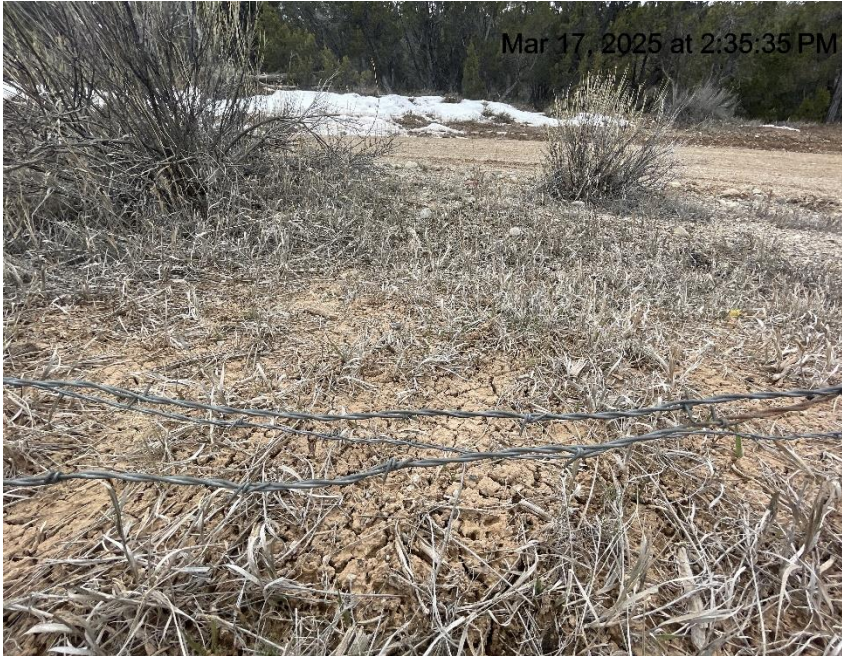
Photo # 4766 Barbed wire fence needs maintenance/wildlife hazard

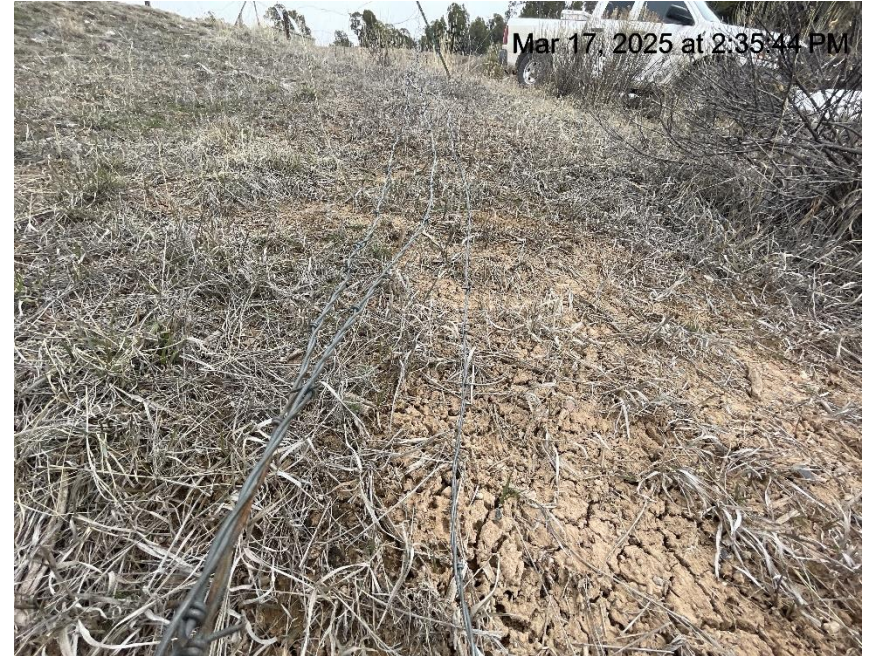
Photo # 4767 Barbed wire fence needs maintenance/wildlife hazard

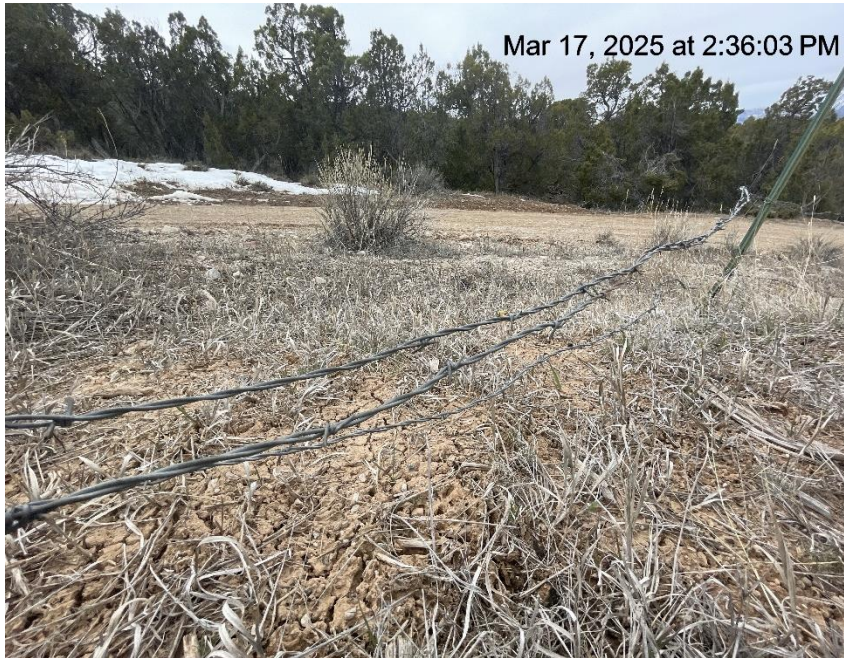
Photo # 4768 Barbed wire fence needs maintenance/wildlife hazard

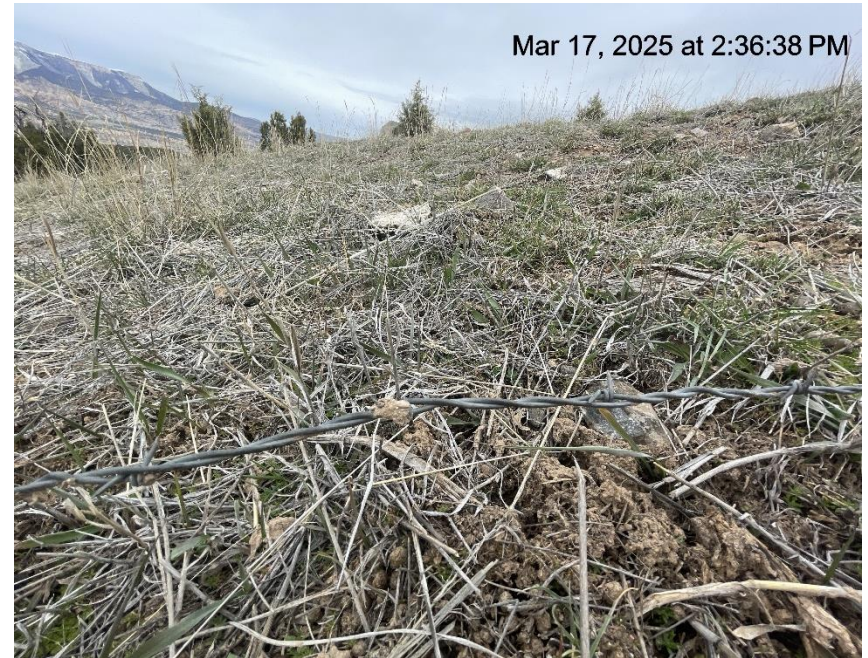
Photo # 4769 Barbed wire fence needs maintenance/wildlife hazard
