Inspection Photos
Location Name: Eyestone 3-35
API Number: 125-07469

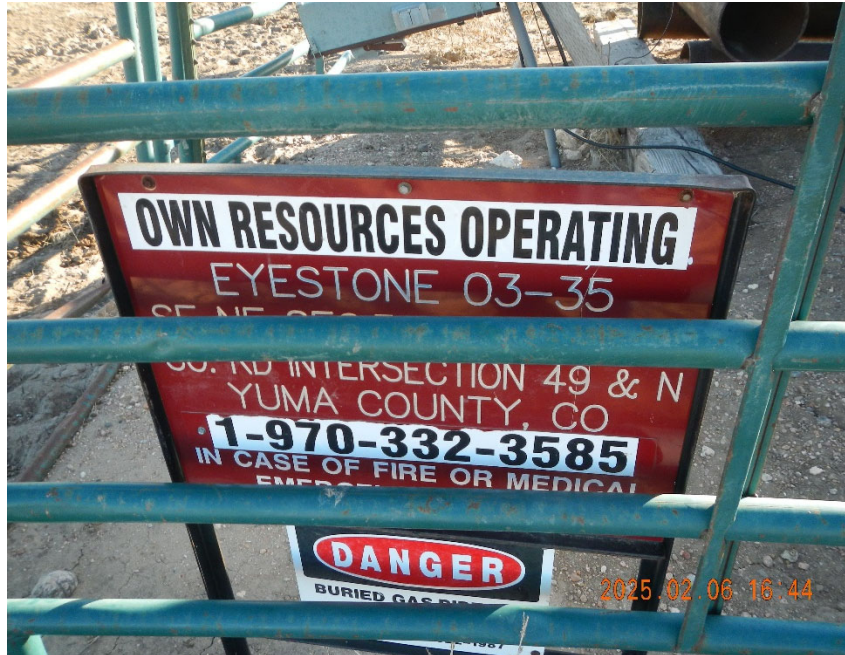
1. Lease sign at well location as seen 02/06/2025.

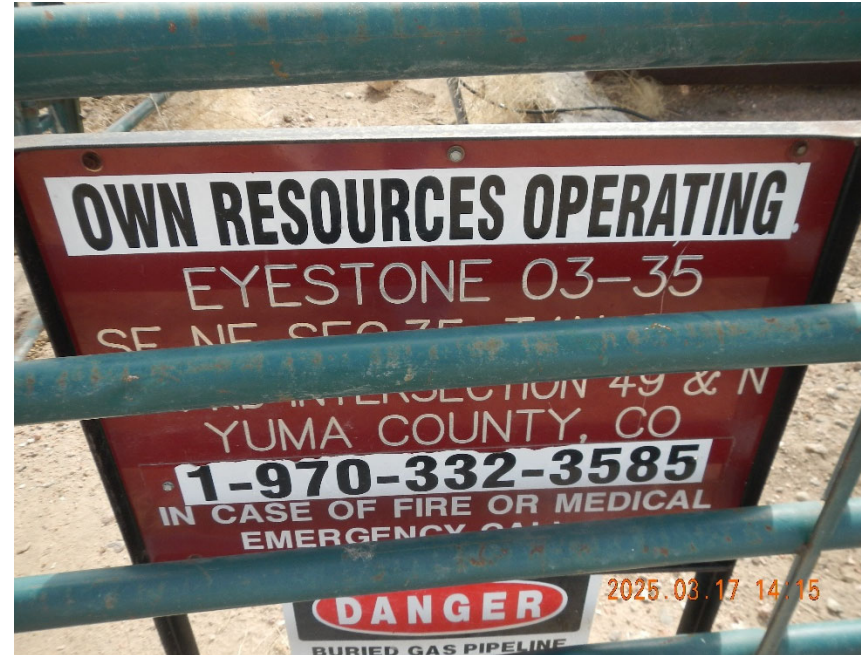
2. Lease sign at well location as seen 03/17/2025.

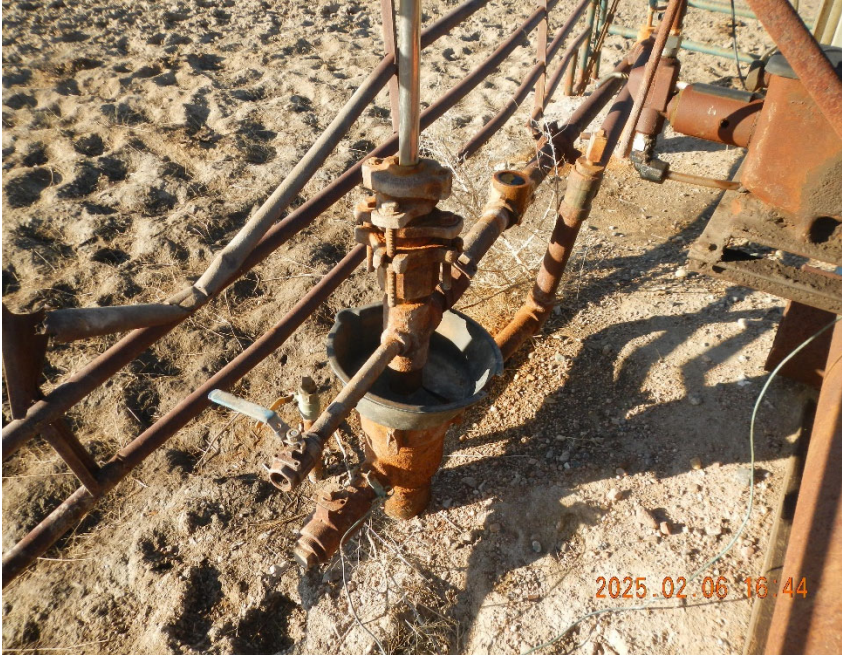
3. View of wellhead as seen 02/06/2025.

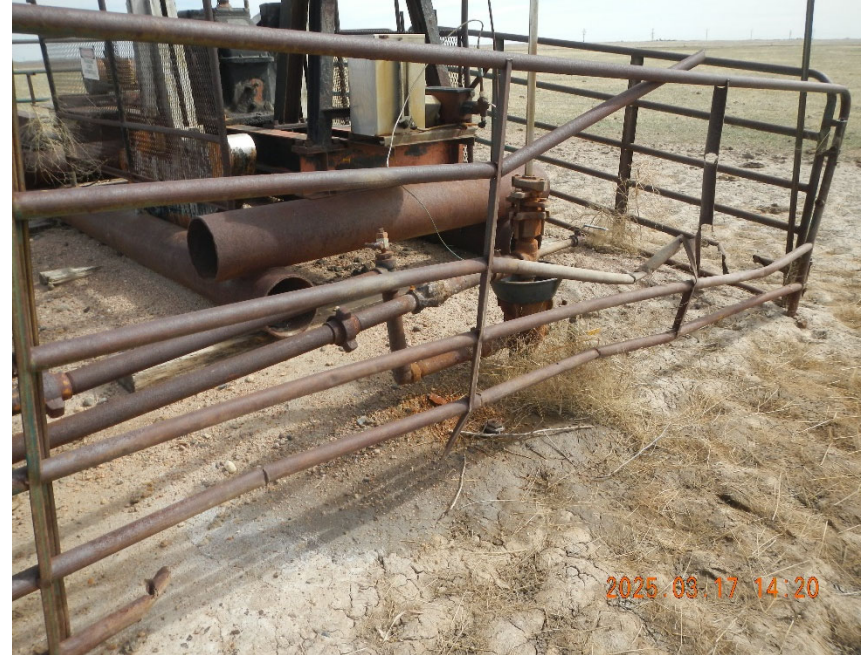
4. View of wellhead area as seen 03/17/2025. Note saturated soil around wellhead.

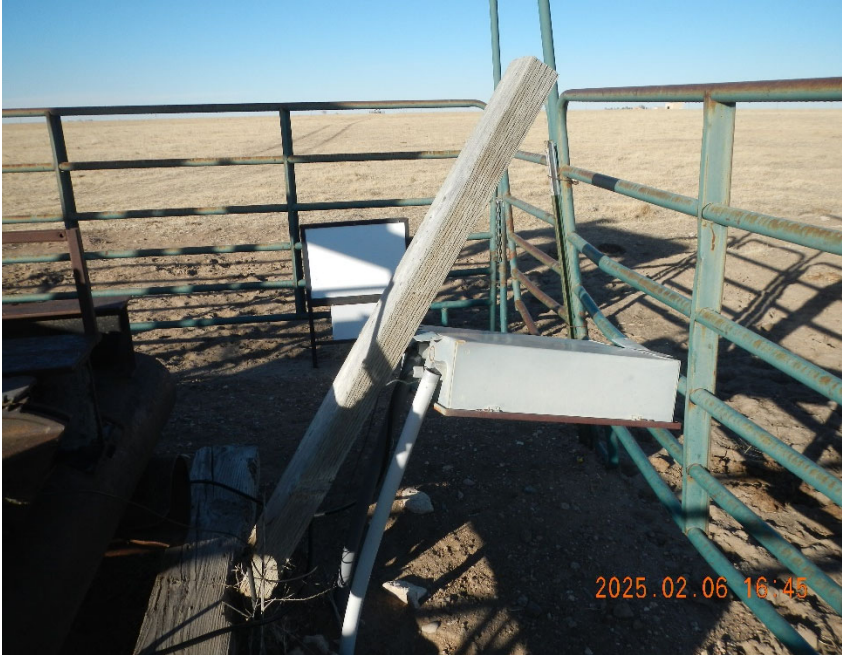
**5. View of broken power panel post and panel as seen
02/06/2025.**

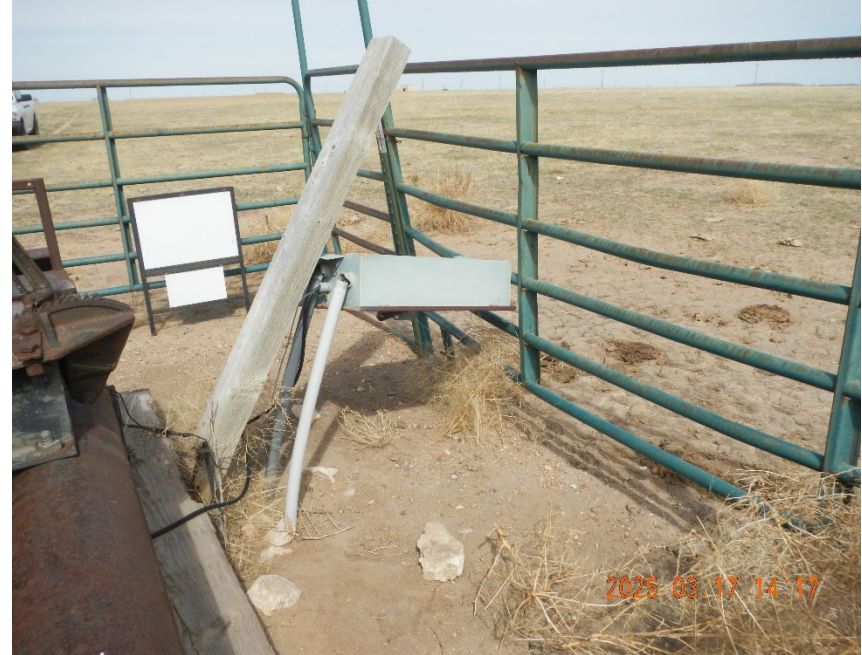
**6. View of broken power panel post and panel as seen
03/17/2025.**

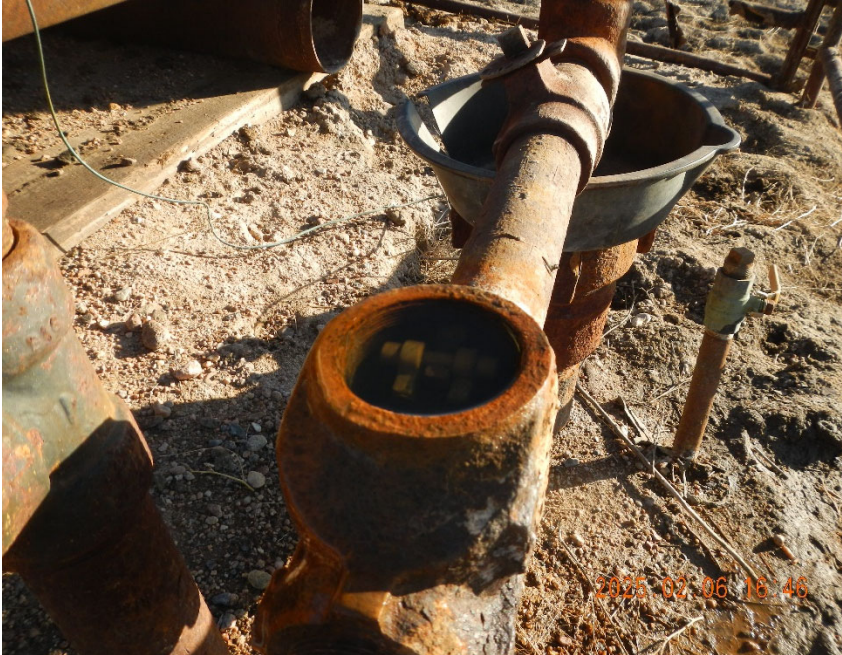
7. View of check valve with missing cap as seen 02/06/2025.

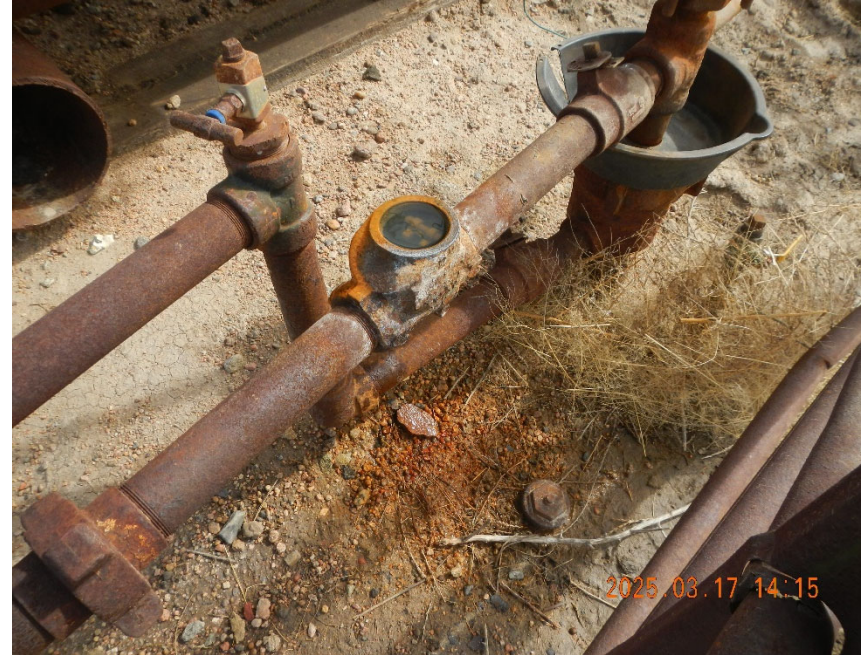
**8. View of check valve with missing cap as seen 03/17/2025.
Note check valve cap on ground at edge of rust stain.**

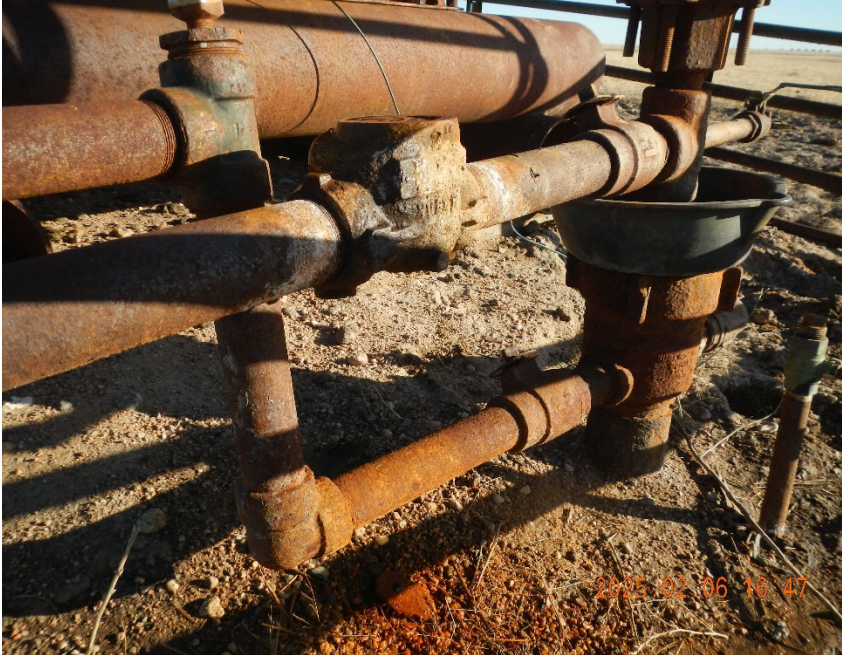
9. View of leaking check valve as spill release point as seen 02/06/2025.

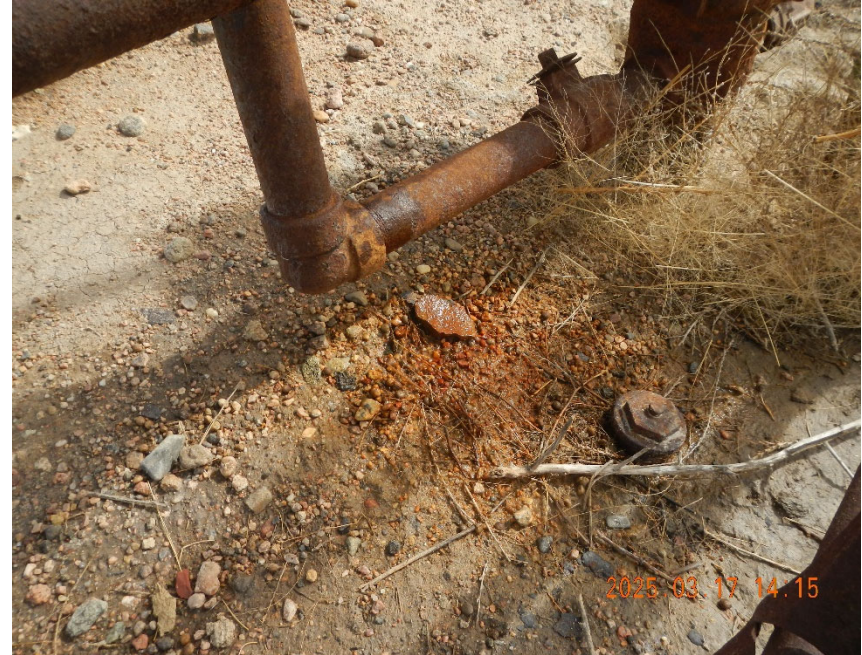
10. View of area below leaking check valve as spill release point. Note check valve cap on ground.

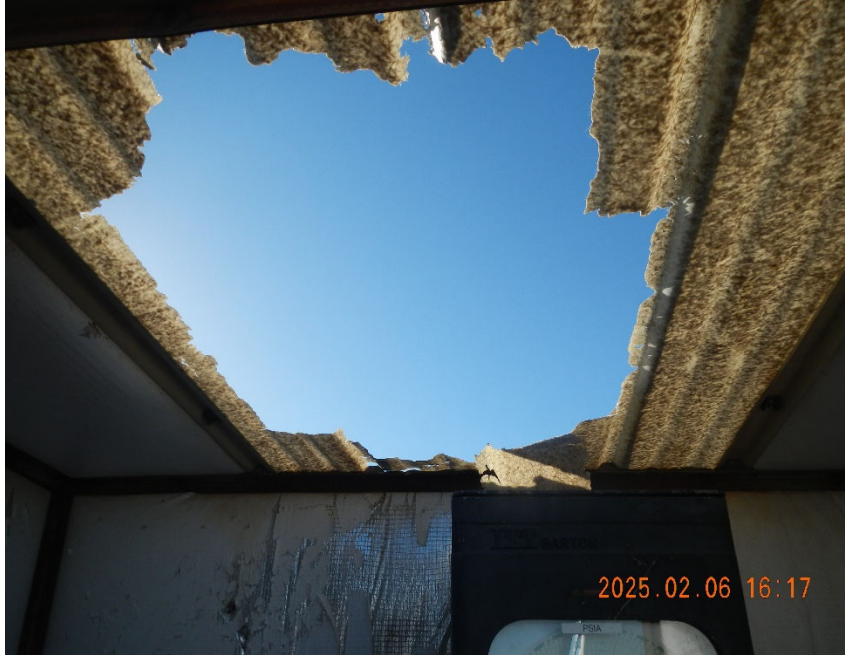
11. View of roof damage on meter shed as seen 02/06/2025.

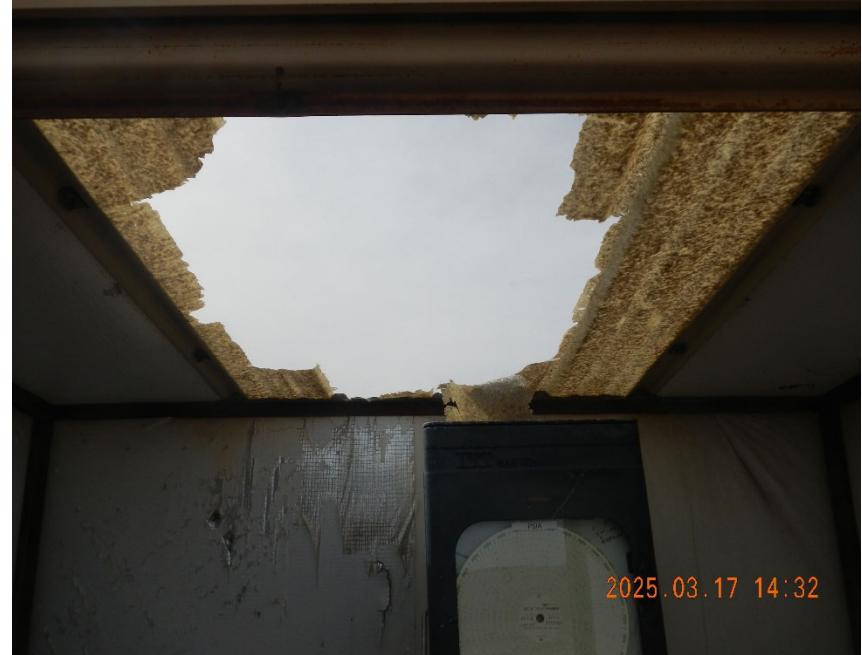
12. View of roof damage on meter shed as seen 03/17/2025.
