Inspection/Audit Photos

Location Name: TEP Rocky Mountain CSF 33B-07-07-91 Pad

Location # 335051

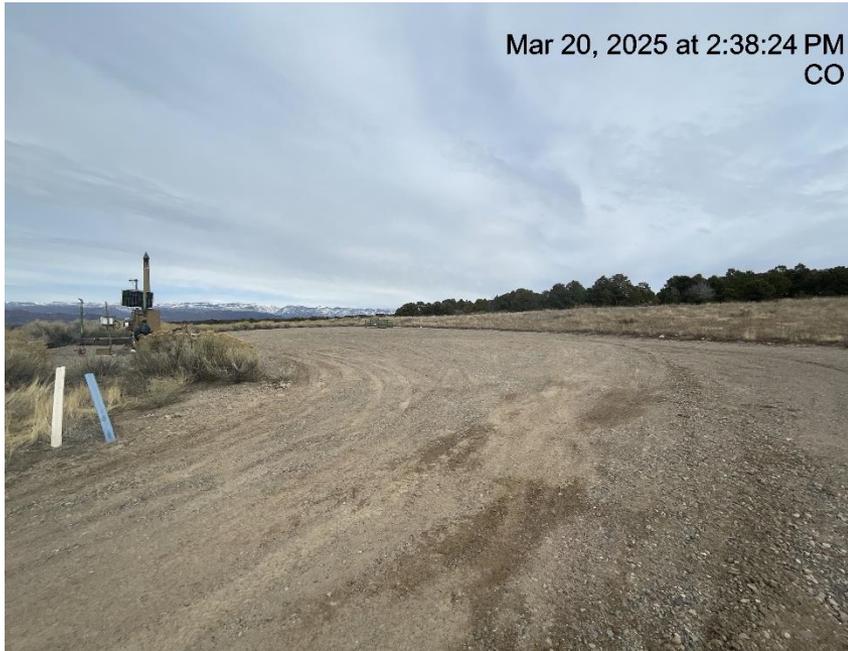
Photo # 6178 From entrance to location

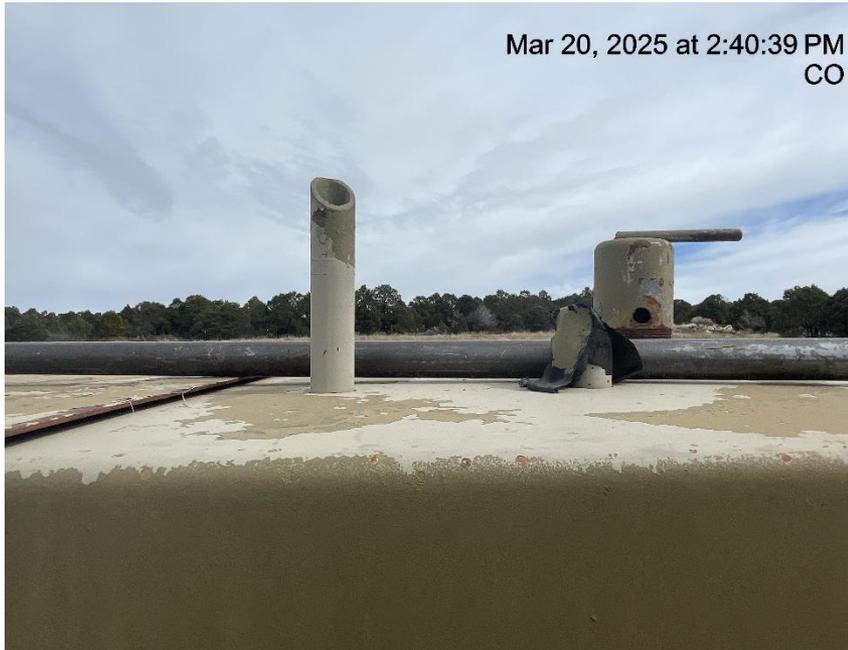
Photo # 6182 PRV vent line on separator does not comply with CECMC pressure safety device rules

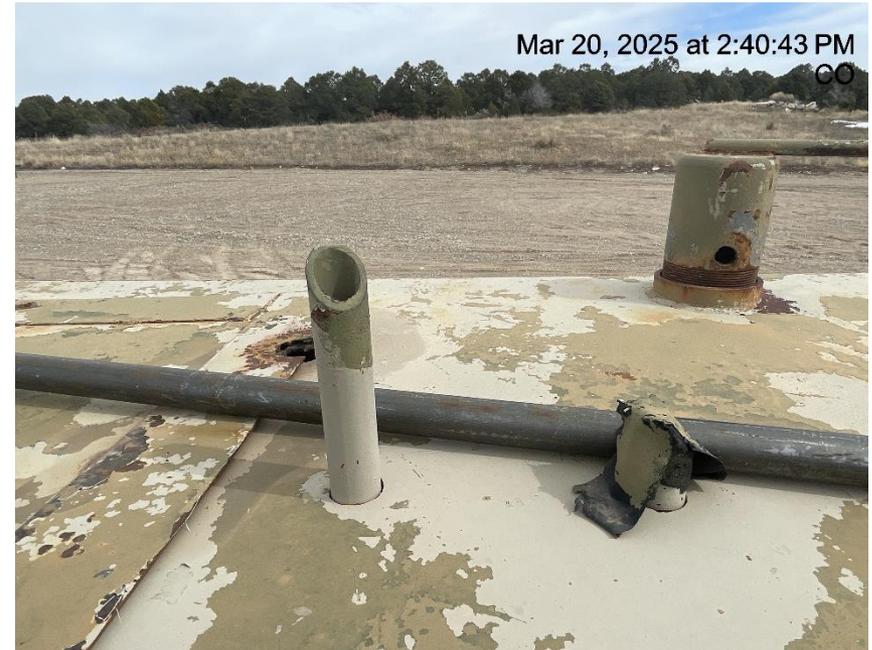
Photo # 6183 PRV vent line on separator does not comply with CECMC pressure safety device rules

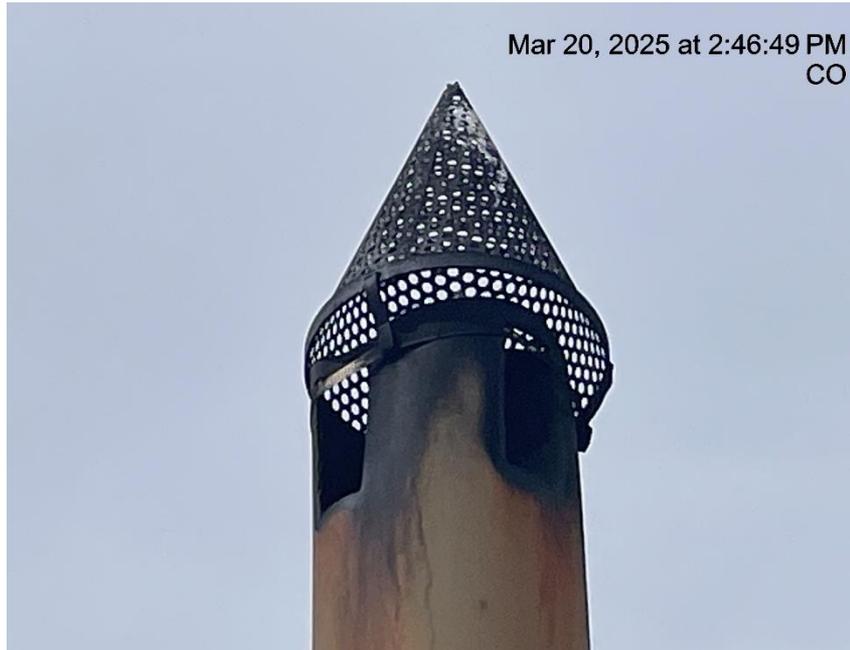
Photo # 6184 Bird protection on separator insufficient
/burner stack available for entry by wildlife/wildlife hazard

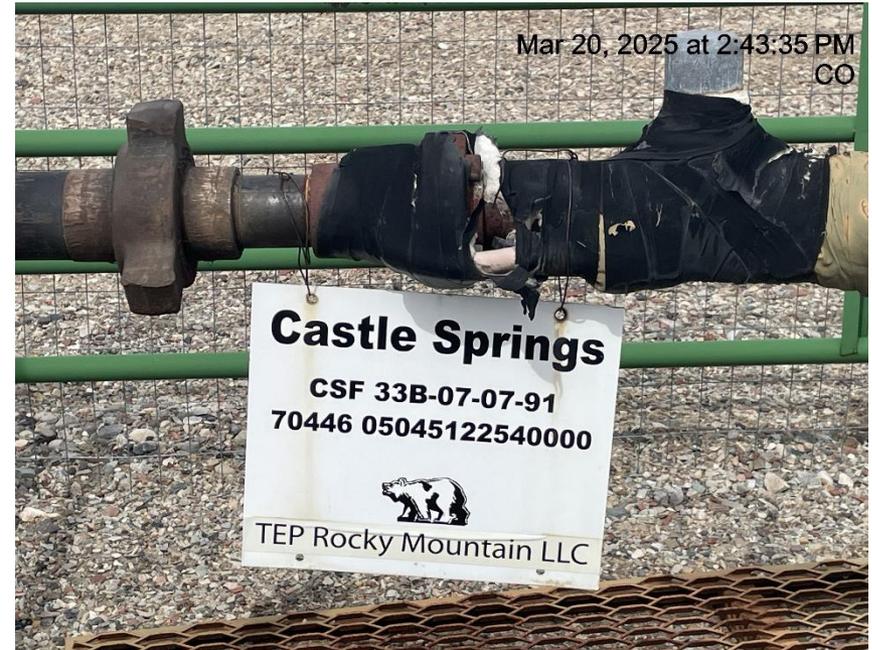
Photo # 6185 Wellhead sign lacks required information
