## Inspection/Audit Photos

Location Name: TEP Rocky Mountain CSF 14C-09-07-91 Pad

Location # 324241

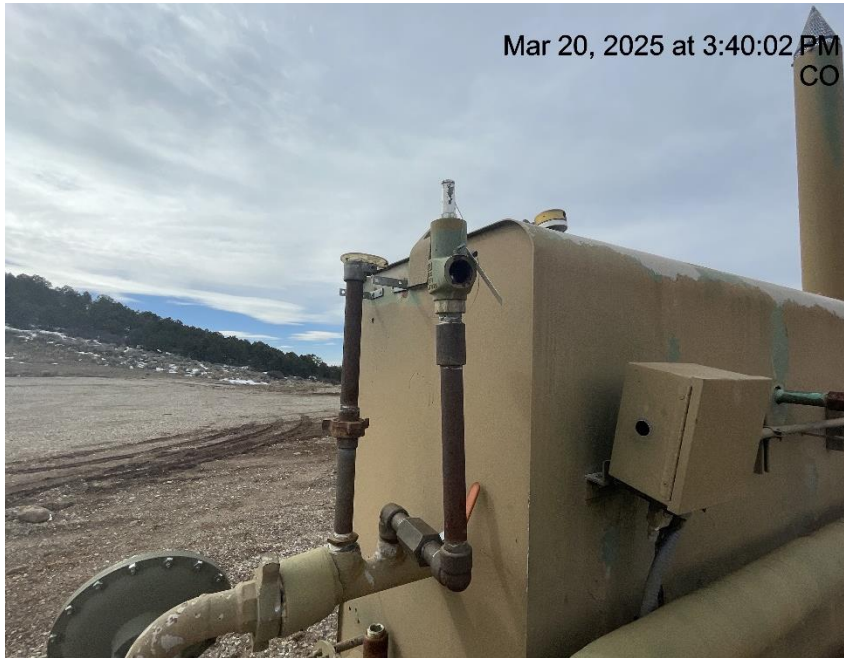
**Photo # 6368 PRV vent line on separator does not comply with CECMC pressure safety device rules**

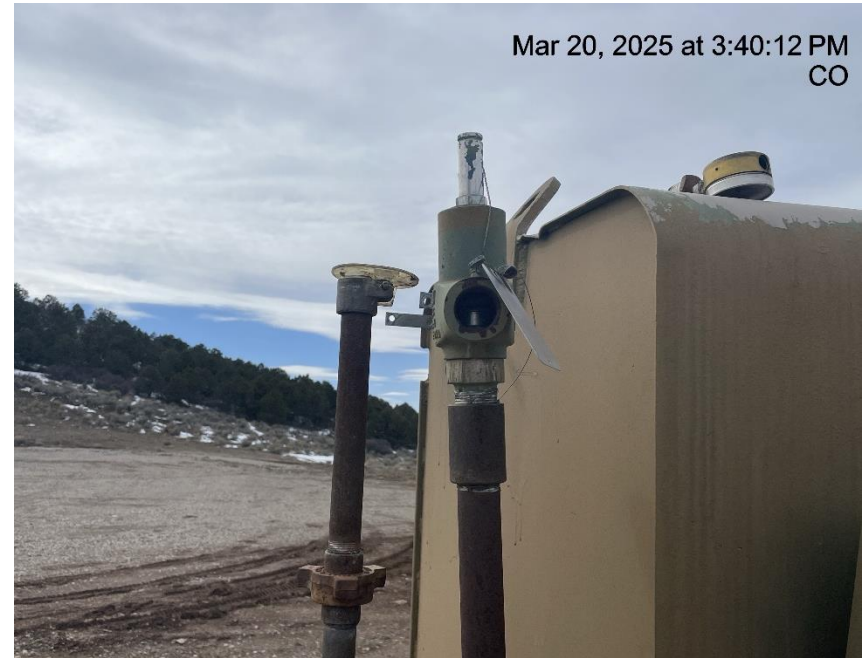
**Photo # 6369 PRV vent line on separator does not comply with CECMC pressure safety device rules**

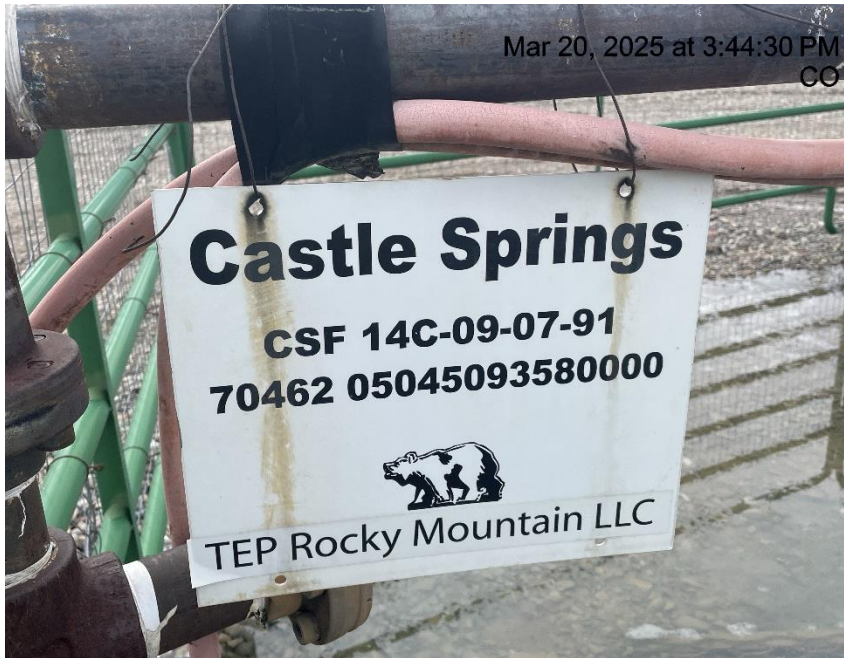
Photo # 6370 Wellhead sign lacks required information
