Inspection Photos  
Location: SE Campo Unit 1101W  
Location ID: 321111  
API # 05-009-06489

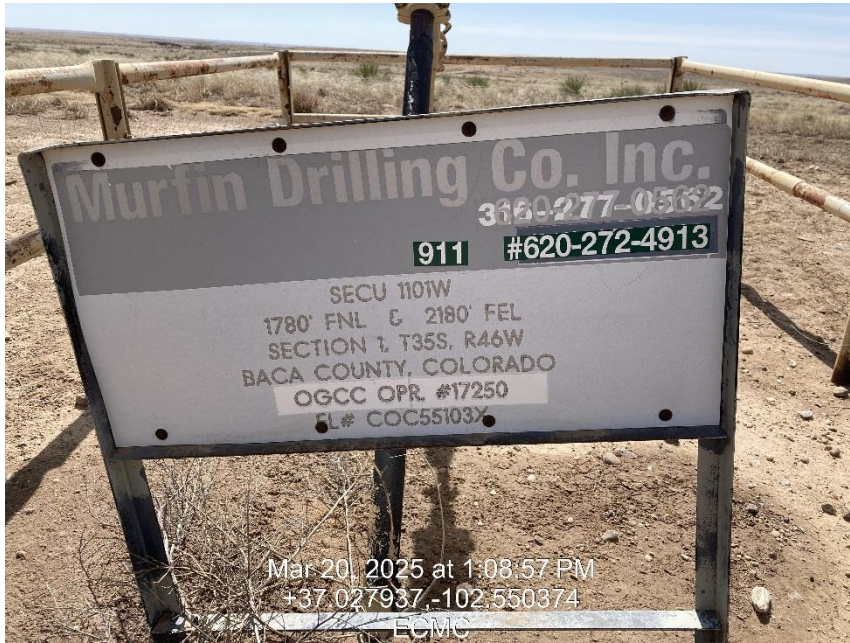
Photo 1 –Well placard

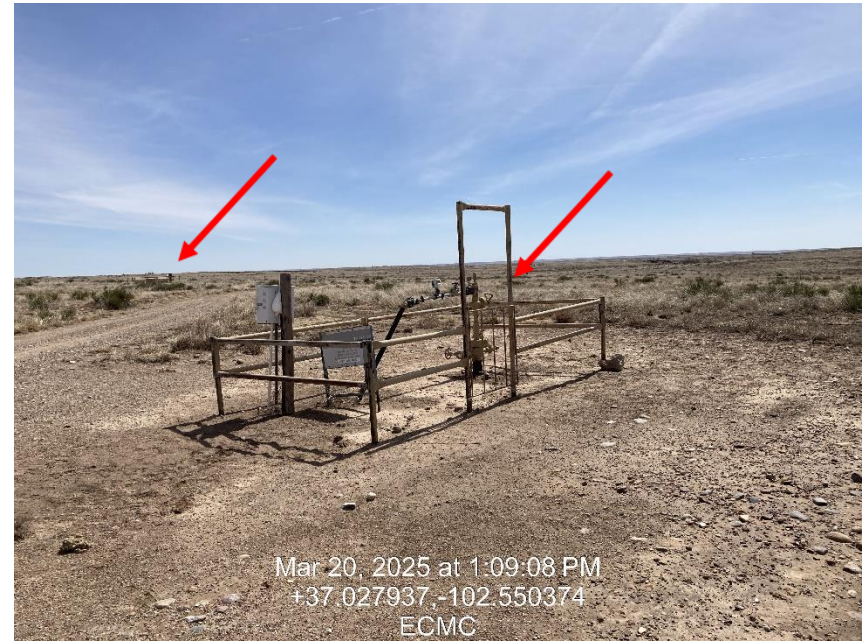
Photo 2 – Wellhead and electrical equipment

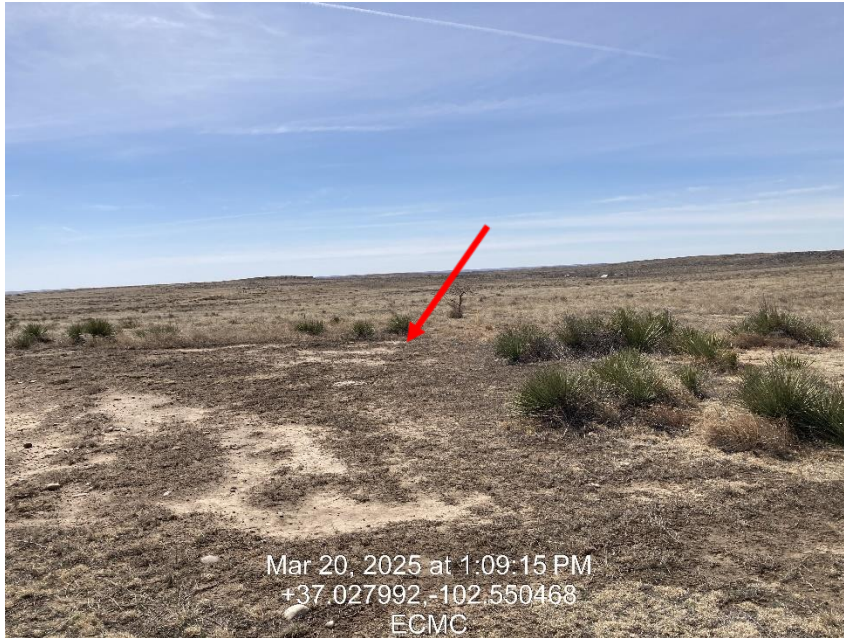
Photo 3 – Location

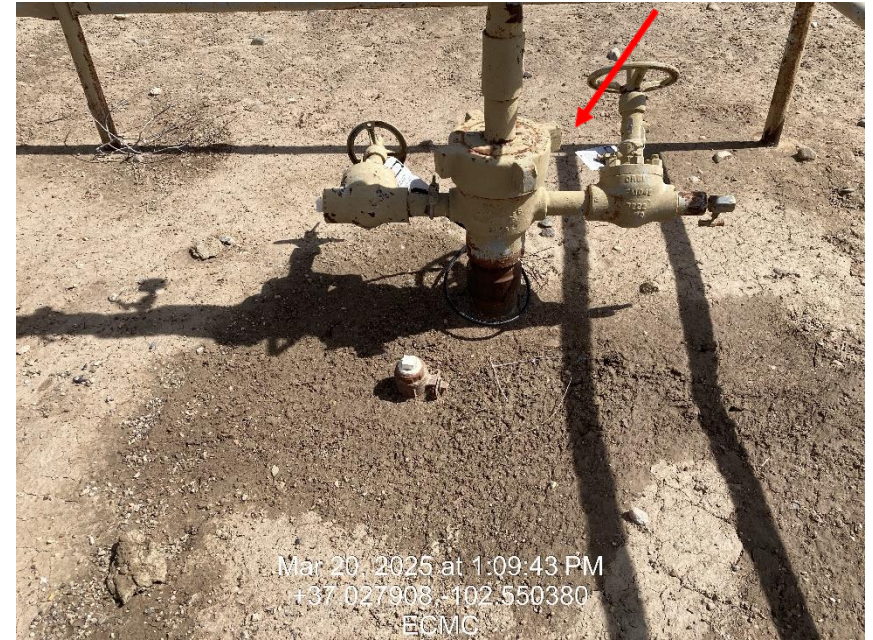
Photo 4 – Wellhead, OOSLAT Applied

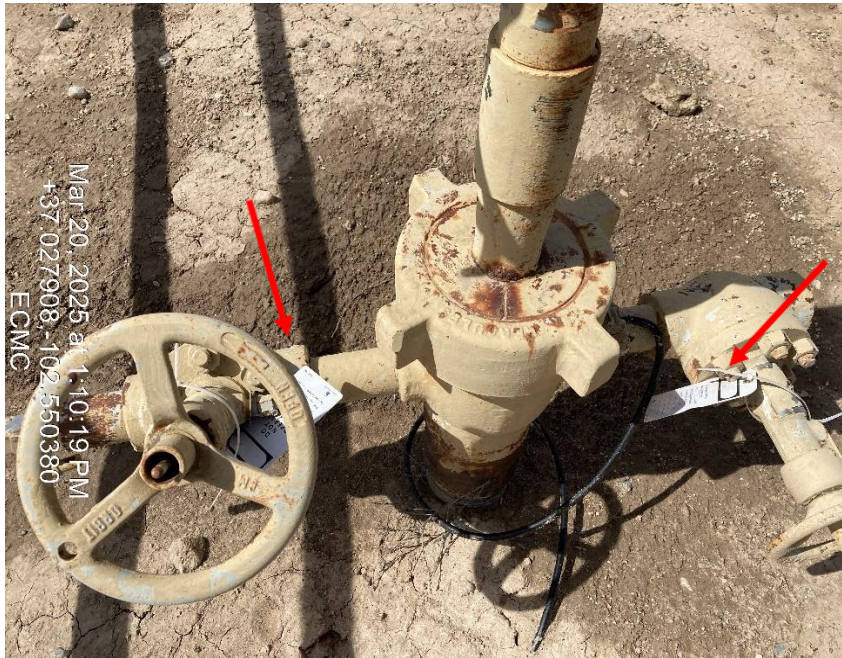
Photo 5 – Wellhead and OOSLAT
