Inspection Photos
Location: SE Campo Unit 602
Location ID: 321110
API # 05-009-06483

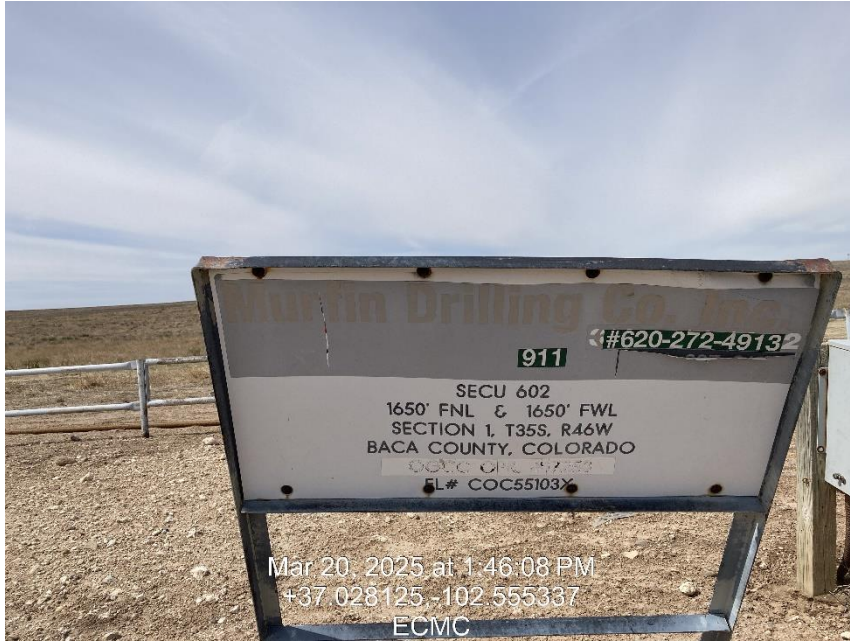
Photo 1 –Well placard

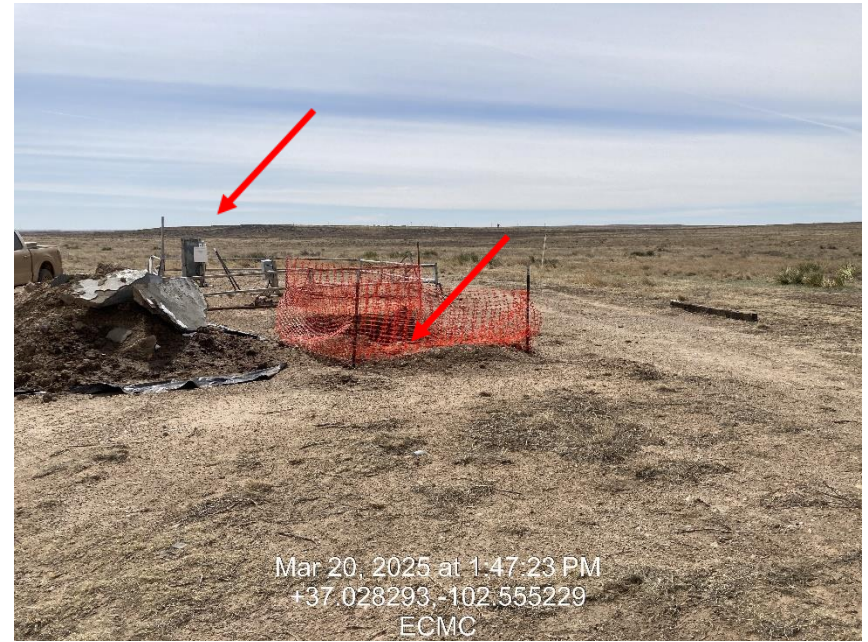
Photo 2 – Historic wellhead and electrical equipment

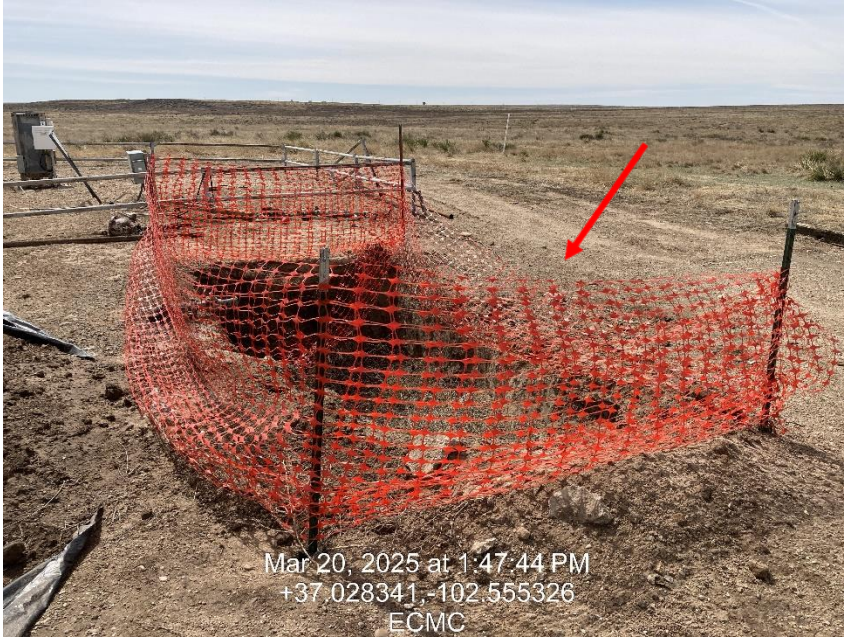
Photo 3 – Wellhead excavation Rem Project # 37141, Fencing not adequate

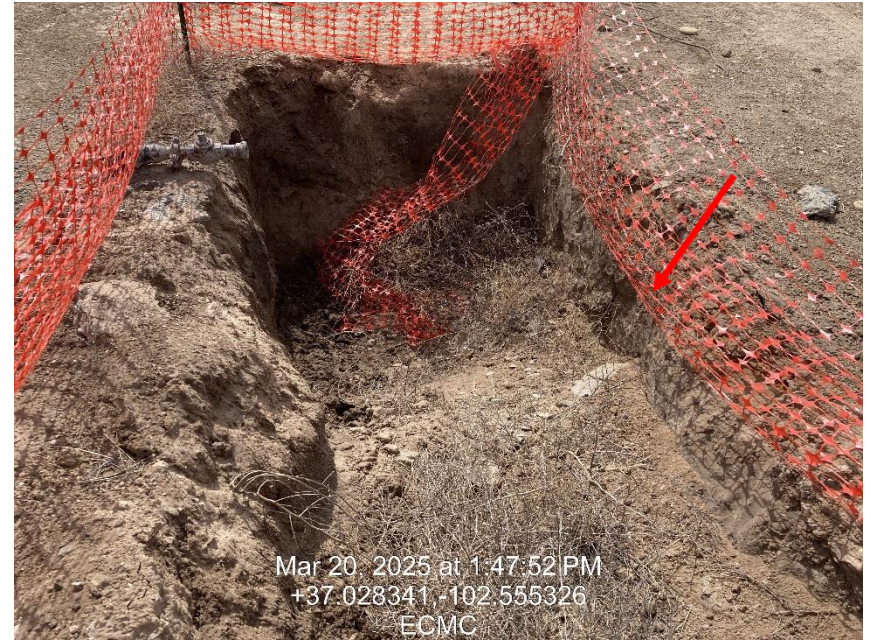
Photo 4 – Wellhead excavation Rem Project # 37141

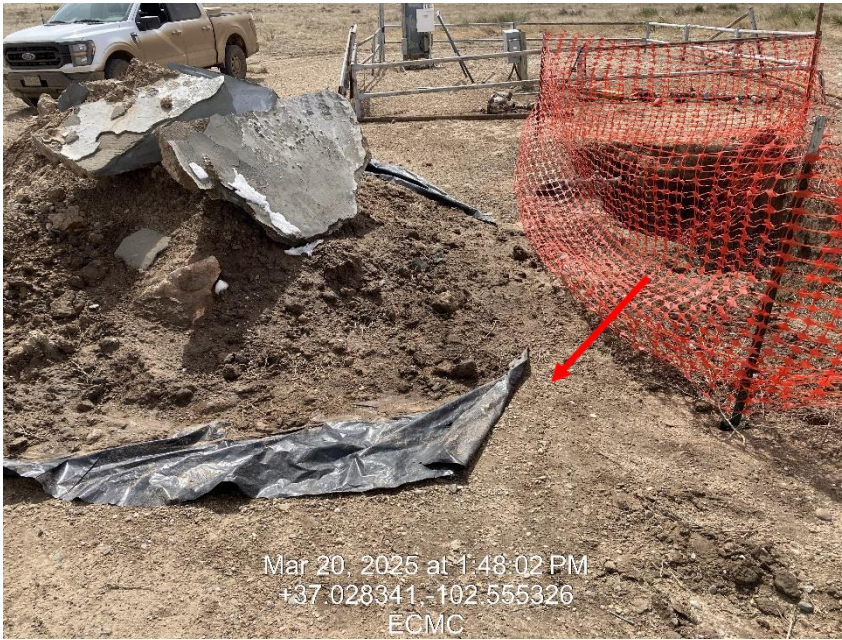
Photo 5 – Spoil Pile on liner, no berm, materials are migrating due to stormwater impacts

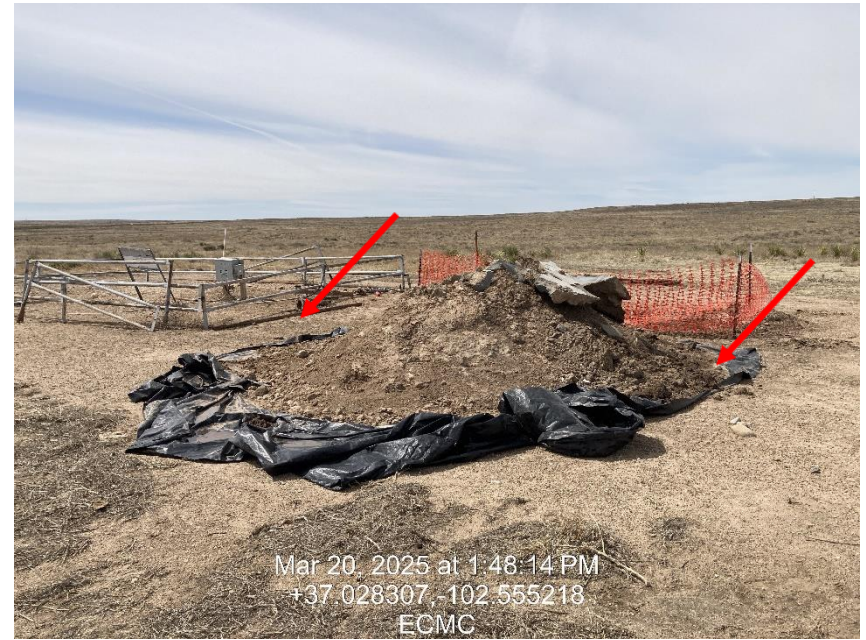
Photo 6 – Spoil Pile on liner, no berm, materials are migrating due to stormwater impacts

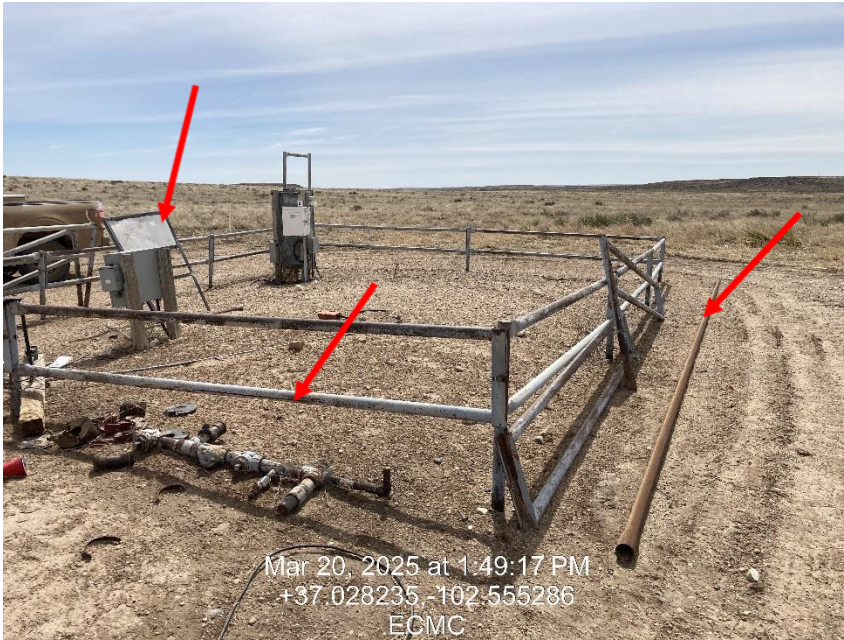
Photo 7 – Ancillary equipment, unused equipment

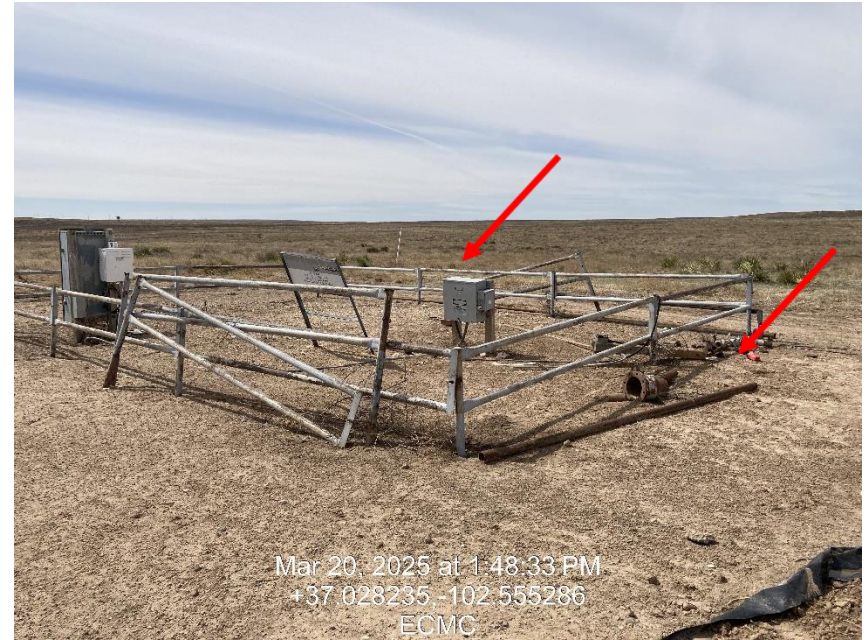
Photo 8 – Ancillary equipment, unused equipment

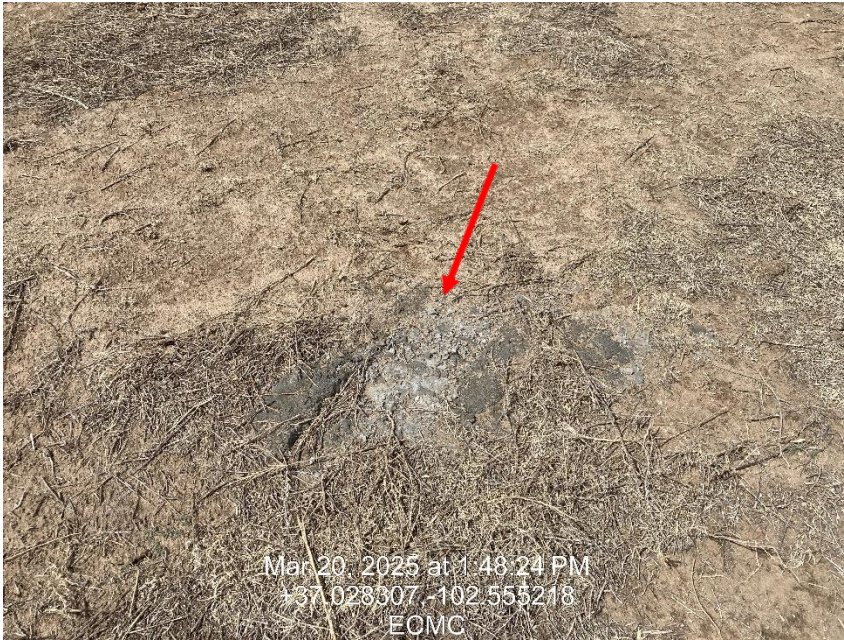
Photo 9 – Cement fines on ground east of wellhead

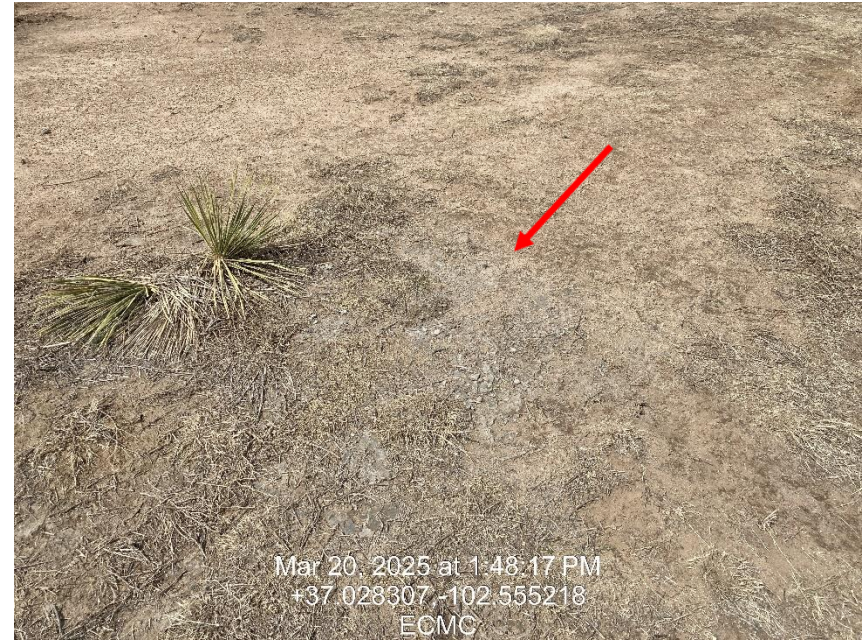
Photo 10 – Cement fines on ground

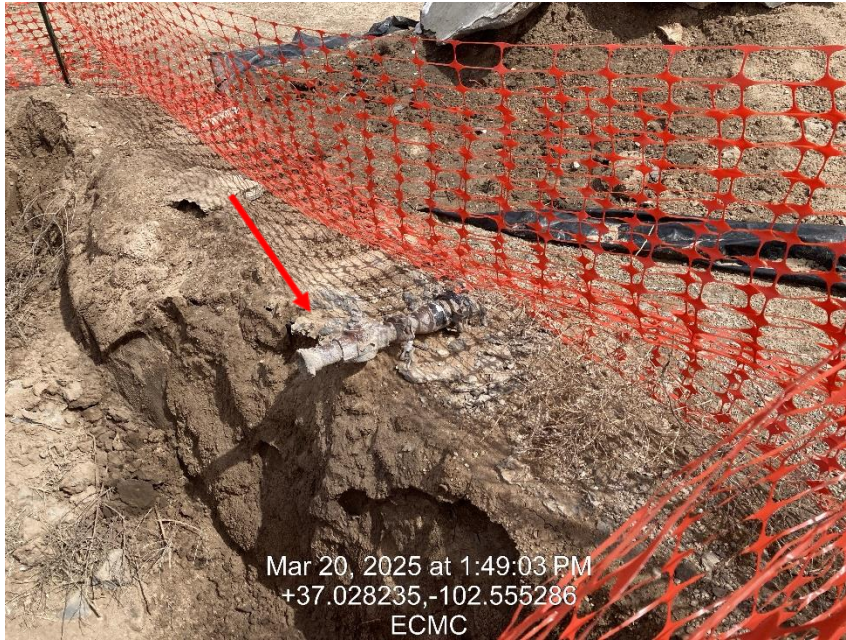
Photo 11 – Flowline at wellhead
