Rhoades 22-35 #2
Attachment A - Photolog
(October 10, 2024)

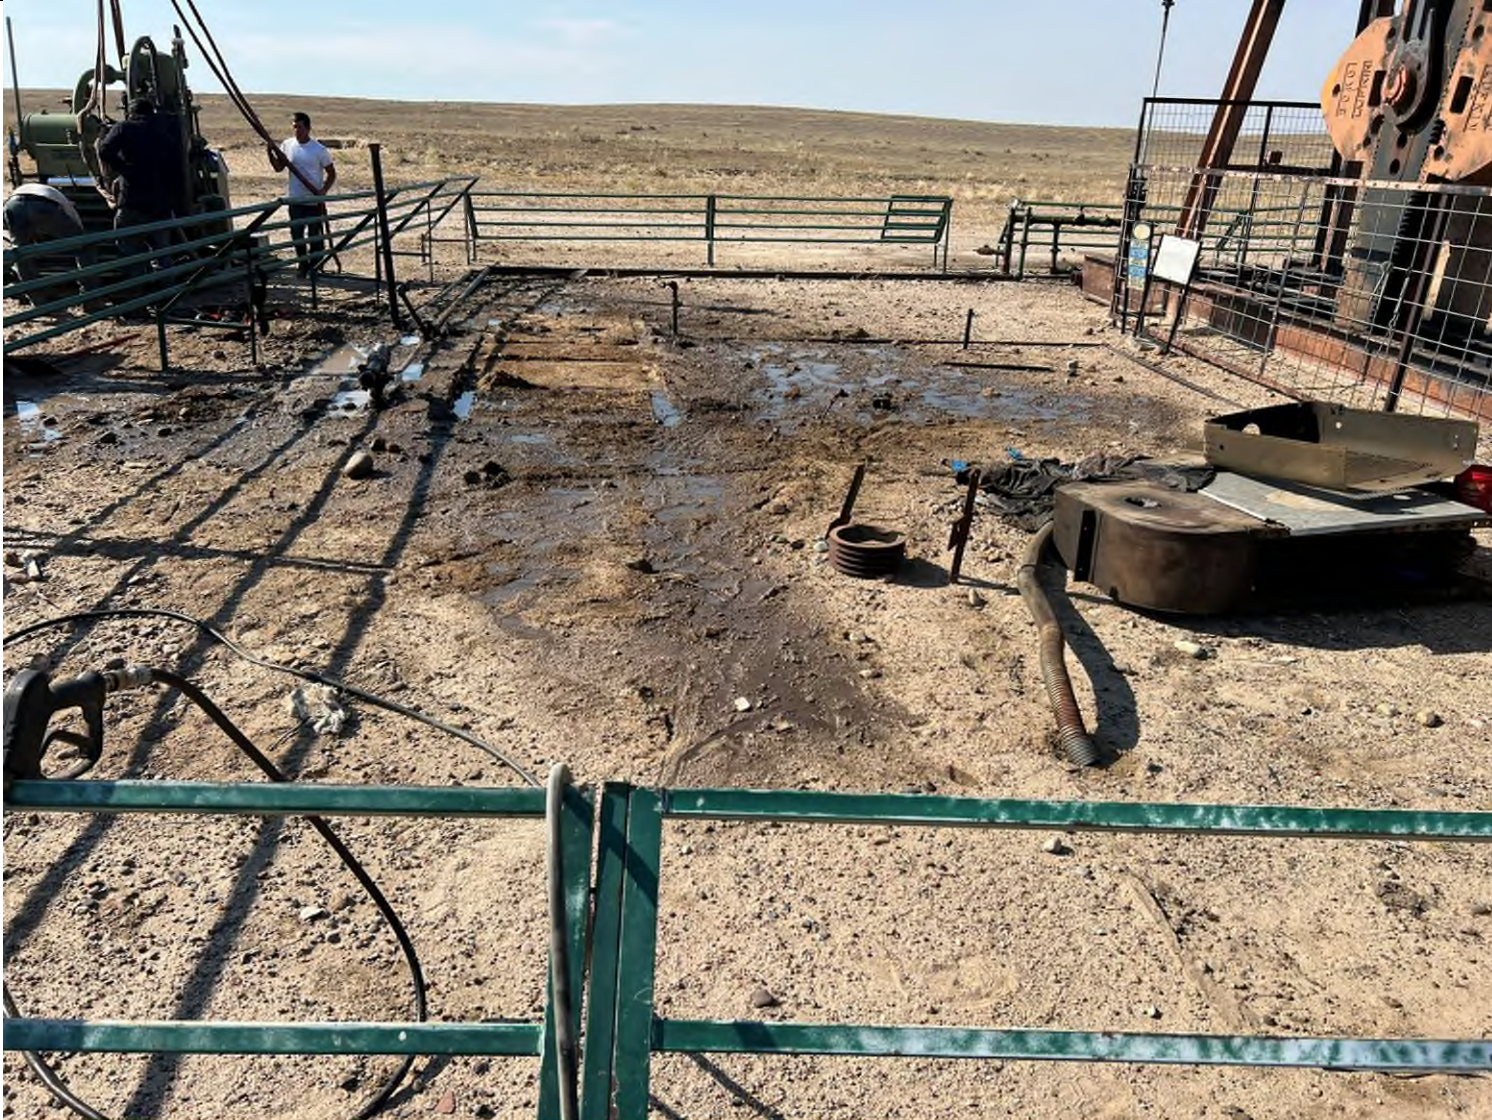
Description: Stained soil located around the disconnected compressor

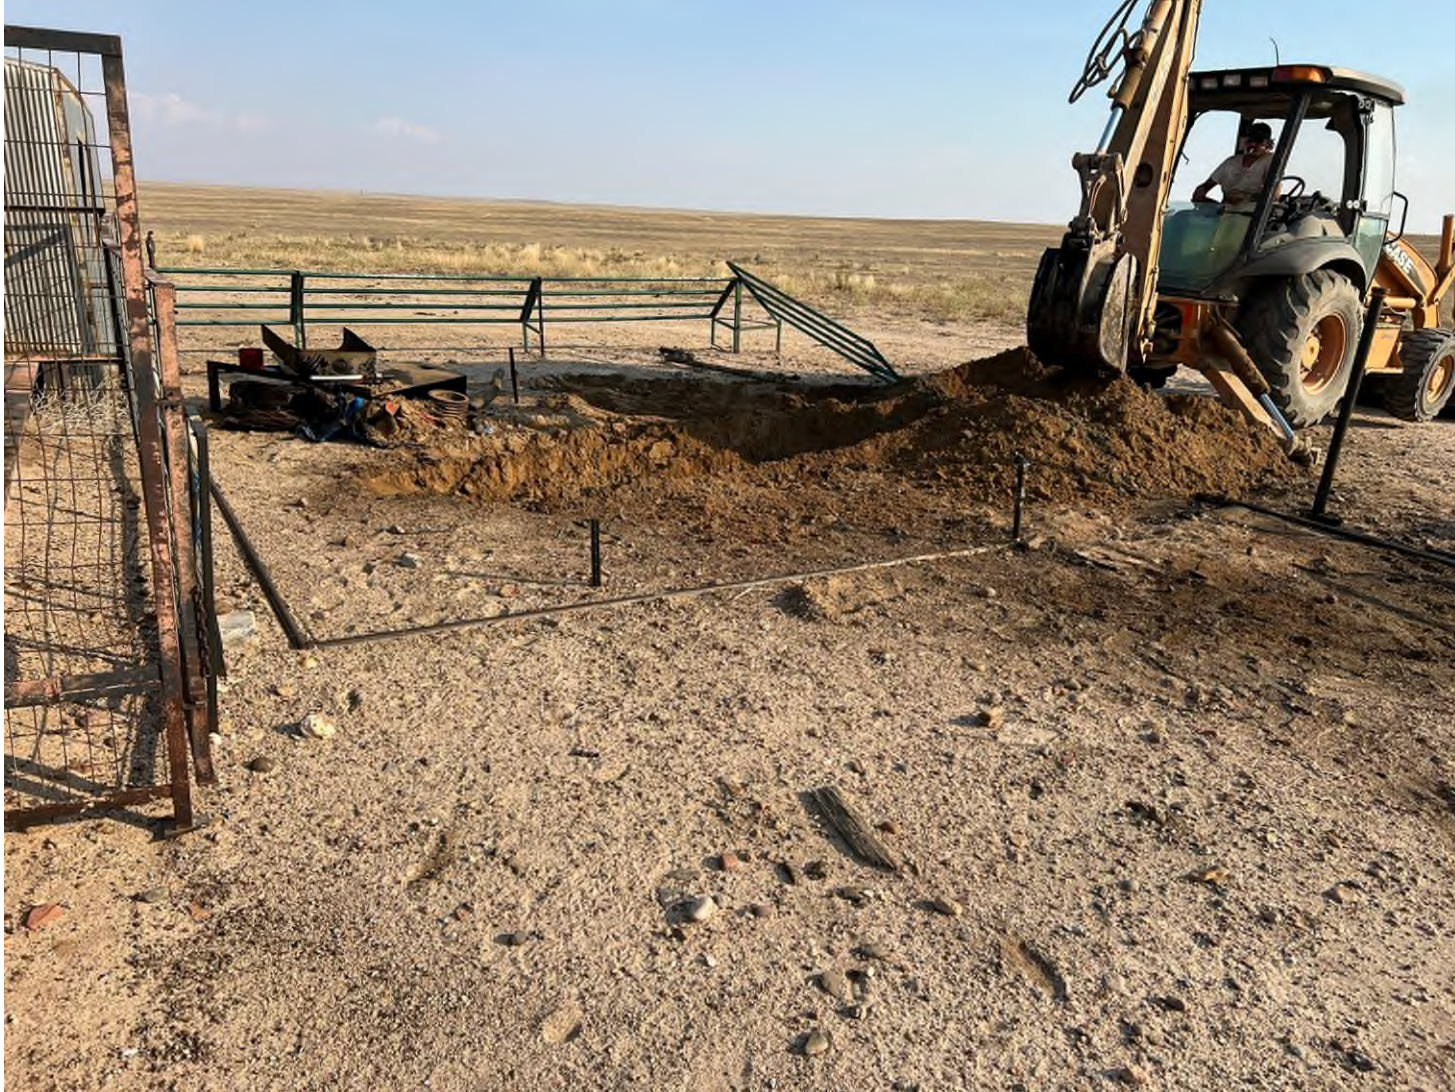
Description: Excavation of stained soil located around the disconnected compressor

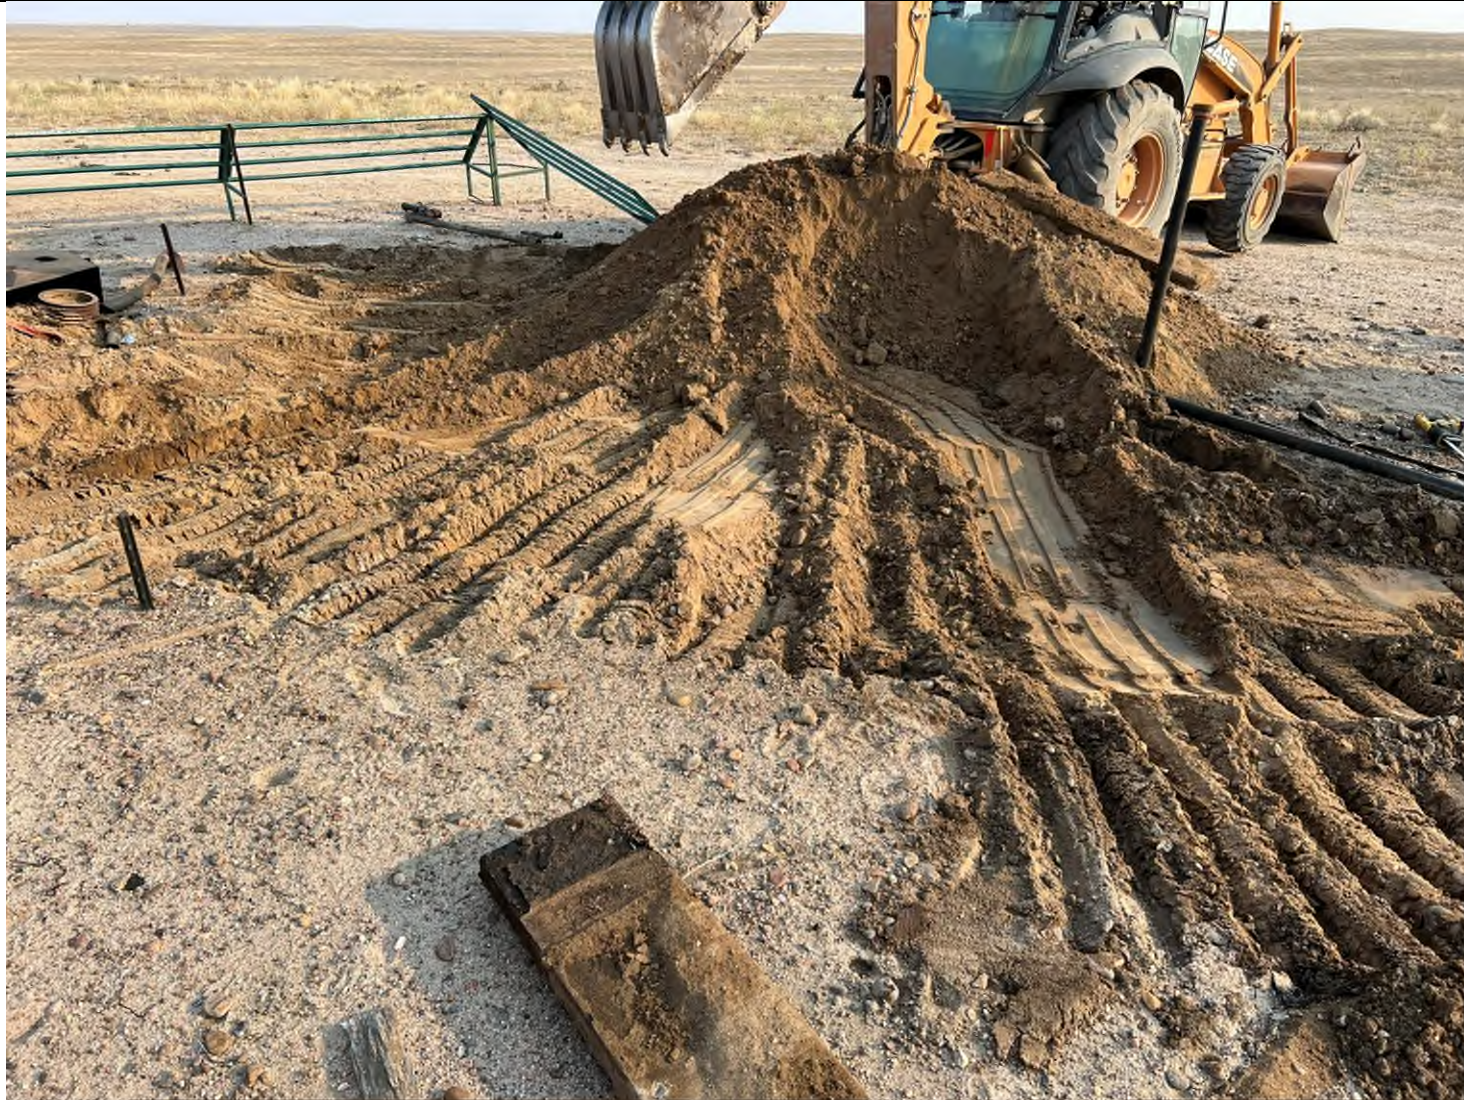
Description: Excavation of stained soil located around the disconnected compressor

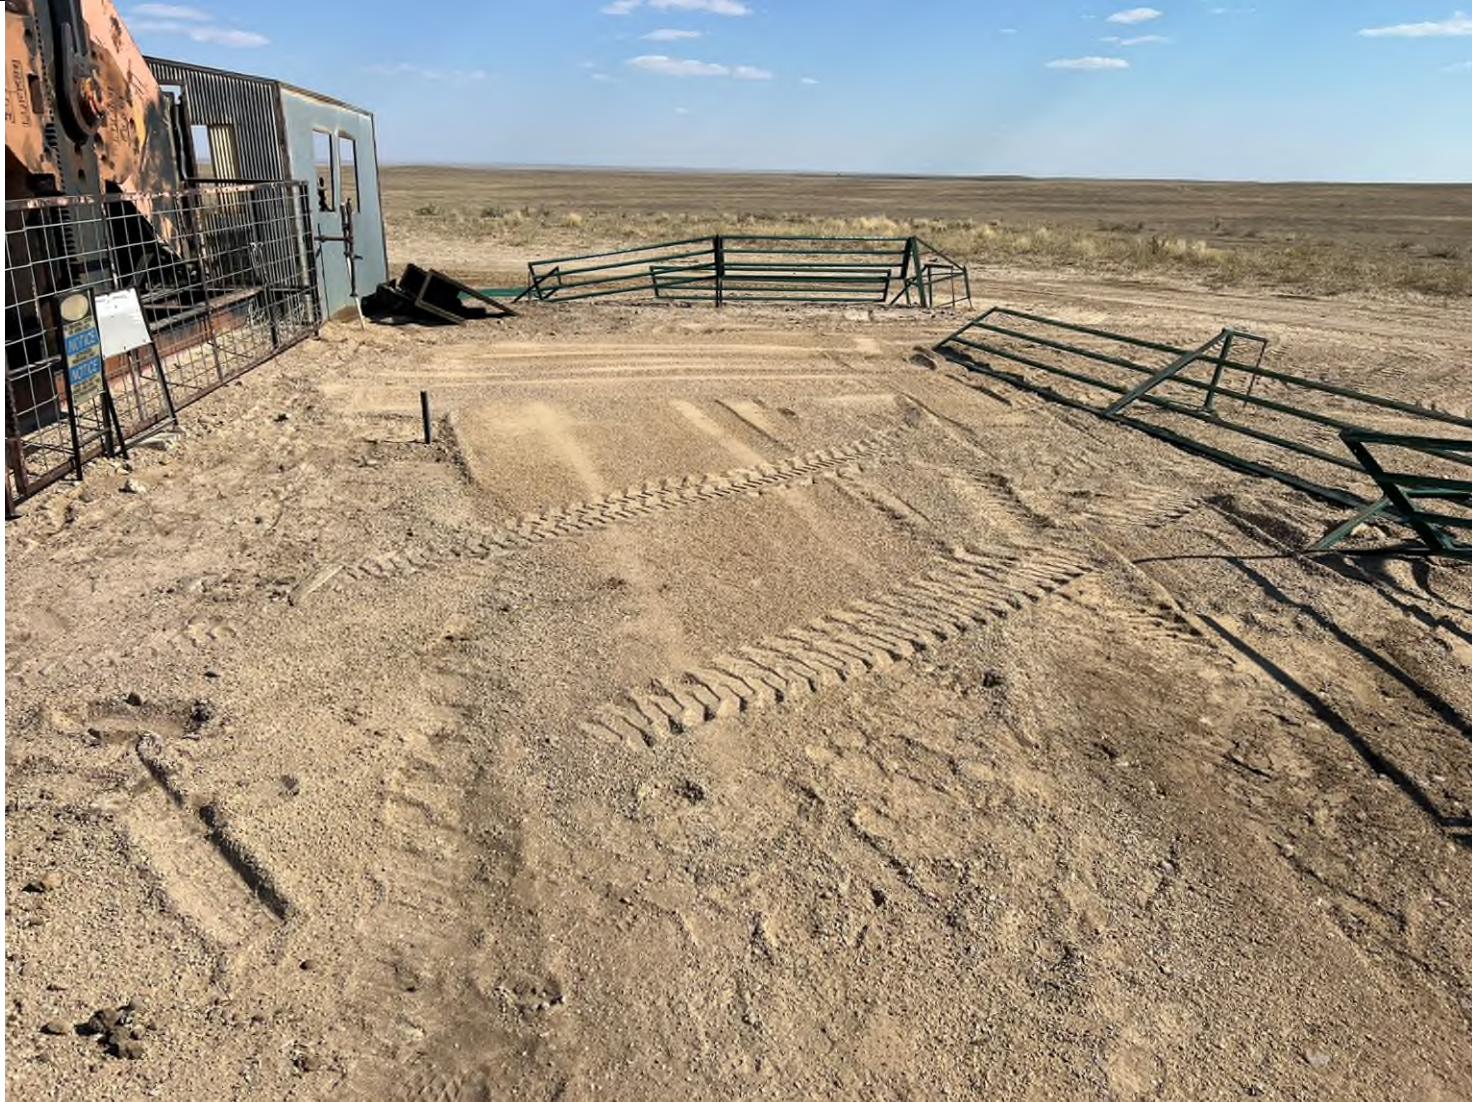
Description: Backfill located around the disconnected compressor

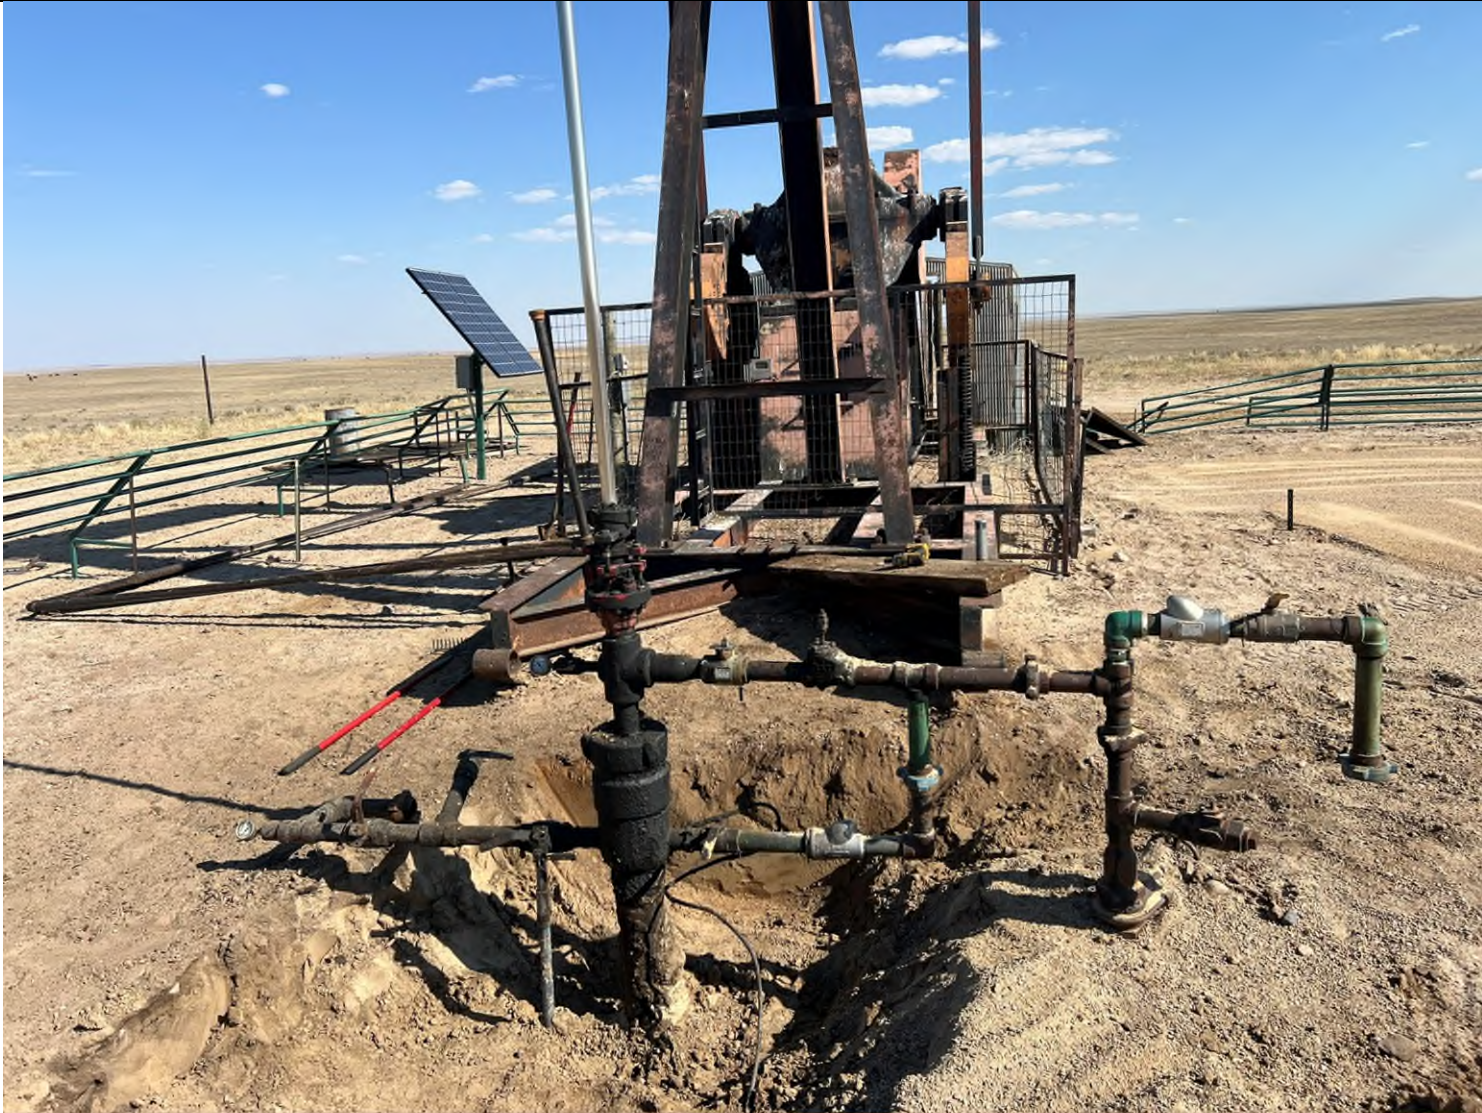
Description: Impacted soil was removed around the wellhead by hand.

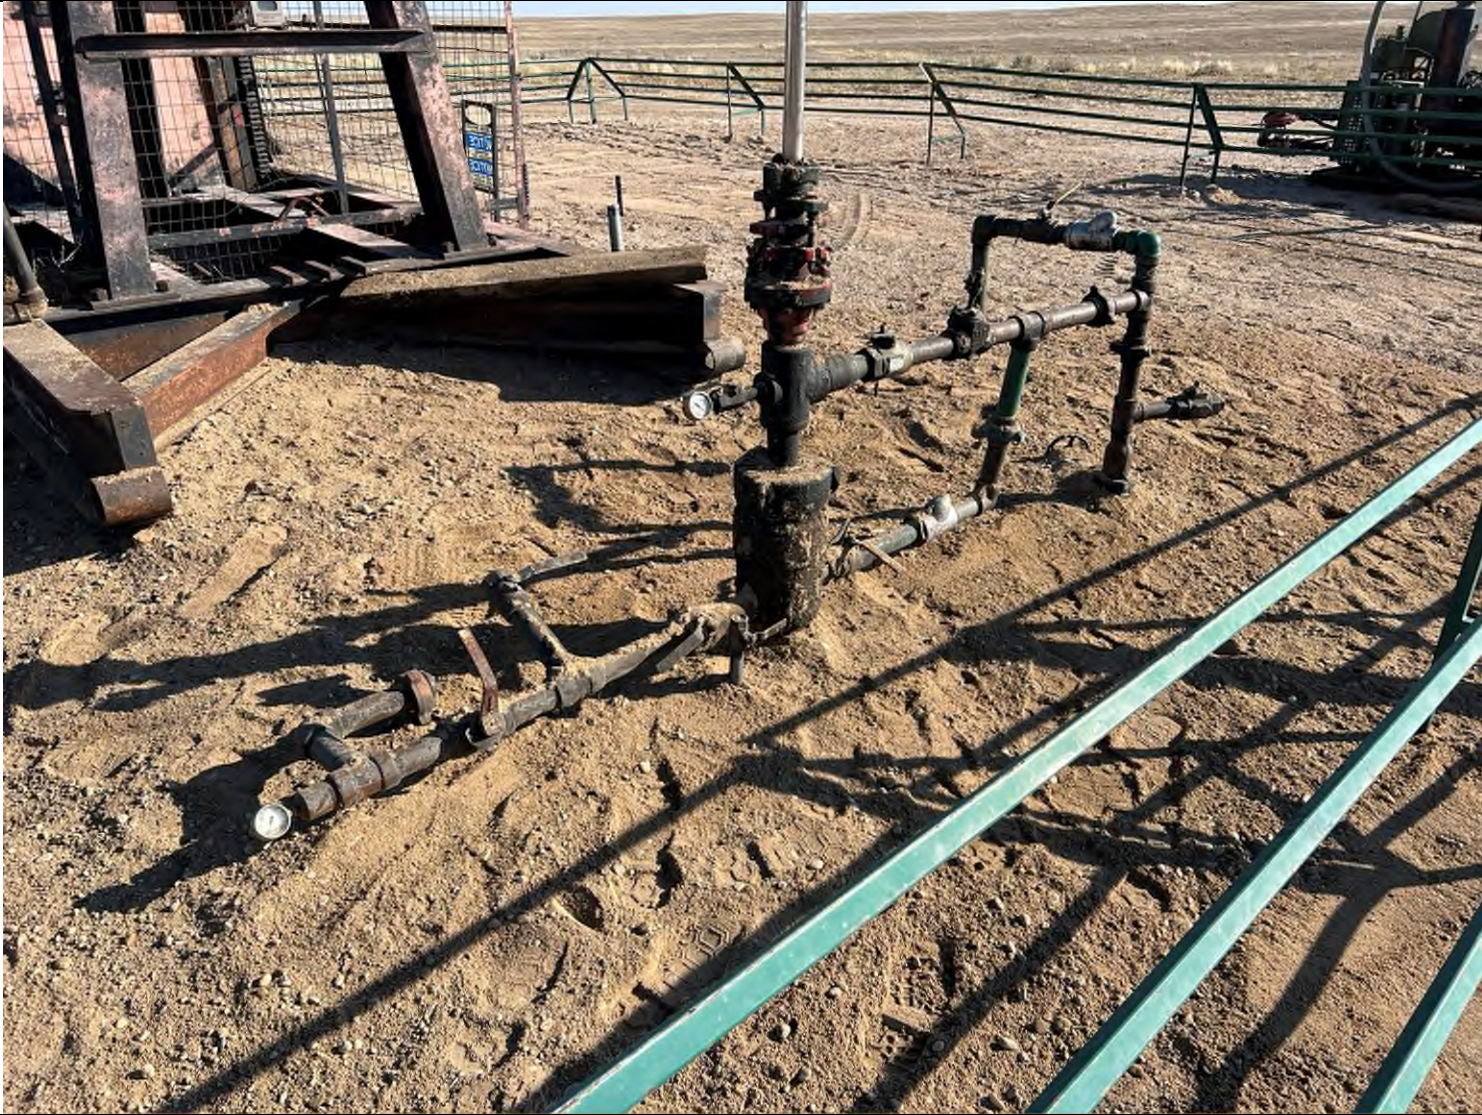
Description: Backfill around the wellhead

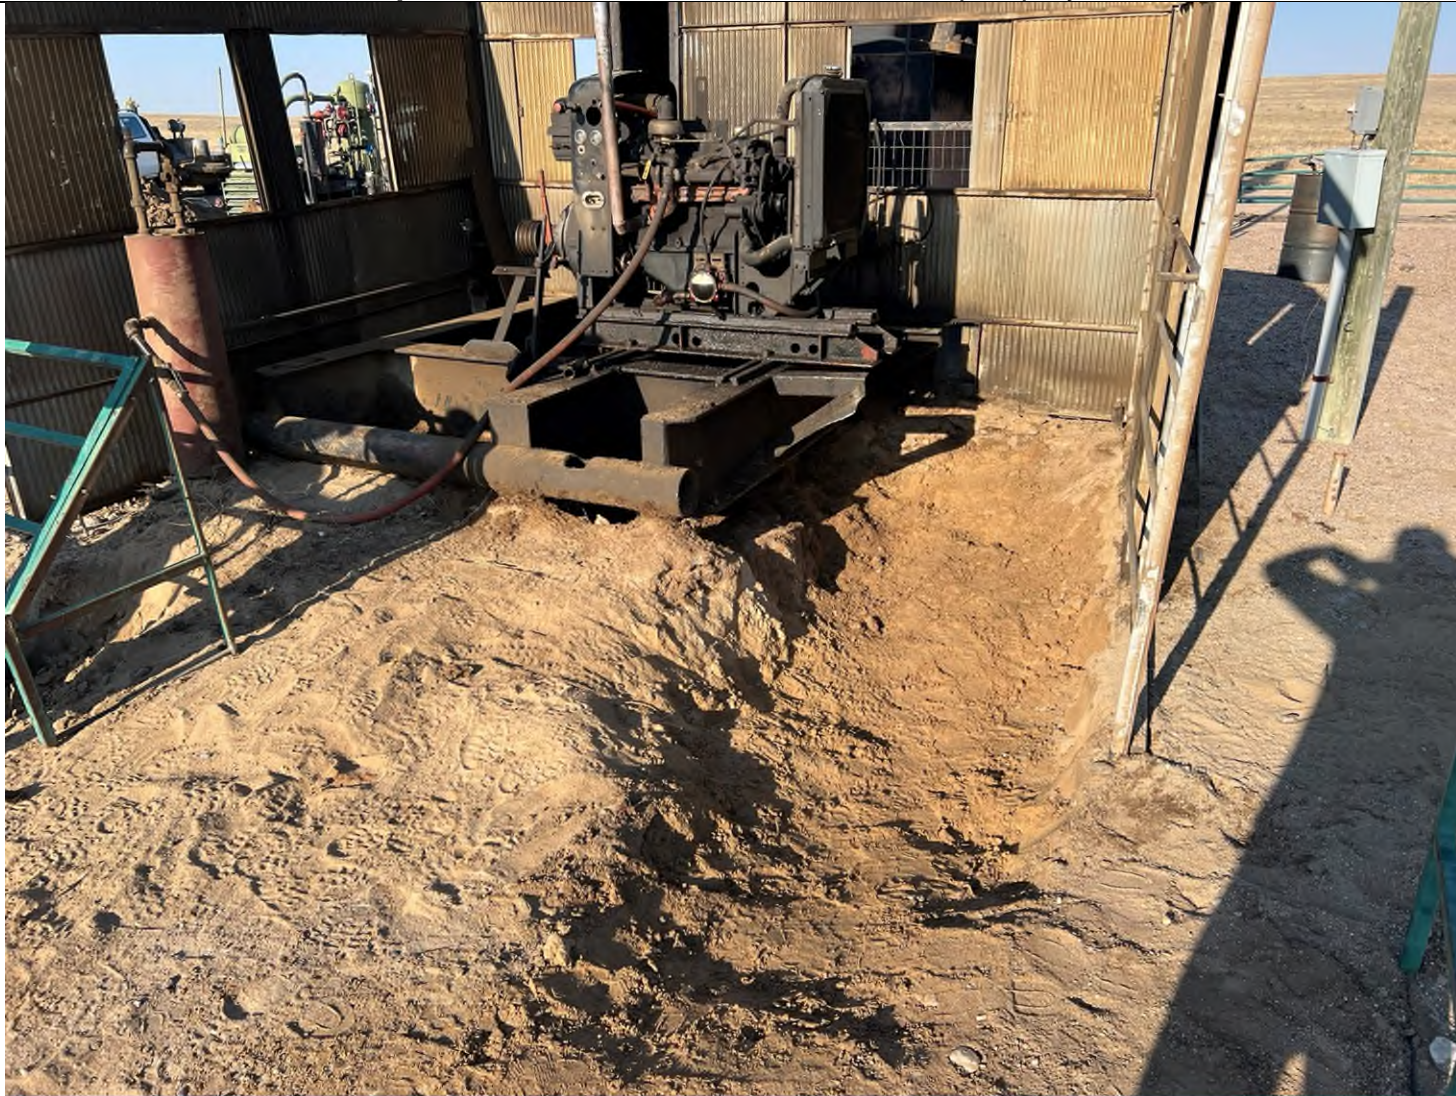
Description: Stained soil was removed below pump by hand.

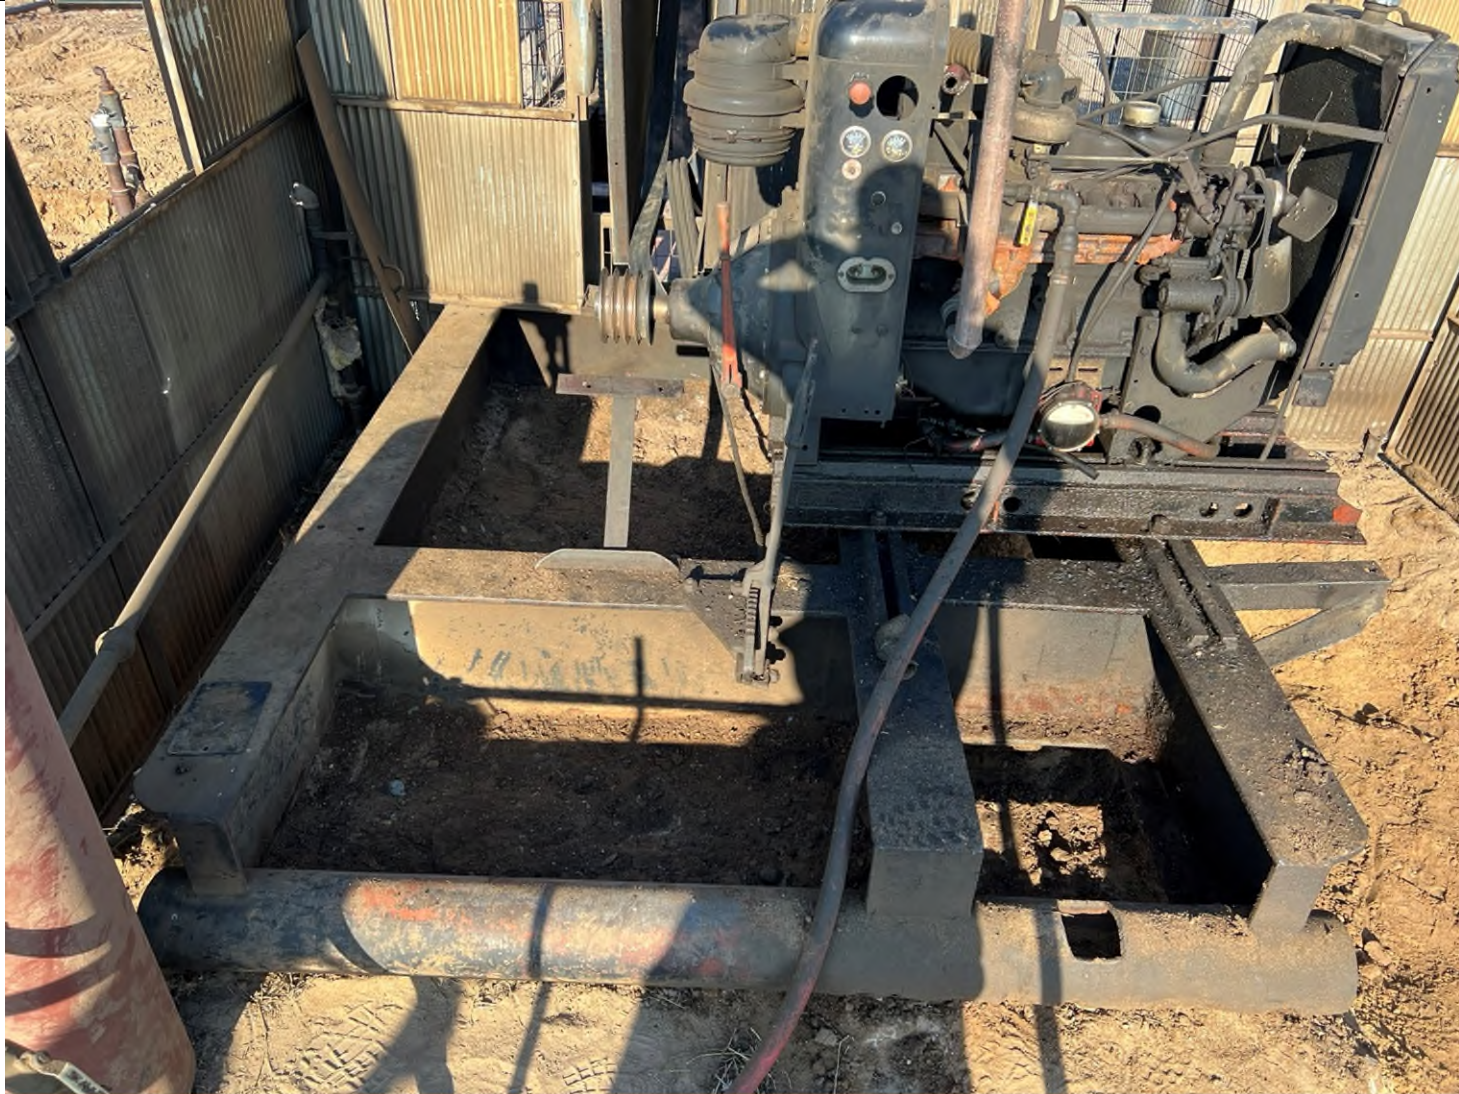
Description: Stained soil was removed below pump by hand.

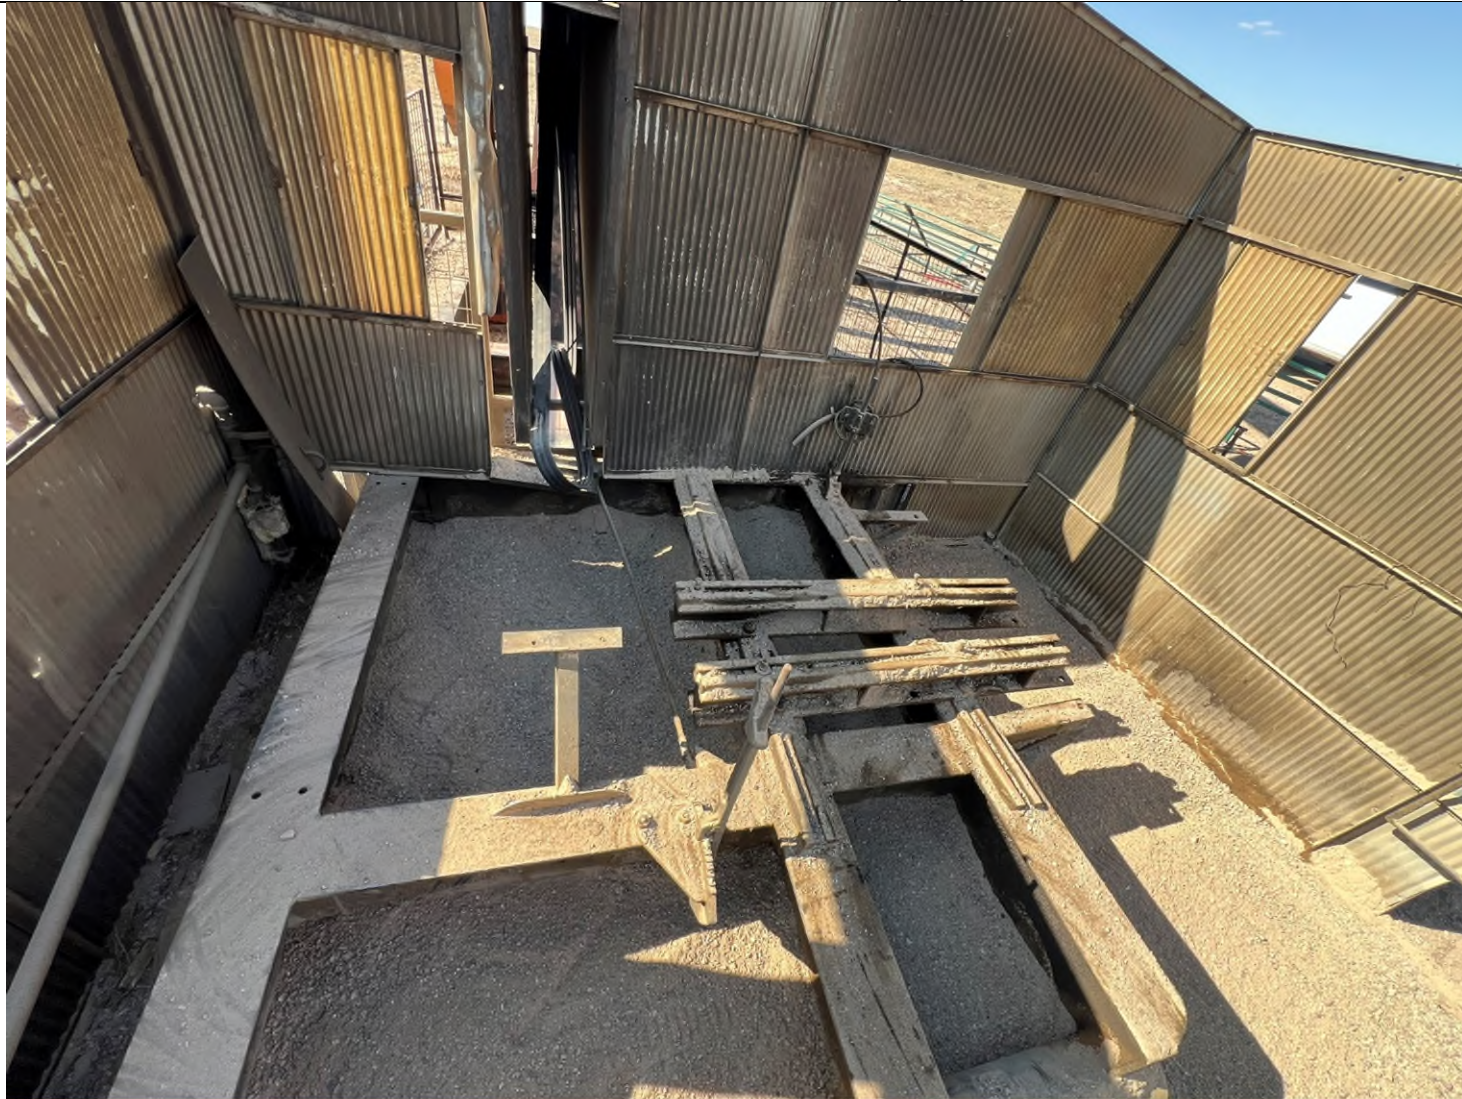
Description: Backfill below pump

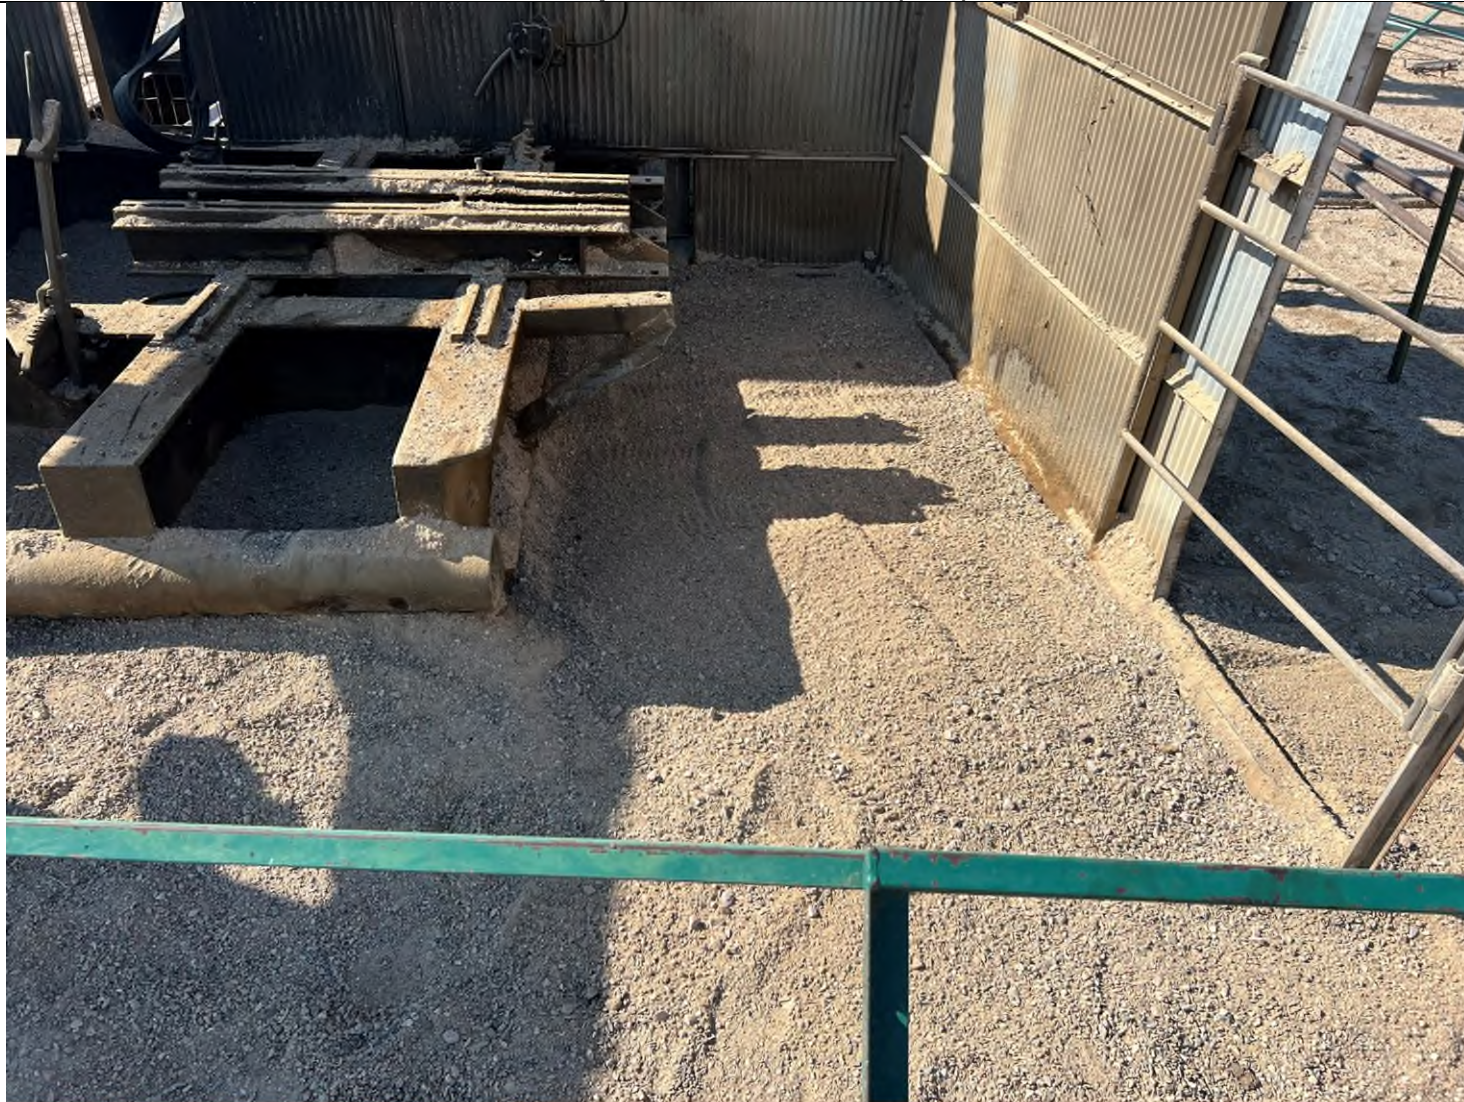
Description: Backfill below pump
