Inspection Photos

Loc #: 487587

Operator: DESERT EAGLE OPERATING

Inspection Date: 3/24/2025

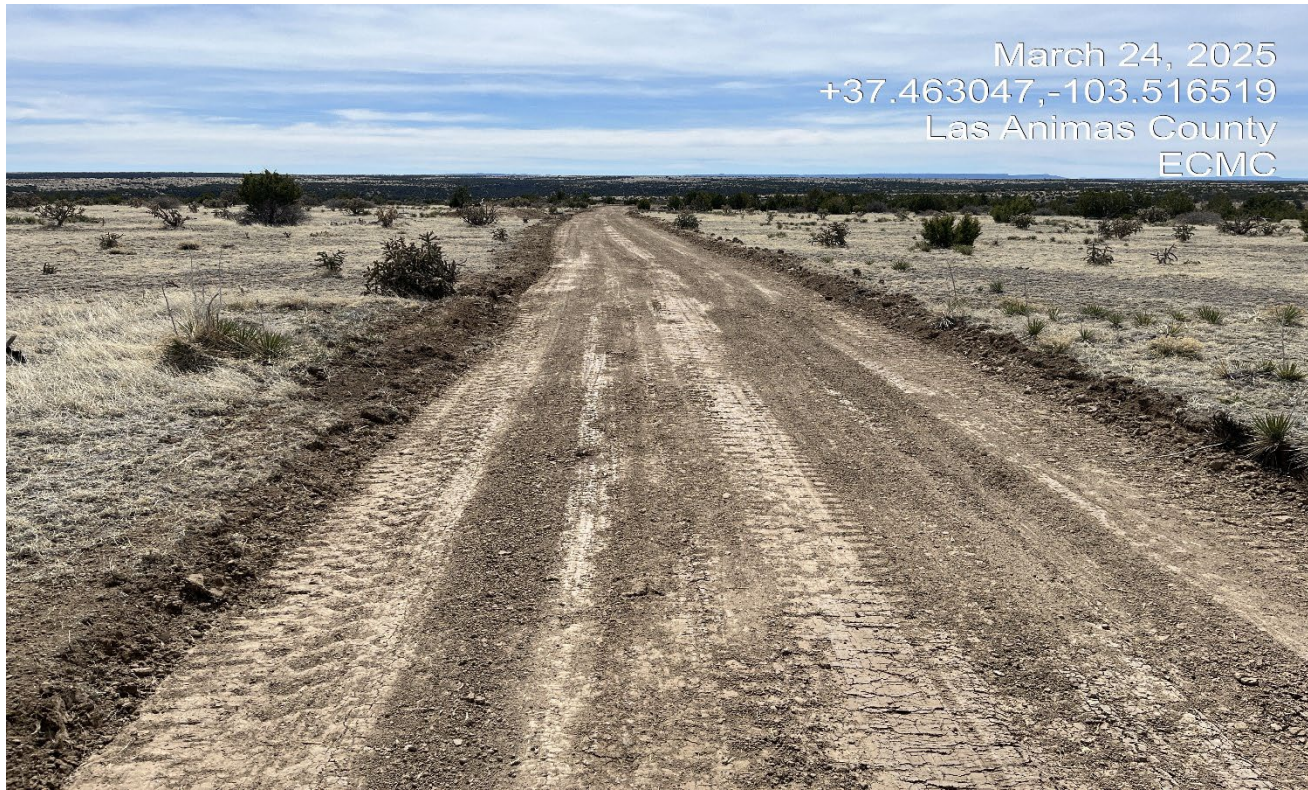
Photo 1. Facing south along the access road. Topsoil was salvaged along the road.

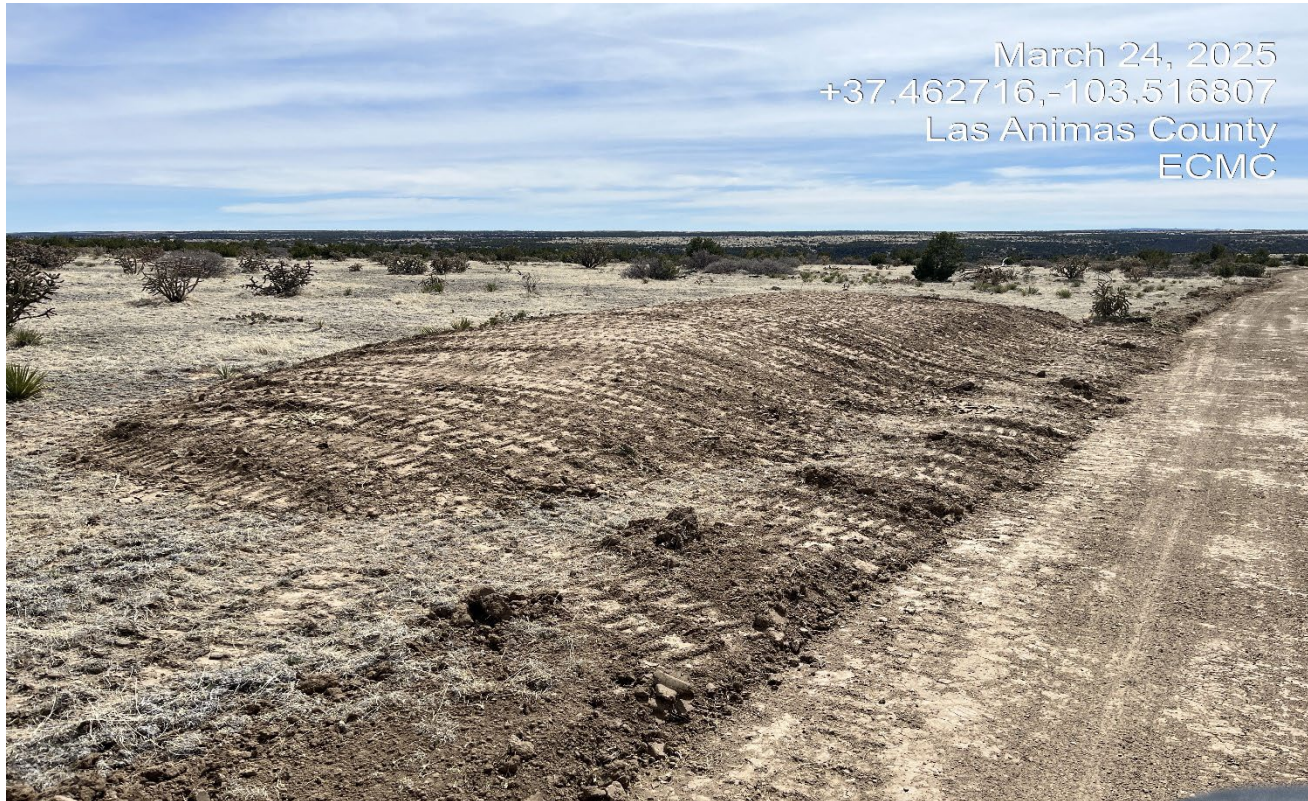
Photo 2. Facing toward the topsoil pile salvaged along the road. The topsoil will need to be seeded for long term stabilization..

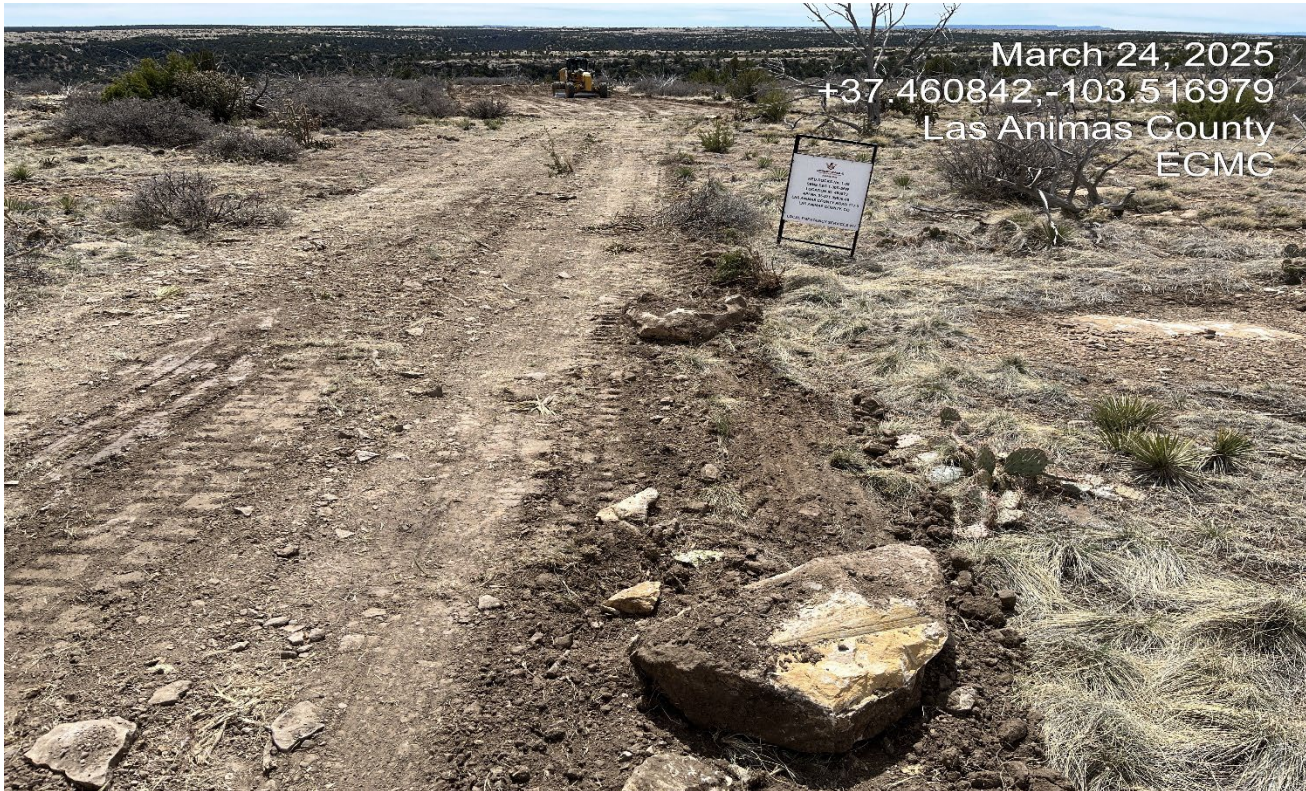
Photo 3. Facing south near the location. This portion of the road was very rocky and topsoil was not salvaged at this area.

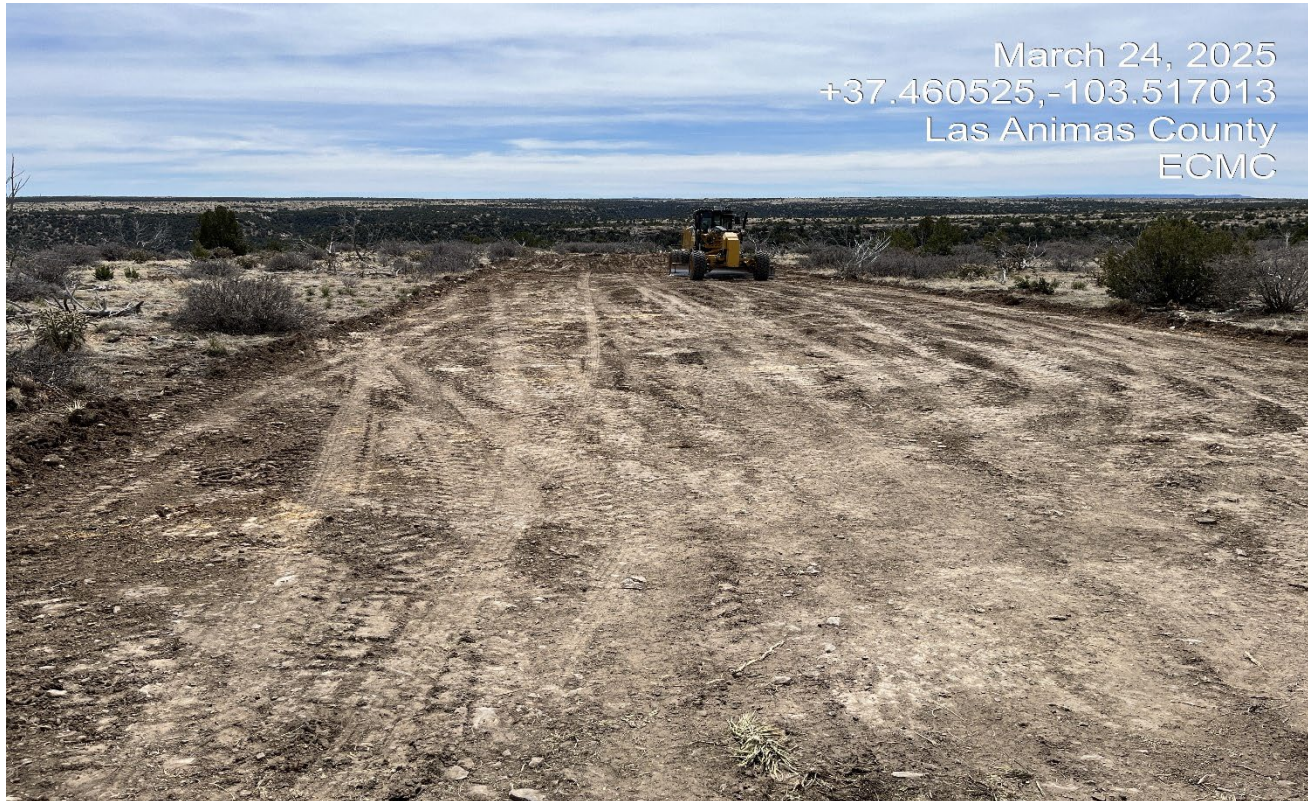
Photo 4. Facing south at the location. Topsoil has been salvaged from the location.

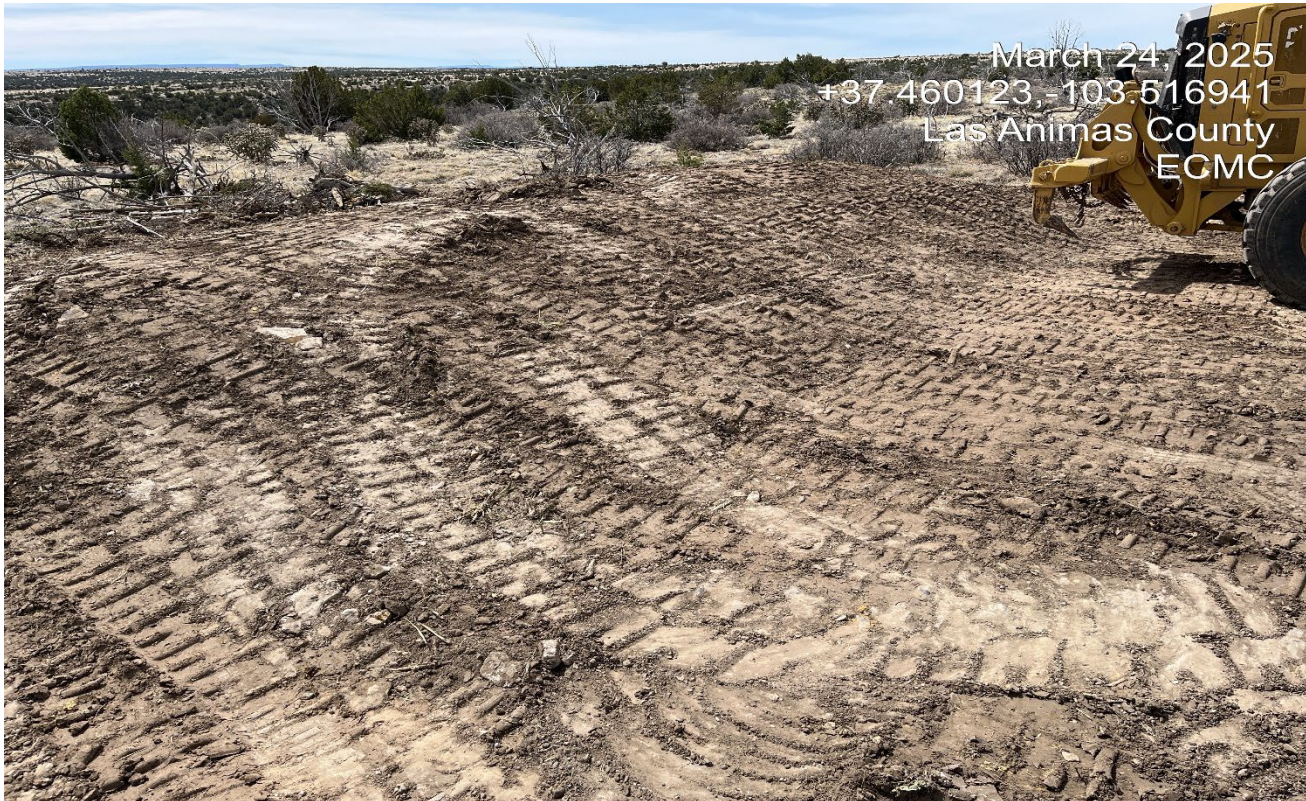
Photo 5. The topsoil pile has been stored at the south side of the location and was tracked for temporary stabilization..

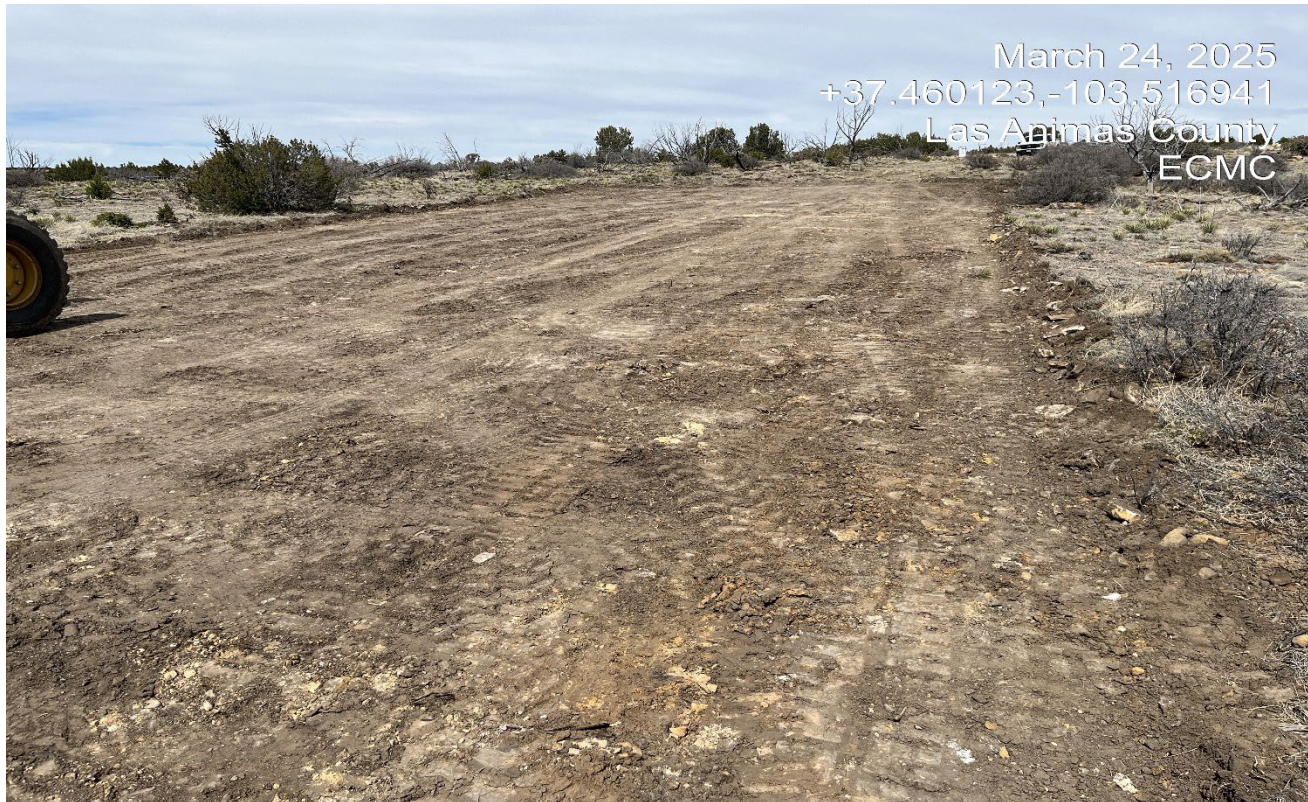
Photo 6. Facing northwest at the location. There were no stormwater BMP's installed at the location at the time of inspections. BMP's need to be installed prior to construction.
