Inspection/Audit Photos

Location Name: TEP Rocky Mountain Castle Springs Federal E Pad

Location # 418828

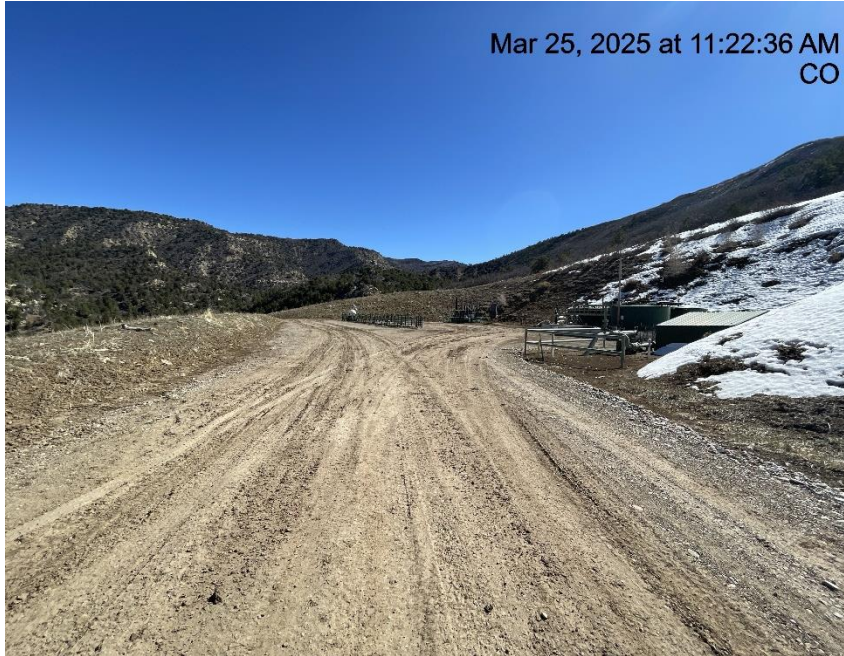
Photo # 6875 From entrance to location

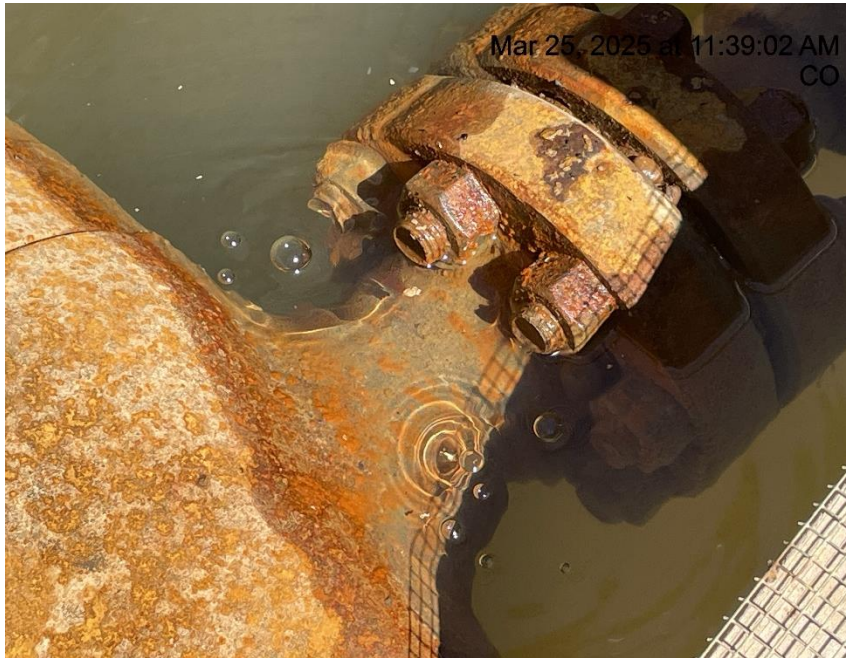
**Photo # 6885 Mechanical Condition - Possible leak on CSF
44C-09-07-91 wellhead**

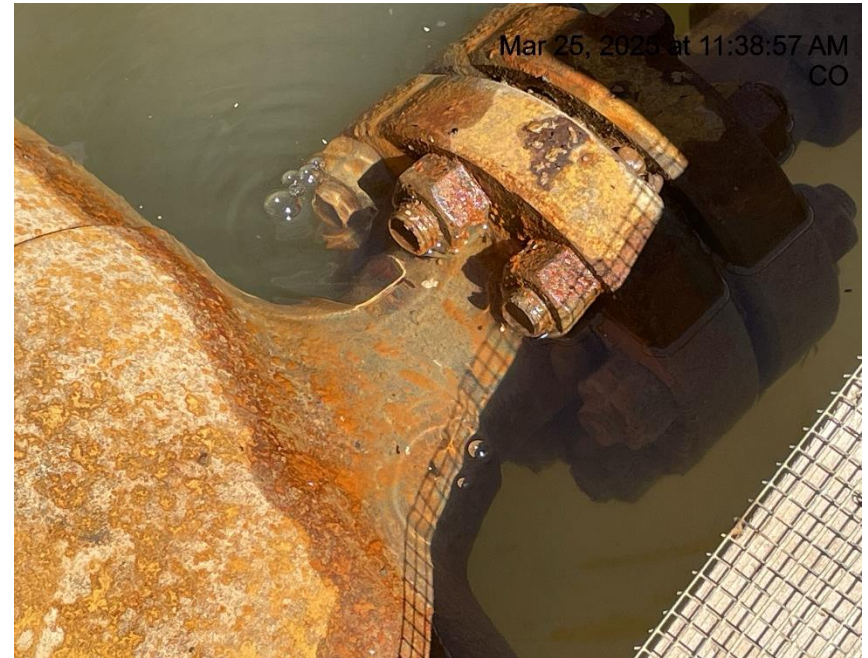
**Photo # 6886 Mechanical Condition - Possible leak on CSF
44C-09-07-91 wellhead**

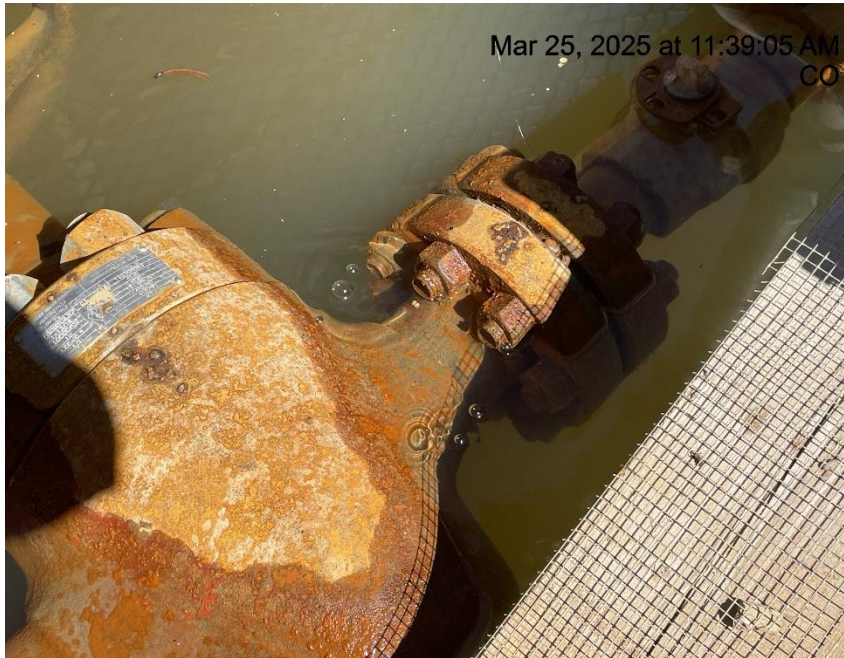
Photo # 6887 Mechanical Condition - Possible leak on CSF 44C-09-07-91 wellhead

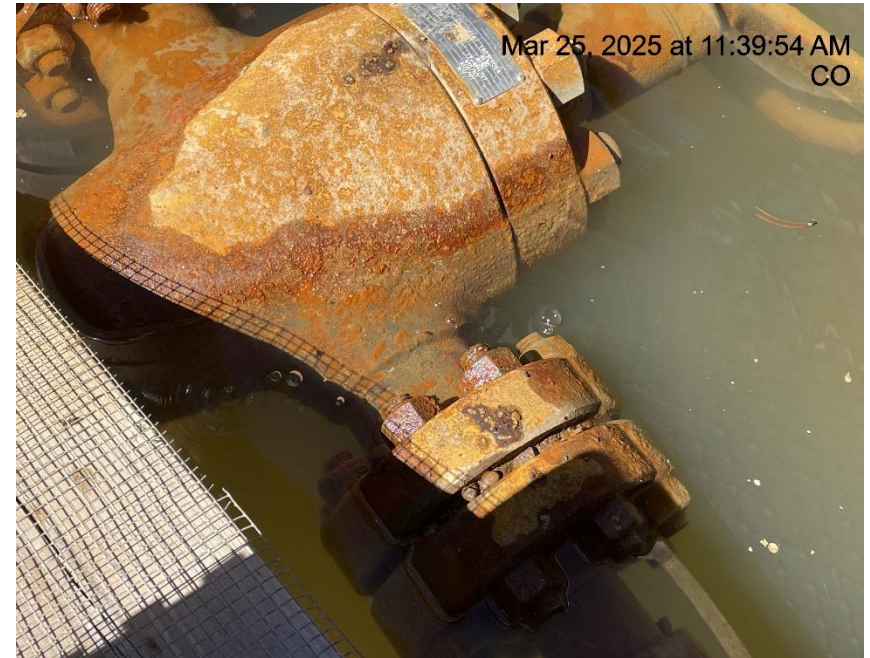
Photo # 6888 Mechanical Condition - Possible leak on CSF 44C-09-07-91 wellhead

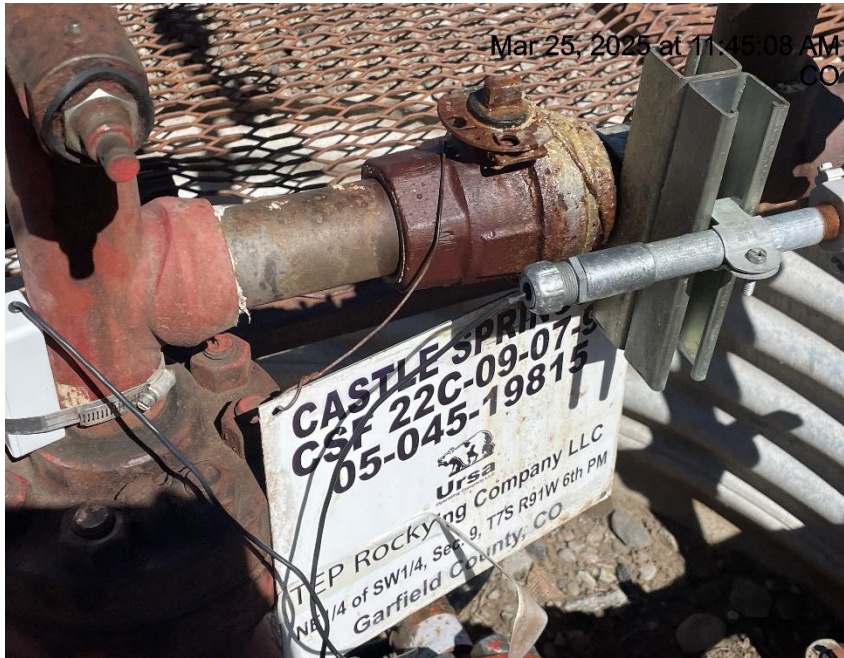
Photo # 6889 Mechanical Condition - Possible ball valve leak on CSF 22C-09-07-91 well

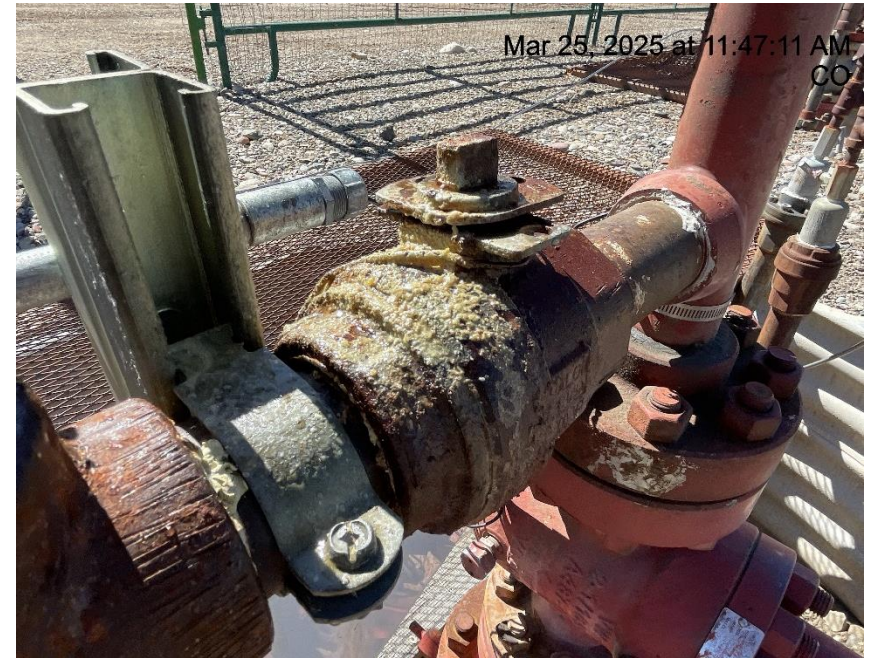
Photo # 6890 Mechanical Condition - Possible ball valve leak on CSF 22C-09-07-91 well

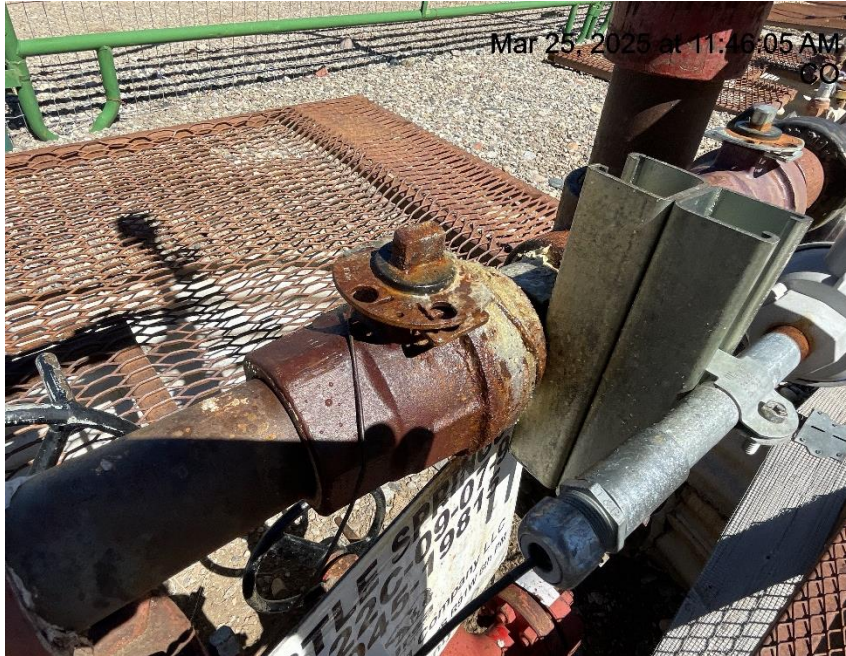
Photo # 6891 Mechanical Condition - Possible ball valve leak on CSF 22C-09-07-91 well

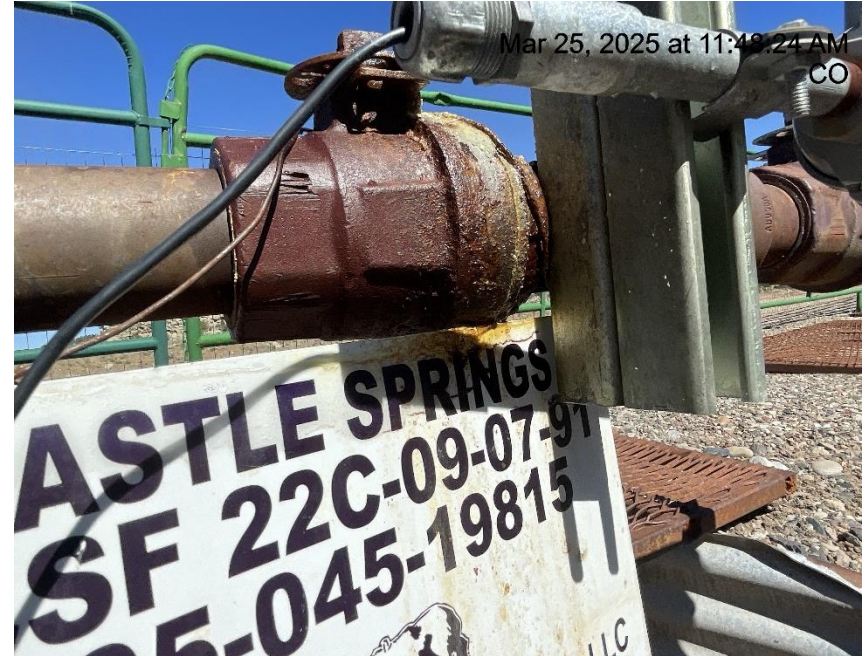
Photo # 6892 Mechanical Condition - Possible ball valve leak on CSF 22C-09-07-91 well

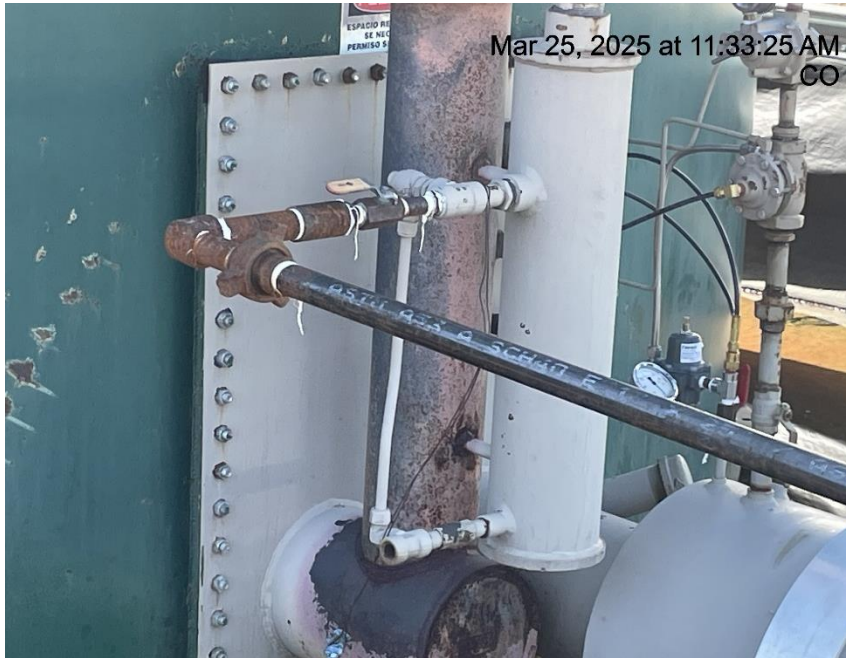
Photo # 6893 PRV vent line on tank burner does not comply with CECMC pressure safety device rules & general safety rules

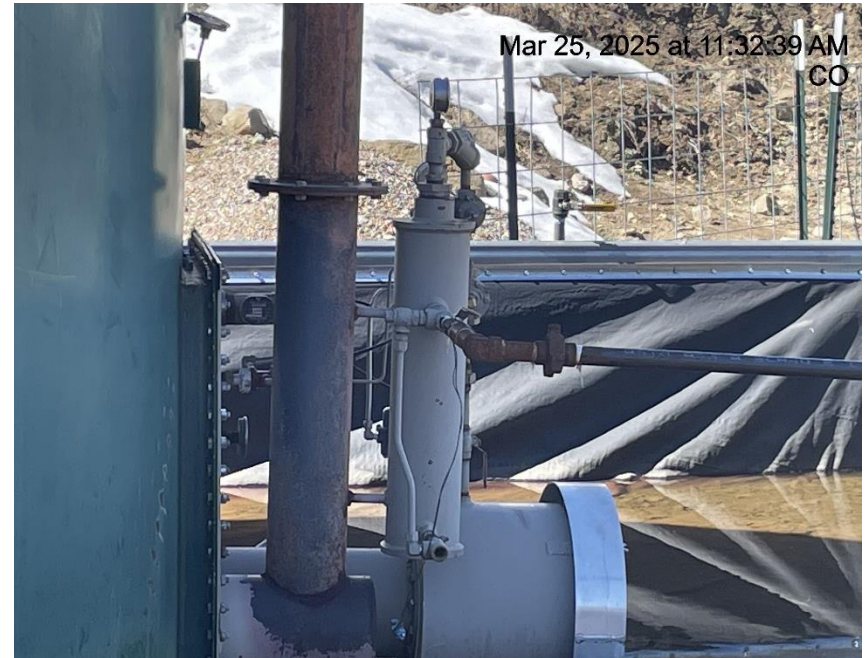
Photo # 6894 PRV vent line on tank burner does not comply with CECMC pressure safety device rules & general safety rules

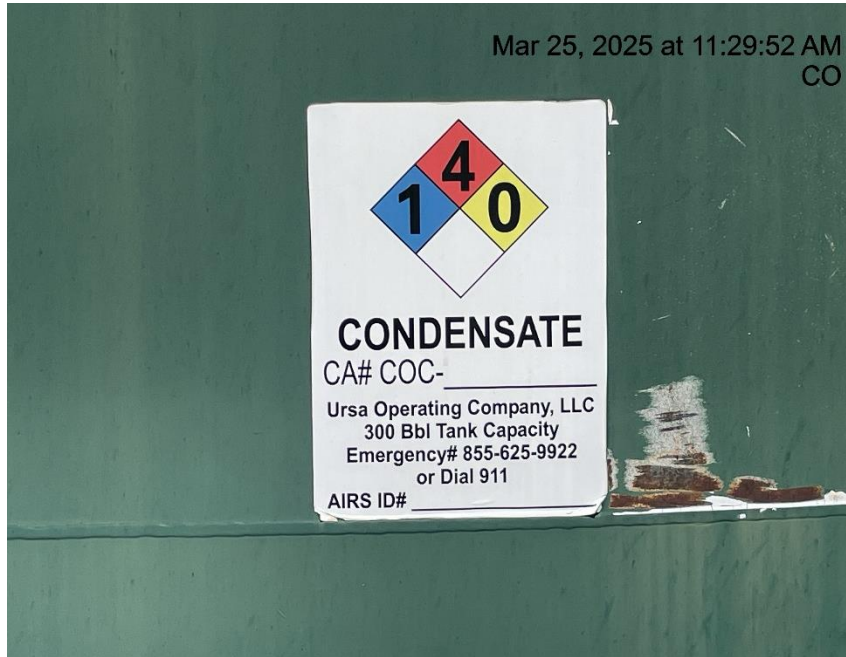
Photo # 6895 Tank label contains inaccurate information

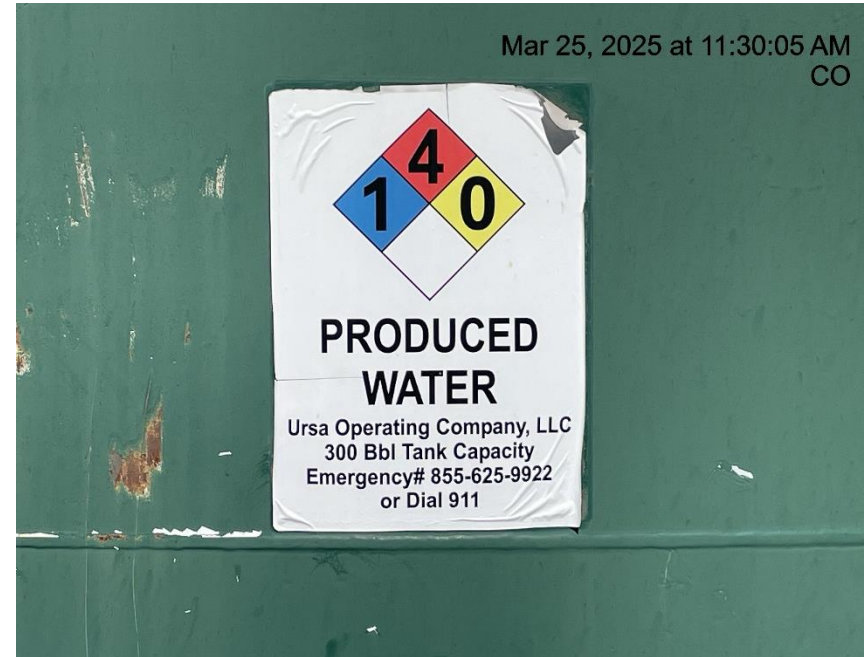
Photo # 6896 Tank label contains inaccurate information

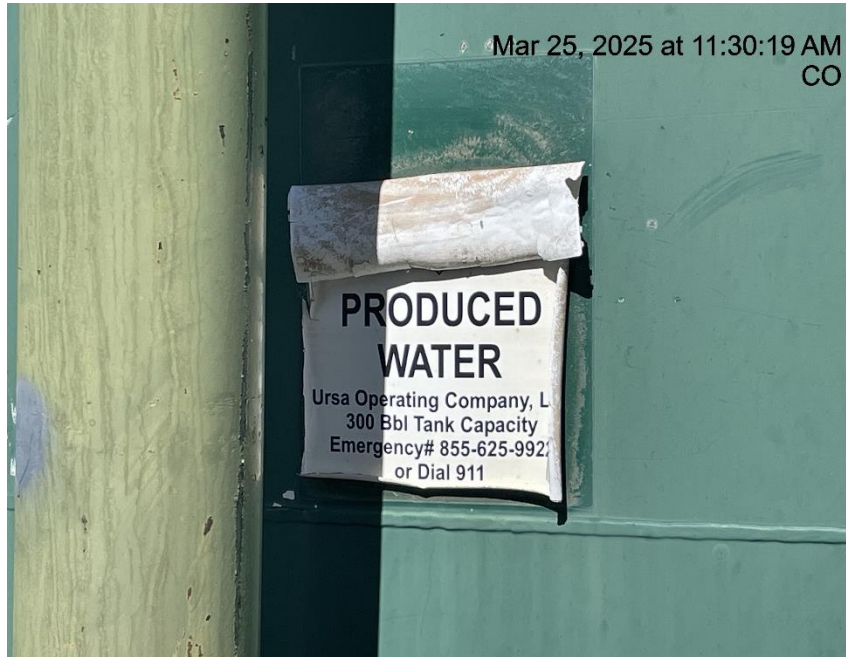
Photo # 6897 Tank label contains inaccurate information

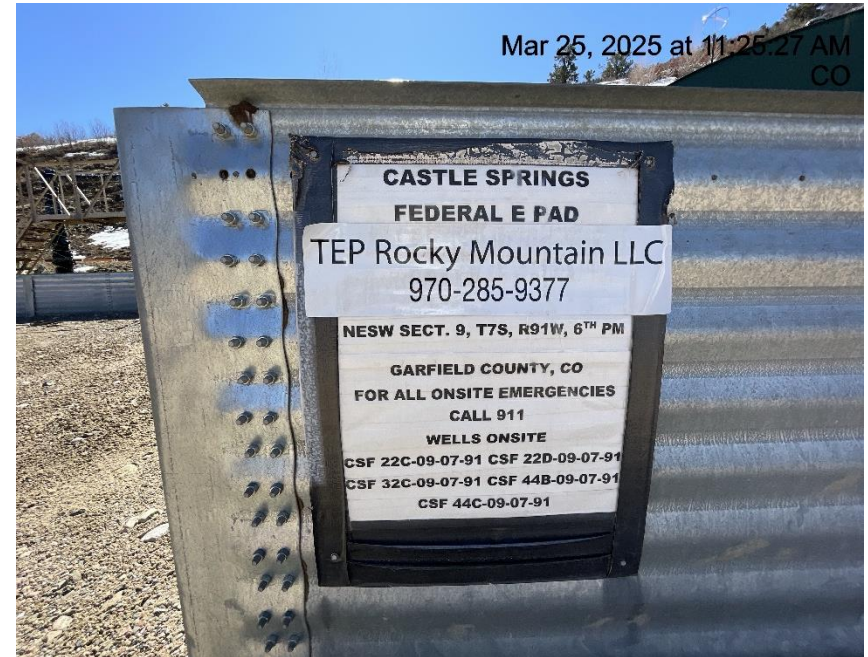
Photo # 6898 Battery sign lacks the public road used to access the site/not in compliance with CECMC rules
