Interim Reclamation and Stormwater Inspection

Operator: SCHMID PROPERTIES INC - 76830

Location ID: 317280

Inspection Photos
Location Name: Fassler #1-28
Location ID: 317280

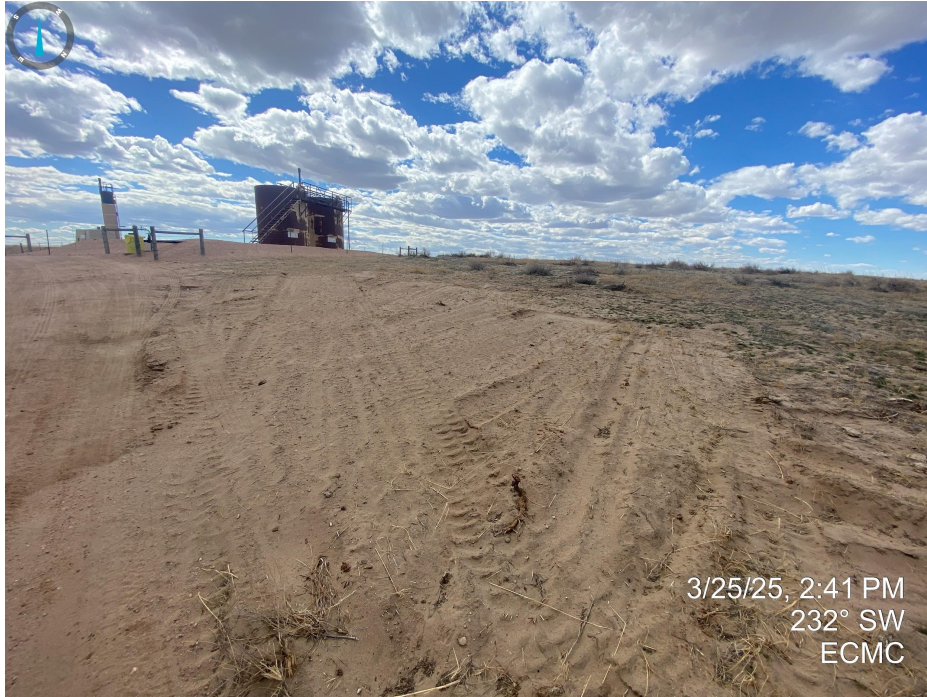
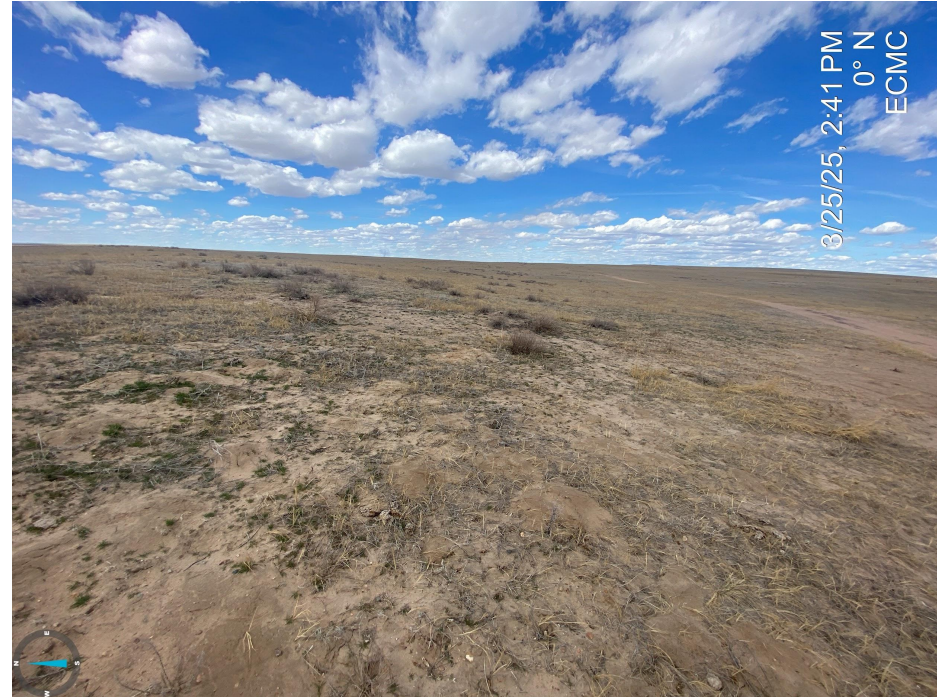
Photos 1 & 2. Evidence of unstabilized soils located on the northwest corner of the location.

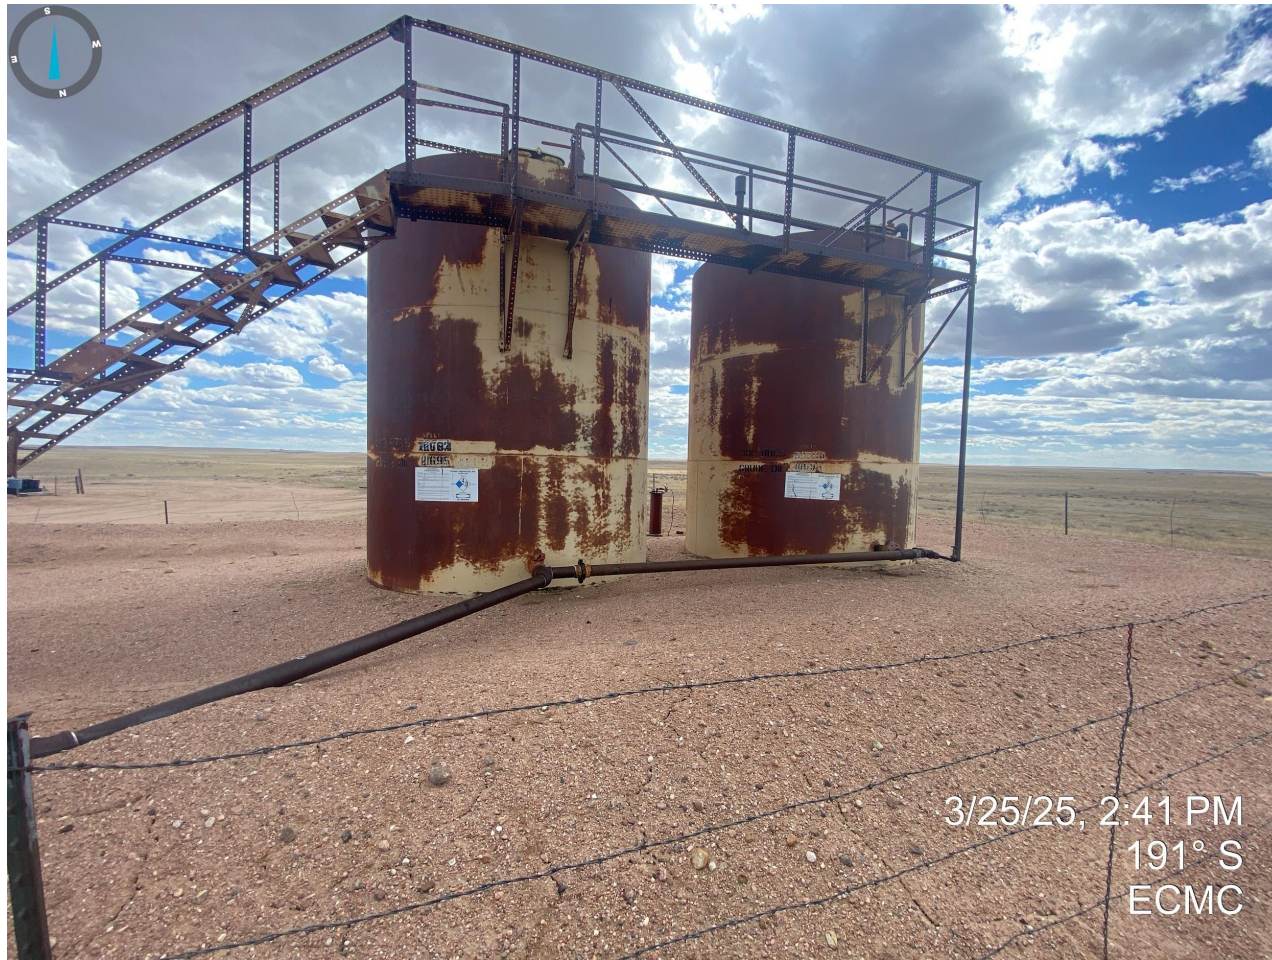
Photo 3. Tank labels/placards are faded/peeling/cracked and require replacement.

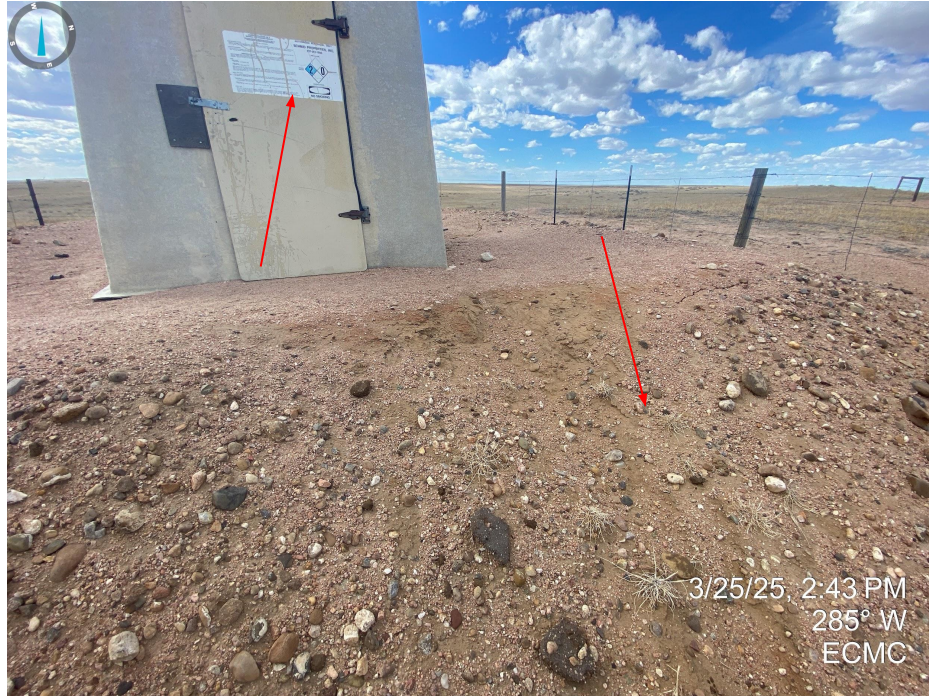
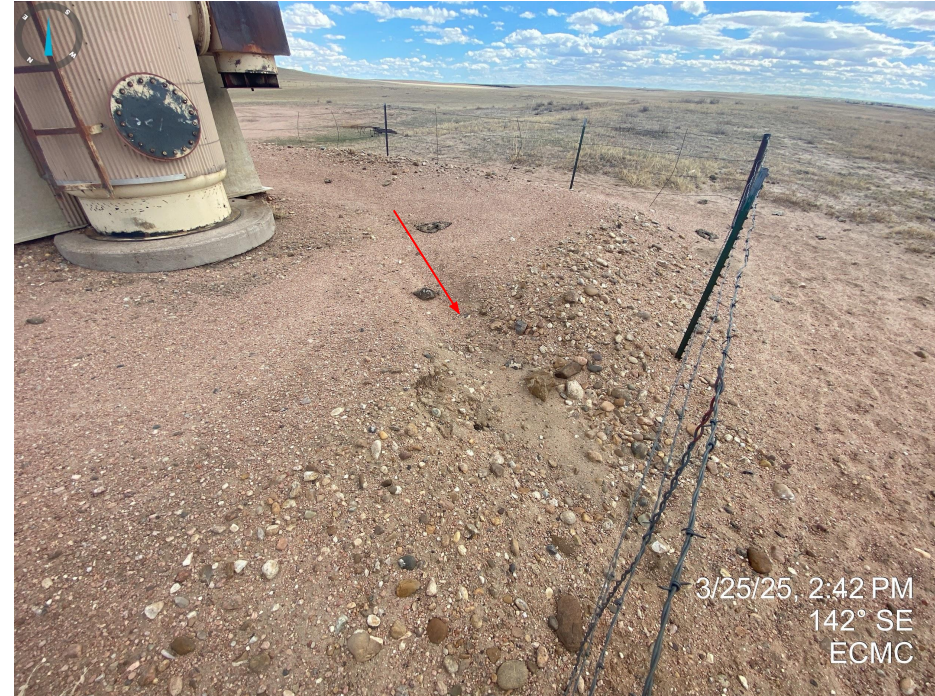
Photos 4 & 5. Berm around vertical heater treater does not appear adequate with erosion degradation and/or breaches observed. Also pictured (Photo 4; left) tank label that is peeling/faded/cracked and requires replacement.

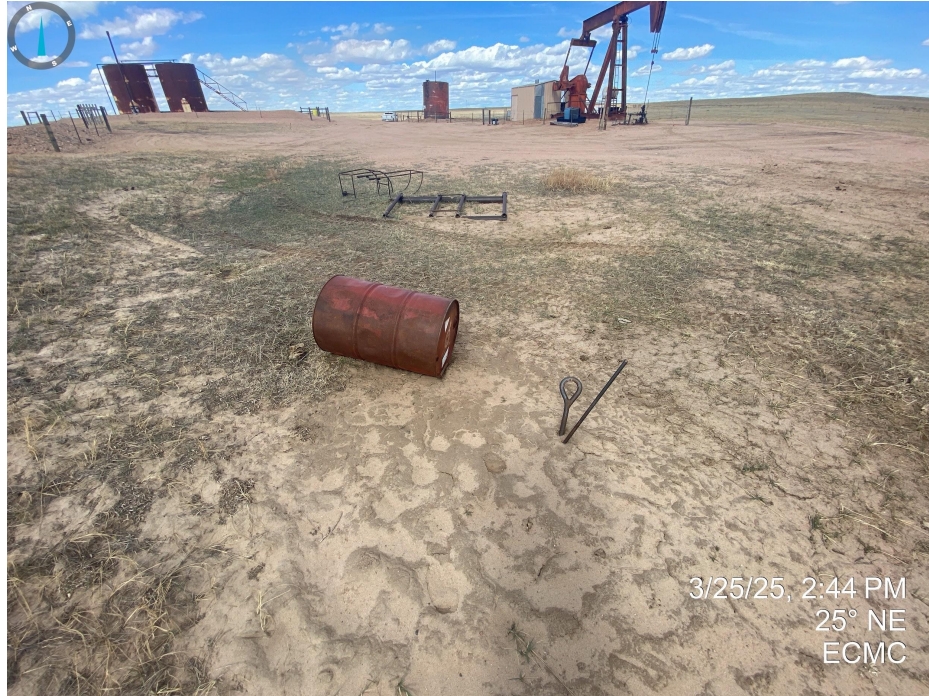
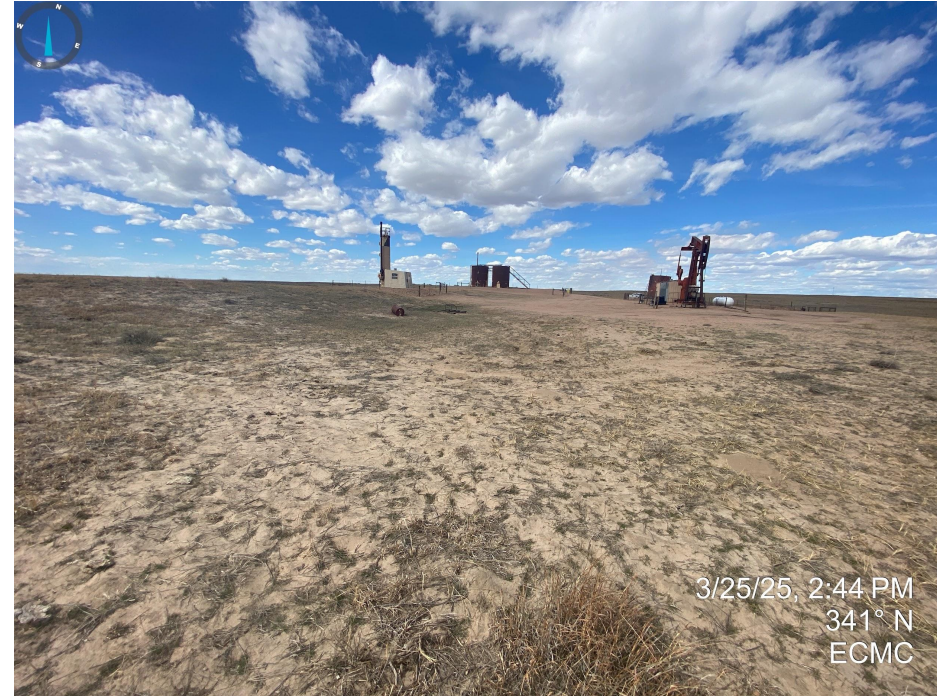
Photos 6 & 7. Taken from the southern end of the location. Photo 6 (left) illustrates unused equipment and improperly marked guy line anchor. Photo 7 (right) illustrates unstabilized soils within the interim areas.

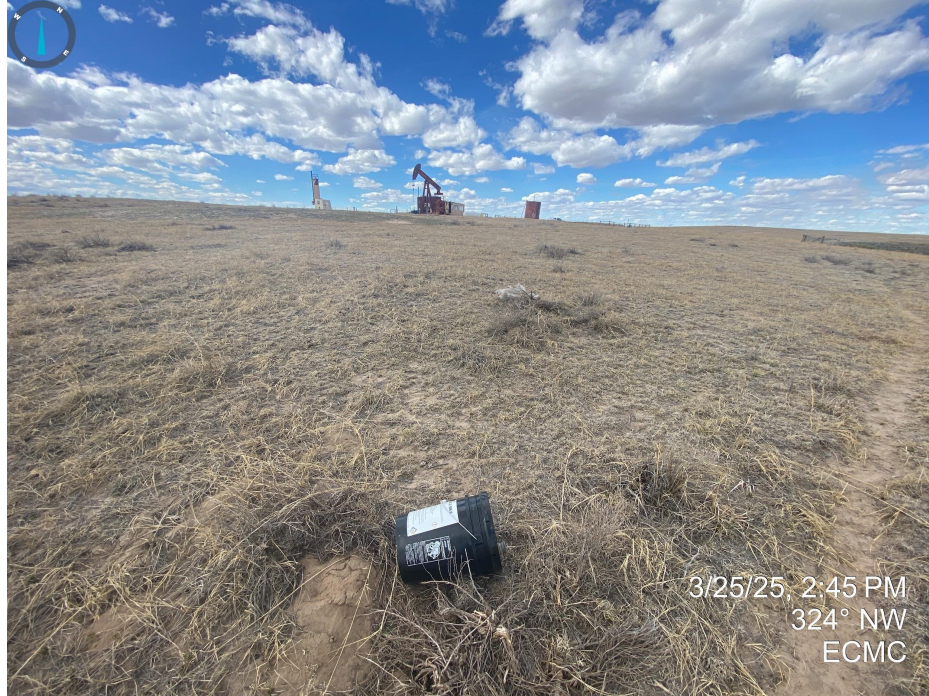
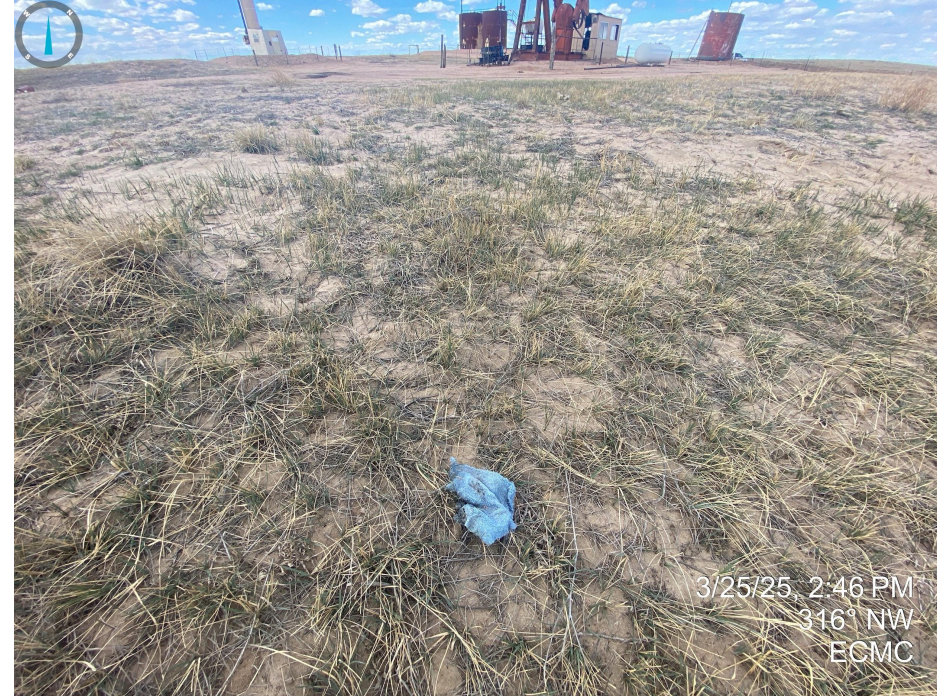
Photos 8 & 9. Trashed observed off location (Photo 8; left) and within the interim areas (Photo 9; right). Operator shall self inspect the entire location to remove all trash, including any within the adjacent reference areas.

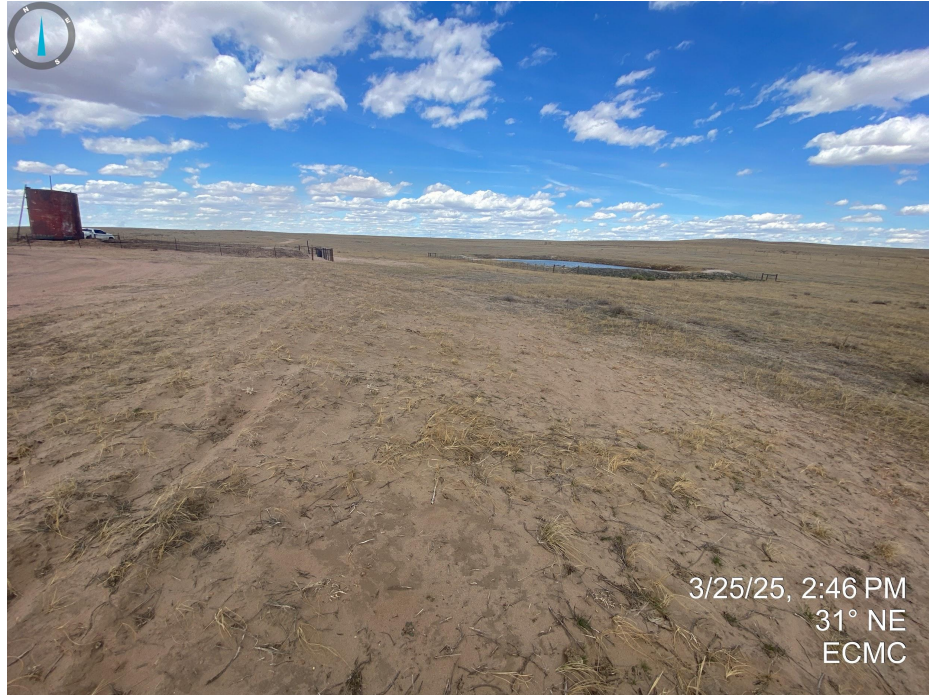
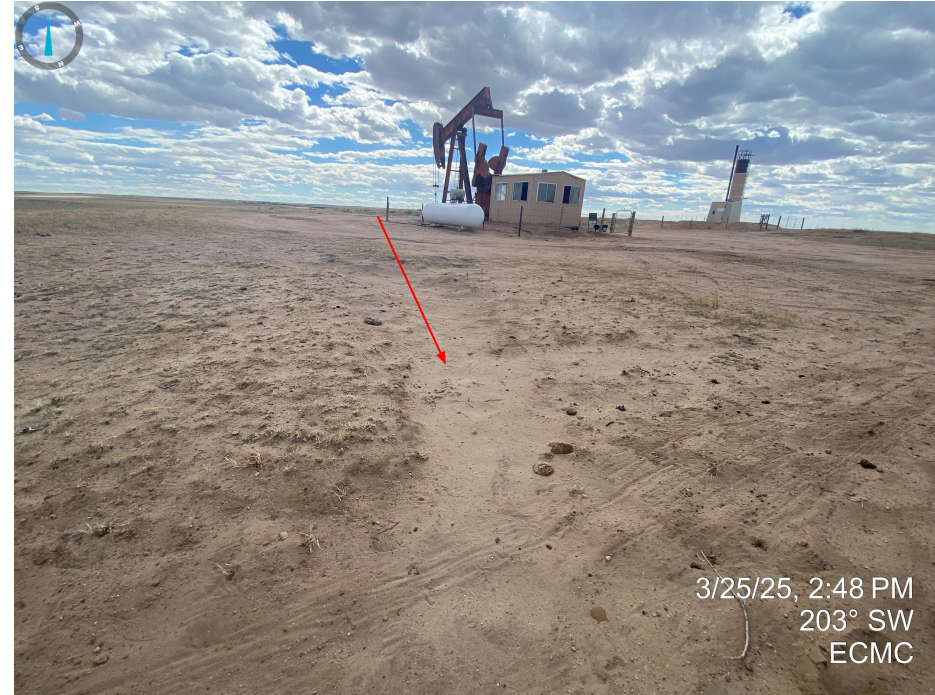
Photos 10 & 11. Eastern interim areas consist primarily of unstabilized soils with evidence of wind and stormwater erosion. Additional reclamation activities and stormwater control measures required.

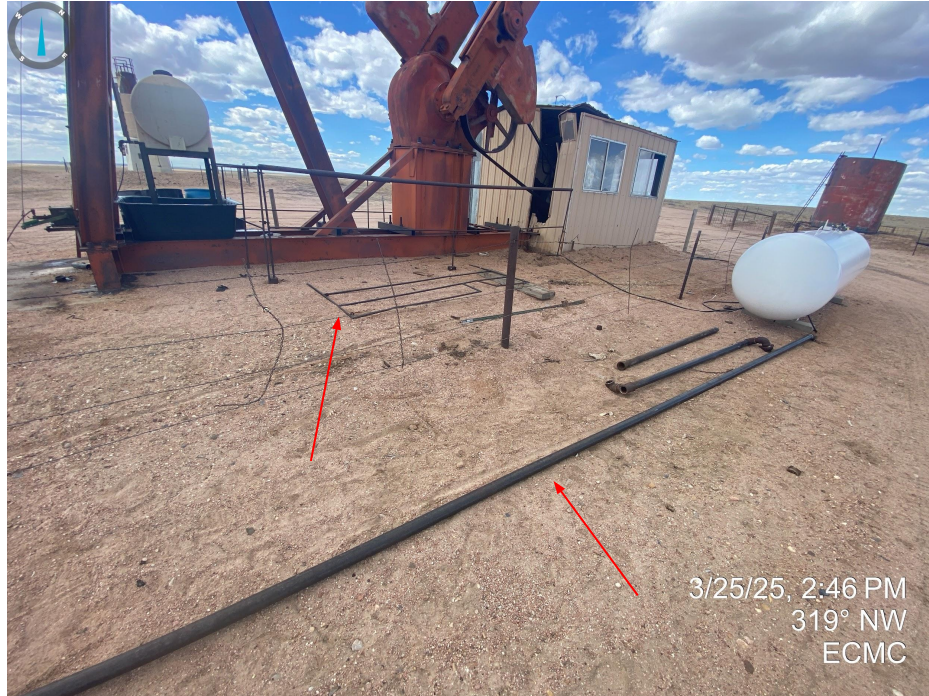
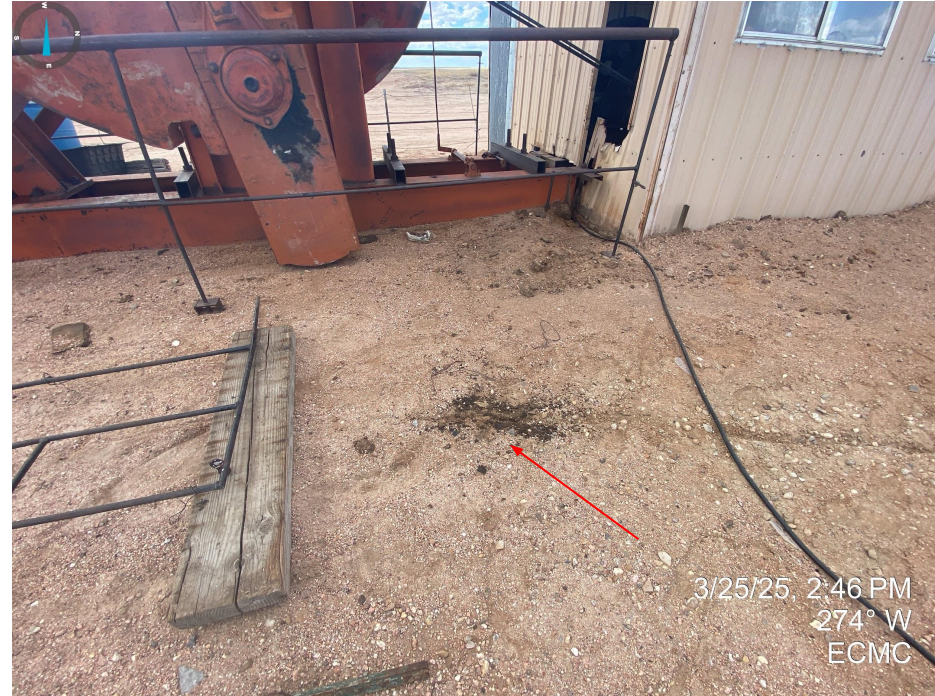
Photos 12 & 13. Unused equipment and stained soil near well location.

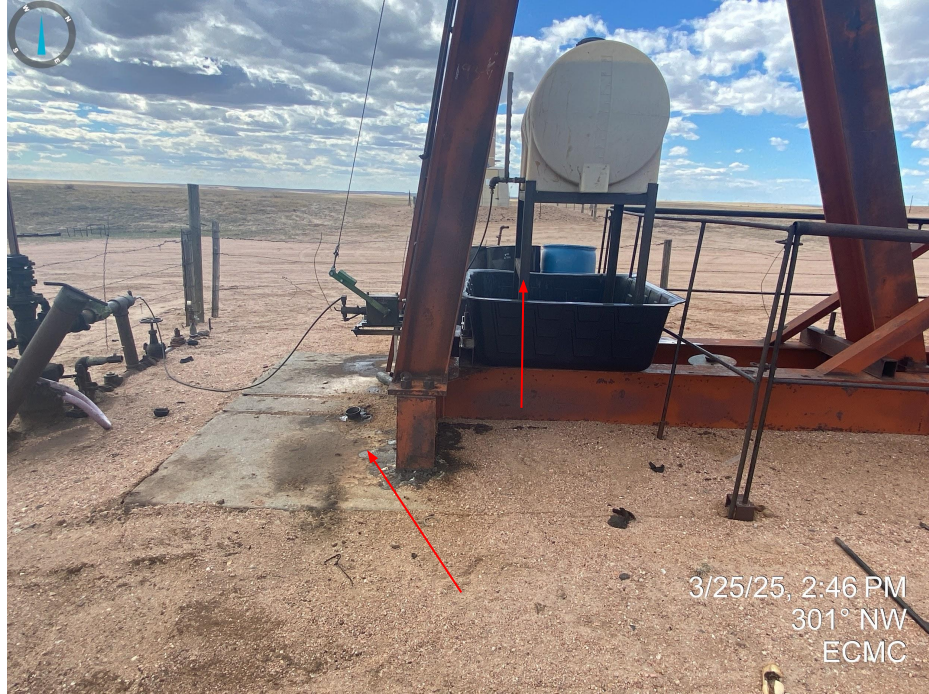
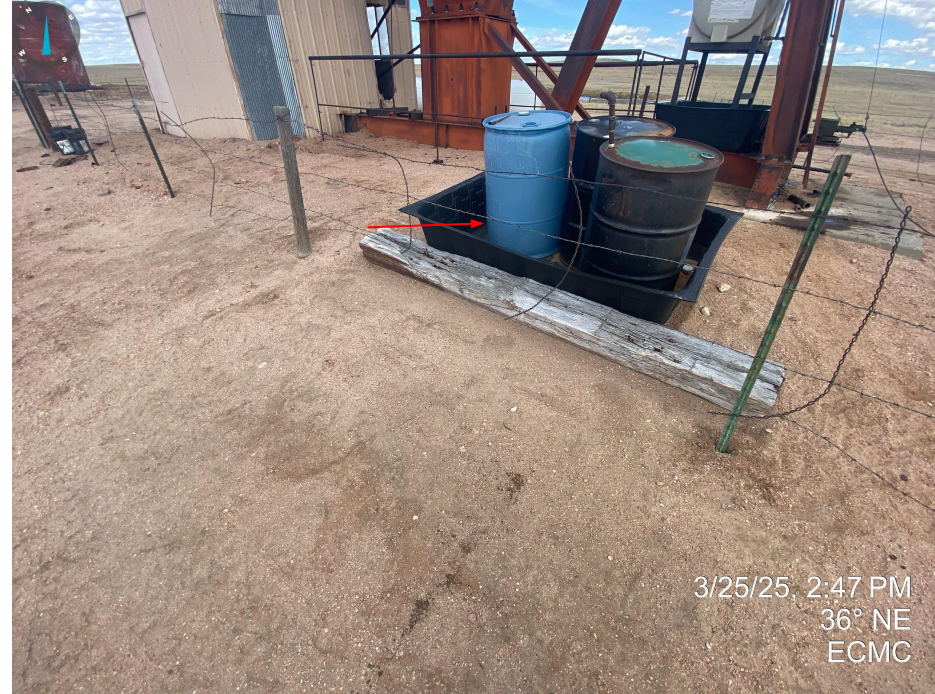
Photos 14 & 15. Stained soils, no wildlife netting at secondary containment and no labels on drums/barrels.

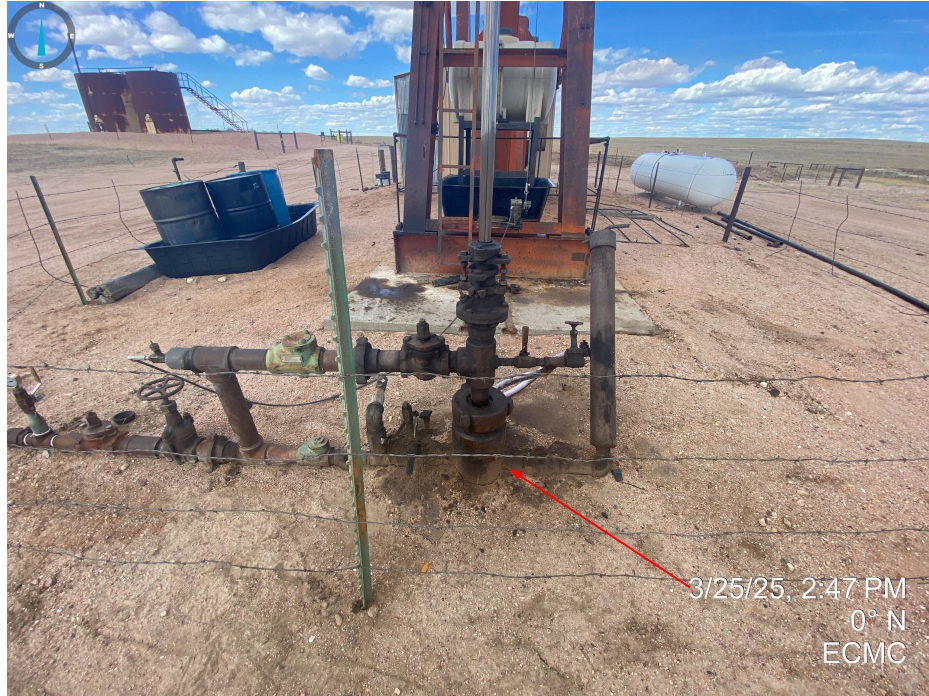
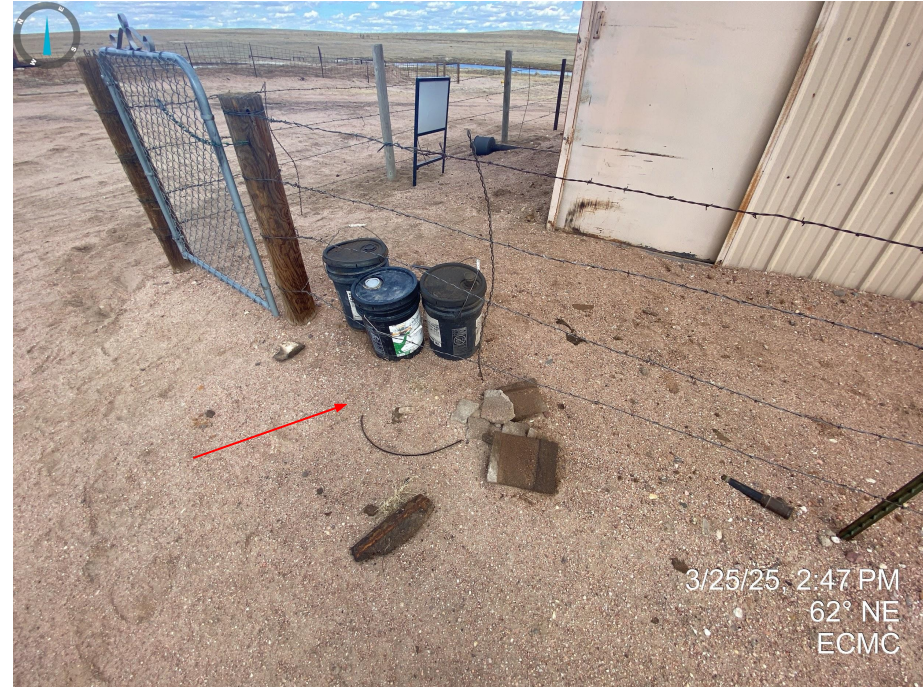
Photos 16 & 17. Stained soils, 5 gallon buckets outside of secondary containment and debris observed around pumpjack.

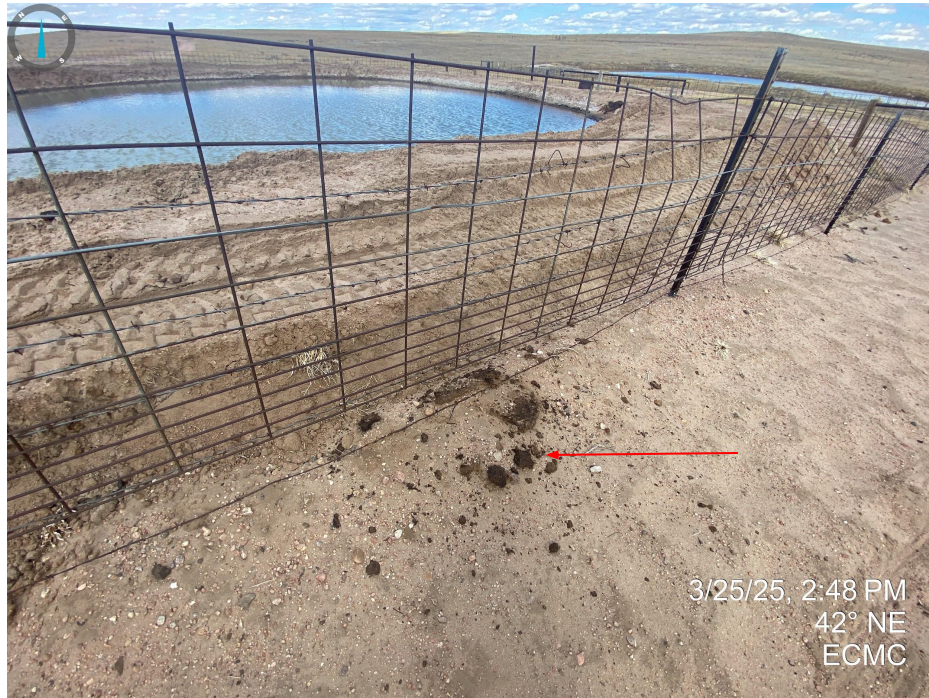
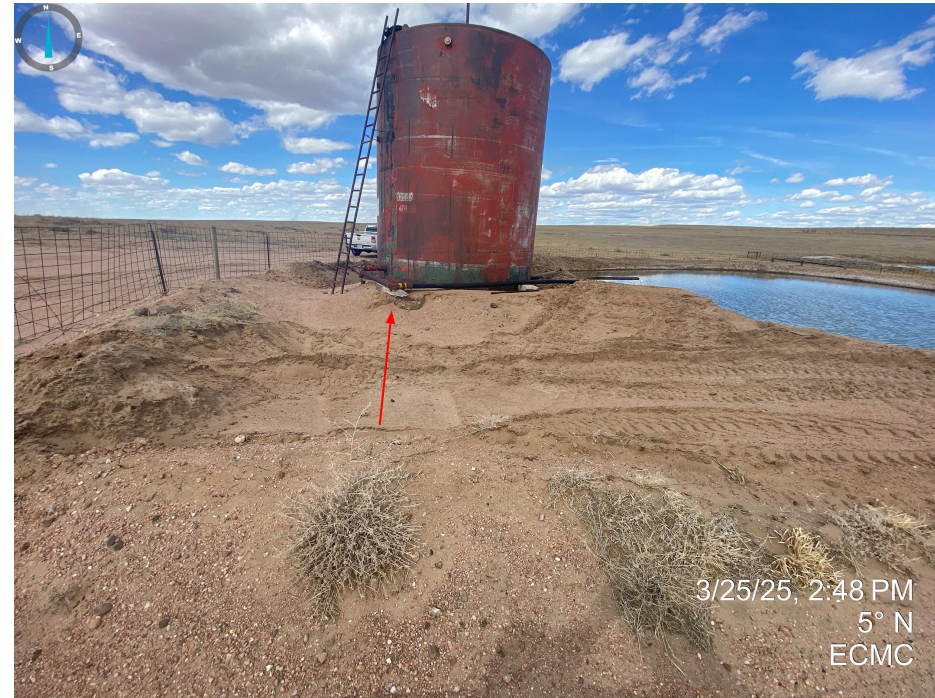
Photos 18 & 19. Stained soils on south side of pit (Photo 18; left) and inadequate secondary containment around vertical AST (Photo 19; right).

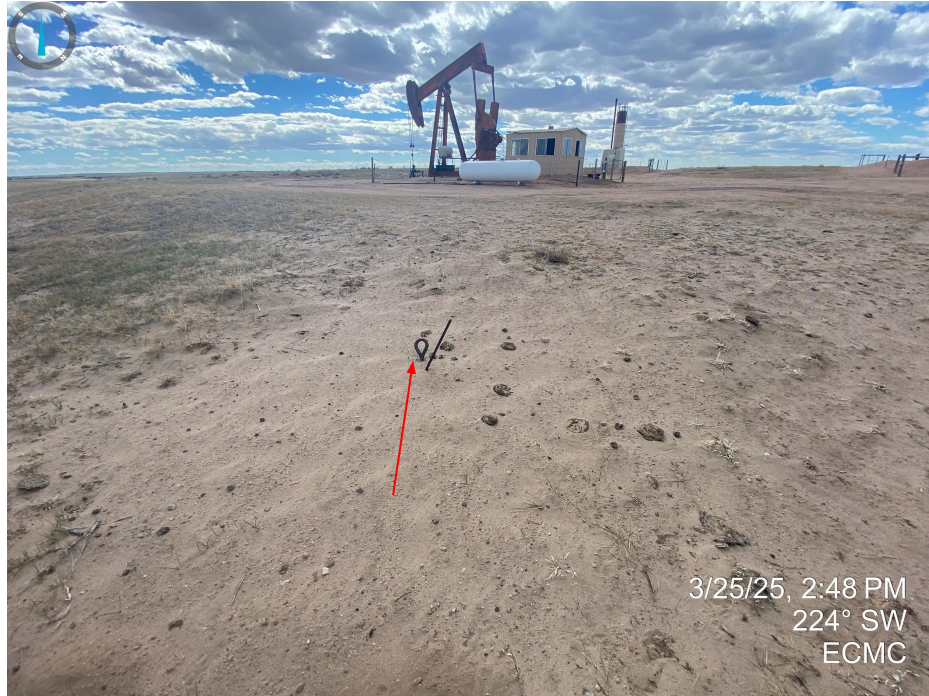
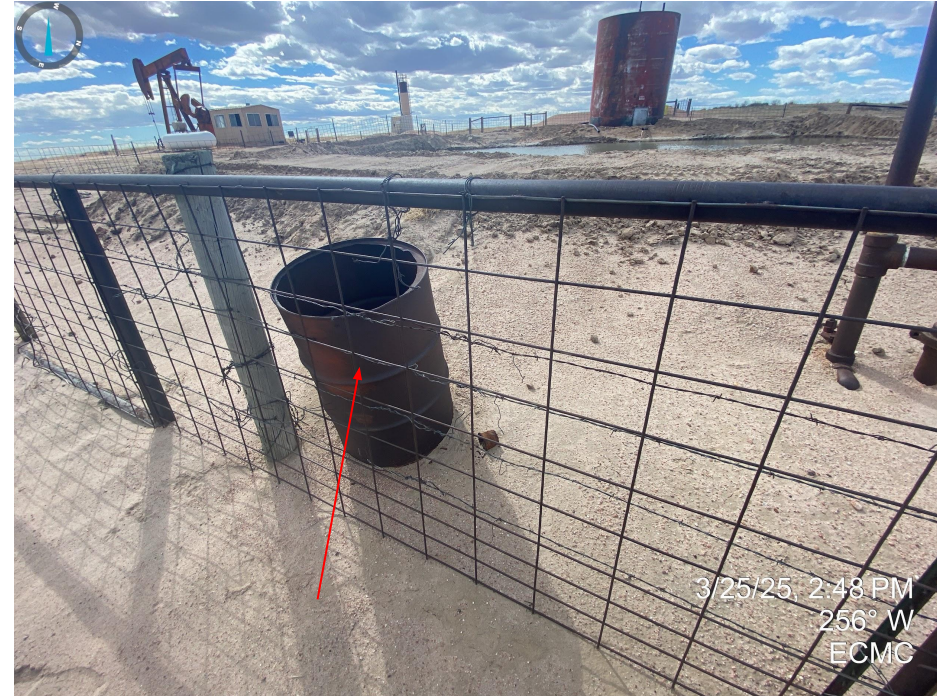
Photos 20 & 21. Improperly marked guy line anchor on northeast corner of pad (Photo 20; left) and unused equipment/debris within the smaller/western pit area.

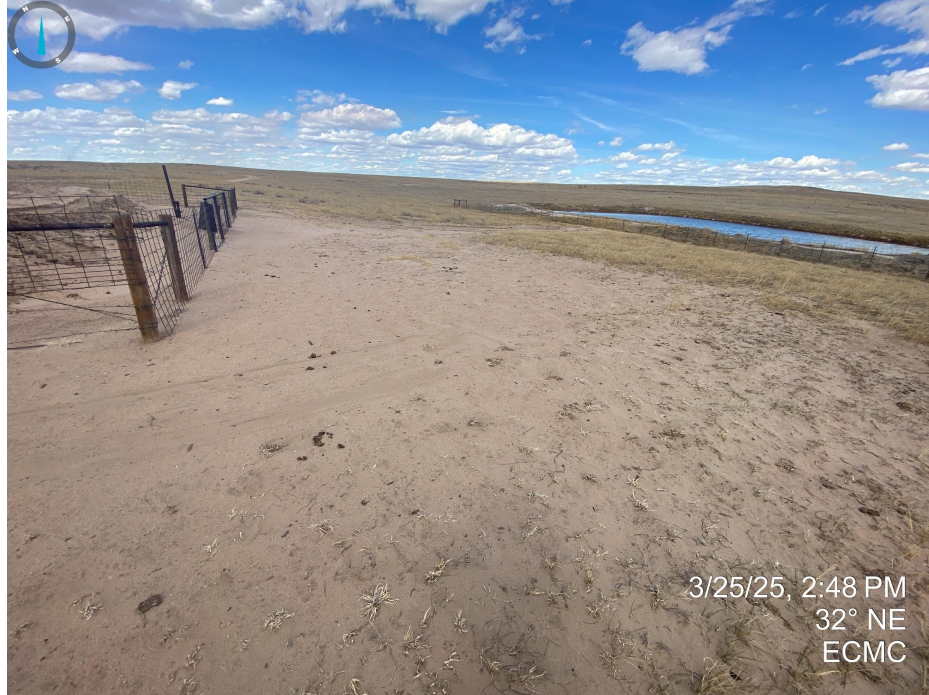
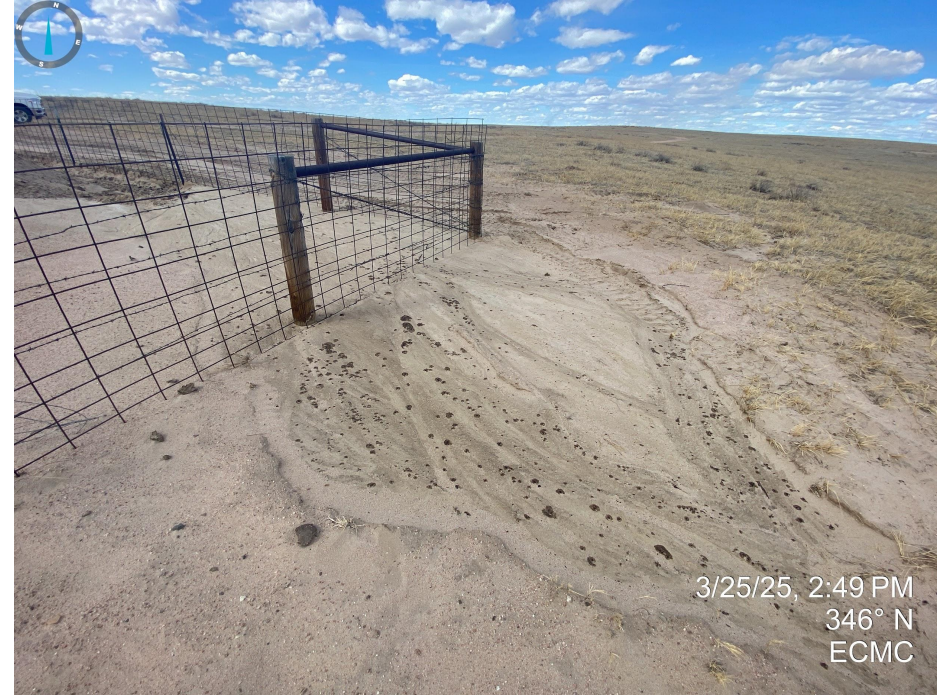
Photos 22 & 23. Unstabilized soils east side of the smaller/western pit with erosion degradation observed originating from the northeast side of the pit (Photo 23; right).

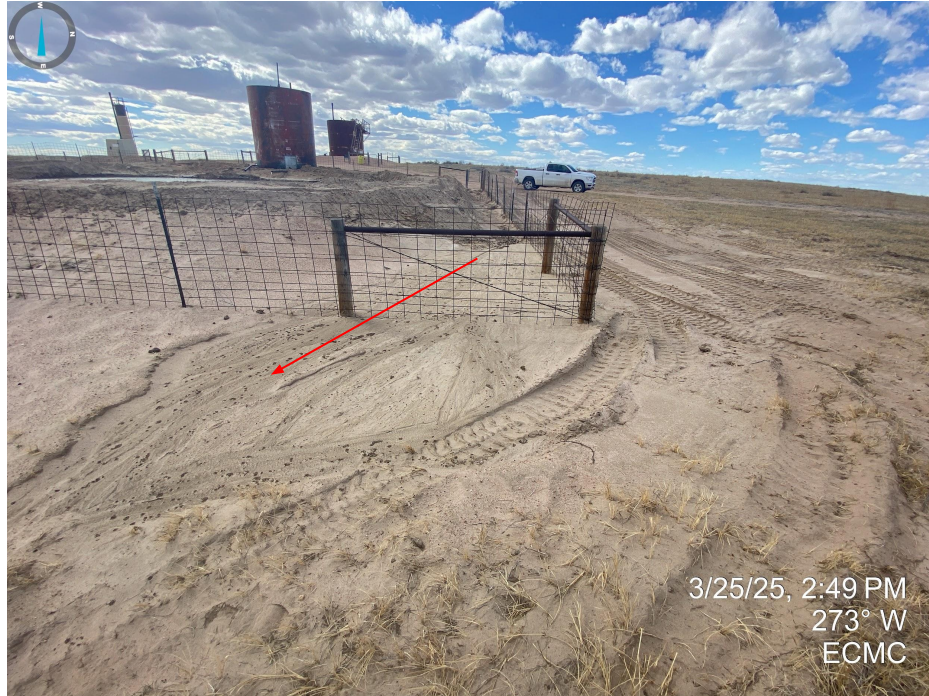
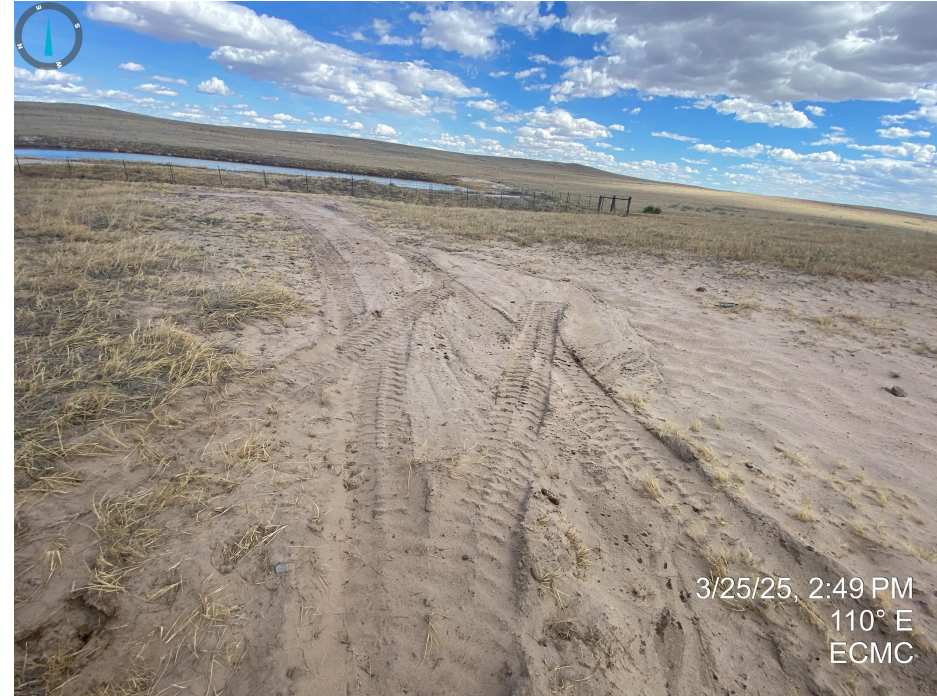
Photos 24 & 25. Taken from the northeast corner of the smaller/western pit. Photos illustrate evidence of erosion degradation possibly a result of a spill/release from the produced water pit.

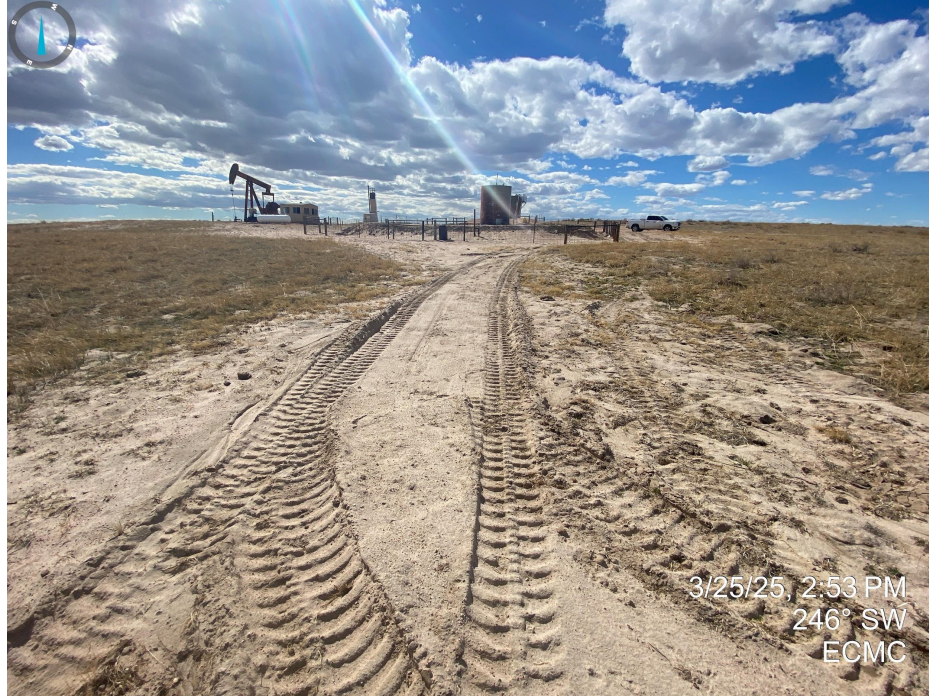
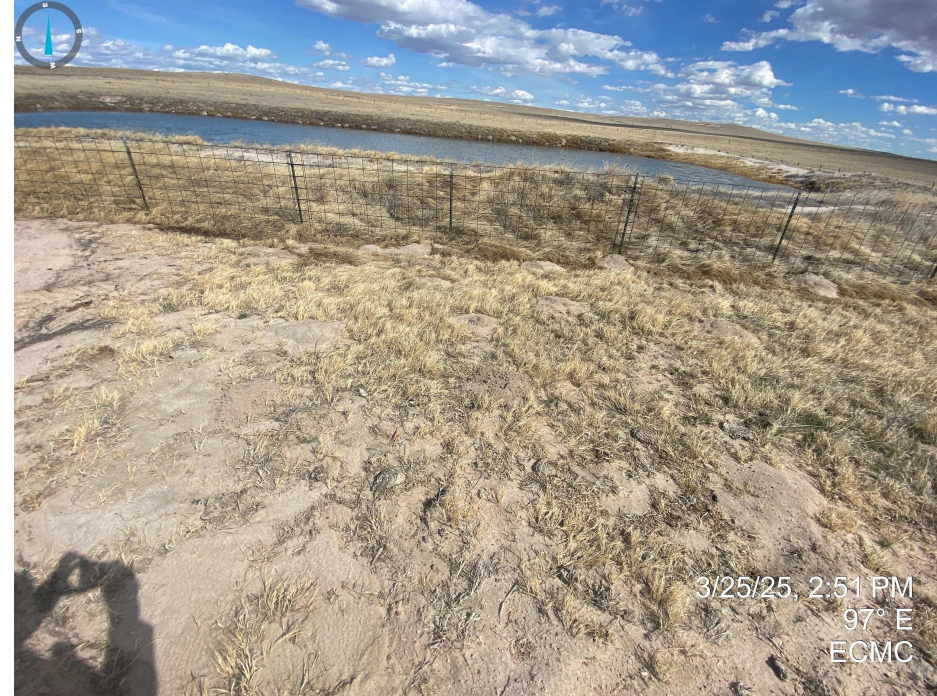
Photos 26 & 27. Taken from the western side of the larger/eastern pit. Photos illustrate evidence of erosion degradation possibly a result of a spill/release from the produced water pit.

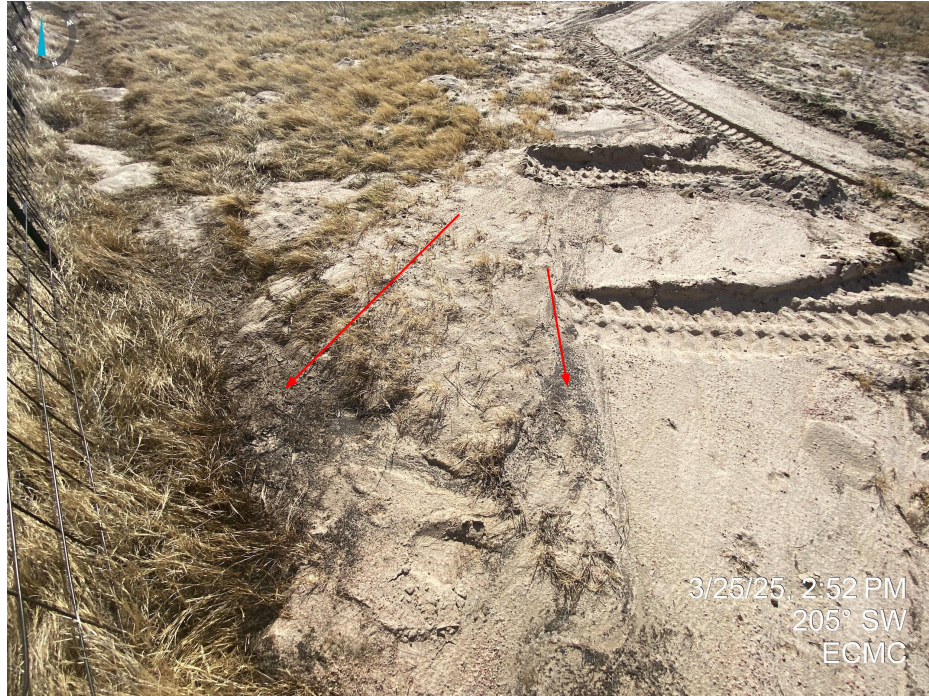
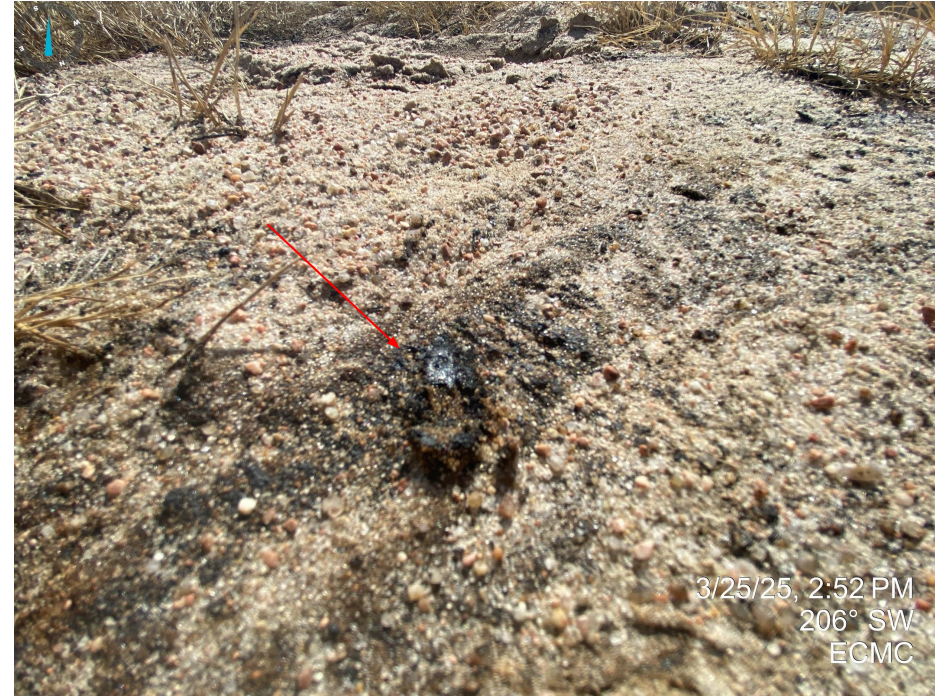
Photos 28 & 29. Stained soil and vegetation with a chemical odor observed within the spill/release area.

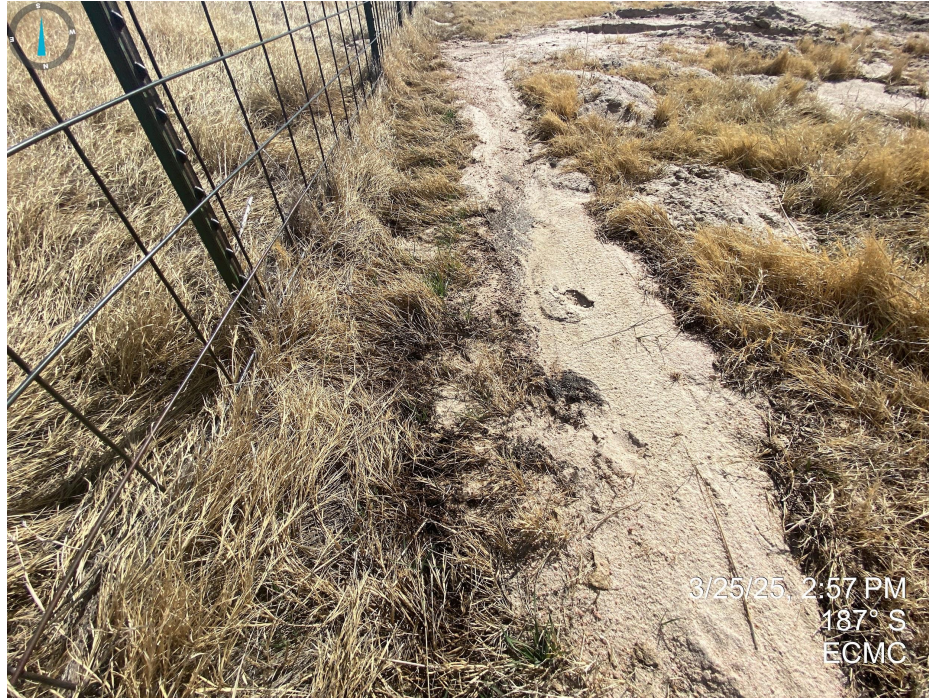
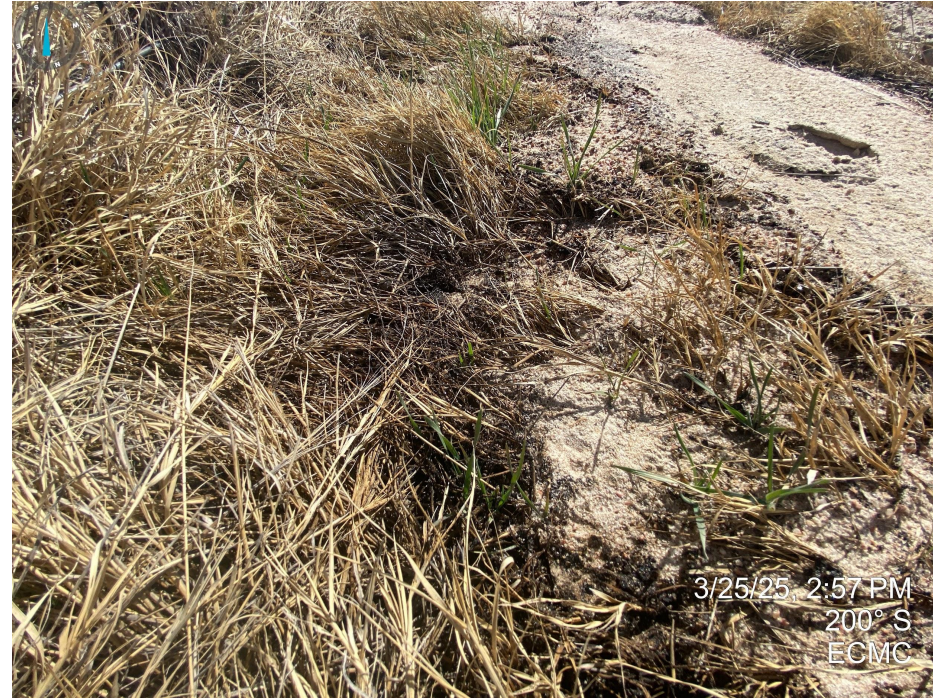
Photos 30 & 31. Continued from previous photos. Stained soil and vegetation with a chemical odor observed within the spill/release area.

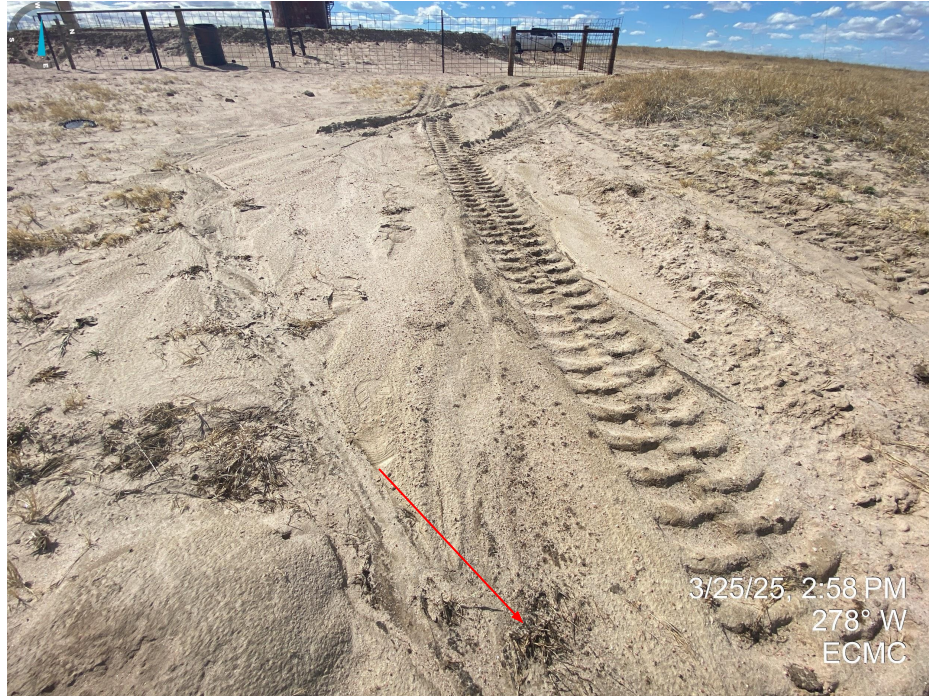
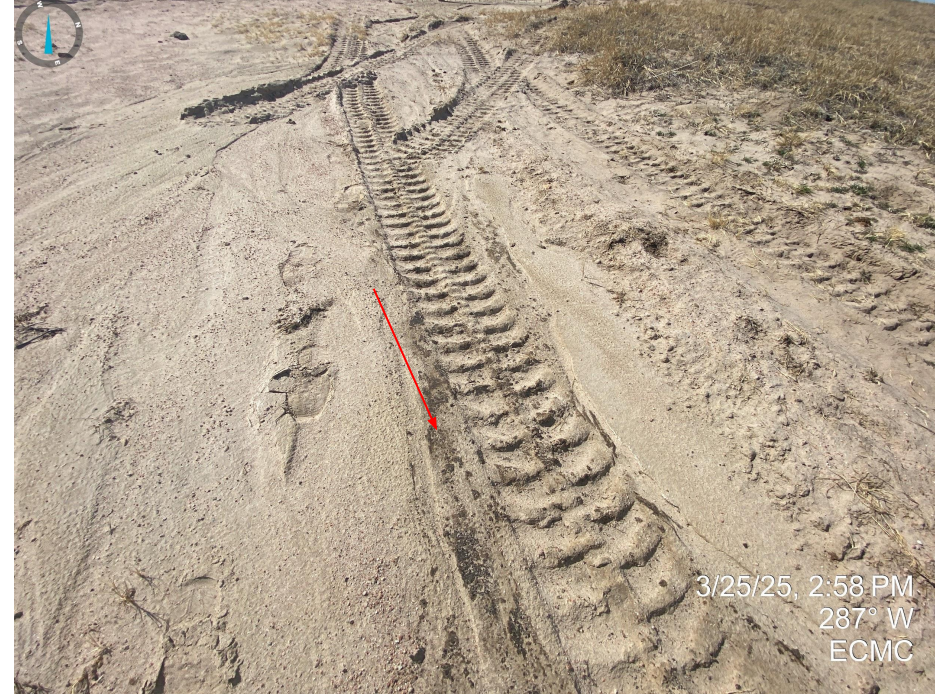
Photos 32 & 33. Stained soils observed within the spill/release area east of the smaller/western pit.
