Interim Reclamation and Stormwater Inspection

Operator: SCHMID PROPERTIES INC - 76830

Location ID: 317280

Inspection Photos
Location Name: Fassler #1-28
Location ID: 317280

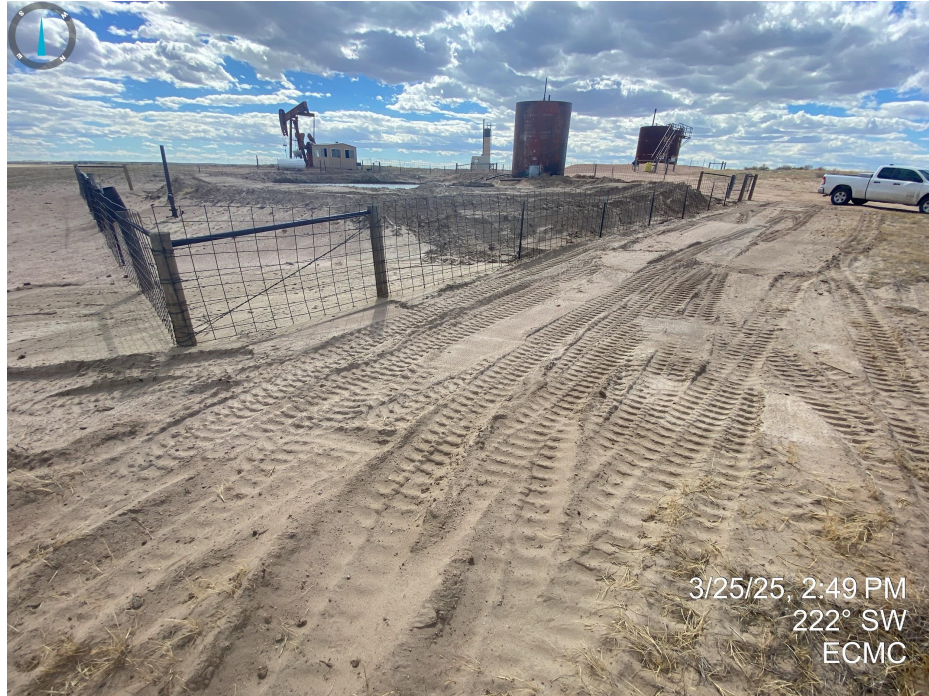
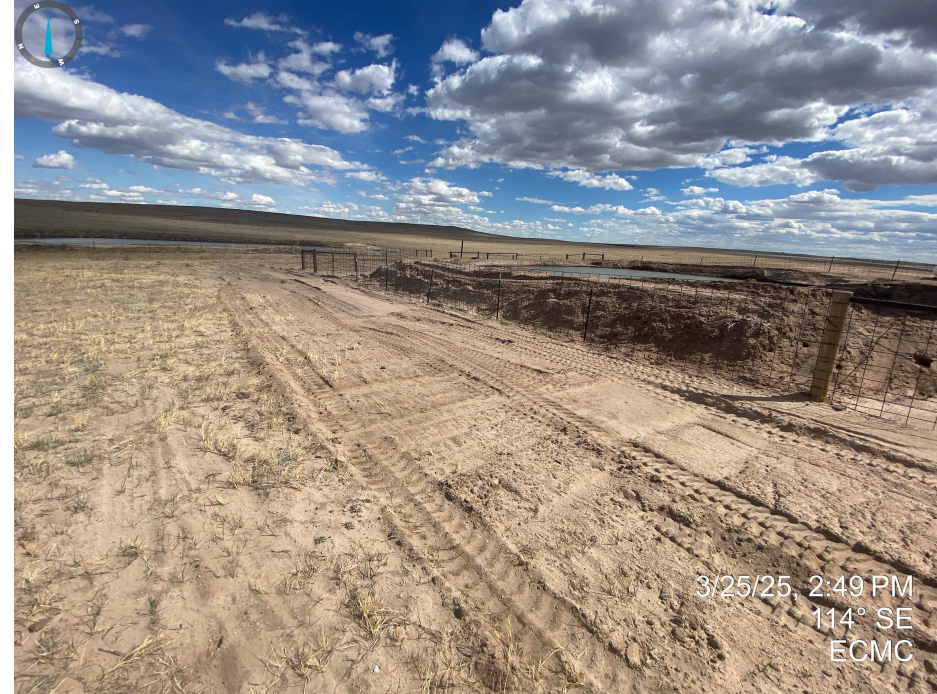
Photos 34 & 35. Unstabilized soil observed on the north side of the smaller/western pit.

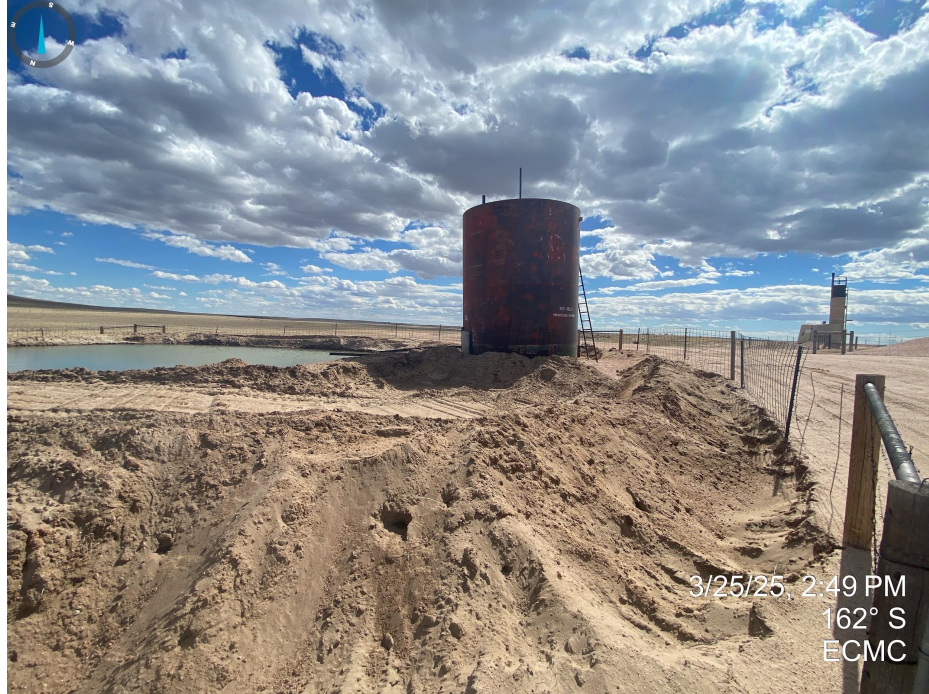
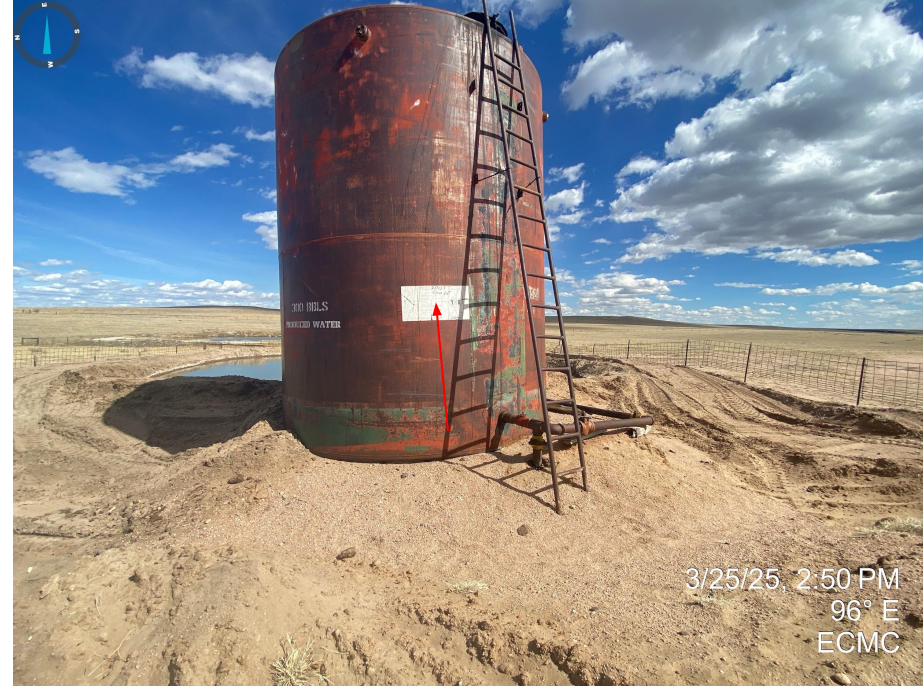
Photos 36 & 37. Berm material around the smaller/western pit appears to be unconsolidated and requires additional stabilization. Additionally, the secondary containment around the vertical AST does not appear adequate and tank labels/placards are missing/faded/peeling/cracked and require replacement.
